**Re: Closure Letter
Burch Keely Unit #963H
API #: 30-015-39576
RP#: 2RP-4916
Unit Letter D, Section 19, Township 17 S, Range 30 E
Lea County, New Mexico**

COG Operating, LLC (COG) is pleased to submit for your consideration the following closure report for the Burch Keely Unit #963H. This release occurred on June 14, 2018. Following the release an assessment of impacted soils was conducted. A remediation work plan was submitted to and subsequently approved by the New Mexico Oil Conservation Division (NMOCD) and the Bureau of Land Management. A copy of the approved work plan is attached in Appendix V.

Burch Keely Unit #963H

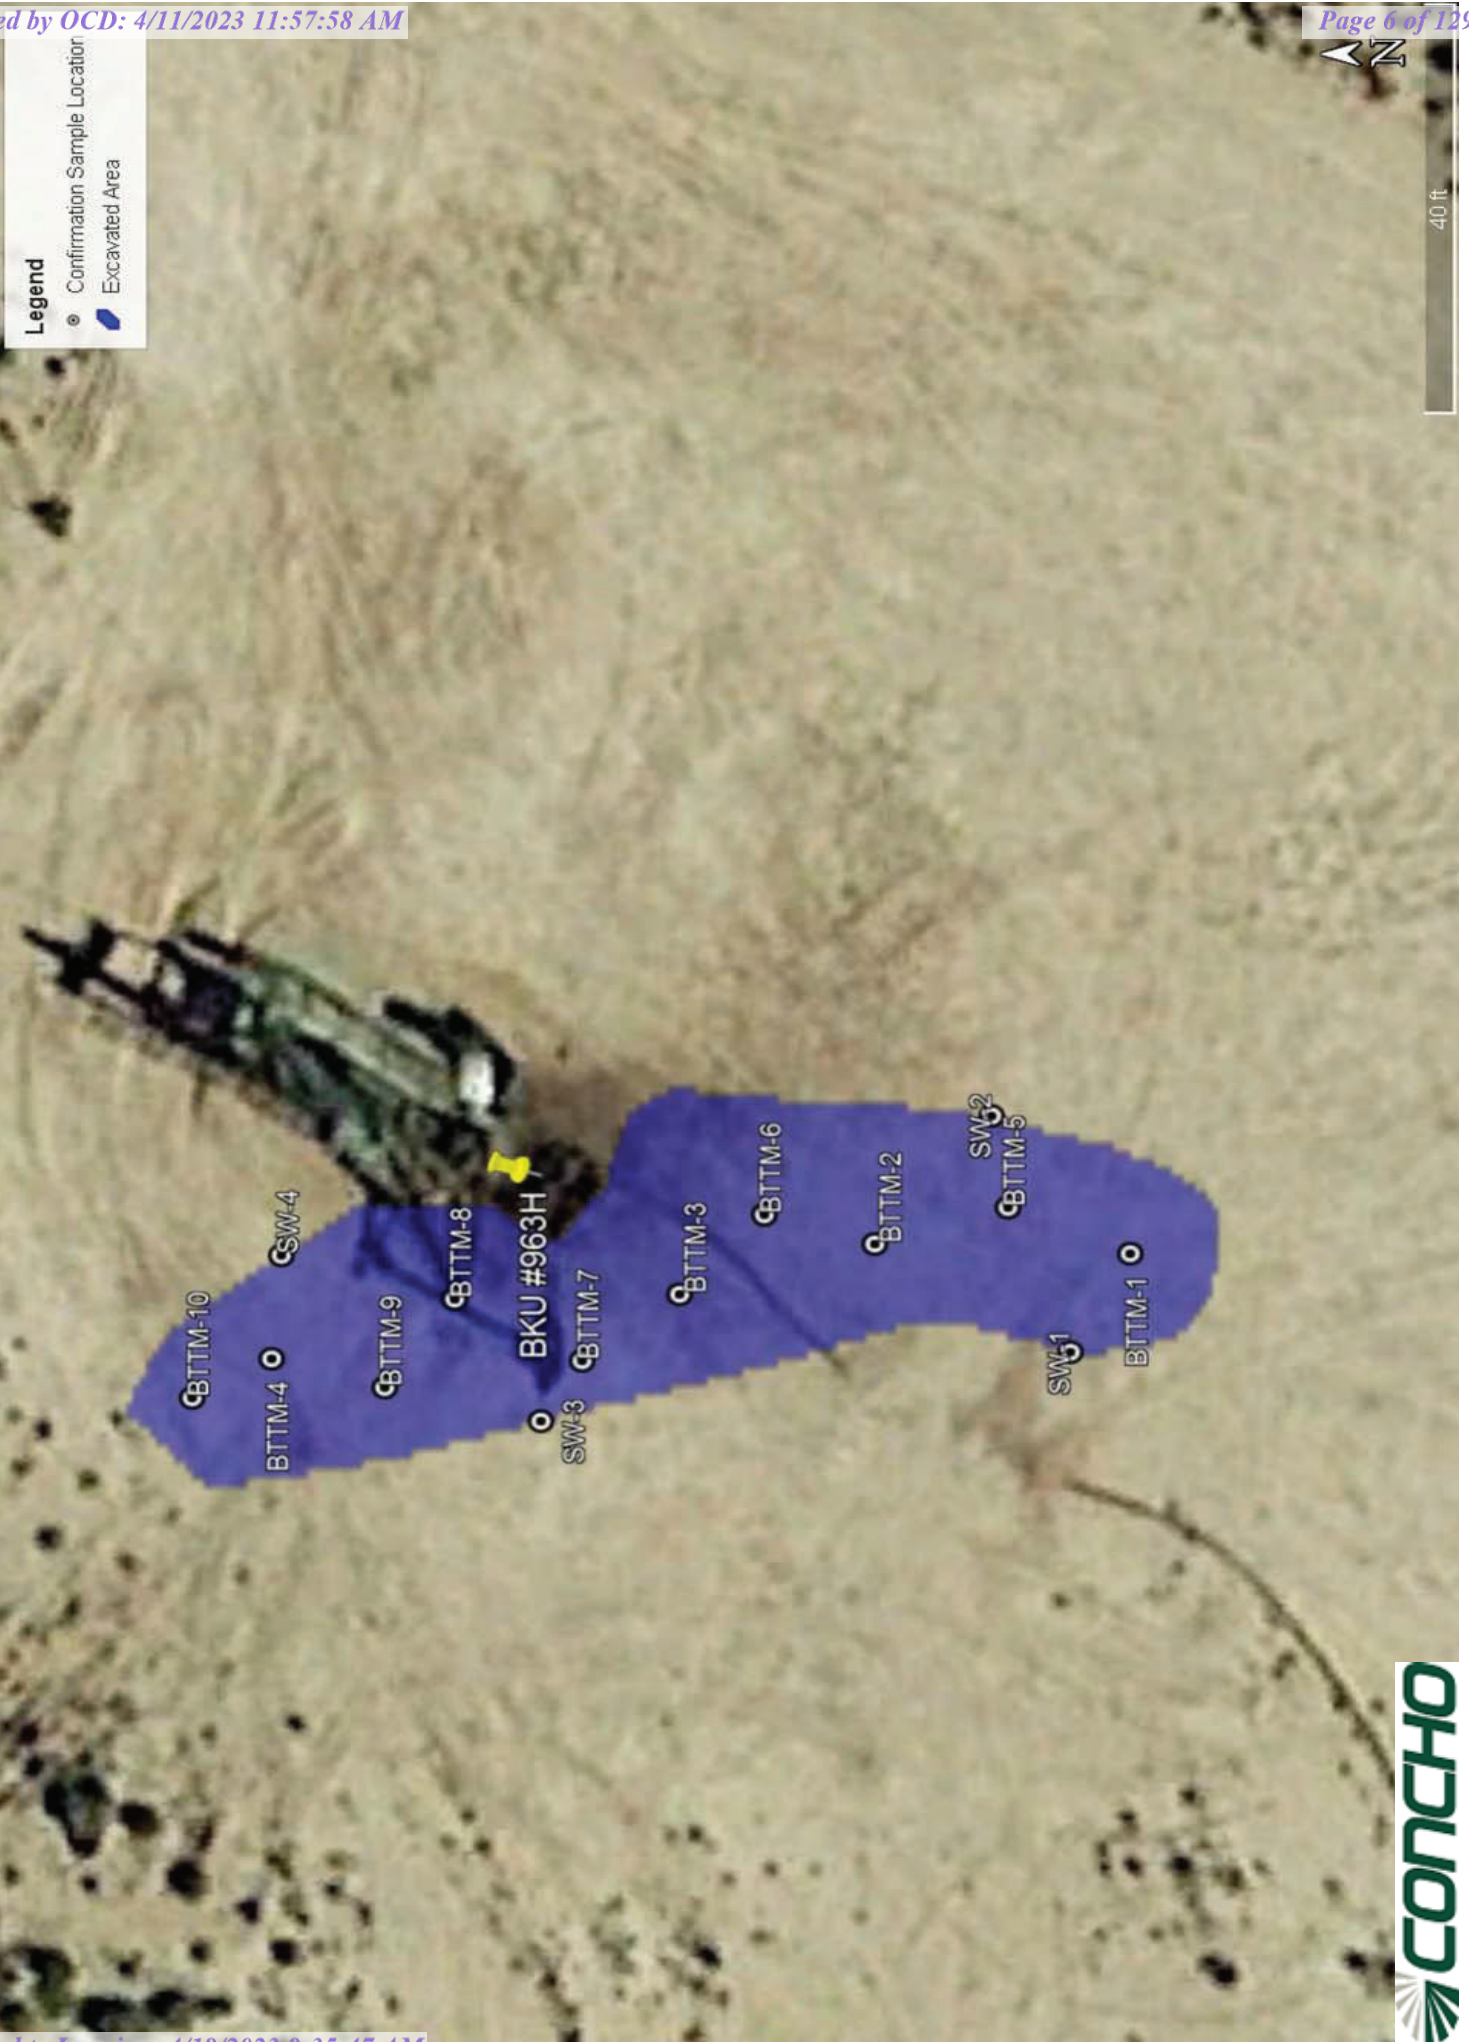
APPENDIX I

Remediation activities were conducted in accordance with the approved work plan and NMOCD/BLM stipulations. The analytical results from the confirmation soil sampling activities are summarized in the table below. A site diagram of the excavated area is presented in Appendix I.

- The impacted area was excavated utilizing field analysis and laboratory results to guide the extent of the excavation.
- Per NMOCD and BLM stipulations, confirmation soil samples were taken from the bottom and the sidewalls of the excavation. A site diagram is presented in Appendix I.
- All of the excavated material was hauled to an NMOCD approved solid waste disposal facility.
- Upon receipt of analytical results confirming that all impacted soil above NMOCD RRAL's was successfully removed the excavation was backfilled with caliche and contoured to match the surrounding location.
