1RP-2915

## Denton No. 3 SWD Injection Line

RE: 1RP-2915

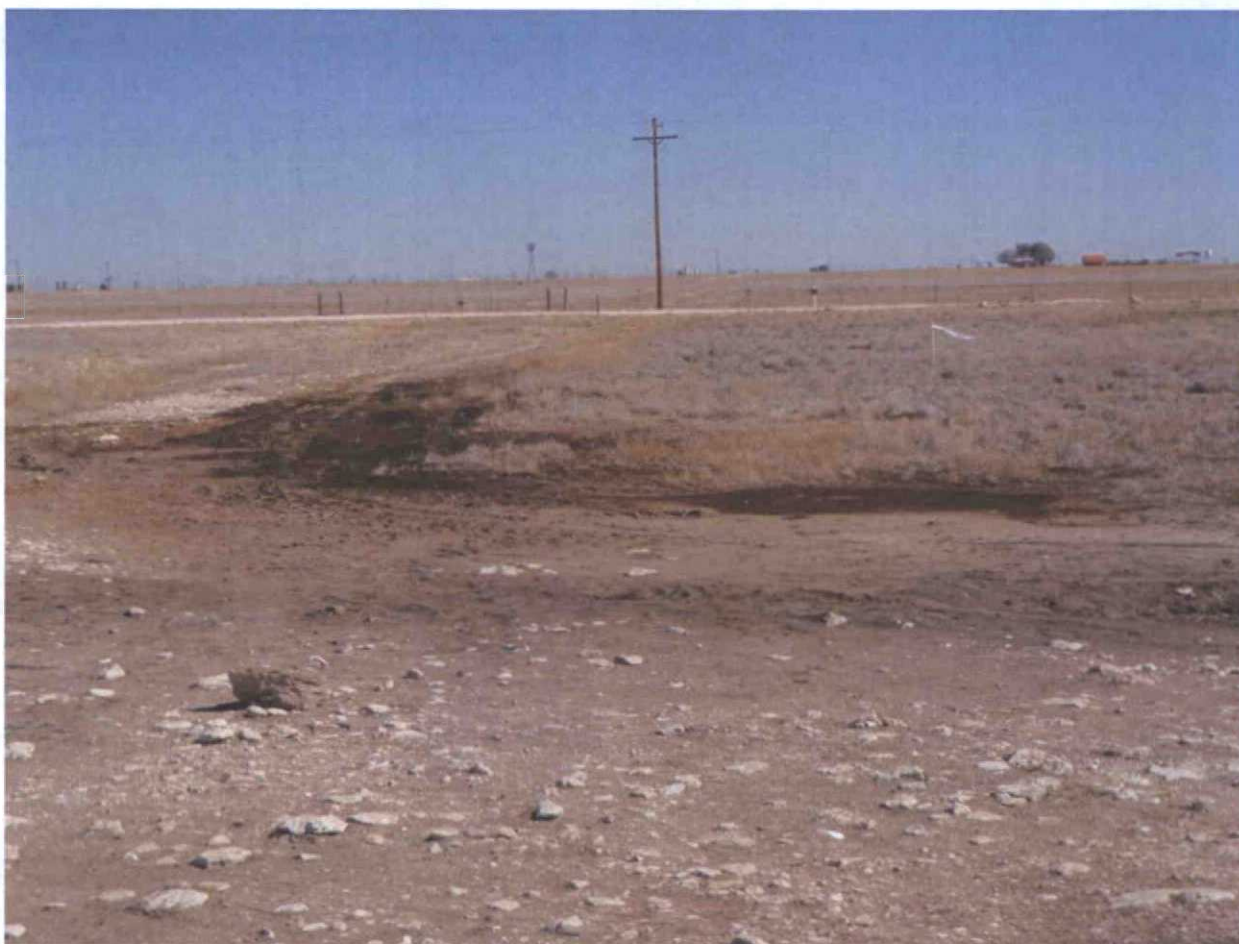
On April 29, 2013, Fasken discovered a release had occurred at the Denton SWD #3. The release was attributed to the failure of a four inch (4") vietaulic clamp. The pump shut down immediately due to low pressure. The site was dug out, and the clamp was replaced. The "Release Notification and Corrective Action" (Form C-141) indicated approximately twenty (20) barrels of produced water were released. The release impacted an area of pasture measuring approximately one hundred feet (100') in length and seventy-five (75') in width.

Photograph of the release at the Denton SWD #3 Environmental Remediation Site.
