Closure

Release Notification

On March 18, 2020, a release occurred at Matador’s Tony La Russa site when a seal on the produced water pump flowline failed. This incident resulted in the release of approximately 16.60 barrels (bbls) of produced water onto the engineered pad and into adjacent pasture. Upon discovery of the release, a hydrovac truck was dispatched to site to recover free fluids; approximately 12 bbls of produced water were recovered. The spill impacted an area off-lease that had experienced previous disturbance. No produced water was released into undisturbed or sensitive areas, or waterways.

ATTACHMENT 2

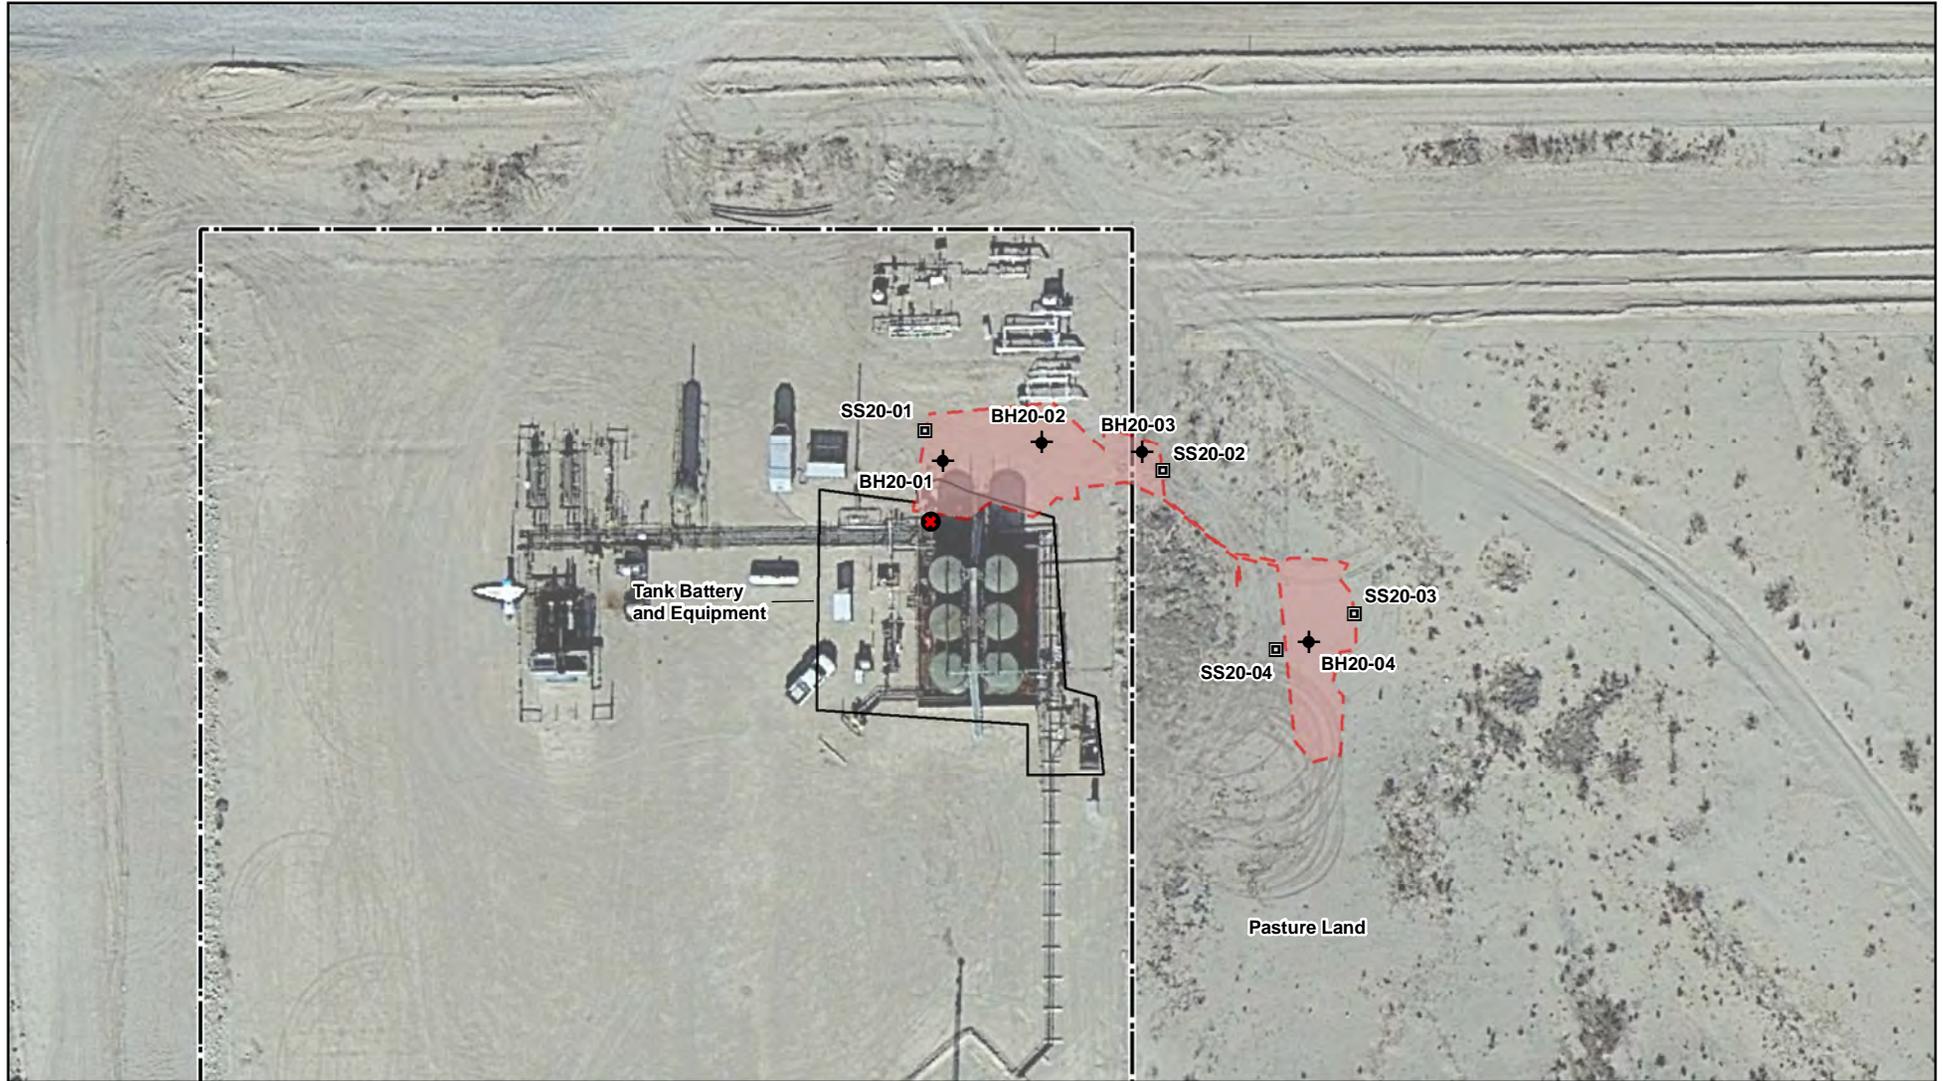
Document Path: G:\1-Projects\US PROJECTS\Material Resources\20E-00239\006 - Tony La Russa State Com #201H\Figure 1 Tony La Russa State Com #201H.mxd

- ◆ Borehole
- ★ Point of Release
- ▣ Soil Sample
- ▭ Approximate Spill Extent (~ 3,411 sq. ft.)
- ⬜ Approximate Lease Boundary
- ▭ Infrastructure (Existing)

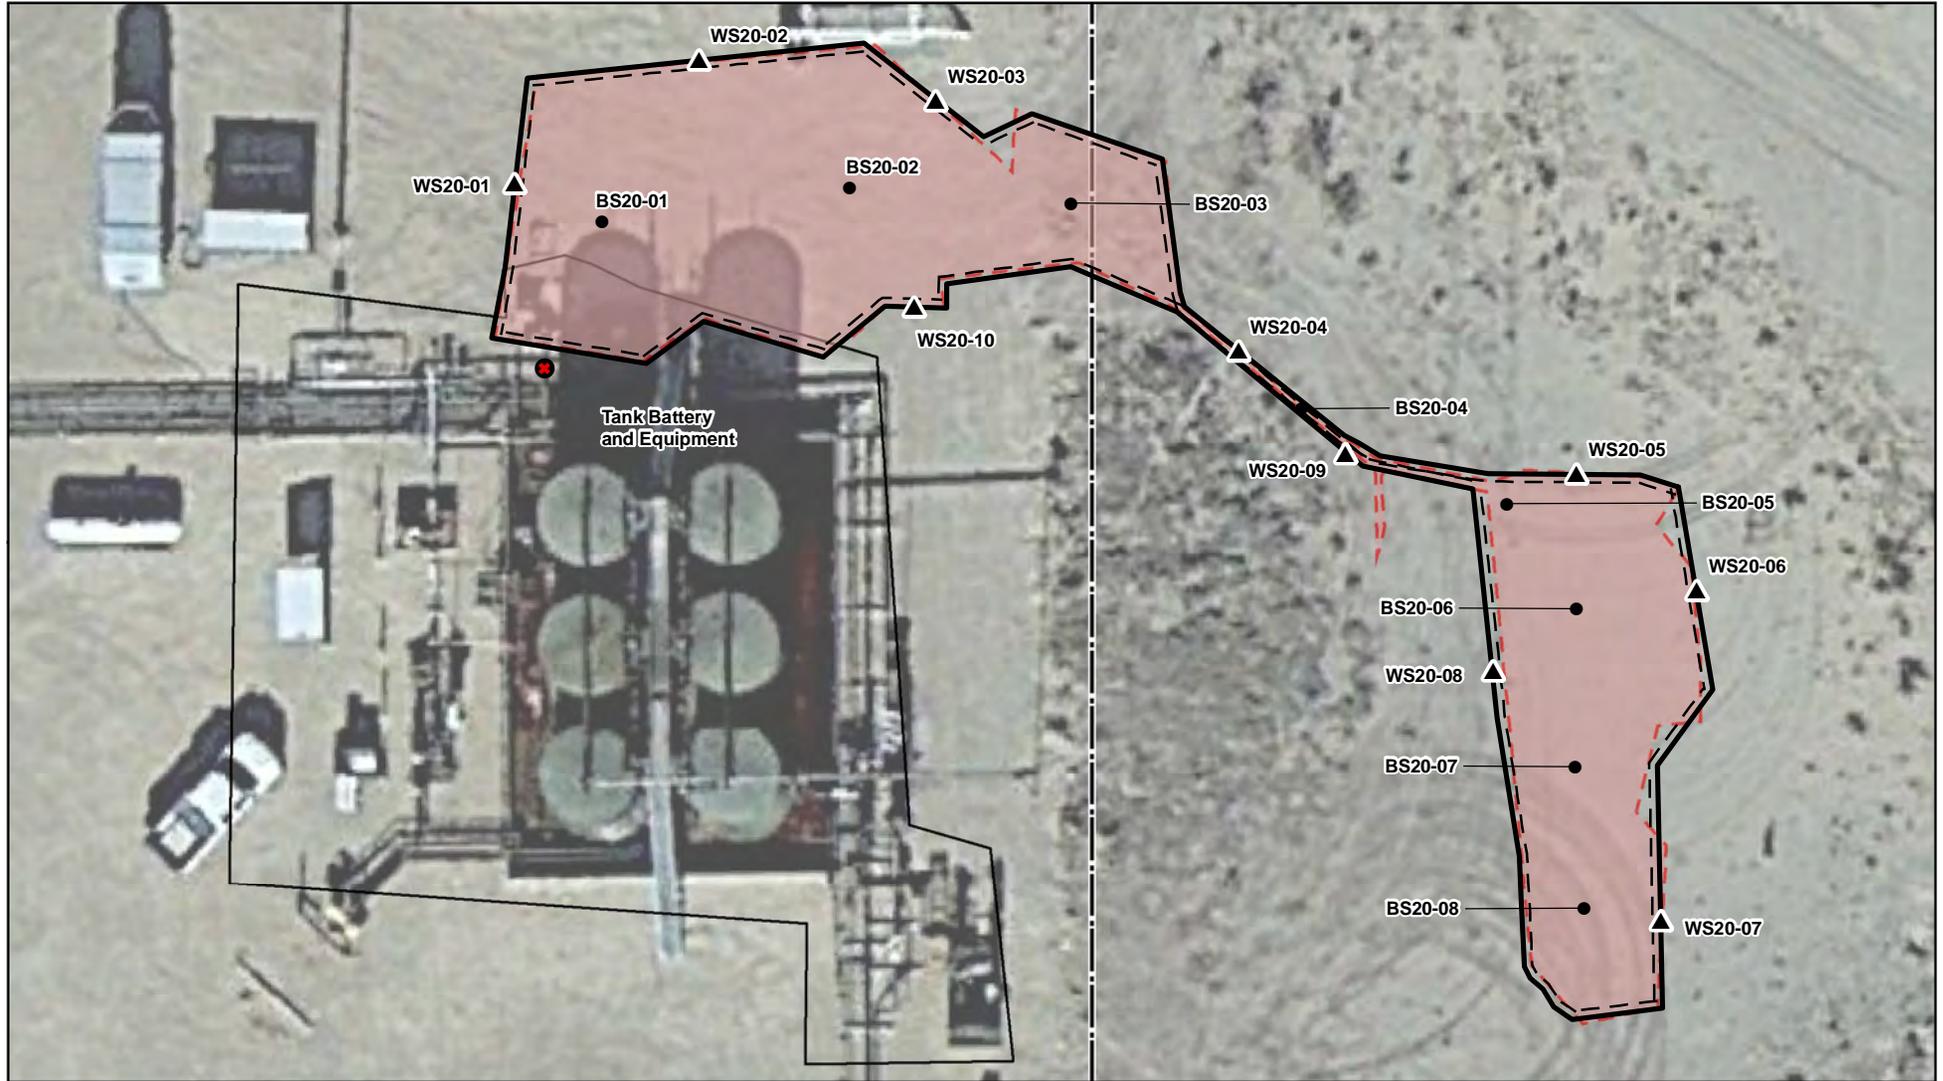
Document Path: G:\1-Projects\US PROJECTS\Material Resources\20E-00239\006 - Tony La Russa State Com #201H\Figure 2 Confirmation Schematic Tony La Russa State Com #201H.mxd

- Base Sample
- ★ Point of Release
- ▲ Wall Sample
- Approximate Spill Extent (~ 3,411 sq. ft.)
- ▭ Approximate Lease Boundary
- ▭ Excavation Extent (~ 3,614 sq. ft.)
- ▭ Infrastructure (Existing)

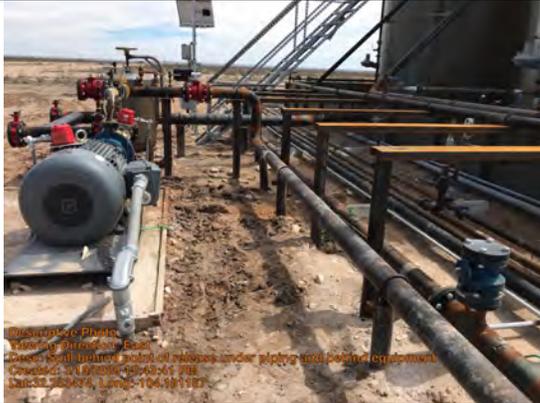
Descriptive Photo:
Viewing Direction: East
Desc: Spill behind point of release under piping and behind equipment
Created: 3/19/2020 12:44:24 PM
Lat:32.253474, **Long:**-104.181187

Spill behind point of release under piping and behind equipment

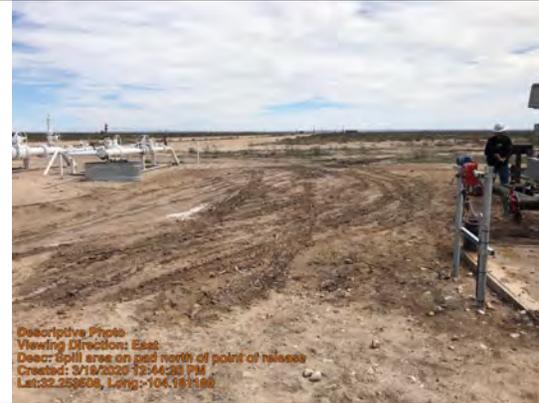
Descriptive Photo:
Viewing Direction: East
Desc: Spill area on pad north of point of release
Created: 3/19/2020 12:44:28 PM
Lat:32.253608, **Long:**-104.181188

Spill area on pad north of point of release

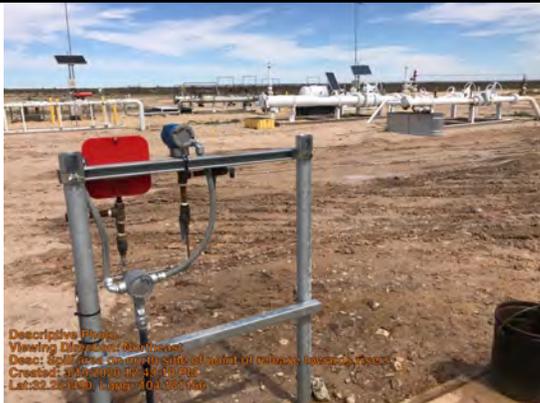
Descriptive Photo:
Viewing Direction: Northeast
Desc: Spill area on north side of point of release towards risers
Created: 3/19/2020 12:48:24 PM
Lat:32.253474, **Long:**-104.181187

Spill area on north side of point of release towards risers

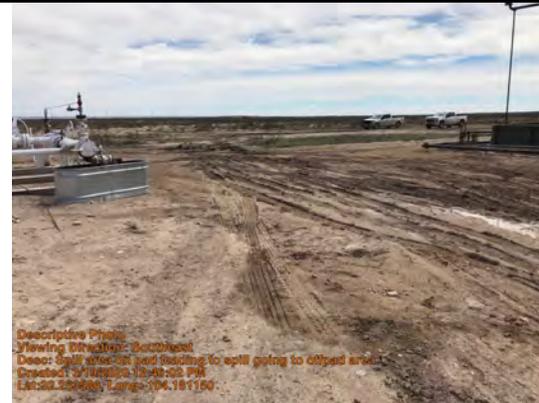
Descriptive Photo:
Viewing Direction: Southeast
Desc: Spill area on pad leading to spill going to offpad area
Created: 3/19/2020 12:48:28 PM
Lat:32.253608, **Long:**-104.181188

Spill area on pad leading to spill going to offpad area

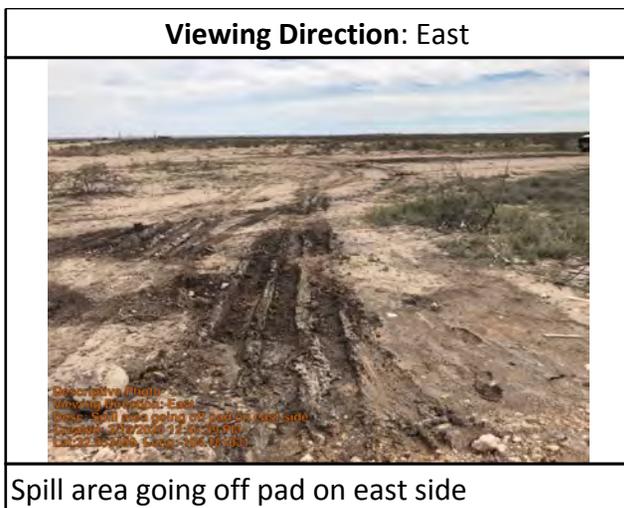
Spill area going off pad on east side

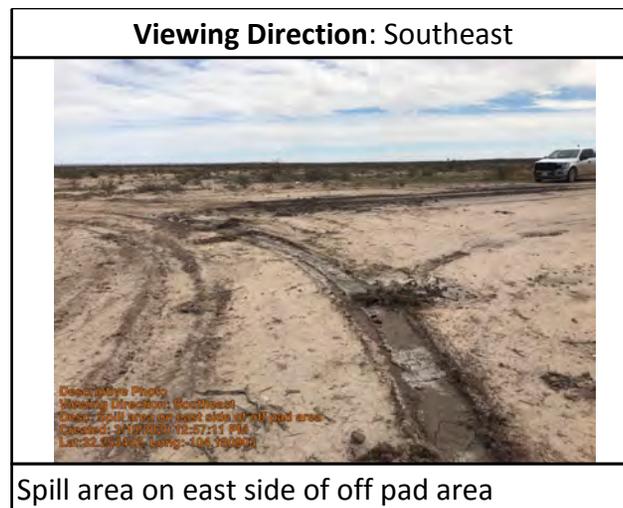
Spill area on east side of off pad area

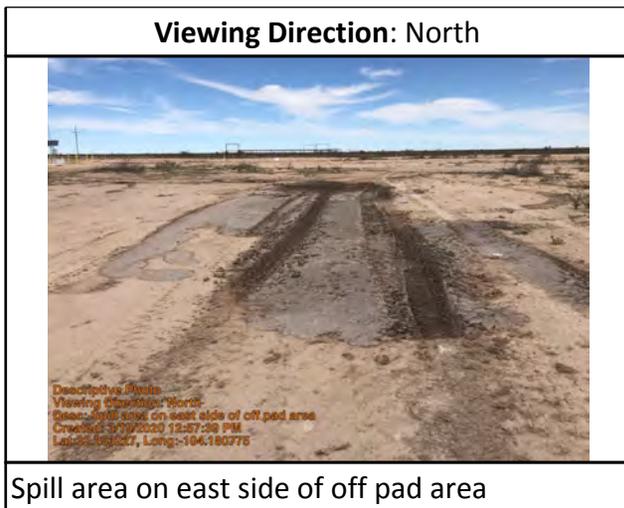
Spill area on east side of off pad area

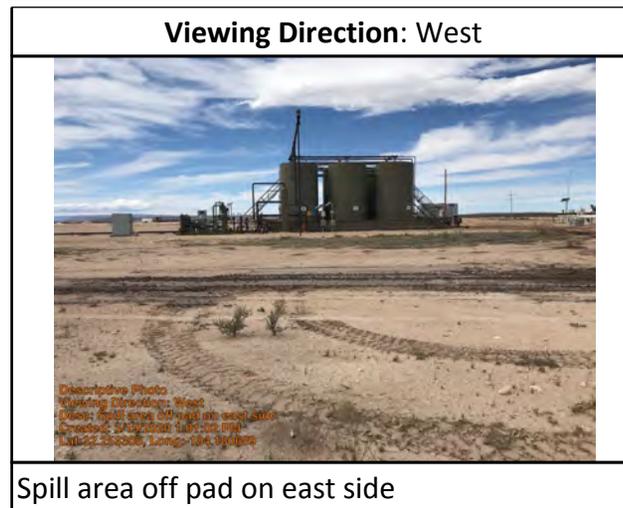
Spill area off pad on east side

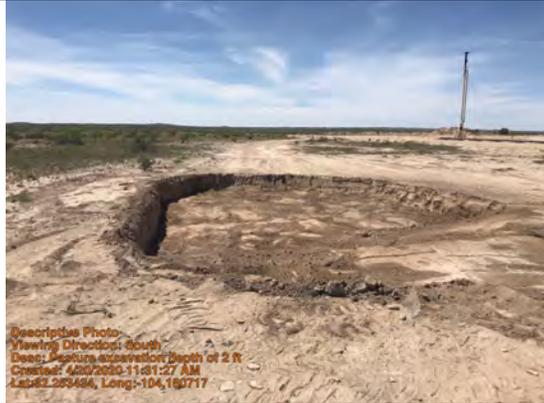
Descriptive Photo
Viewing Direction: South
Desc: Pasture excavation depth of 2 ft
Created: 4/20/2020 11:31:27 AM
Lat:32.283464, Long:-104.160717

Pasture excavation depth of 2 ft

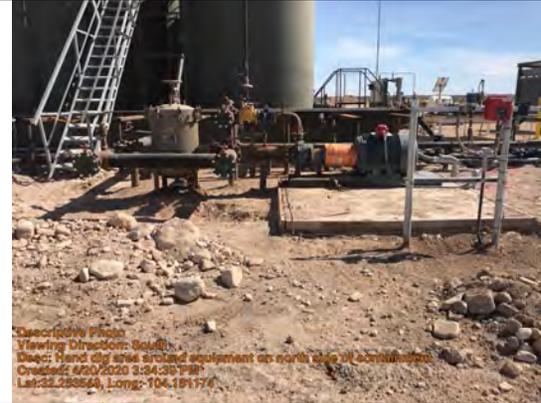
Descriptive Photo
Viewing Direction: South
Desc: Hand dig area around equipment on north side of containment
Created: 4/20/2020 3:04:35 PM
Lat:32.283544, Long:-104.161574

Hand dig area around equipment on north side of containment

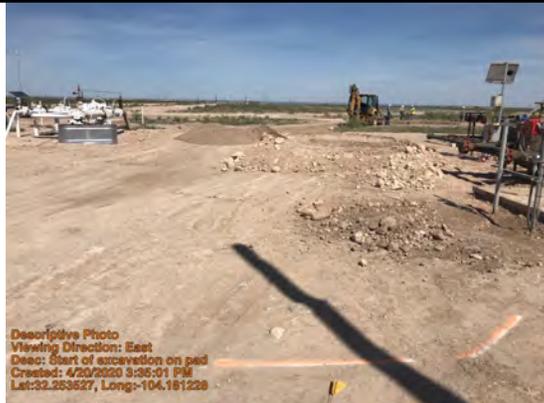
Descriptive Photo
Viewing Direction: East
Desc: Start of excavation on pad
Created: 4/20/2020 3:35:01 PM
Lat:32.283527, Long:-104.161228

Start of excavation on pad

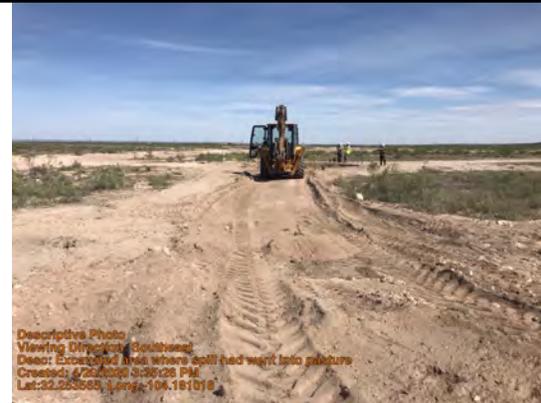
Descriptive Photo
Viewing Direction: Southeast
Desc: Excavated area where spill had went into pasture
Created: 4/20/2020 3:35:28 PM
Lat:32.283565, Long:-104.161018

Excavated area where spill had went into pasture

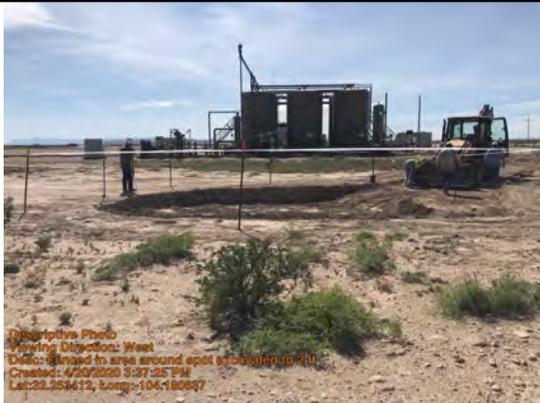
Describe Photo
Viewing Direction: West
Date: 4/20/2020 3:37:25 PM
Created: 4/20/2020 3:37:25 PM
Lat:32.253612, Long:-104.180837

Fenced in area around spot excavated to 2 ft

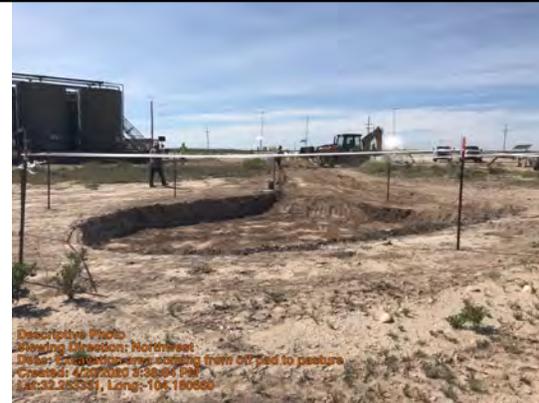
Describe Photo
Viewing Direction: Northwest
Date: 4/20/2020 3:38:04 PM
Created: 4/20/2020 3:38:04 PM
Lat:32.253351, Long:-104.180680

Excavation area coming from off pad to pasture

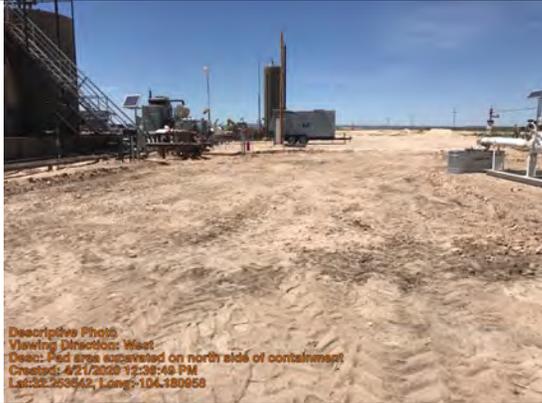
Descriptive Photo
Viewing Direction: West
Desc: Pad area excavated on north side of containment
Created: 4/21/2020 12:38:48 PM
Lat:32.263942, Long:-104.180958

Pad area excavated on north side of containment

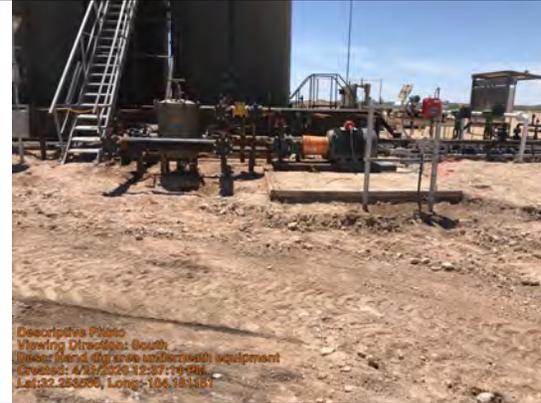
Descriptive Photo
Viewing Direction: South
Desc: Hand dig area underneath equipment
Created: 4/21/2020 12:37:19 PM
Lat:32.263086, Long:-104.181451

Hand dig area underneath equipment

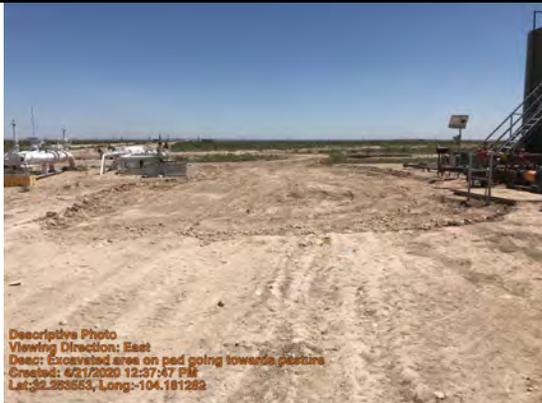
Descriptive Photo
Viewing Direction: East
Desc: Excavated area on pad going towards pasture
Created: 4/21/2020 12:37:47 PM
Lat:32.263553, Long:-104.181282

Excavated area on pad going towards pasture

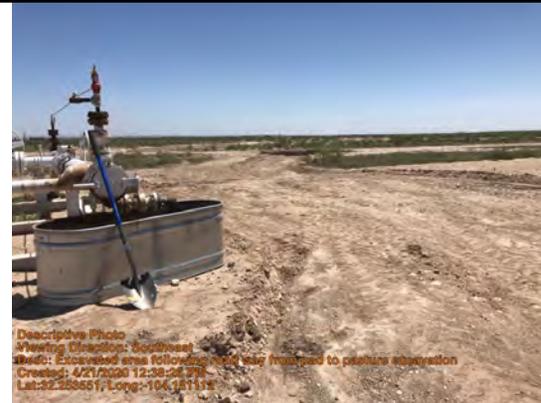
Descriptive Photo
Viewing Direction: Southeast
Desc: Excavated area following road way from pad to pasture excavation
Created: 4/21/2020 12:36:24 PM
Lat:32.263551, Long:-104.181112

Excavated area following road way from pad to pasture excavation

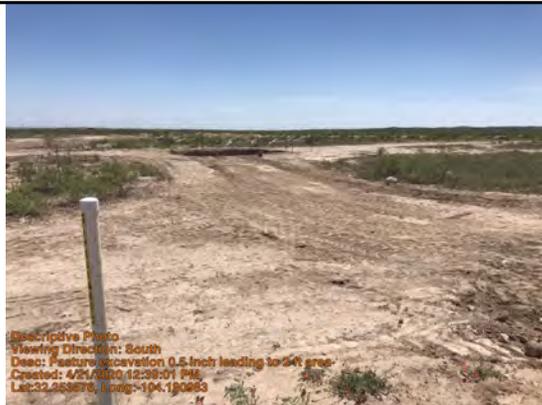
Descriptive Photo
Viewing Direction: South
Desc: Pasture excavation 0.5 inch leading to 2 ft area
Created: 4/21/2020 12:39:01 PM
Lat:32.263276, Long:-104.180983

Pasture excavation 0.5 inch leading to 2 ft area

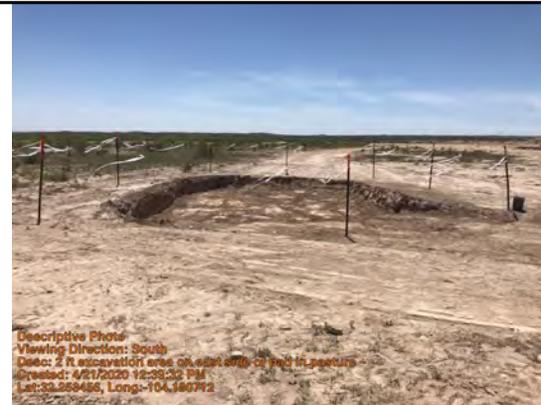
Descriptive Photo
Viewing Direction: South
Desc: 2 ft excavation area on east side of pad in pasture
Created: 4/21/2020 12:39:32 PM
Lat:32.263456, Long:-104.180712

2 ft excavation area on east side of pad in pasture

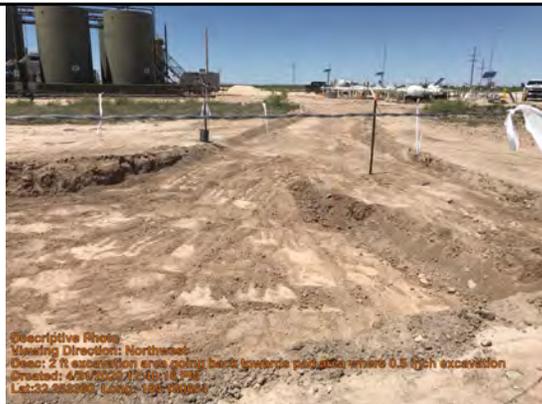
Descriptive Photo
Viewing Direction: Northwest
Desc: 2 ft excavation area going back towards pad area where 0.5 inch excavation
Created: 4/21/2020 12:41:18 PM
Lat:32.263441, Long:-104.180983

2 ft excavation area going back towards pad area where 0.5 inch excavation occurred

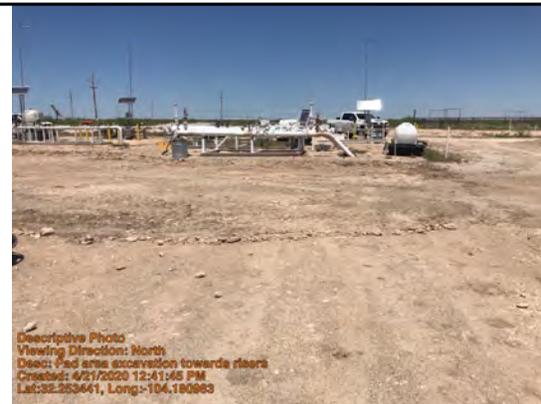
Descriptive Photo
Viewing Direction: North
Desc: Pad area excavation towards risers
Created: 4/21/2020 12:41:46 PM
Lat:32.263441, Long:-104.180983

Pad area excavation towards risers
