**RE: Liner Inspection and Closure Report
Cotton Draw 32 State SWD #2
API No. 30-015-41524
GPS: Latitude 32.1699175 Longitude -103.6913616
UL- P, Section 32, Township 24S, Range 32E,
Lea County, NM
NMOCD Reference No. NAPP2233243493**

Devon Energy Production Company (Devon) has contracted Pima Environmental Services, LLC (Pima) to perform a liner inspection and prepare this closure report for a produced water and crude oil release that happened on the Cotton Draw 32 State SWD #2 (Cotton). An initial C-141 was submitted on January 16, 2023, and can be found in Appendix B. This incident was assigned Incident ID NAPP2233243493, by the New Mexico Oil Conservation Division (NMOCD).

**SITE PHOTOGRAPHS
DEVON ENERGY**

COTTON DRAW 32 ST SWD 2

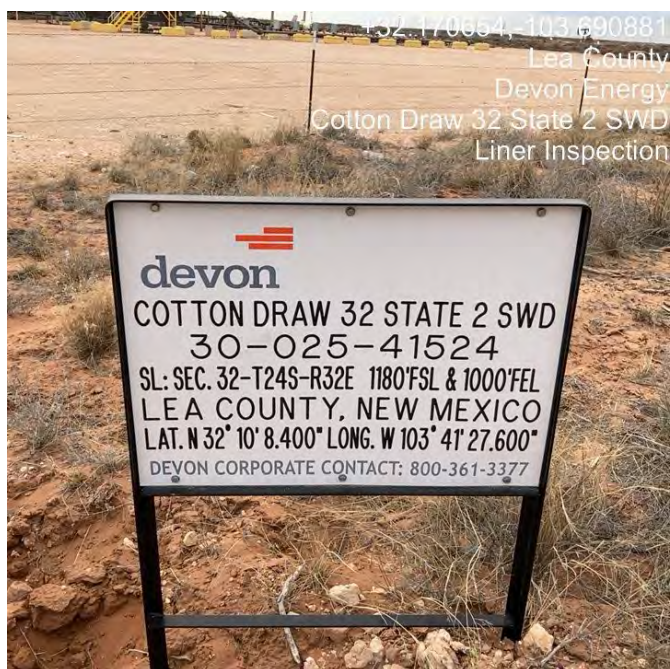
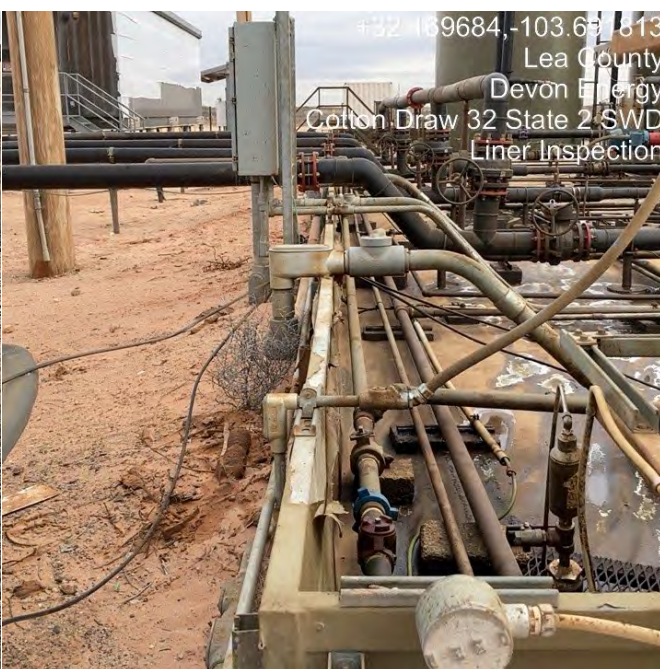
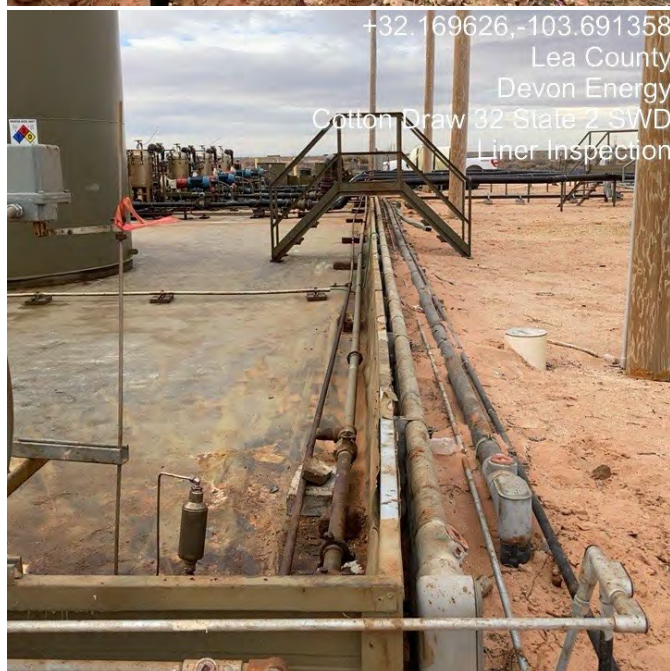
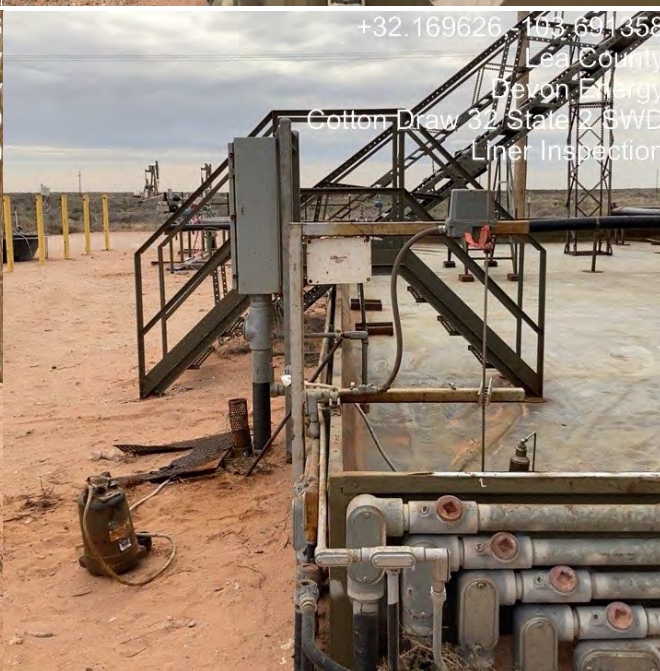
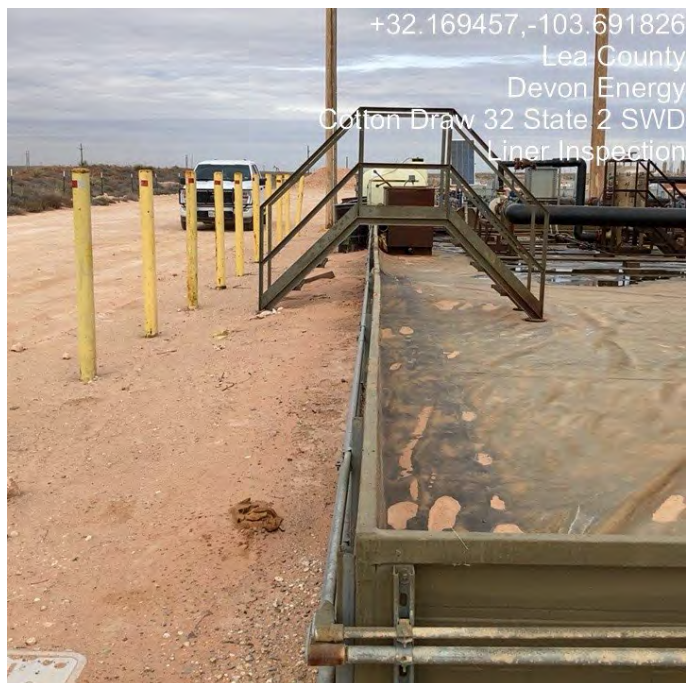
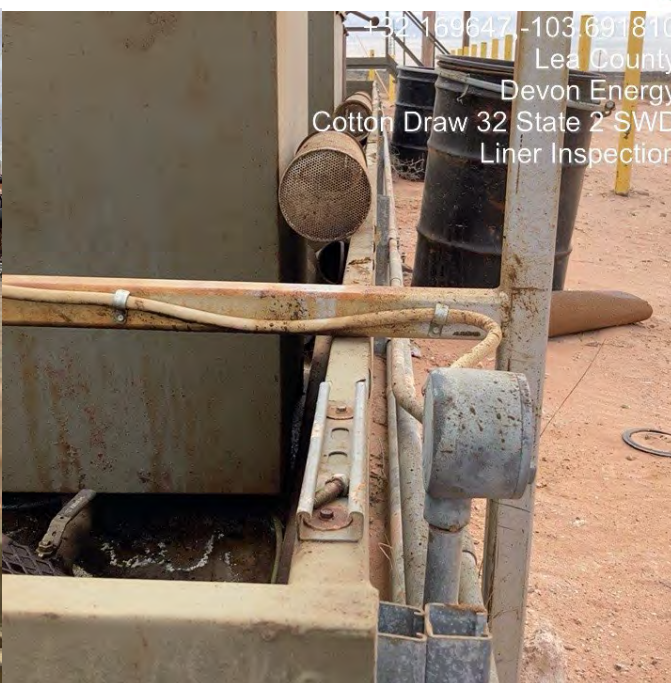
Liner Inspection

On December 2, 2022, after sending the 48-hour notification via email, Pima Environmental conducted a liner inspection at this location. We concluded that this liner and containment maintained its integrity and was able to retain the fluids. The liner inspection form and photographic documentation can be found in Appendix C.

Visualization	Yes	No	Comments
Is there a tear in the liner?		X	
Are there holes in the liner?		X	
Is the liner retaining any fluids?	x		Rain water
Does the liner have integrity to contain a leak?	X
