RE: Liner Inspection and Closure Report
Seawolf 1-12 CBT 1
API No. N/A
GPS: Latitude 32.077077 Longitude -103.526861
UL- C, Section 1, Township 26S, Range 33E,
Lea County, NM
NMOCD Reference No. NAPP2106443694

Devon Energy Production Company (Devon) has contracted Pima Environmental Services, LLC (Pima) to perform a liner inspection and prepare this closure report for a produced water release that happened on the Seawolf 1-12 CBT 1 (Seawolf). An initial C-141 was submitted on March 5, 2021, and can be found in Appendix B. This incident was assigned Incident ID NAPP2106443694, by the New Mexico Oil Conservation Division (NMOCD).

**SITE PHOTOGRAPHS
DEVON ENERGY – LINER INSPECTION
SEAWOLF 1-12 CTB 1**

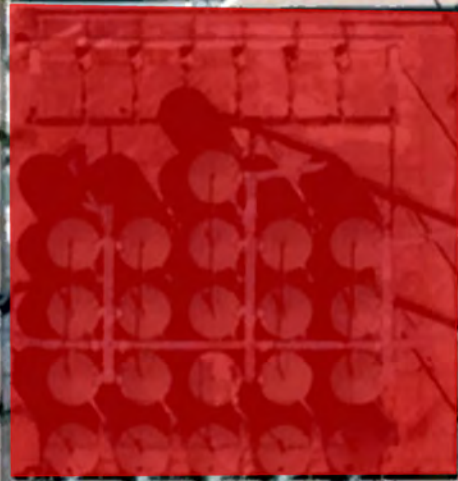
Devon Energy
API# N/A
Lea County, NM
Site Map

NAPP2106443694: On February 19, 2021. A release was due to a failed dump that hung open causing the skim tank to run over. Approximately 720 barrels (bbls) of produced water were released from the skim tank. Vacuum trucks were dispatched and recovered all 720 bbls of fluid from the lined SPCC containment ring. Once fluids were removed, the liner was visually inspected by Devon field staff for any pinholes or punctures, and none were found. Based on this inspection there is no evidence that the spilled fluids left containment.

Spill Area

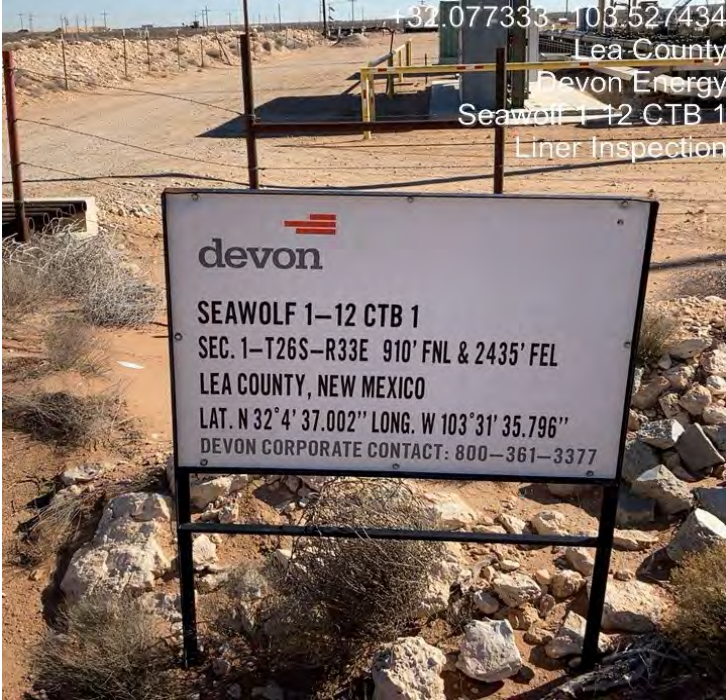
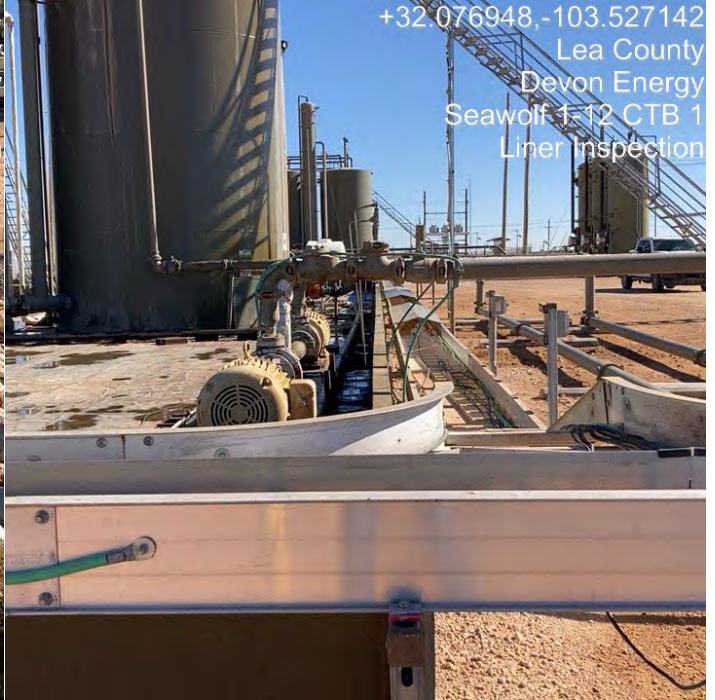
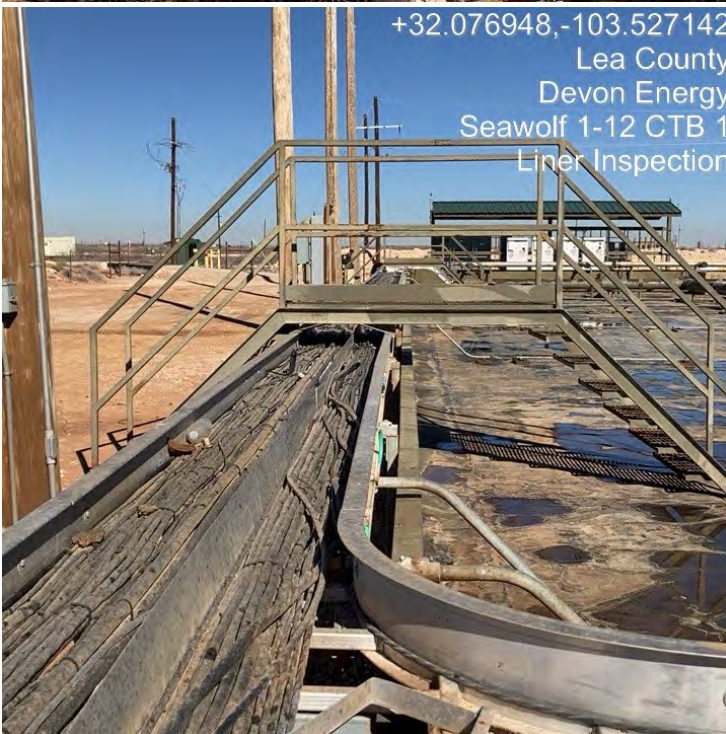
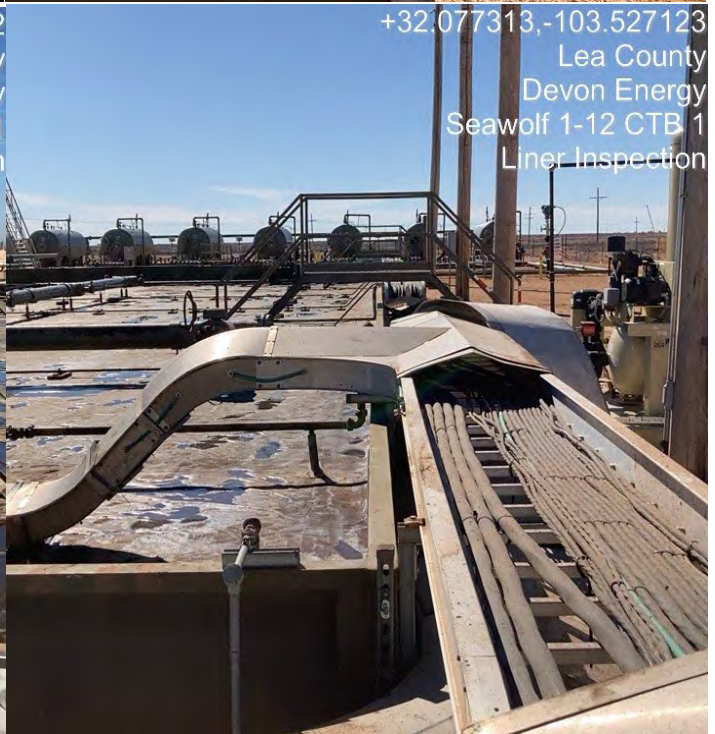
On April 23, 2023, after sending the 48-hour notification via email, Pima Environmental conducted a liner inspection at this location. We concluded that this liner and containment maintained its integrity and was able to retain the fluids. The liner inspection form and photographic documentation can be found in Appendix C.

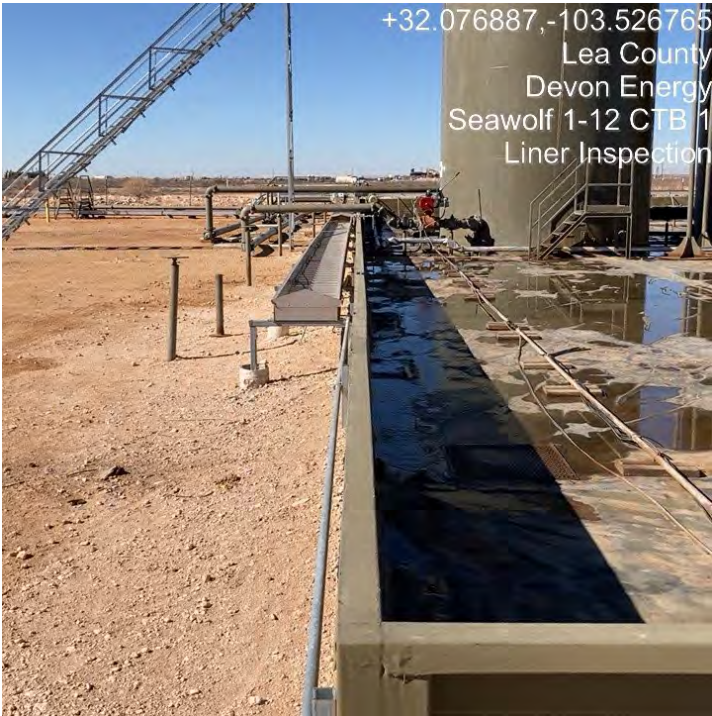
+32.076887,-103.526765
Lea County
Devon Energy
Seawolf 1-12 CTB 1
Liner Inspection

Visualization	Yes	No	Comments
Is there a tear in the liner?		X	
Are there holes in the liner?		X	
Is the liner retaining any fluids?	X		Rain water
Does the liner have integrity to contain a leak?	X
