**Re: Closure Letter
White Oak State #1
API #: 30-015-29749
RP#: 2RP-4154
Eddy County, NM**

Report Type: Work Plan 2RP-4154

Re: Work Plan for the COG Operating LLC., White Oak State #1, Unit P, Section 23, Township 17 South, Ranch 28 East, Eddy County, New Mexico. 2RP-4154.

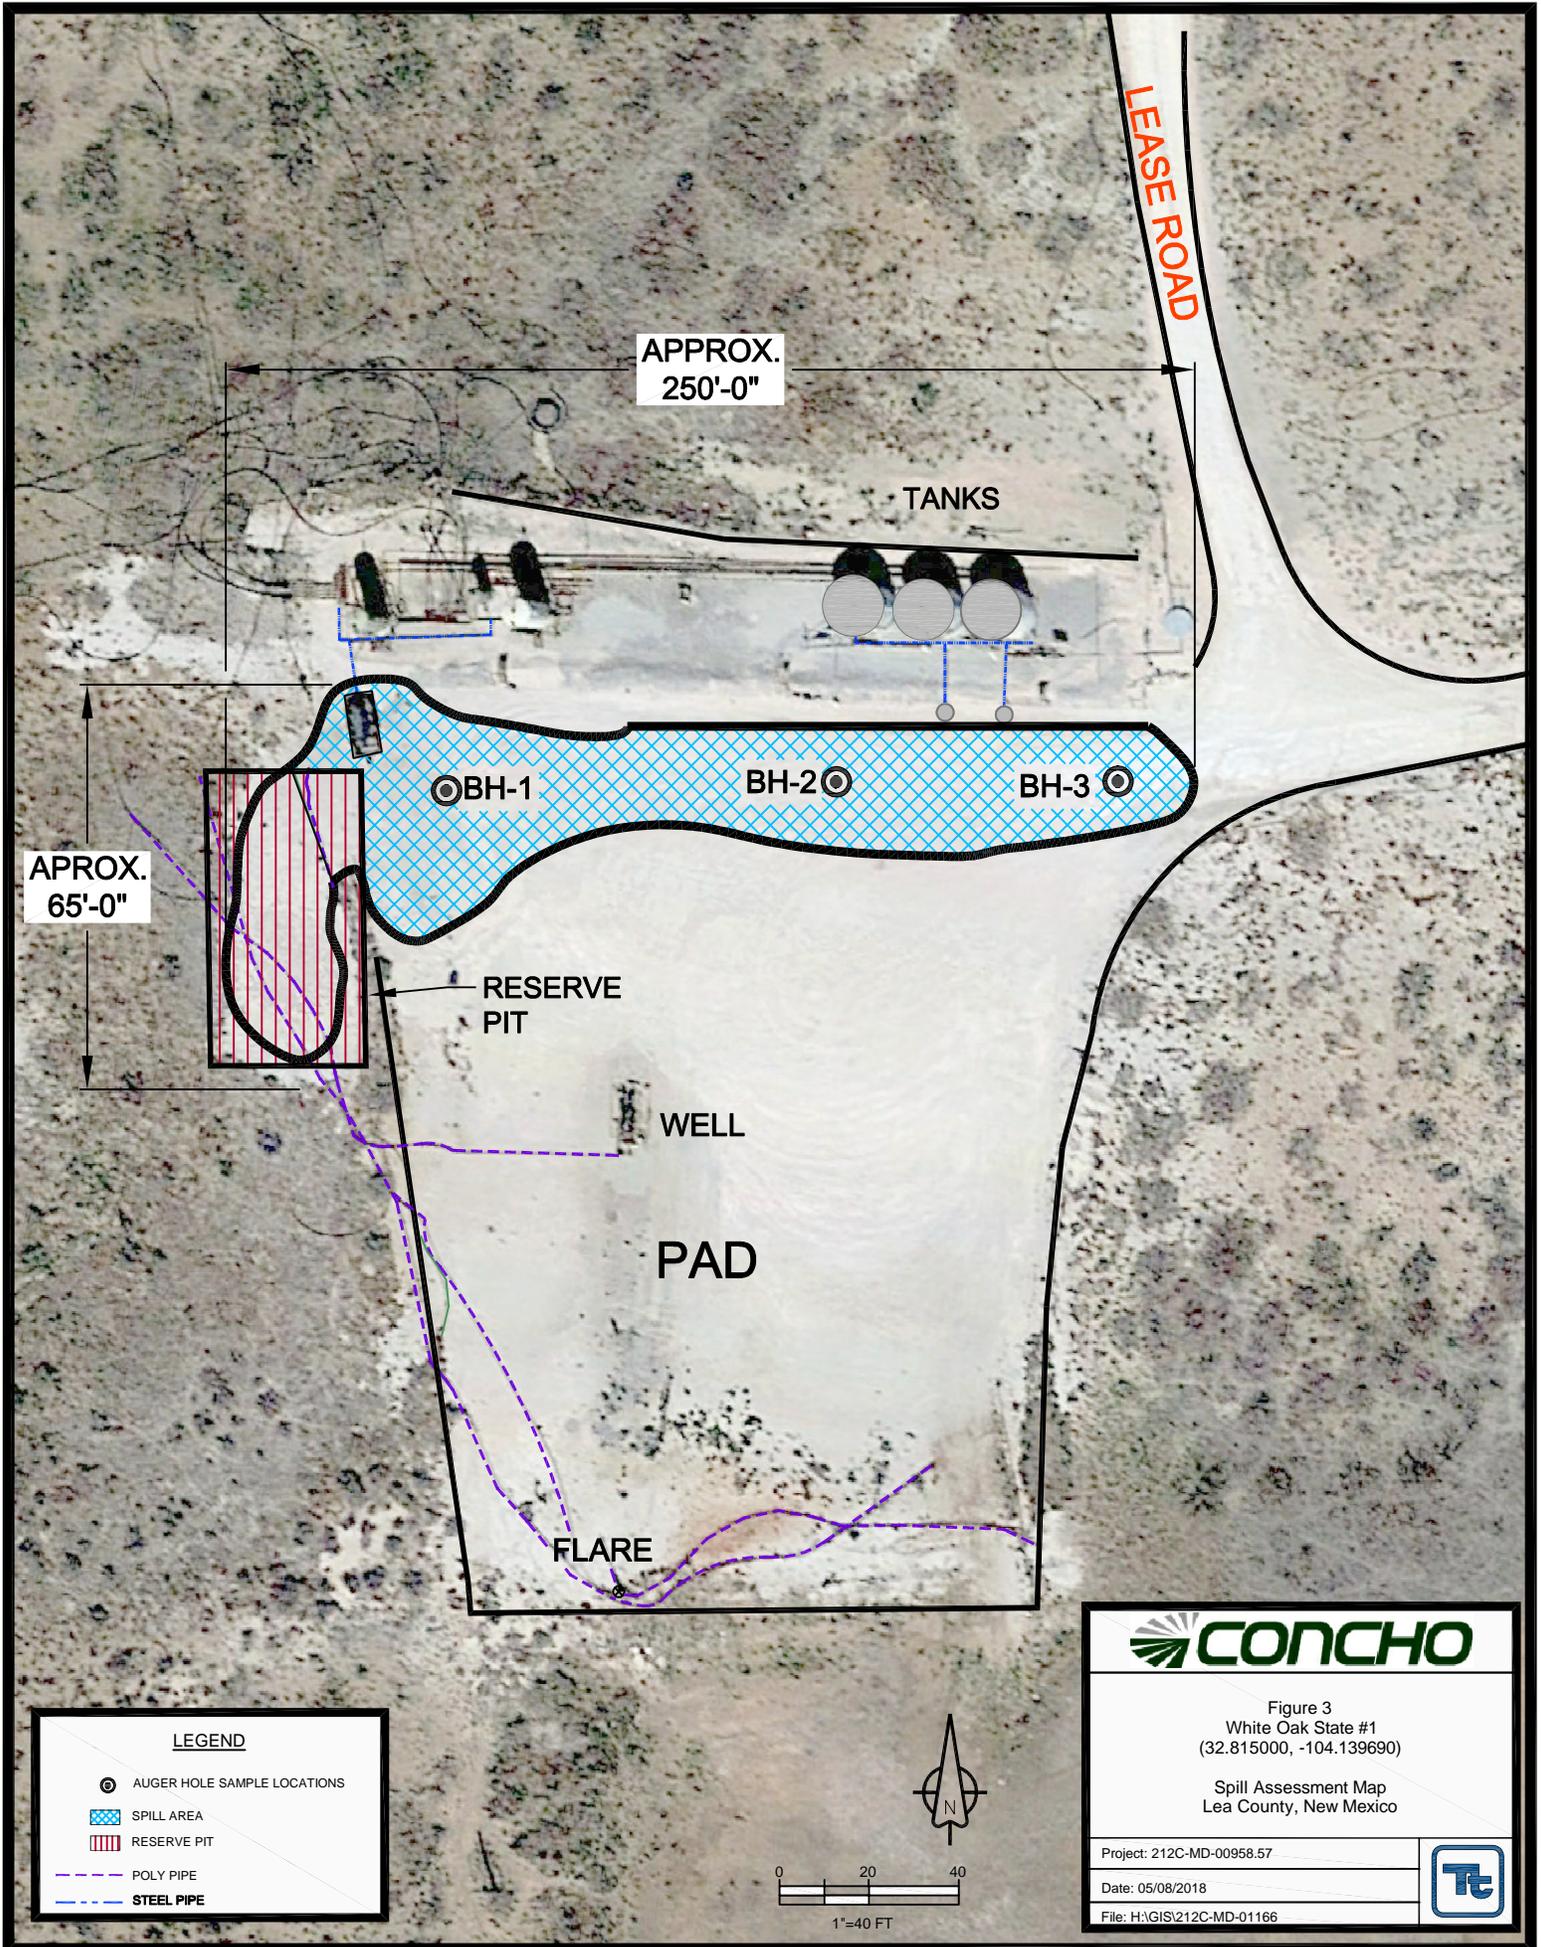
On April 23, 2018, Tetra Tech personnel were onsite to evaluate and sample the release area. Three (3) boreholes (BH-1, BH-2, and BH-3) were installed in the release footprint in order to evaluate the soils. Selected samples were analyzed for TPH analysis by EPA method 8015 modified, BTEX by EPA Method 8021B and chloride by EPA method 300.0. Copies of laboratory analysis and chain-of-custody documentation are included in Appendix C. The sampling results are summarized in Table 1. The borehole locations are shown on Figure 3.

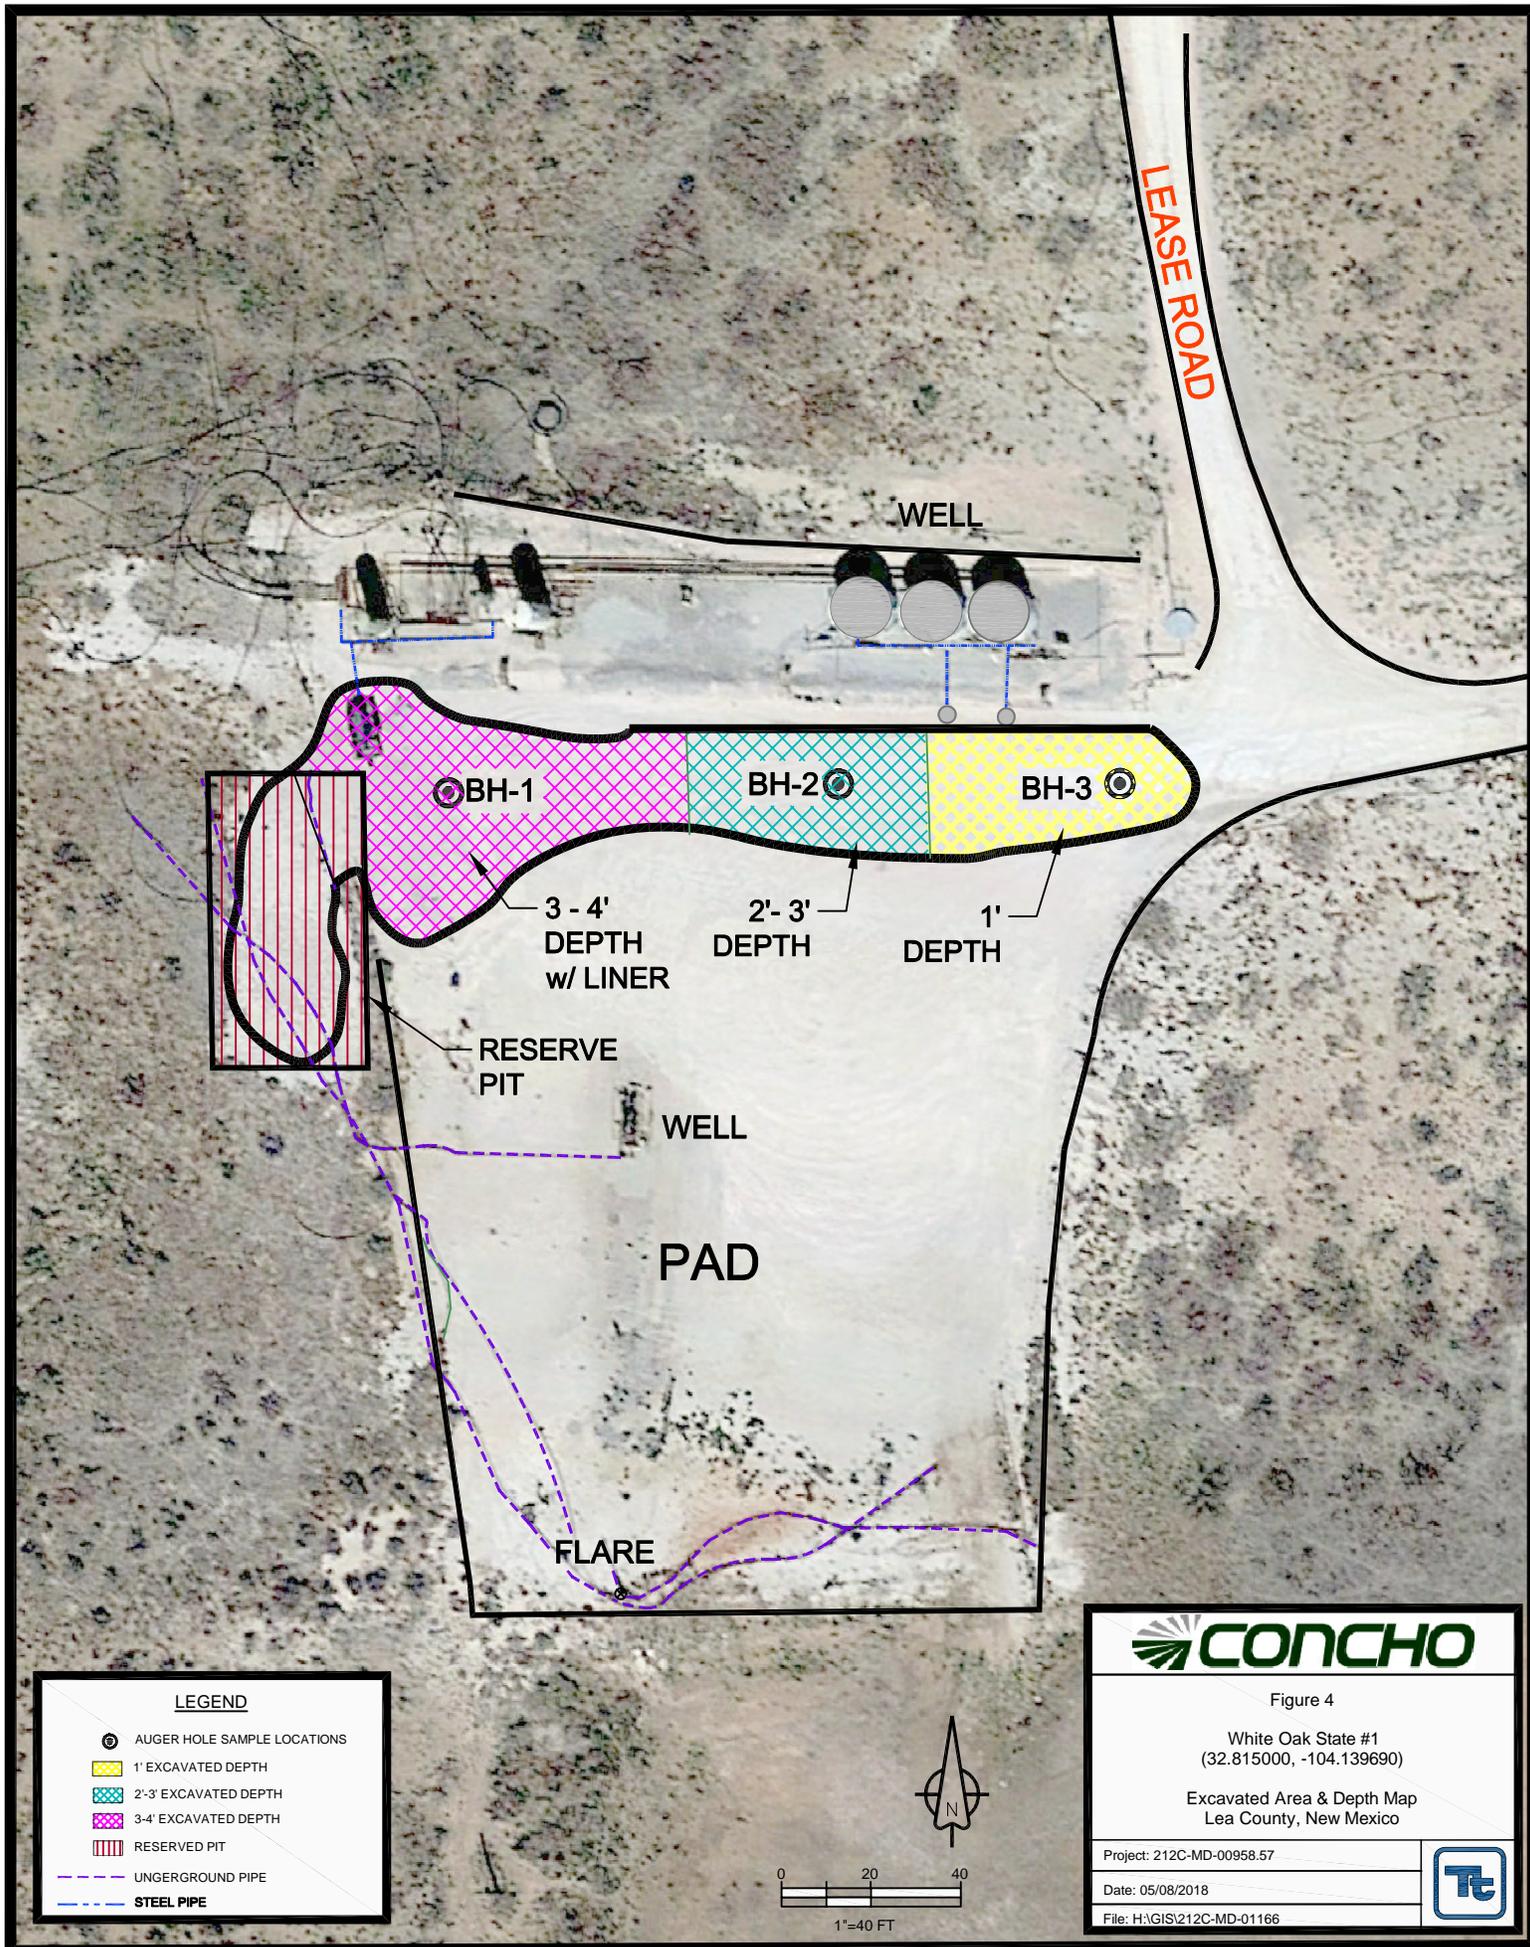
Proposed Excavation Depths

COG proposes to remove the chloride concentrations that were identified in the shallow soils in the areas of boreholes (BH-1, BH-2 and BH-3). The areas of borehole (BH-2) will be excavated to approximately 2.0' to 3.0' and the area of borehole (BH-3) will be excavated to approximately 1.0' below surface. The area of borehole (BH-1) will be excavated to approximately 3.0' to 4.0' below surface and capped with a 20-mil liner to prevent vertical migration of the deeper impact. Once the areas are excavated to the appropriate depth, the excavation will be backfilled with clean material to surface grade. All of the excavated material will be transported offsite for proper disposal.

- The impacted area in the vicinity of BH-3 was excavated to the depth of one (1) foot BGS.
- The impacted area in the vicinity of BH-2 was excavated to the depth of three (3) feet BGS.
- The impacted area in the vicinity of BH-1 was excavated to the depth of four (4) feet BGS and a 20 mil plastic liner was installed.
- All of the excavated material was transported to an NMOCD approved solid waste disposal facility.
- The excavation was backfilled with caliche and contoured to match the surrounding location.

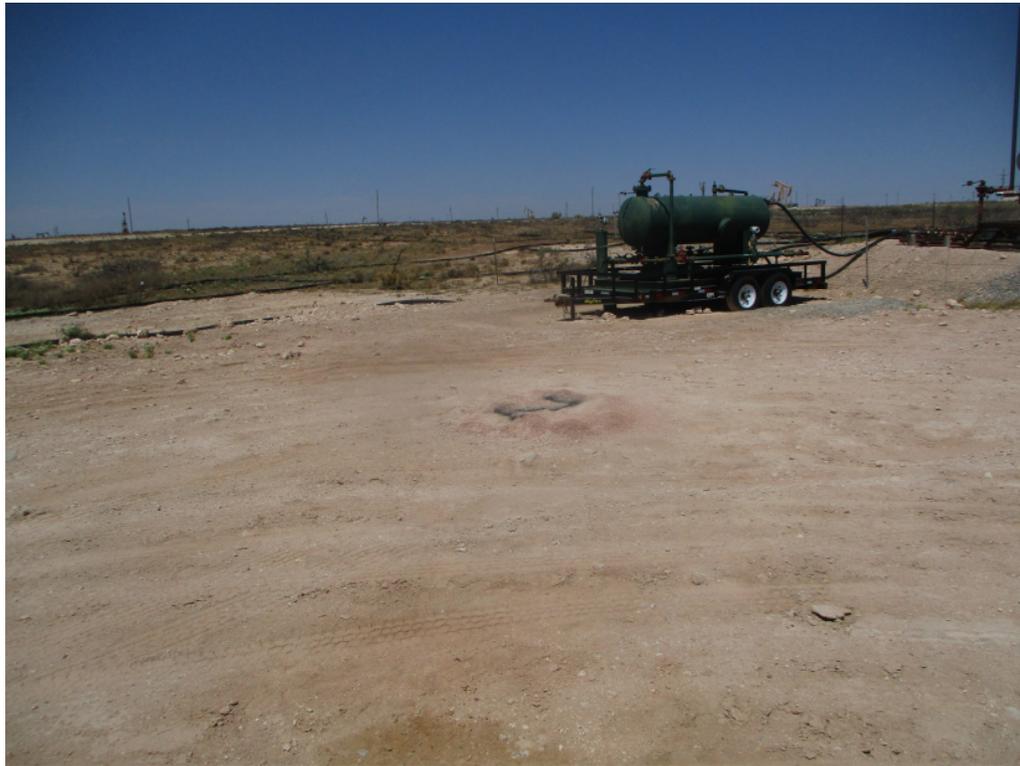
View West – Area of BH-1

However, a shallow chloride impact was detected in all areas. The area of borehole (BH-1) showed a chloride high of 30,900 mg/kg at 2-3', which declined with depth to 644 mg/kg at 9-10' and 244 mg/kg at 14'-15' below surface. The area of borehole (BH-2) showed a chloride concentration of 11,200 mg/kg at 0-1', which declined with depth to 306 mg/kg at 4-5' and 182 mg/kg at 6-7' below surface. The area of borehole (BH-3) showed a chloride high of 3,170 mg/kg at 0-1' which then declined to below the 600 mg/kg threshold at 2-3' below surface.
