Release Notification

Site Name	Ojo Encino	Site Type	Oil Field
Date Release Discovered	Aug 18 th , 2022	API# (if applicable)

Closure Report

Remediation of Spill on 8/18/2022

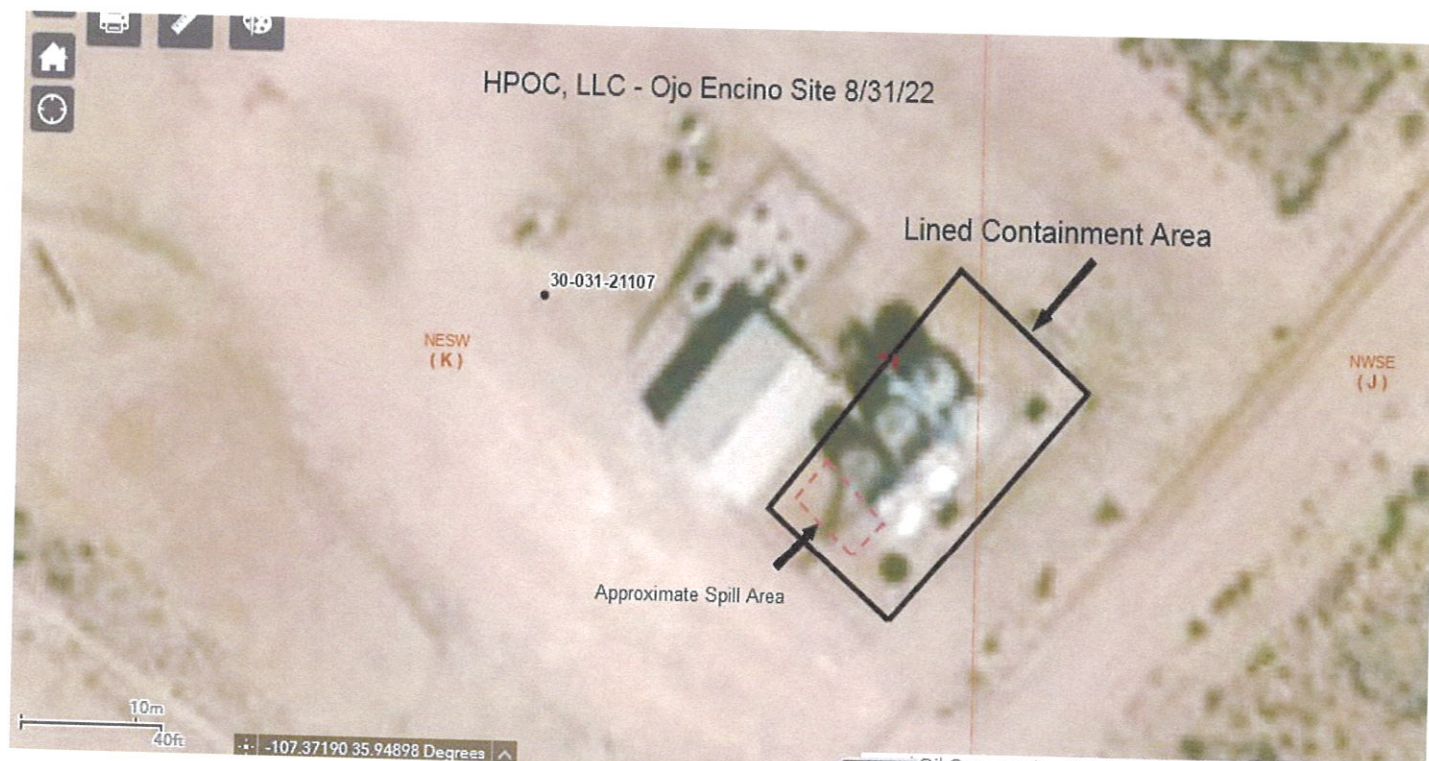
Picture 1: Ojo Encino 08/18/22 Spill Site Diagram

On 8/18/2022 HPOC detected a spill that occurred at the Ojo Encino Field. We reported the spill to Monica Kueling of OCD via telephone on the same day. The spill was caused by electrical damage to the VFD Drive of the 8 Fed DWS well (see detailed description above in Initial Report). Our production water tank over- flowed into the tank containment area (see Picture #1). Approximately 23 bbls of total fluid (3bbls oil and 20bbls water) spilled. On the same day we cleaned up 1 bbl of oil into the oil tank. On Aug 19th Riley Industrial used a vacuum truck to clean up as much of the water/oil/sand mixture as possible (there was about 10 inches of sand on top of the liner in the containment area). Riley picked up 70bbls of total mixture and disposed of it at Envirotech. On Aug 20 and 21st, we steam sprayed the outside of the production water tank to clean as much residue as possible. On Aug 22, we cleaned any remnants of the spill off the liner. We then inspected the liner for leaks/cuts. The liner looked good (see Picture #2: Please note the seams in the liner. These seams are glued together to form one continuous sheet). Since the liner integrity was sound, we did not see the need to test the soil underneath. Our last item to complete the remediation is to place fresh dirt back on the liner, but have been unable to do so because of daily rain and puddling on the top of the liner. Once the rain stops, and the liner dries out, we will place the 6-8 inches of fresh dirt on the liner.
