2022 ANNUAL GROUNDWATER REPORT**Knight #1****Incident Number: nAUTOfAB000324****Meter Code: 72556****T30N, R13W, Sec5, Unit A****REVIEWED**

The location of the Site is depicted on Figure 1. A Site Plan map depicting the locations of monitoring wells, the remediation well and piping layout, and current and historical site features is provided as Figure 2. Light non-aqueous phase liquid (LNAPL) has been periodically observed and manually recovered at the Site. Currently, groundwater sampling is conducted on a semi-annual basis.

2022 ANNUAL GROUNDWATER REPORT

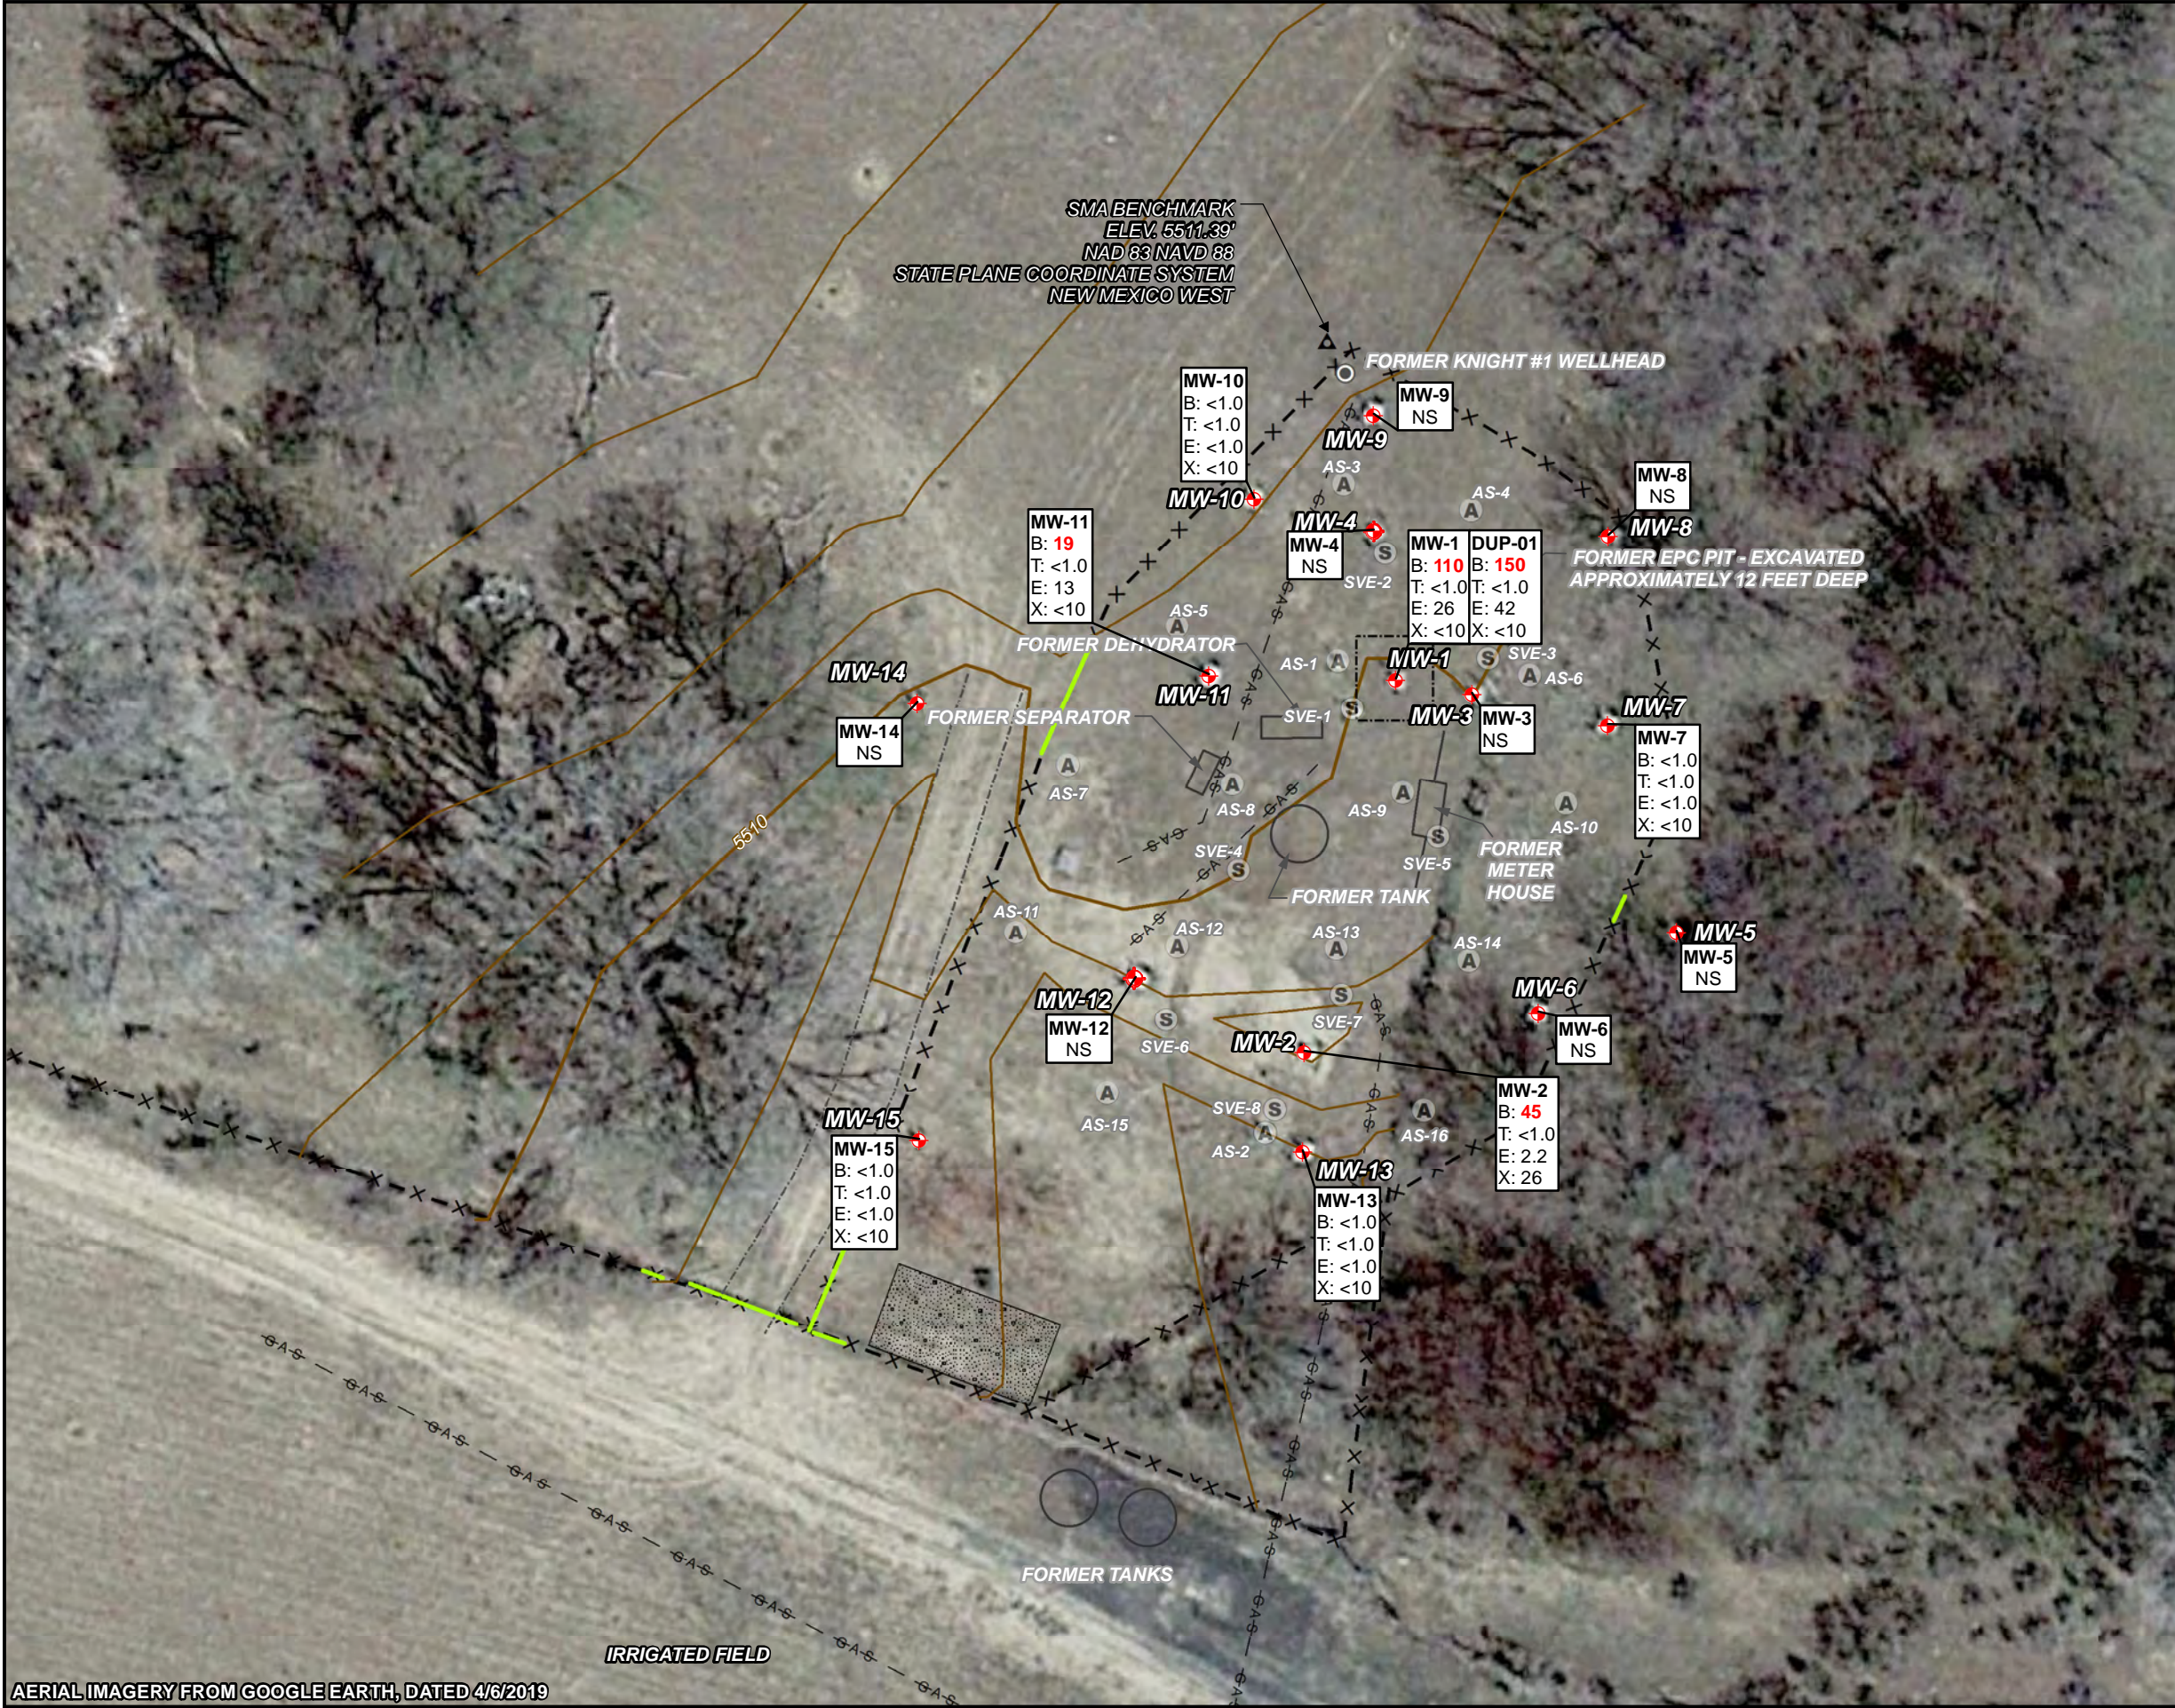
Figure No.: 3
--	----------------------

Groundwater analytical maps (Figures 3 and 5) and groundwater elevation contour maps (Figures 4 and 6) summarize results of the 2022 groundwater sampling and gauging events.

TITLE: *GROUNDWATER ANALYTICAL RESULTS
MAY 19, 2022*

- Groundwater samples collected in 2022 from MW-1 and MW-11; and during the May event from MW-2 and MW-3, exceeded the New Mexico Water Quality Control Commission (NMWQCC) standard (10 µg/L) for benzene in groundwater. Benzene concentrations were either below the NMWQCC standard or were not detected in other site monitoring wells sampled in 2022.

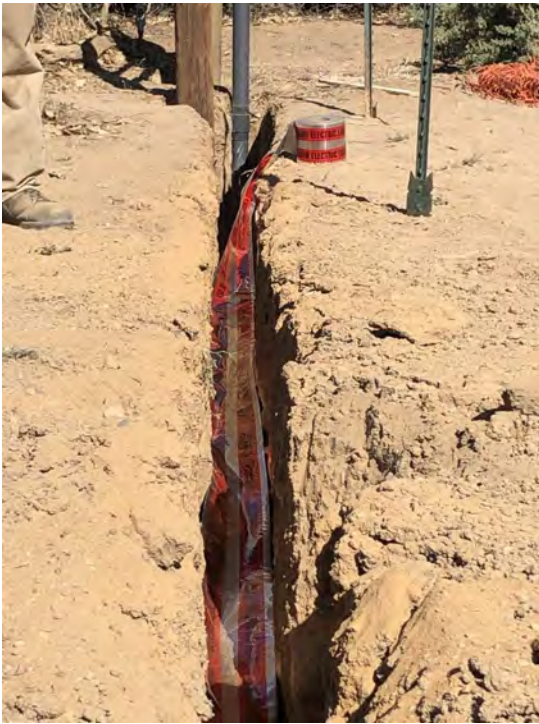
Client:	El Paso CGP Company	Project:	Knight #1 Air Sparge/Soil Vapor Extraction Installation
Site Name:	Knight #1	Site Location:	T30N, R13W, Sec 5, Unit A
Photograph ID: 1

Photo Location:			
Direction: West			
Survey Date: 5/25/2022			
Comments: Taft installs tracer tape above 4" underground conduit between main shutoff and proposed equipment location prior to backfilling.			
Photograph ID: 2

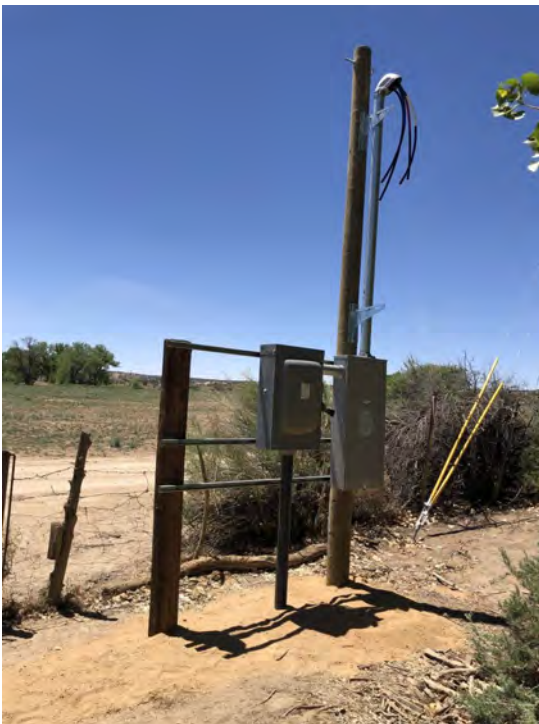
Photo Location:			
Direction: Southwest			
Survey Date: 5/25/2022			
Comments: View of utility meter and main shutoff installed by Taft in May 2022. Backfilling over 4" buried conduit visible (lighter colored fill material).

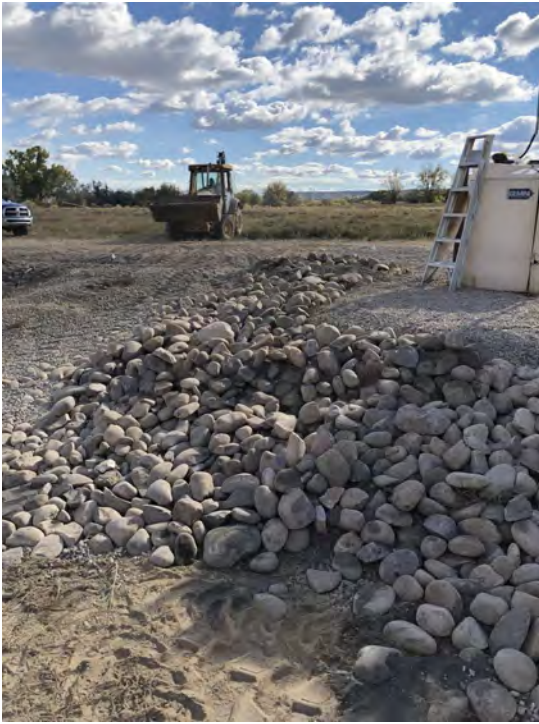
Client:	El Paso CGP Company	Project:	Knight #1 Air Sparge/Soil Vapor Extraction Installation
Site Name:	Knight #1	Site Location:	T30N, R13W, Sec 5, Unit A
Photograph ID: 5

Photo Location:			
Direction: South			
Survey Date: 10/17/2022			
Comments: Sierra places riprap material around the gravel equipment pad to further stabilize the area.			
Photograph ID: 6

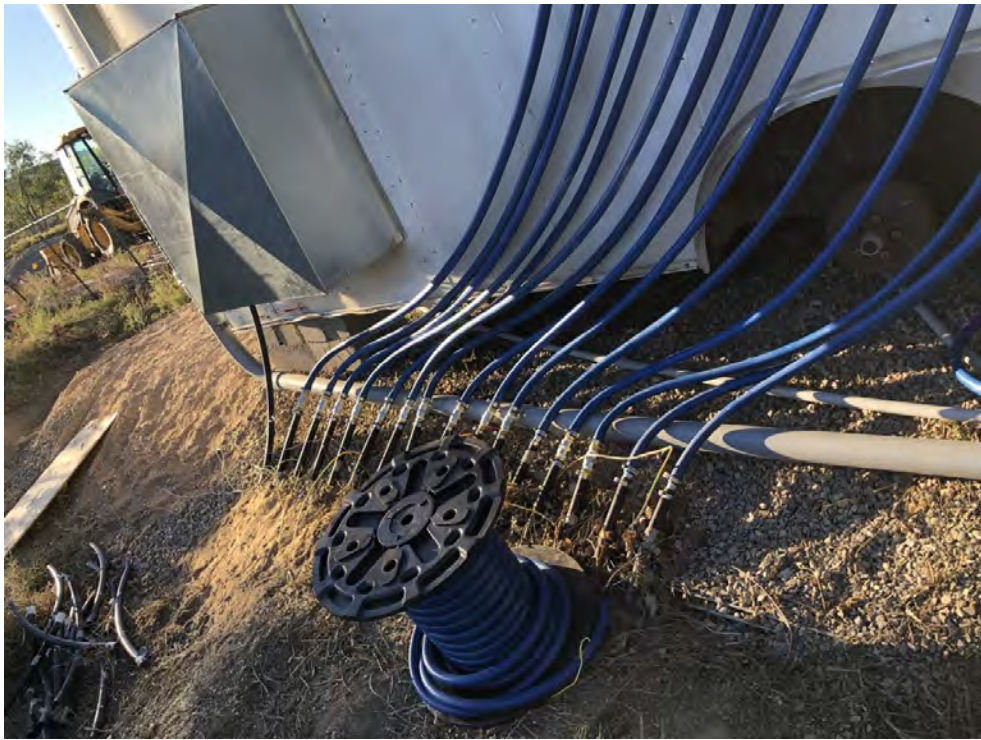
Photo Location:			
Direction: Southeast			
Survey Date: 10/14/2022			
Comments: 1" air sparge connections between laterals and equipment trailer completed by Sierra.

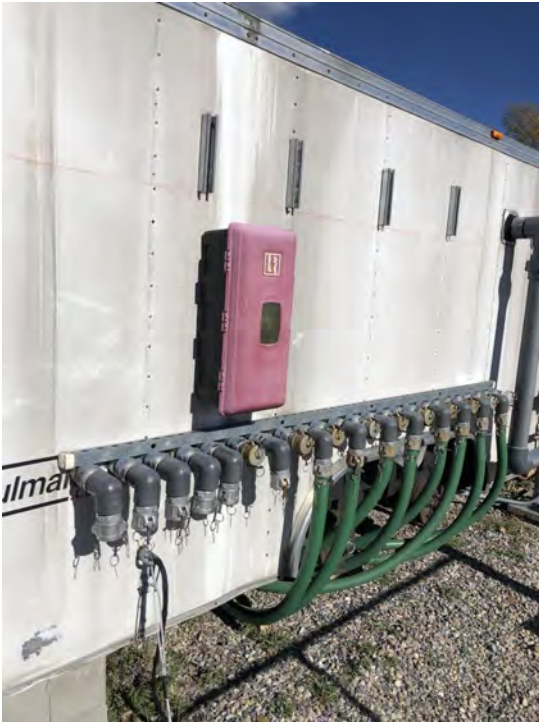
Client:	El Paso CGP Company	Project:	Knight #1 Air Sparge/Soil Vapor Extraction Installation
Site Name:	Knight #1	Site Location:	T30N, R13W, Sec 5, Unit A
Photograph ID: 7

Photo Location:			
Direction: Northeast			
Survey Date: 11/4/2022			
Comments: 2" soil vapor extraction connections made between laterals and equipment trailer completed by Sierra.			
Photograph ID: 8	 		
Photo Location:			
Direction: North			
Survey Date: 11/4/2022			
Comments: View of air sparge manifold inside equipment trailer.

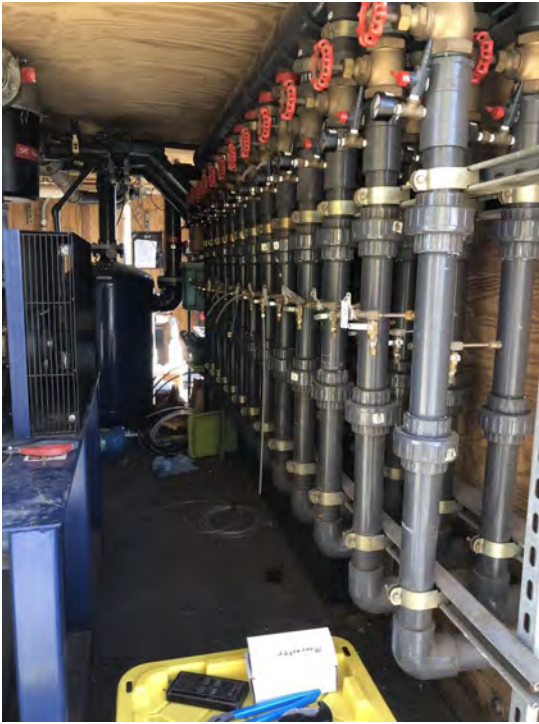
Client:	El Paso CGP Company	Project:	Knight #1 Air Sparge/Soil Vapor Extraction Installation
Site Name:	Knight #1	Site Location:	T30N, R13W, Sec 5, Unit A
Photograph ID: 9

Photo Location:			
Direction: Southwest			
Survey Date: 11/4/2022			
Comments: View of soil vapor extraction manifold inside equipment trailer.			
Photograph ID: 10

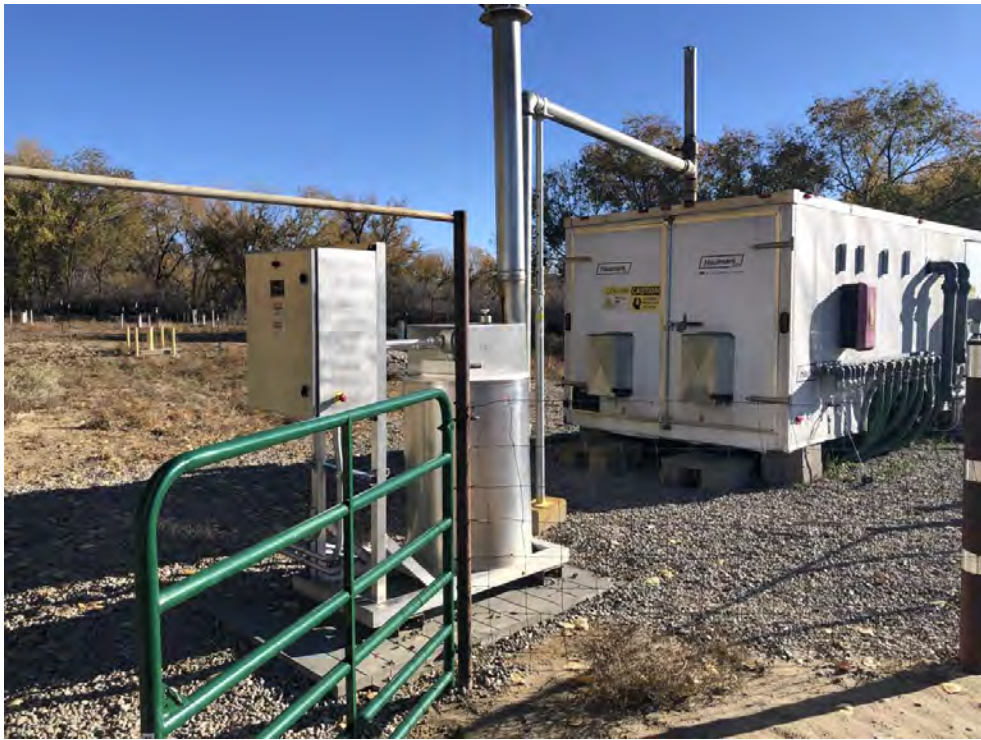
Photo Location:			
Direction: Northeast			
Survey Date: 11/7/2022			
Comments: View of FALCO 300 oxidizer, equipment trailer, and support post for galvanized pipe.

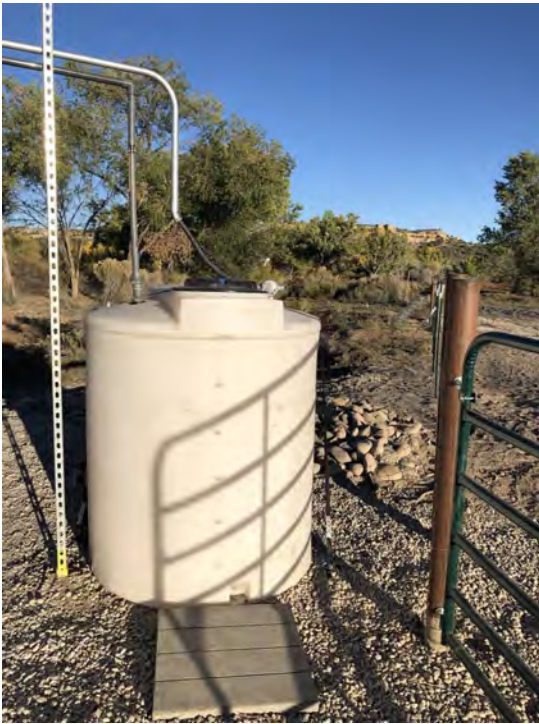
Client:	El Paso CGP Company	Project:	Knight #1 Air Sparge/Soil Vapor Extraction Installation
Site Name:	Knight #1	Site Location:	T30N, R13W, Sec 5, Unit A
Photograph ID: 11

Photo Location:			
Direction: East			
Survey Date: 10/20/2022			
Comments: View of double walled condensate tank and associated schedule 80 PVC piping.			
Photograph ID: 12

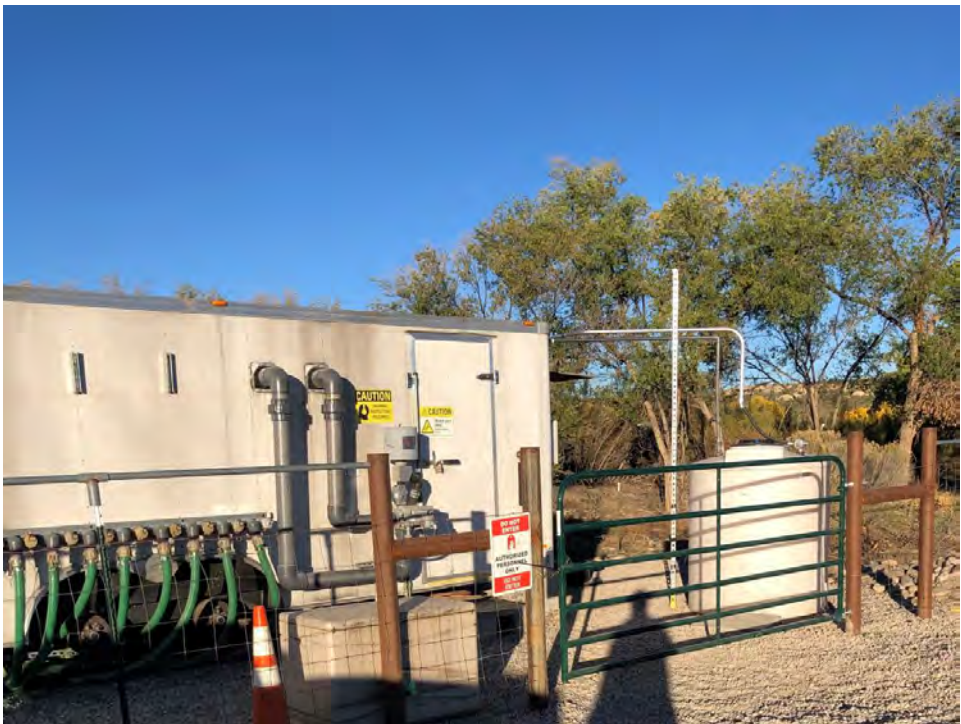
Photo Location:			
Direction: Northeast			
Survey Date: 10/20/2022			
Comments: View (left to right) soil vapor extraction connections, FALCO Vapor Control Valve (VCV) and associated piping, and double wall condensate tank.

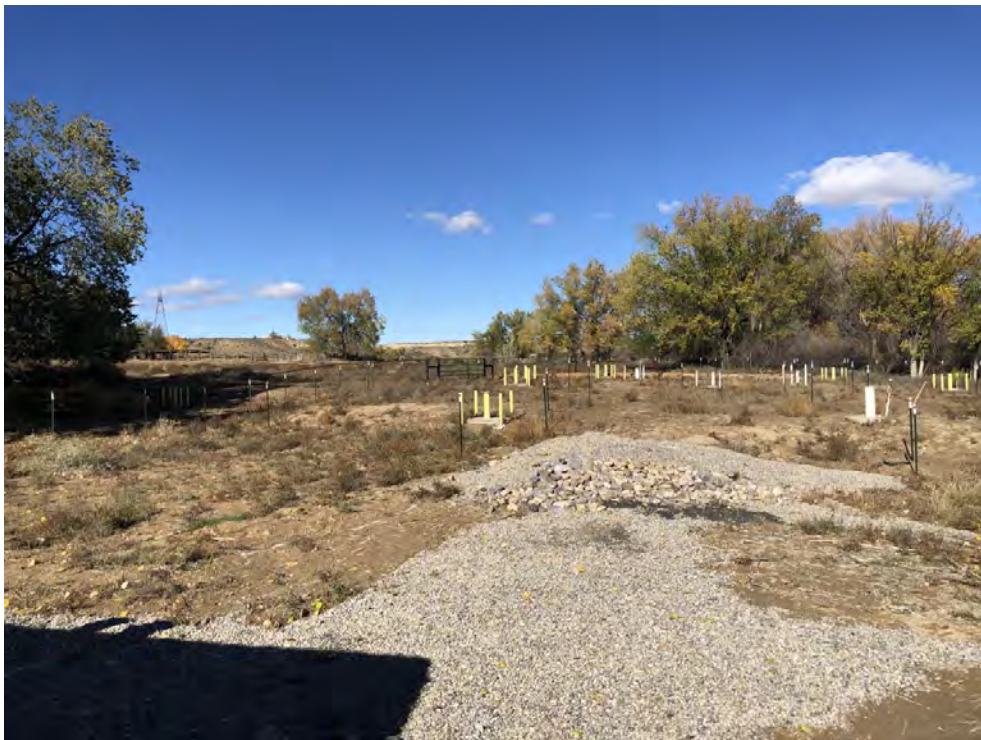
Client:	El Paso CGP Company	Project:	Knight #1 Air Sparge/Soil Vapor Extraction Installation
Site Name:	Knight #1	Site Location:	T30N, R13W, Sec 5, Unit A
Photograph ID: 13

Photo Location:			
Direction: North			
Survey Date: 10/11/2022			
Comments: View of remediation well array.			
Photograph ID: 14

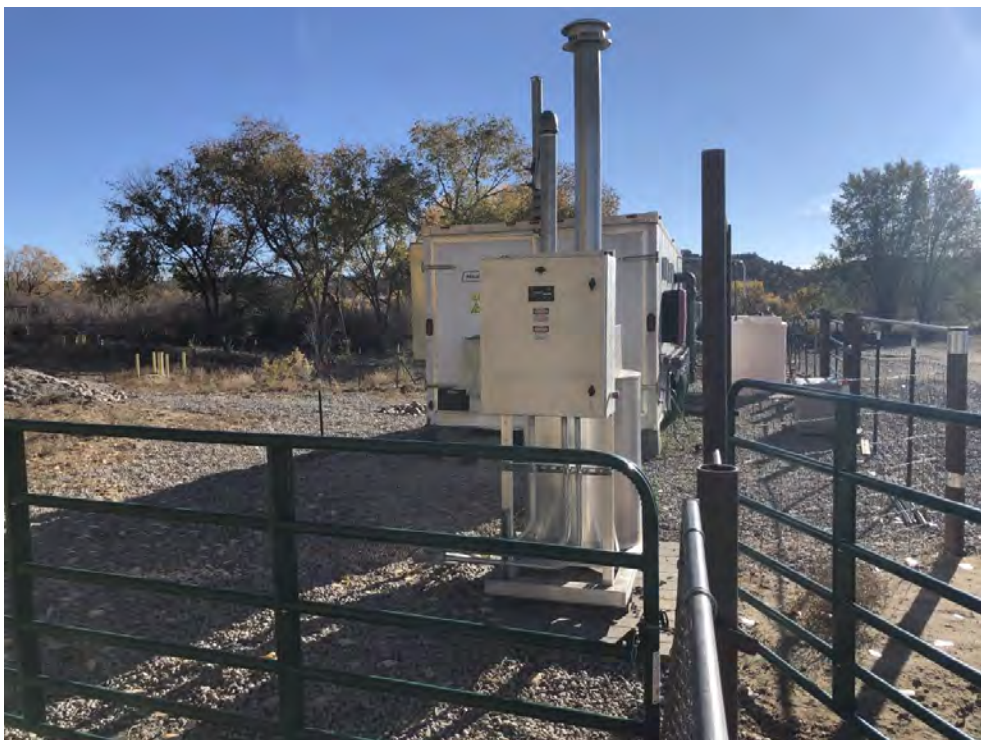
Photo Location:			
Direction: Northeast			
Survey Date: 11/7/2022			
Comments: View of assembled system from west side.

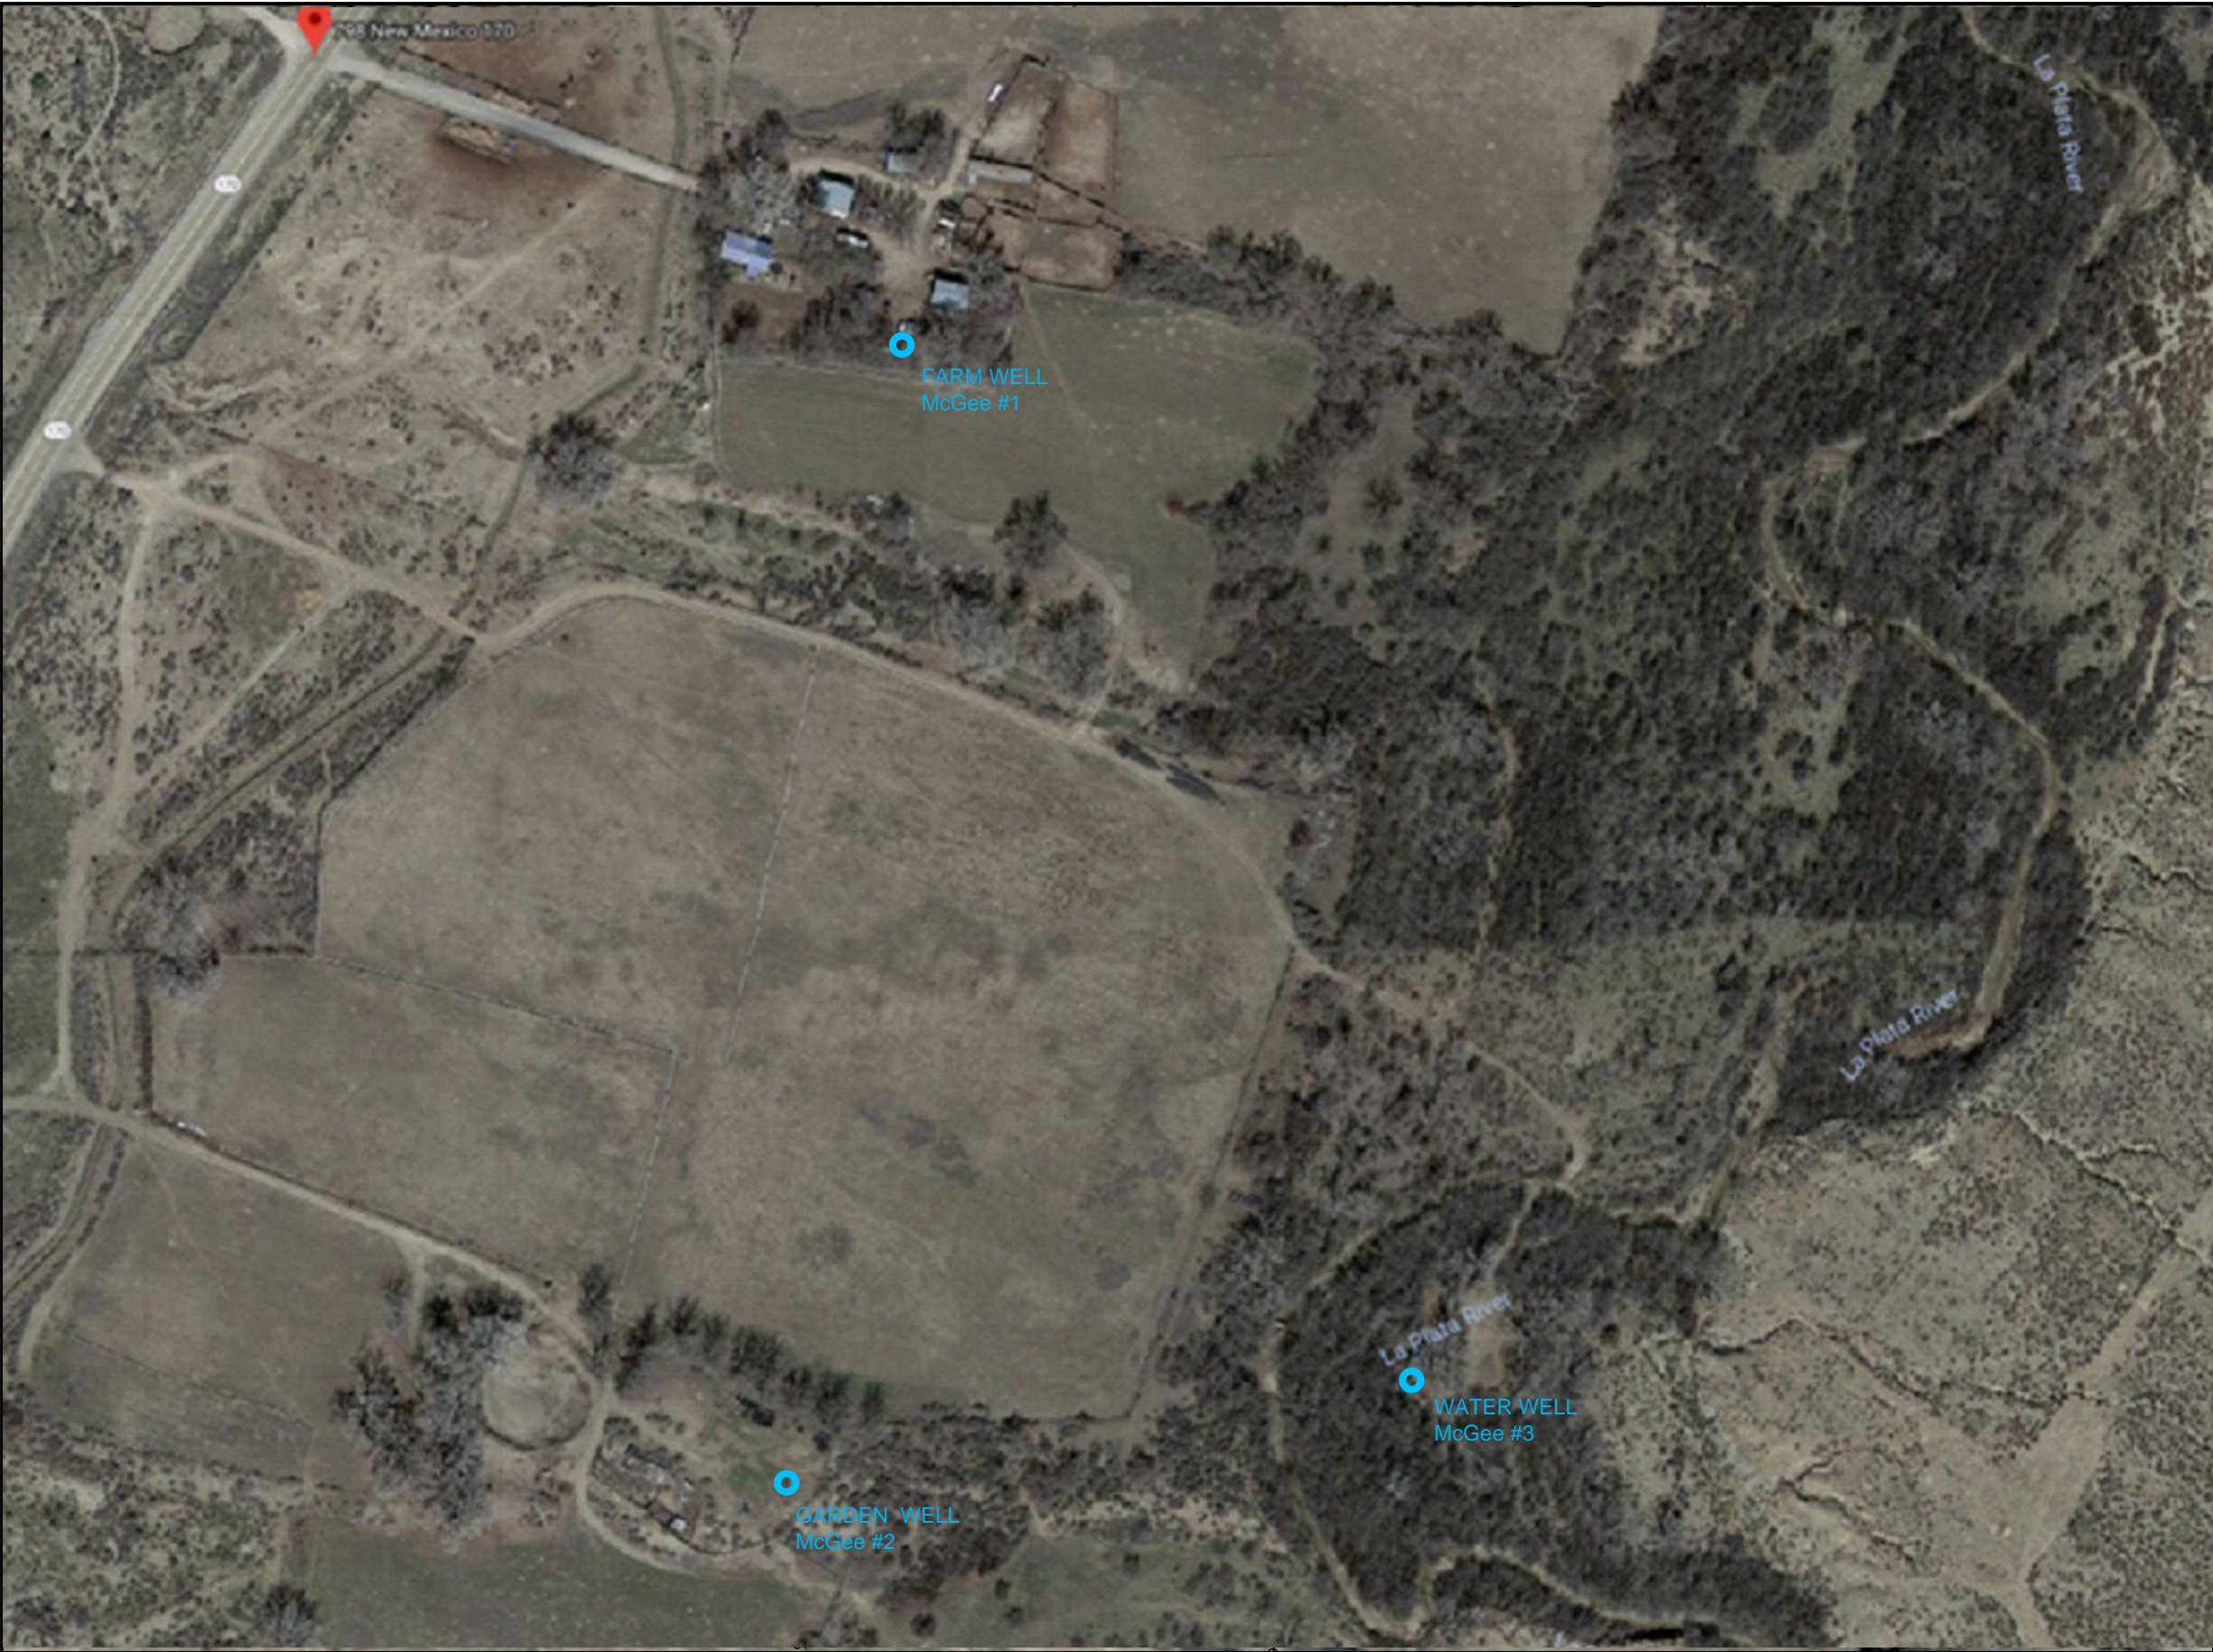
Please find enclosed a copy of the laboratory sample results of water samples collected from two water supply wells on the McGee Ranch property located at 798 NM-170 north of Farmington, New Mexico. The samples were collected by Stantec, a contractor for El Paso CGP Company LLC (EPCGP), on October 13 and 14, 2022. A third water well (McGee 3- Water Well) was not sampled due to mud inside the well casing and pitcher pump. The locations of the two water wells sampled and third water well not sampled is depicted on Figure 1 (attached). The condition of the three water wells is presented on a photolog (attached).

- WATER WELL
McGee #1, #2, #3

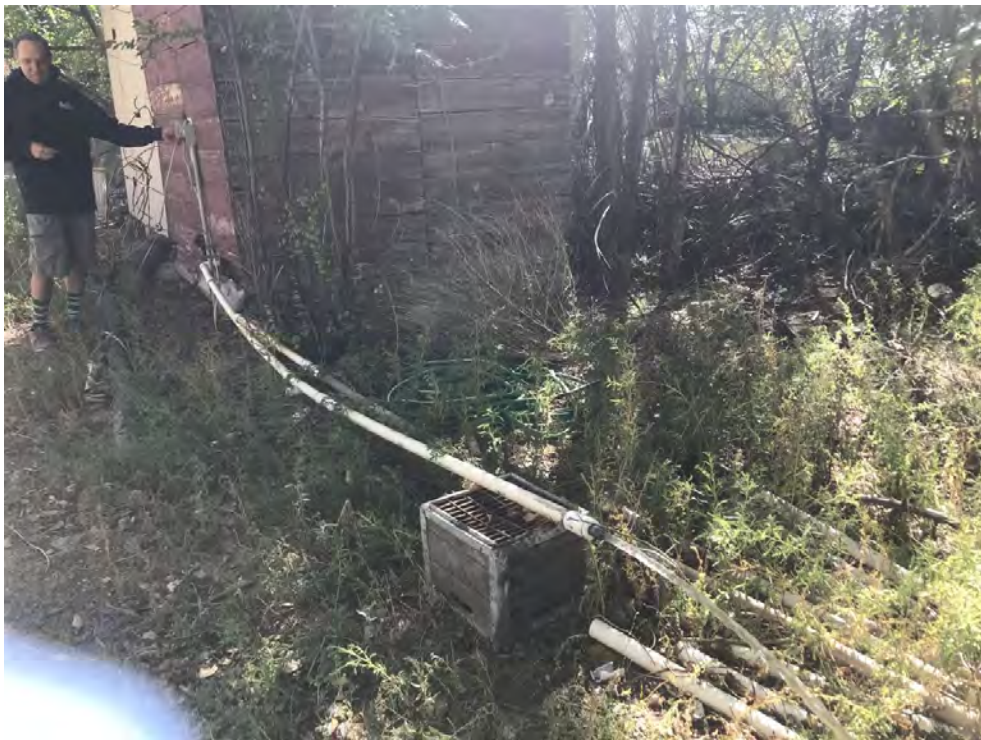
Client:	El Paso CGP Company, LLC	Project:	193708949
Site Name:	Knight #1	Site Location:	La Plata, NM
Photograph ID: 1

Photo Location: KNIGHT #1 - McGee #1			
Direction: East			
Survey Date: 10/14/2022			
Comments: View of McGee #1 Farm Well. Well is being purged prior to sample.			
Photograph ID: 2

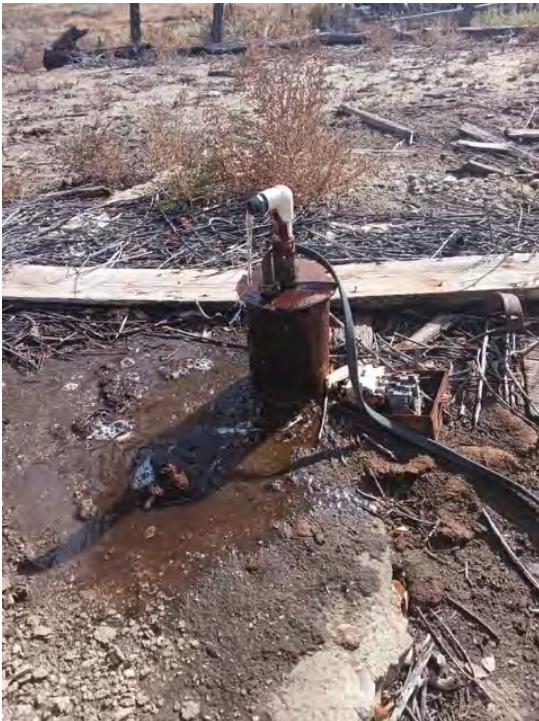
Photo Location: KNIGHT #2 - McGee #2			
Direction: East			
Survey Date: 10/14/2022			
Comments: View of McGee #2 (Garden Well) being purged.

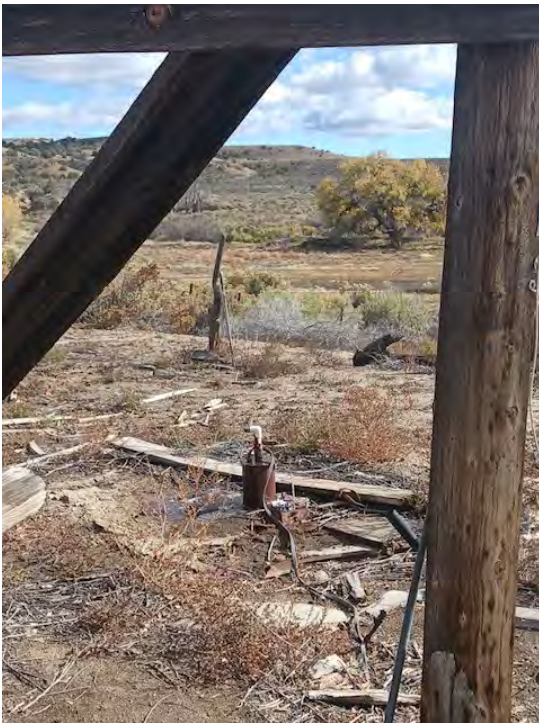
Client:	El Paso CGP Company, LLC	Project:	193708949
Site Name:	Knight #1	Site Location:	La Plata, NM
Photograph ID: 3

Photo Location: KNIGHT #2 - McGee #2			
Direction: Northeast			
Survey Date: 10/14/2022			
Comments: View of McGee #2 Garden Well.			
Photograph ID: 4

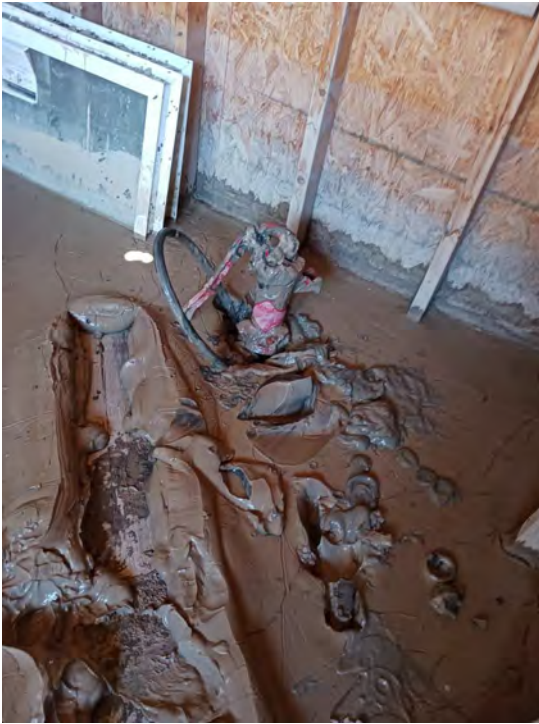
Photo Location: KNIGHT #3 - McGee #3			
Direction: North			
Survey Date: 10/13/2022			
Comments: View of McGee #3 (Water Well). The well casing and pitcher pump were filled with mud.

Prior to start-up of the AS/SVE system, and pursuant to the Work Plan, Stantec inspected the three water wells (McGee#1 through McGee#3), located on the McGee property. McGee#1 (Farm well) was inspected and sampled on October 14, 2022, and McGee#2 (Garden well) was inspected and sampled on October 13, 2022. McGee#3 (Water well) was found to be full of sediment and could not be sampled.
