## CLOSURE REPORT

**Trunk 3A (01/24/23)**  
Unit Letter J, S33 T29N R12W  
San Juan County, New Mexico

**New Mexico EMNRD OCD Incident ID No. NAPP2302448038**

Ensolum Project No. 05A1226227

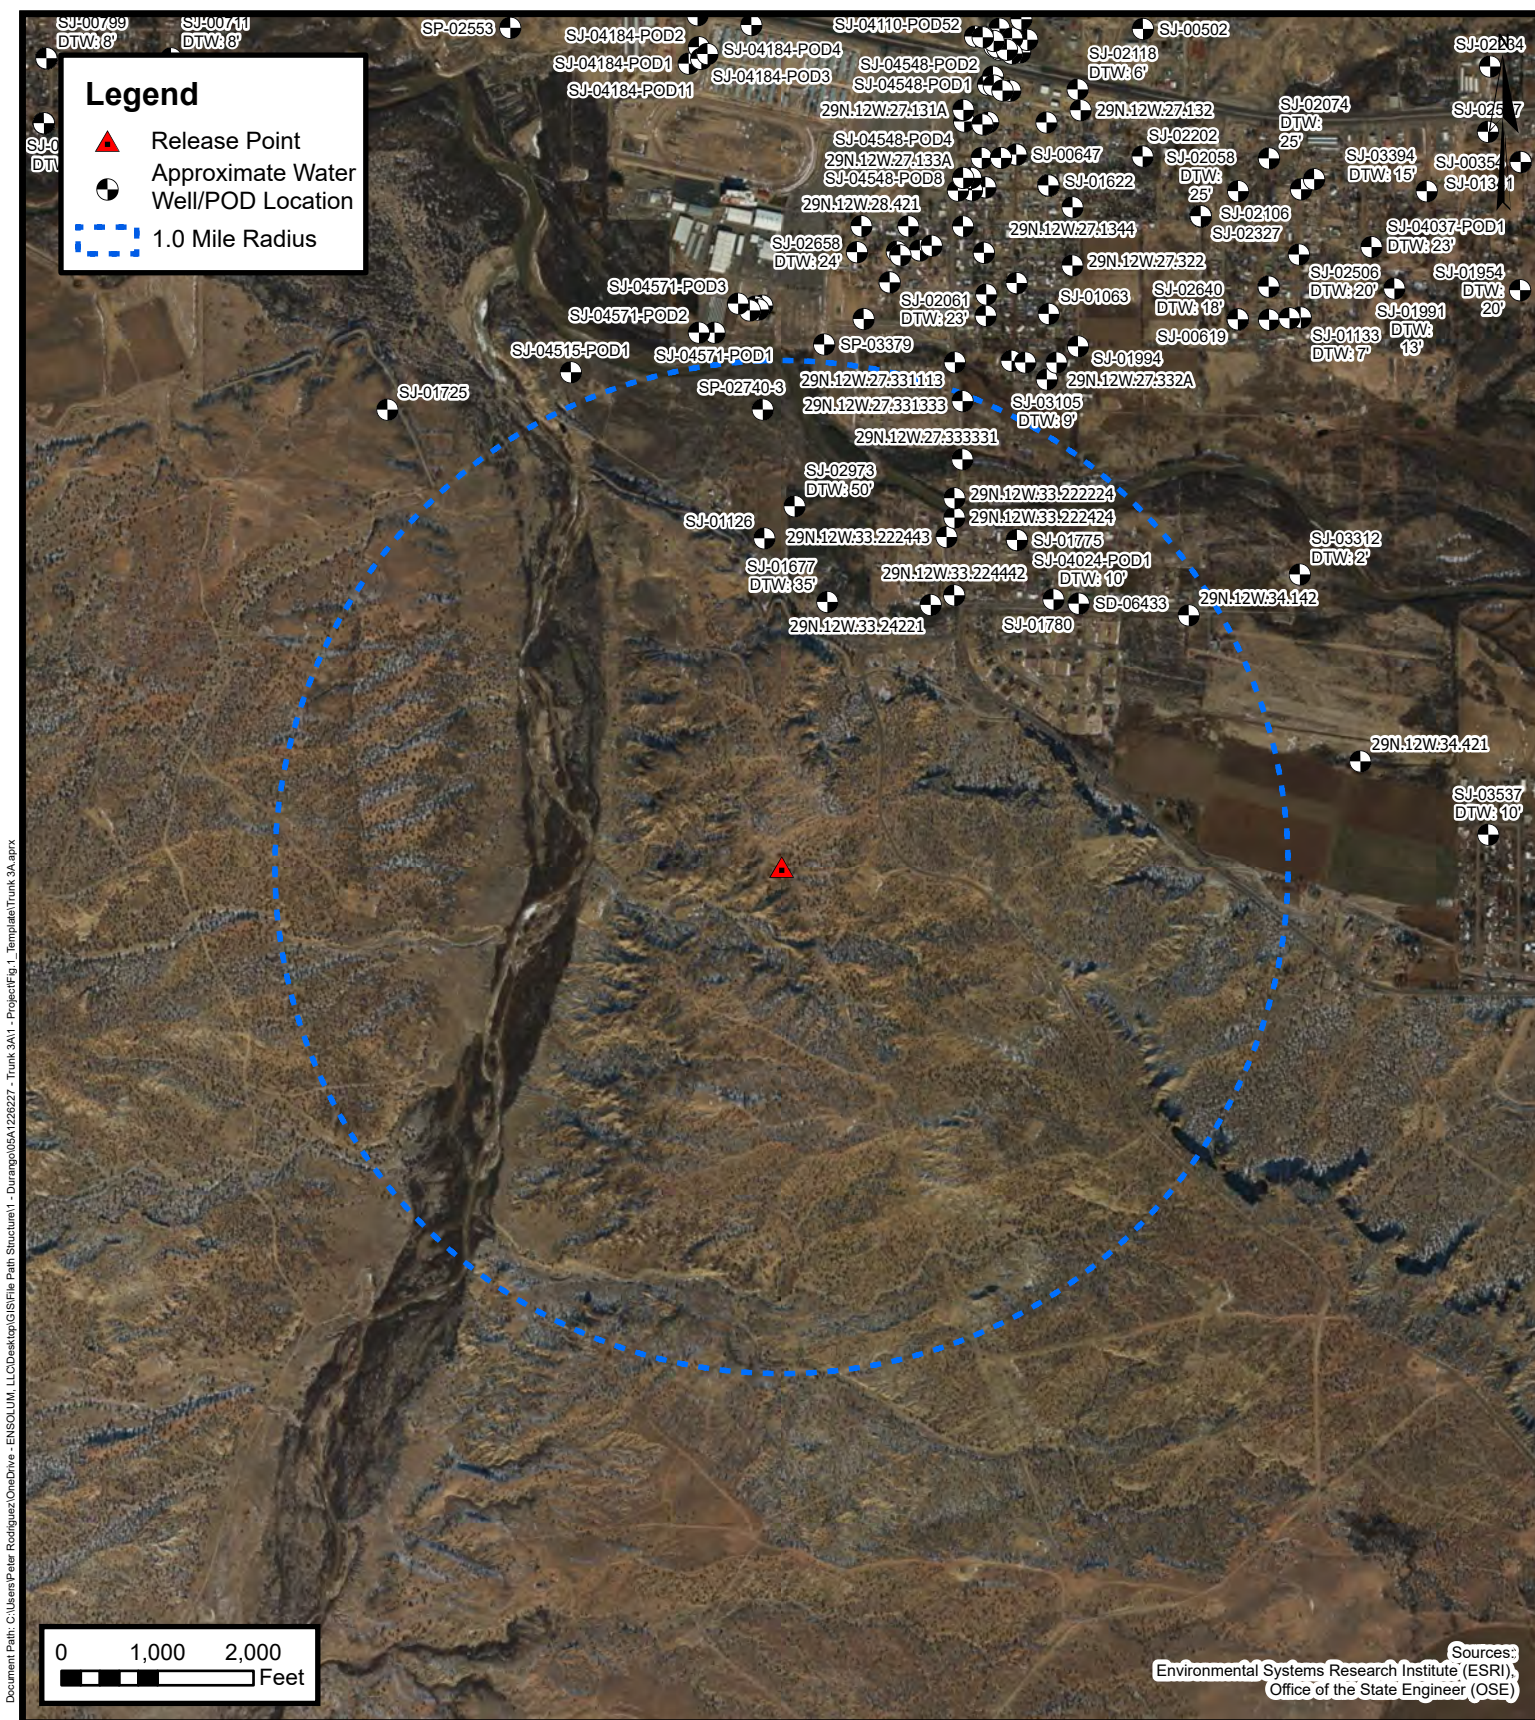
FIGURE  
**A**

## 1.0 Mile Radius Water Well/ Pod Location Map

- The NM Office of the State Engineer (OSE) tracks the usage and assignment of water rights and water well installations and records this information in the Water Rights Reporting System (WRRS) database. Water wells and other points of diversion (PODs) are each assigned POD numbers in the database (which is searchable and includes an interactive map). Numerous PODs with recorded depths to water were identified in the same Public Land Survey System (PLSS) section as the Site, and in the adjacent PLSS sections (**Figure A, Appendix B**). The average depth to water for the PODs is 16 feet below grade surface (bgs). The closest POD (SJ-01677) is approximately 0.54 miles north of the Site and approximately 134 feet lower in elevation than the Site. The recorded depth to water for this POD is 35 feet bgs. Most, if not all, of the identified PODs are located in the river valley.

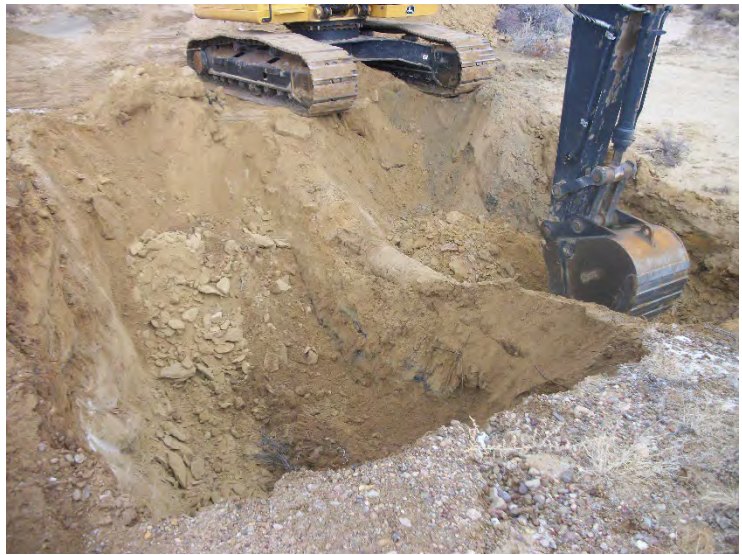
**Photograph 1**

Photograph Description: View of the in-process excavation activities.

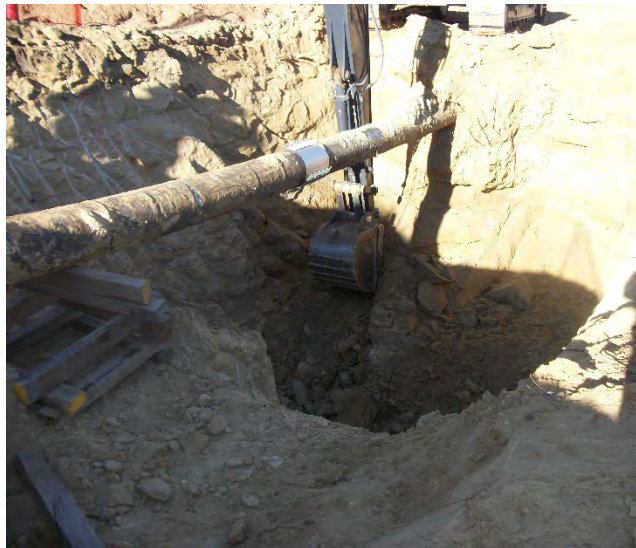
**Photograph 2**

Photograph Description: View of the in-process excavation activities.

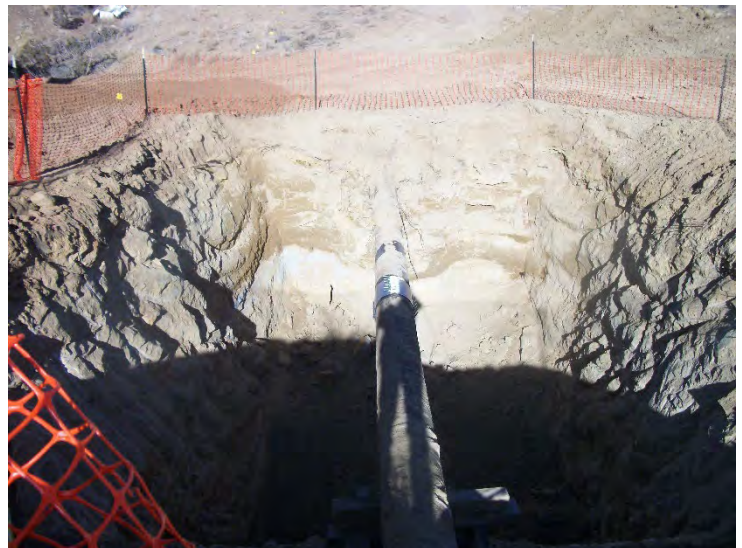
**Photograph 3**

Photograph Description: View of the excavation (first sampling event).

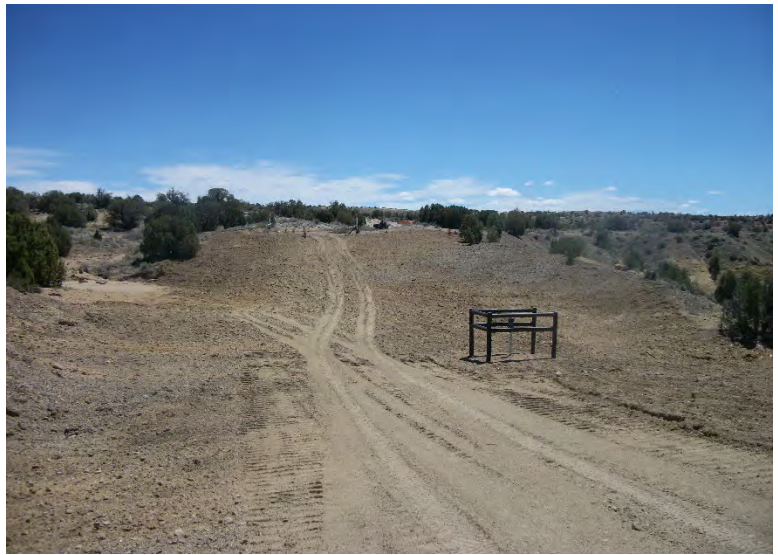
### Photograph 4

Photograph Description: View of the site after initial restoration.

The excavation was backfilled with imported fill and then contoured to the surrounding topography.
