**Environmental Site Remediation Work Plan**

NMOCD District:	District 2	Incident ID:	nMCS0124838636
Landowner:	Private	RP Reference:	N/A
Client:	EOG Resources, Inc.	Site Location:	Federal AB-B Battery
Date:	May 25, 2023	Project #:	22E-00123-15
Client Contact:	Chase Settle	Phone #:	575.748.4171
Vertex PM:	Chance Dixon	Phone #:	575.988.1472

# Comprehensive Site Map

Federal AB-B Battery  
Closure Report  
#nMCS0124838636

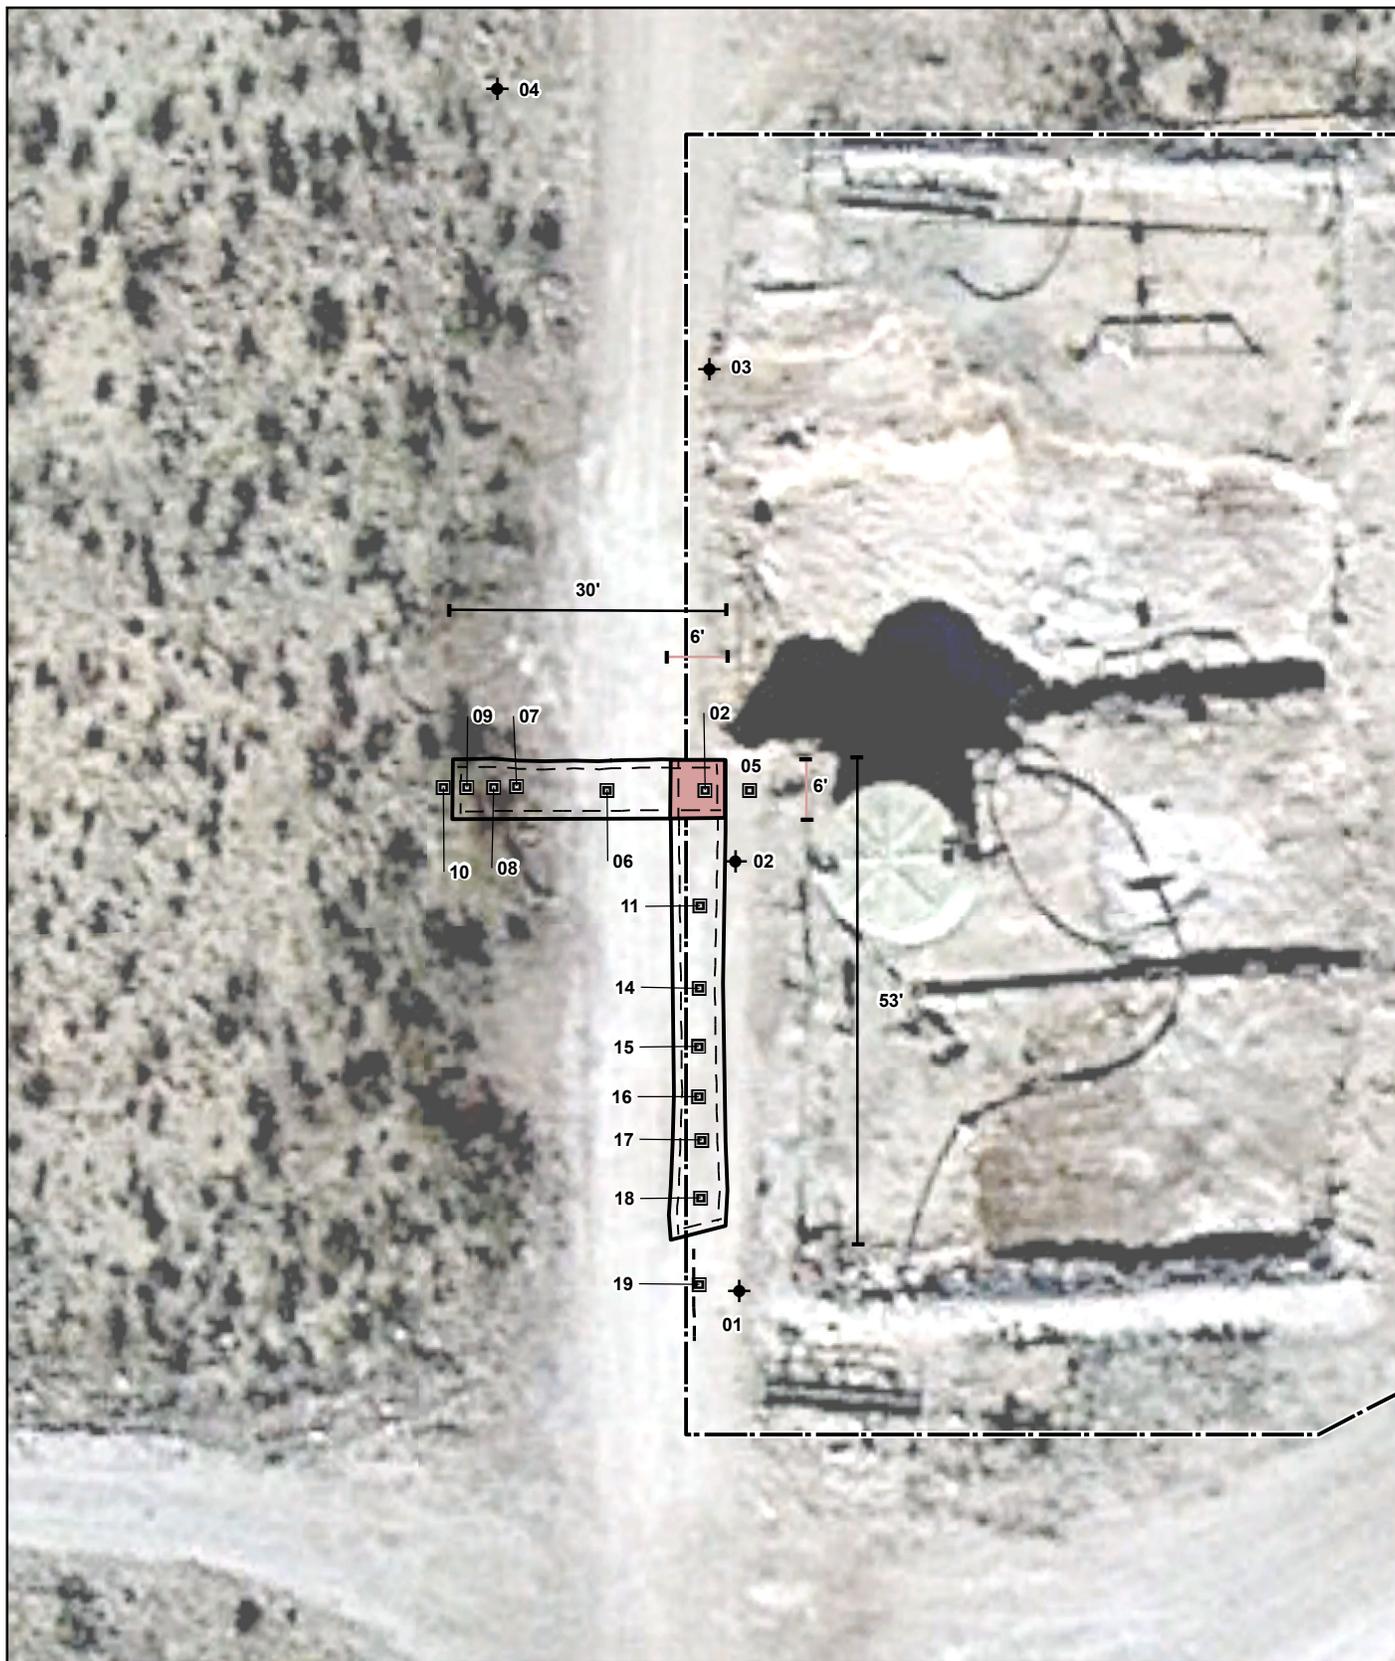
# ATTACHMENT 1

Exceedances to closure criteria were found at sample points BH21-02, TP23-06 to TP23-09, TP23-11, and TP23-14 to TP23-19. Mechanical excavation equipment will be used to complete the excavation at these boreholes. The estimated volume to be excavated is 300 yards.

- ◆ Borehole (Prefixed by "BH21-")
- ▣ Sample Points (Prefixed by "TP23-")
- Pipeline (Underground)
- Approximate Lease Boundary
- ▭ Proposed 2' Excavation (~449 sq. ft)
- ▭ Proposed 6' Excavation (~38 sq. ft)

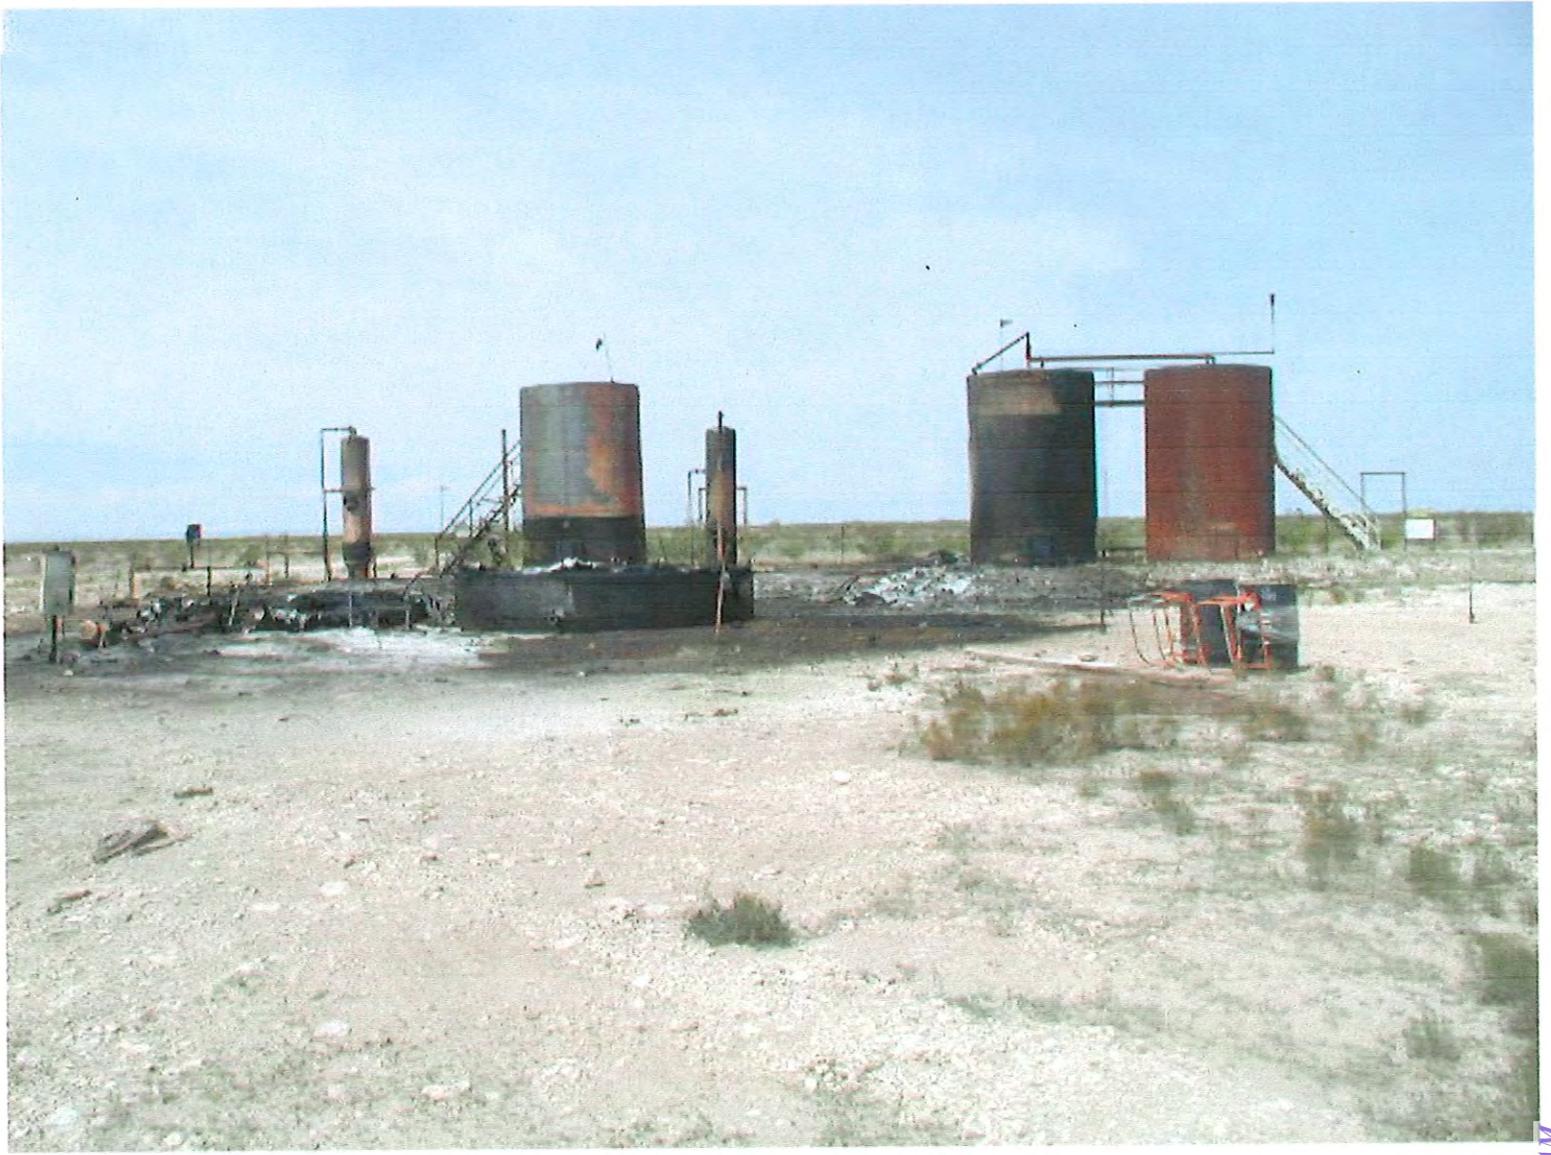
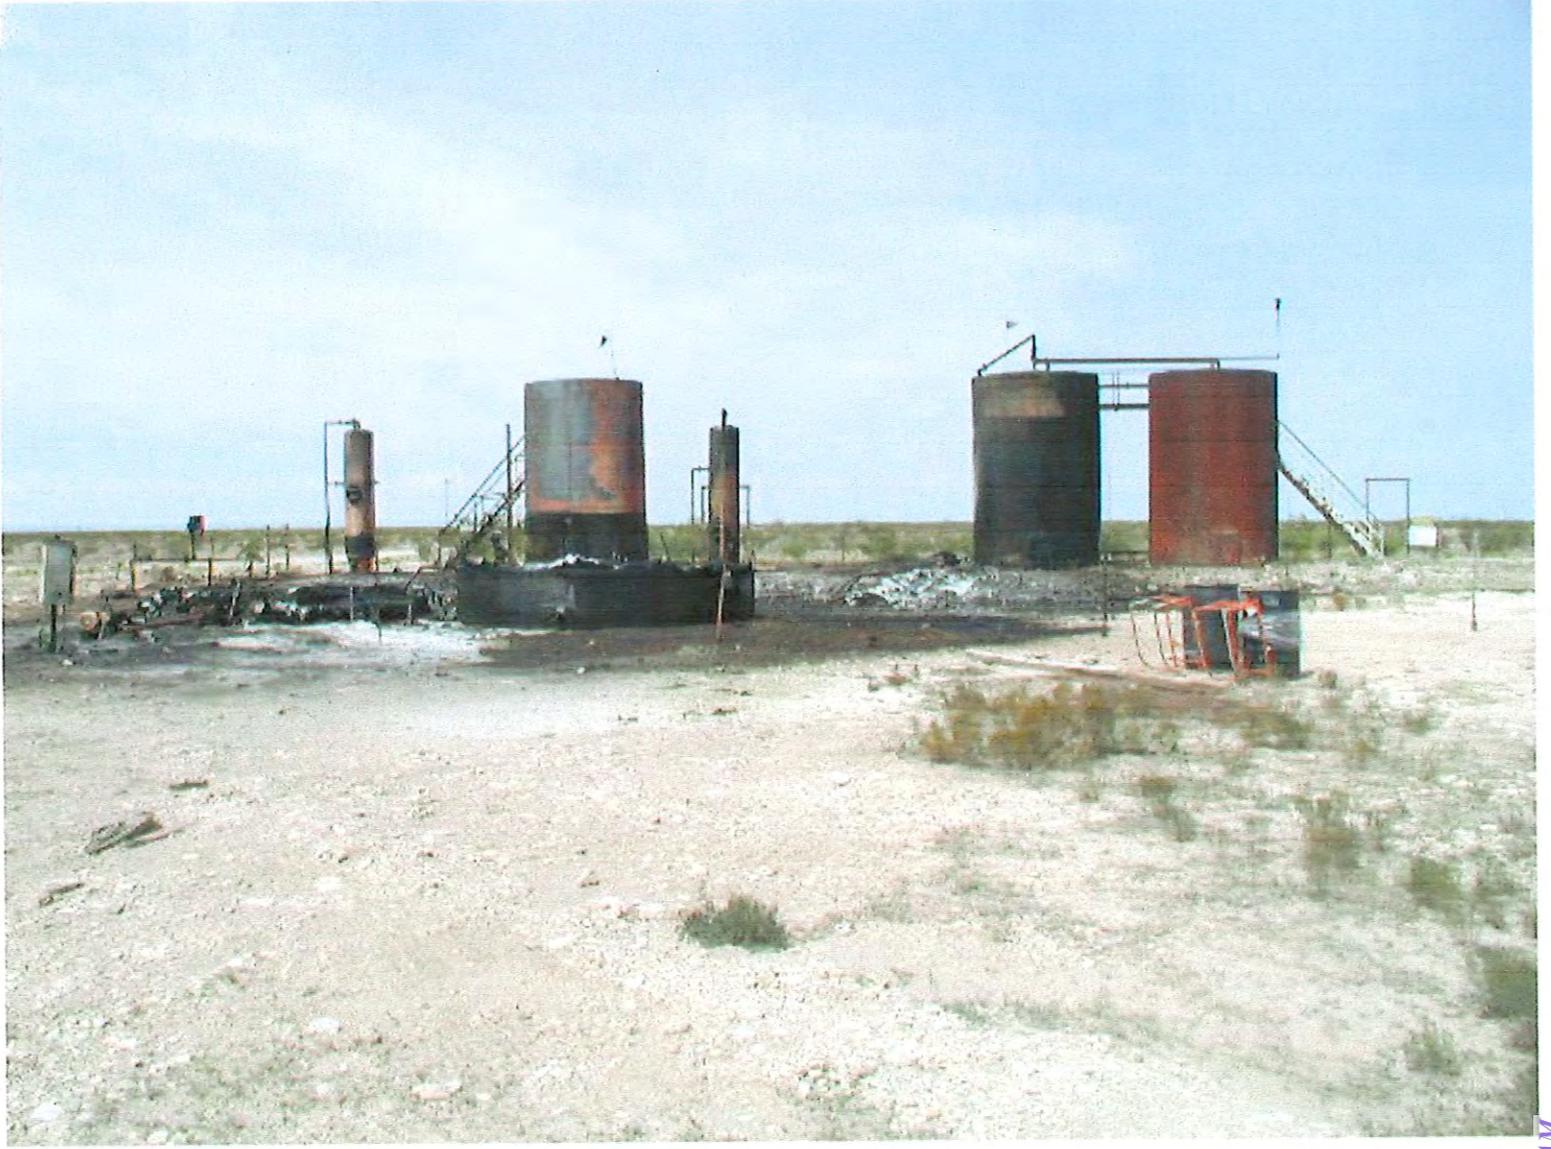
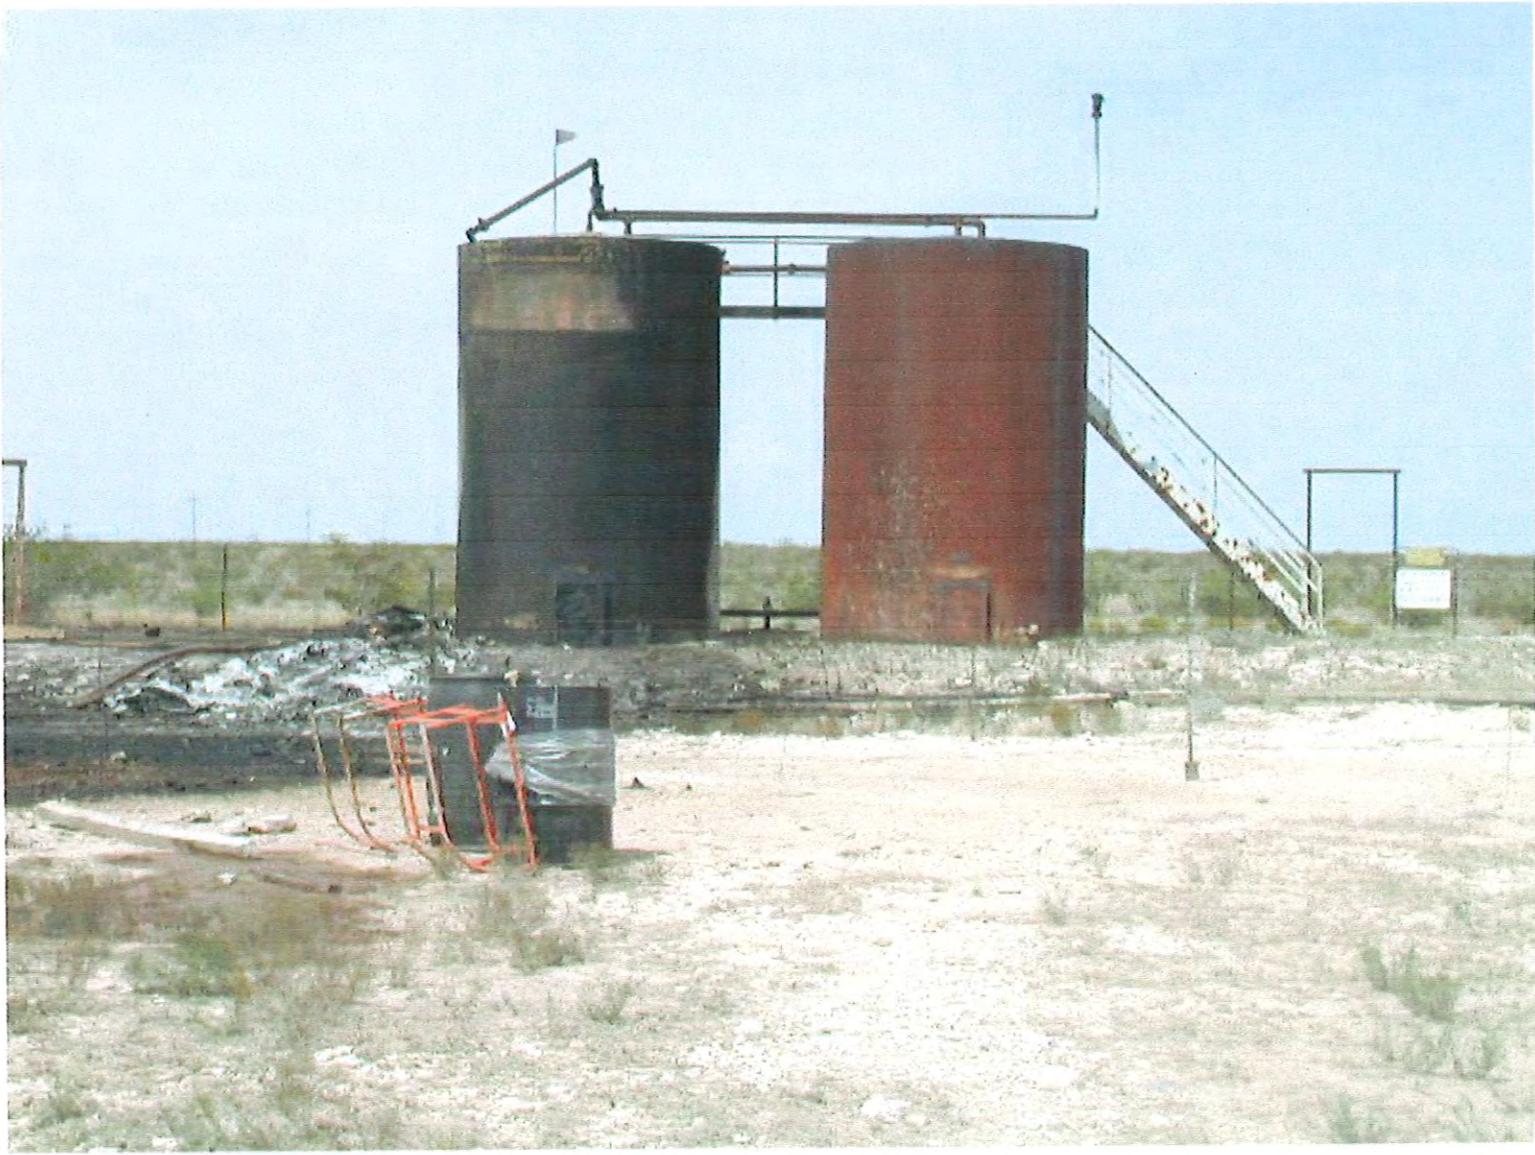
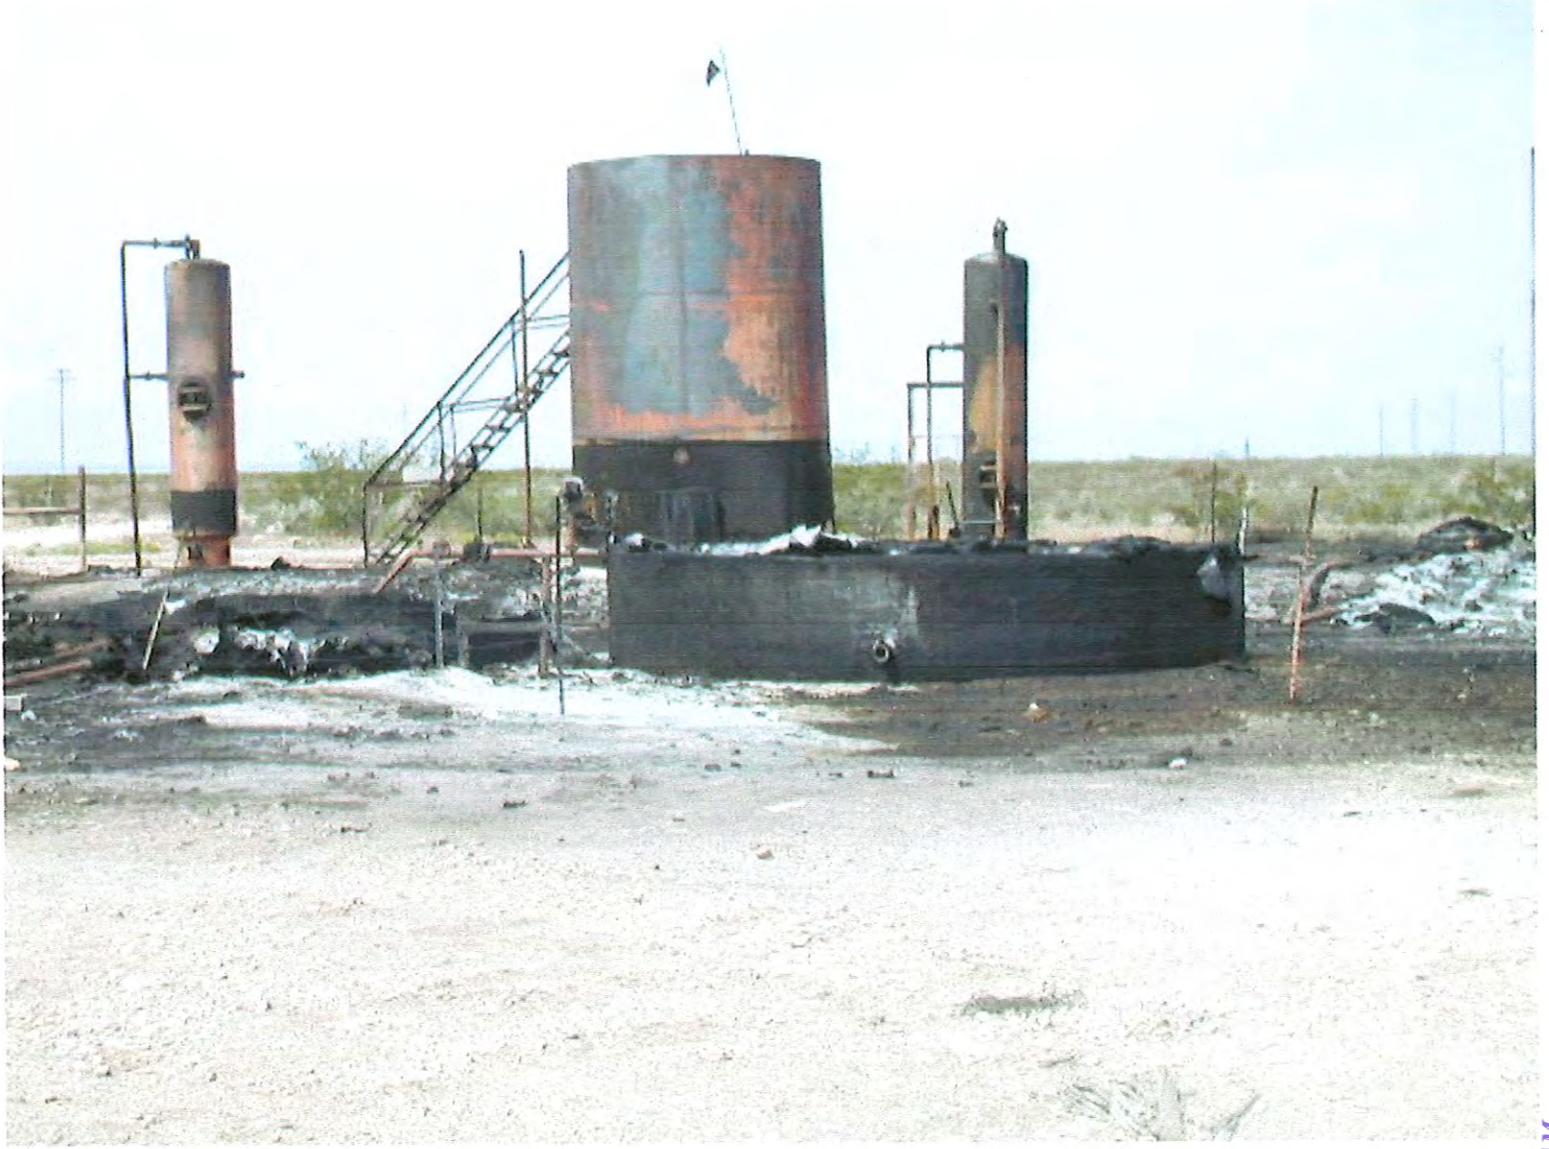
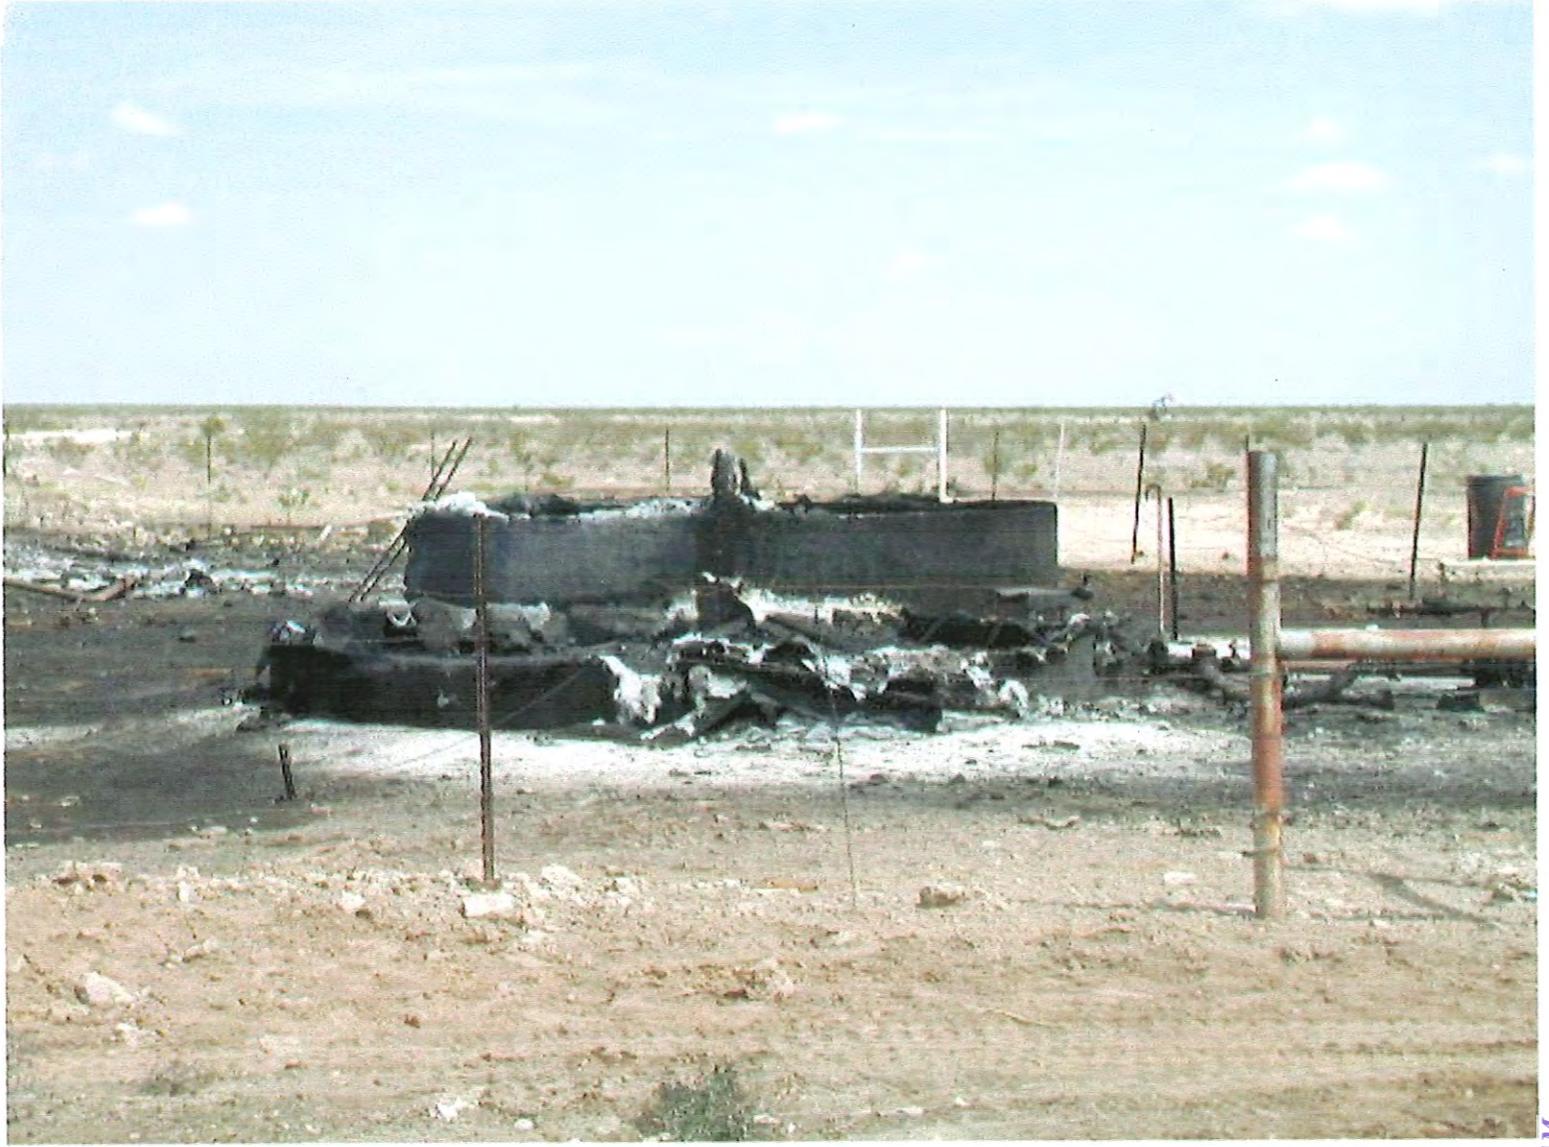
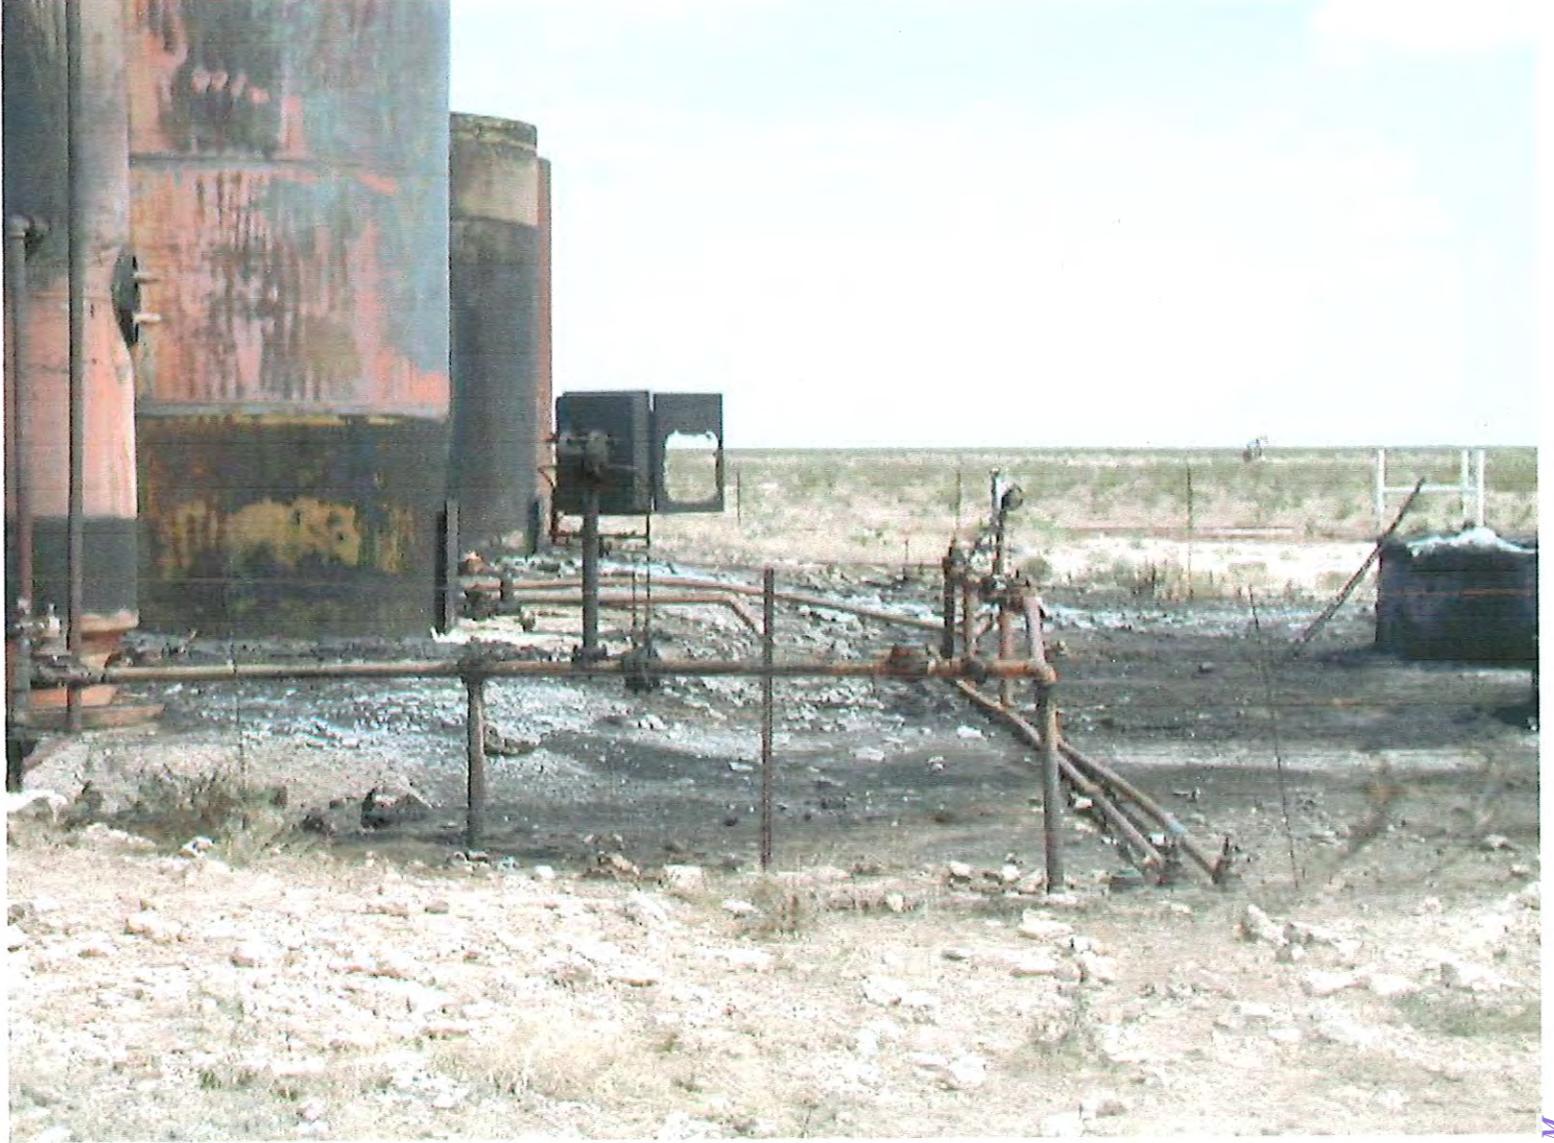
FEDERAL AB-B BATTERY  
8-17-01

Describe Cause of Problem and Remedial Action Taken.\*  
**Lightning struck and burned tank battery. Area secured to insure safety of personnel and public. Atoka volunteer fire department responded. Fire controlled and extinguished .**

Describe Area Affected and Cleanup Action Taken.\*  
**Area affected included lease road on the west side of tank battery and approximately a 4 foot x 50 foot area adjacent to west side of the lease road.  
This area had a thin surface layer and spray of BS & W which came from the burned gun barrel. Water and residue as a result of the fire departments efforts covered an area approximately 30 feet x 50 feet along and just outside the east fence around the battery . All of this residue contained on location.  
Fire debris and residue will be removed from location. Remaining water residue will be disced and treated on location.**

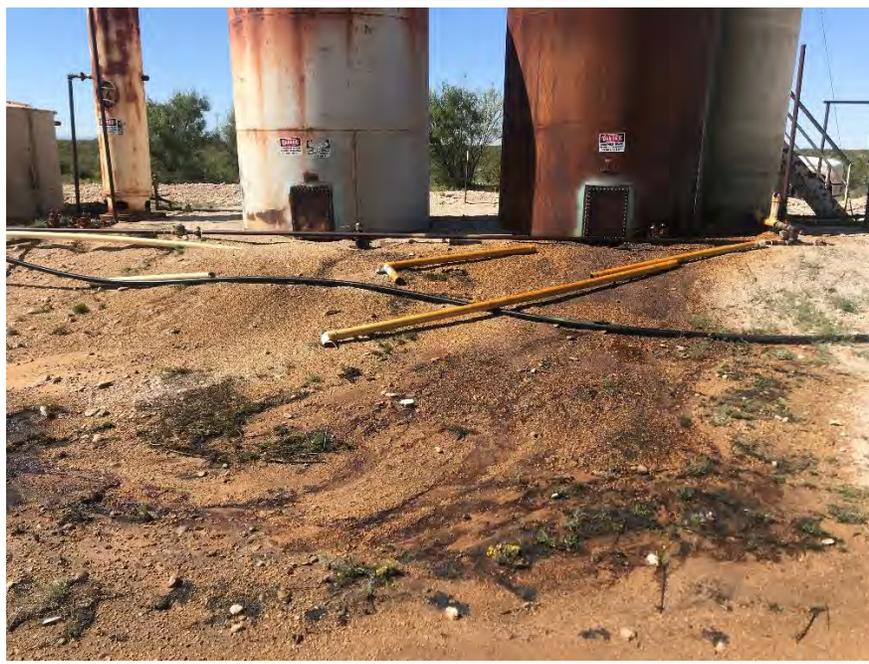
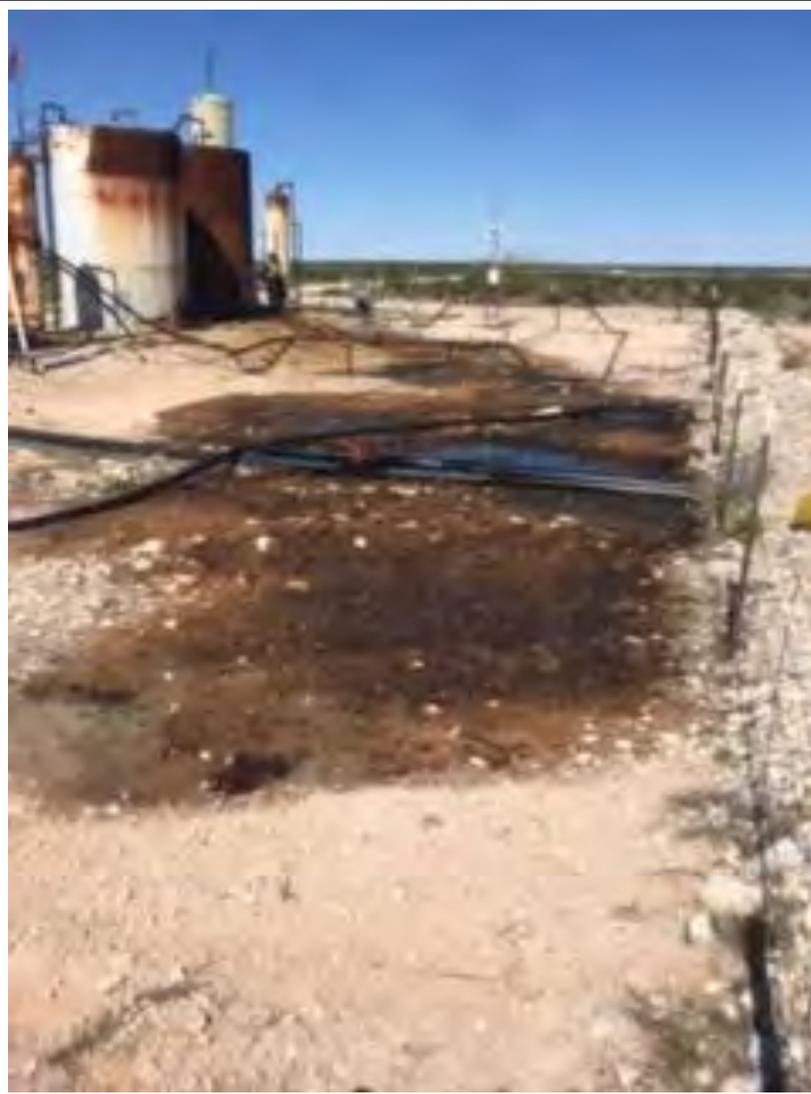
## Initial Images

In 2019, EOG began remediation at the site for a 20 barrel release when high winds caused a pvc water leg to break on a 3-Phase Vertical Separator. Initial pictures of the release area indicated impacts were isolated to the east of the separator before flowing south remaining entirely within the battery berm. These initial pictures, as well as final excavation pictures are included as Appendix D. Through the course of the initial assessment, it became obvious that some historical impacts were being encountered, which increased the footprint of the remediation area far beyond the area impacted by the recent release. Note that with the release occurring in 2019, the current Spill Rule (NMAC 19.15.29) was in effect, so the remediation limits had become more stringent than they were in the early 2000's. During the remediation of the 2019 release, the site was excavated until confirmation samples indicated Table 1 thresholds had been achieved, then a Closure Report was submitted to NMOCD for review, with approval coming May 28, 2020. A Comprehensive Site Map and the 2019 Closure Report are included with this report as Figure 1 and Appendix E to provide illustration and detail of the overlap involved with the release areas, as well as the remediation efforts completed in 2019 which address both areas. Note that the 2001 impacted area depicted on the Figure 1 Comprehensive Site Map is approximate, and based on the initial pictures included with the report in Appendix C.

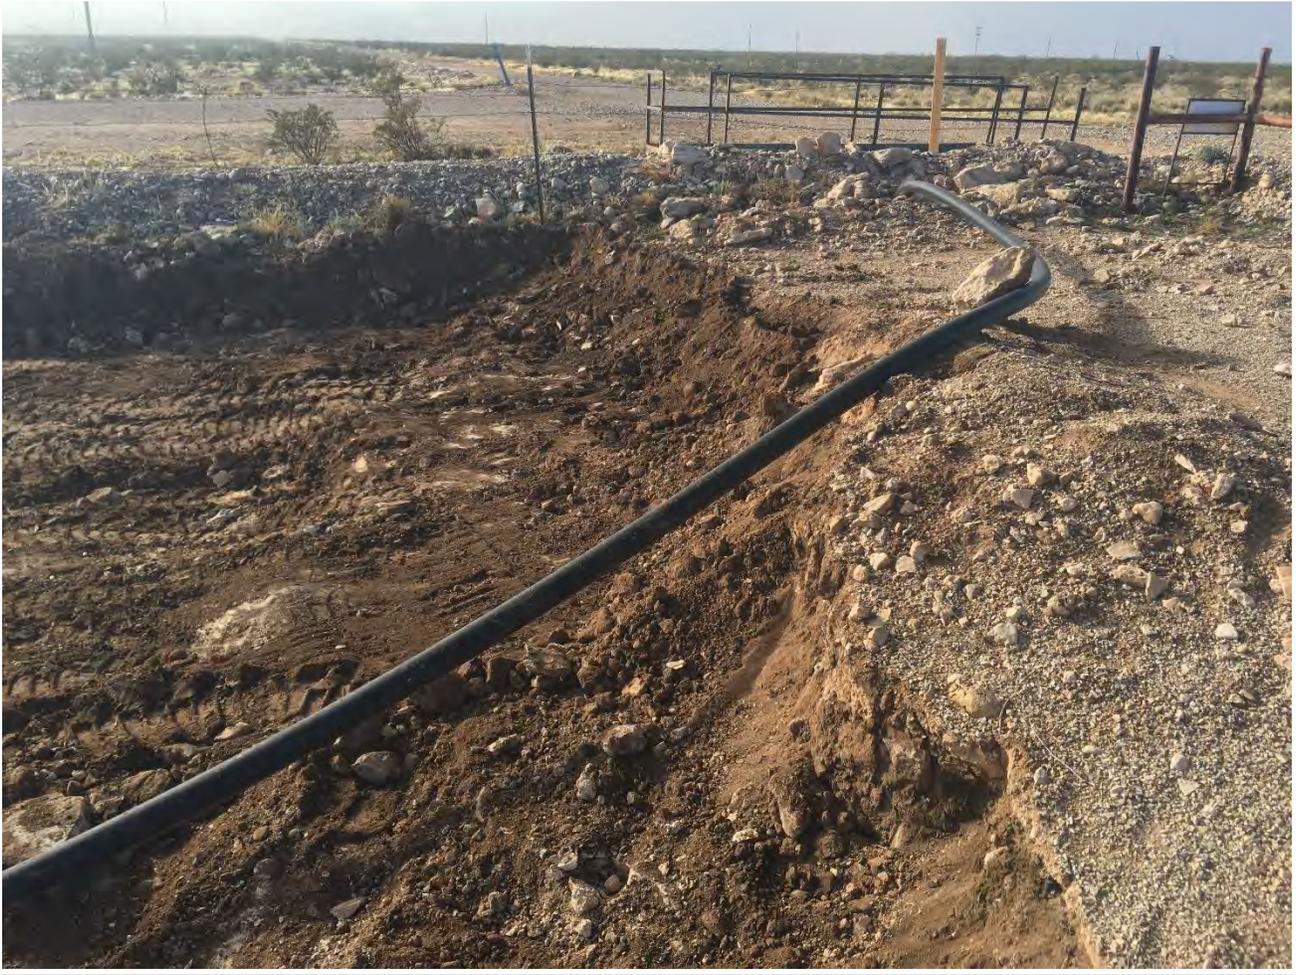
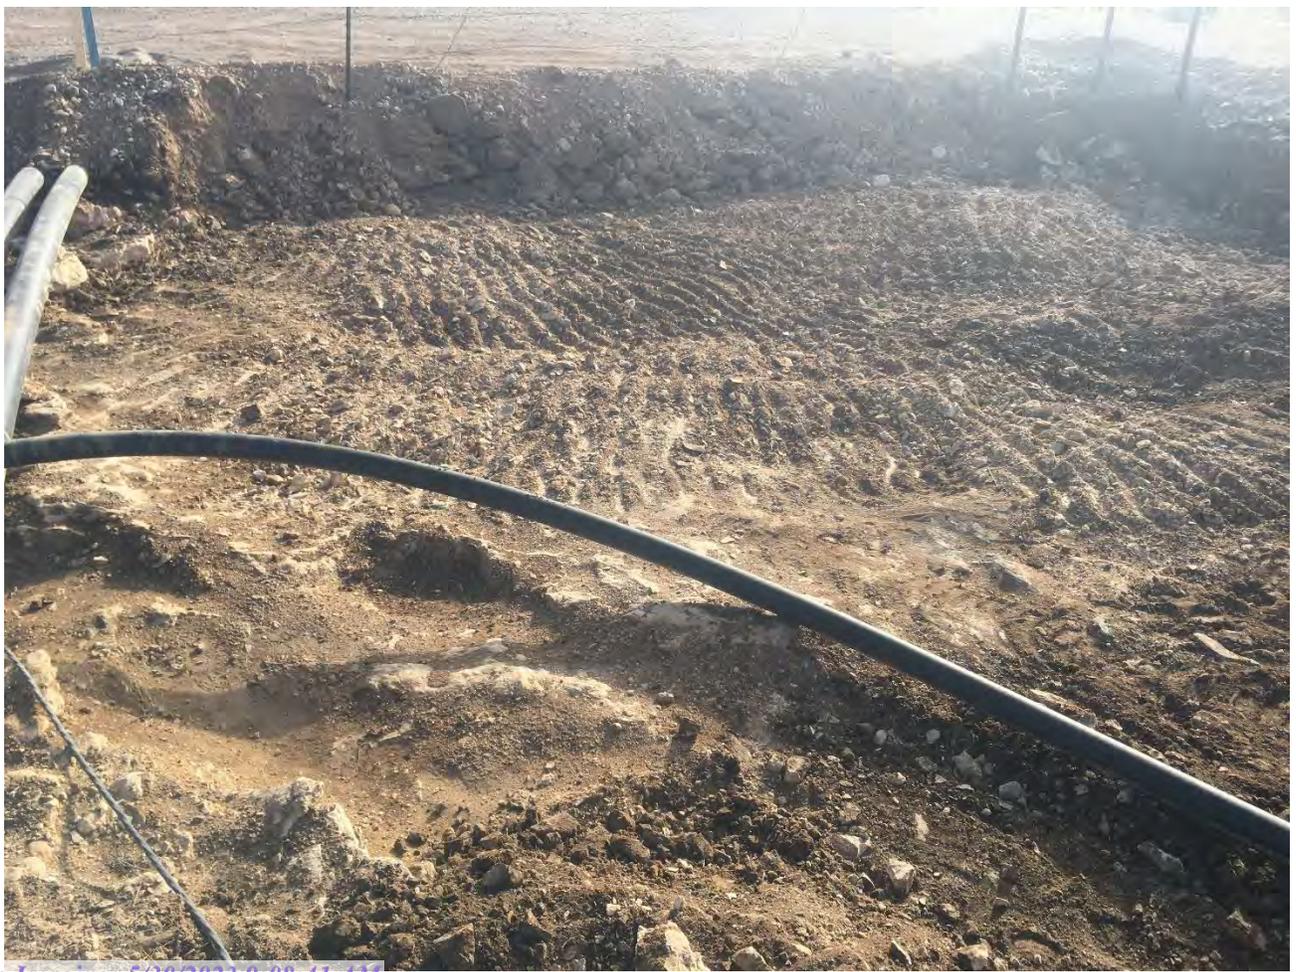
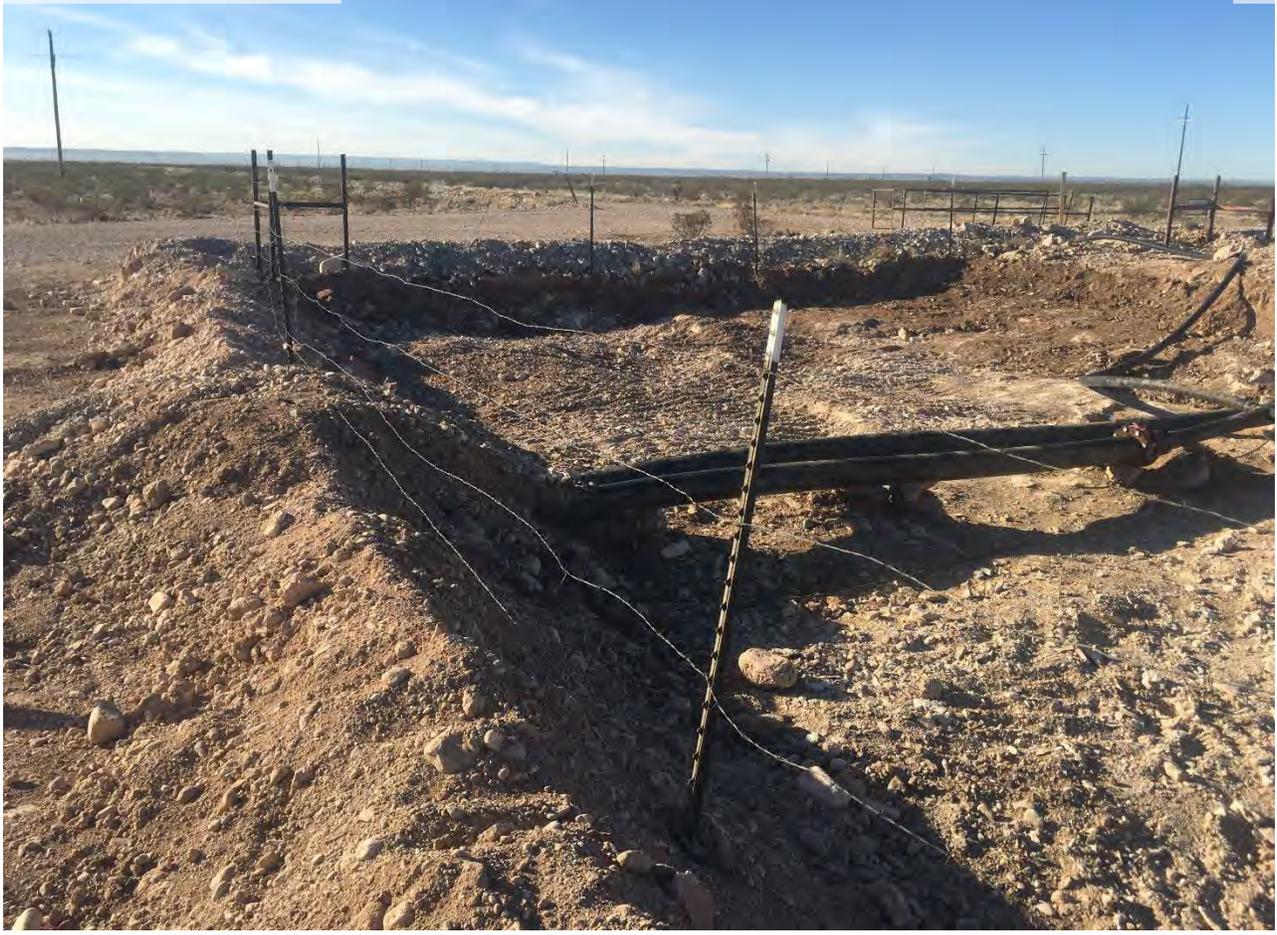
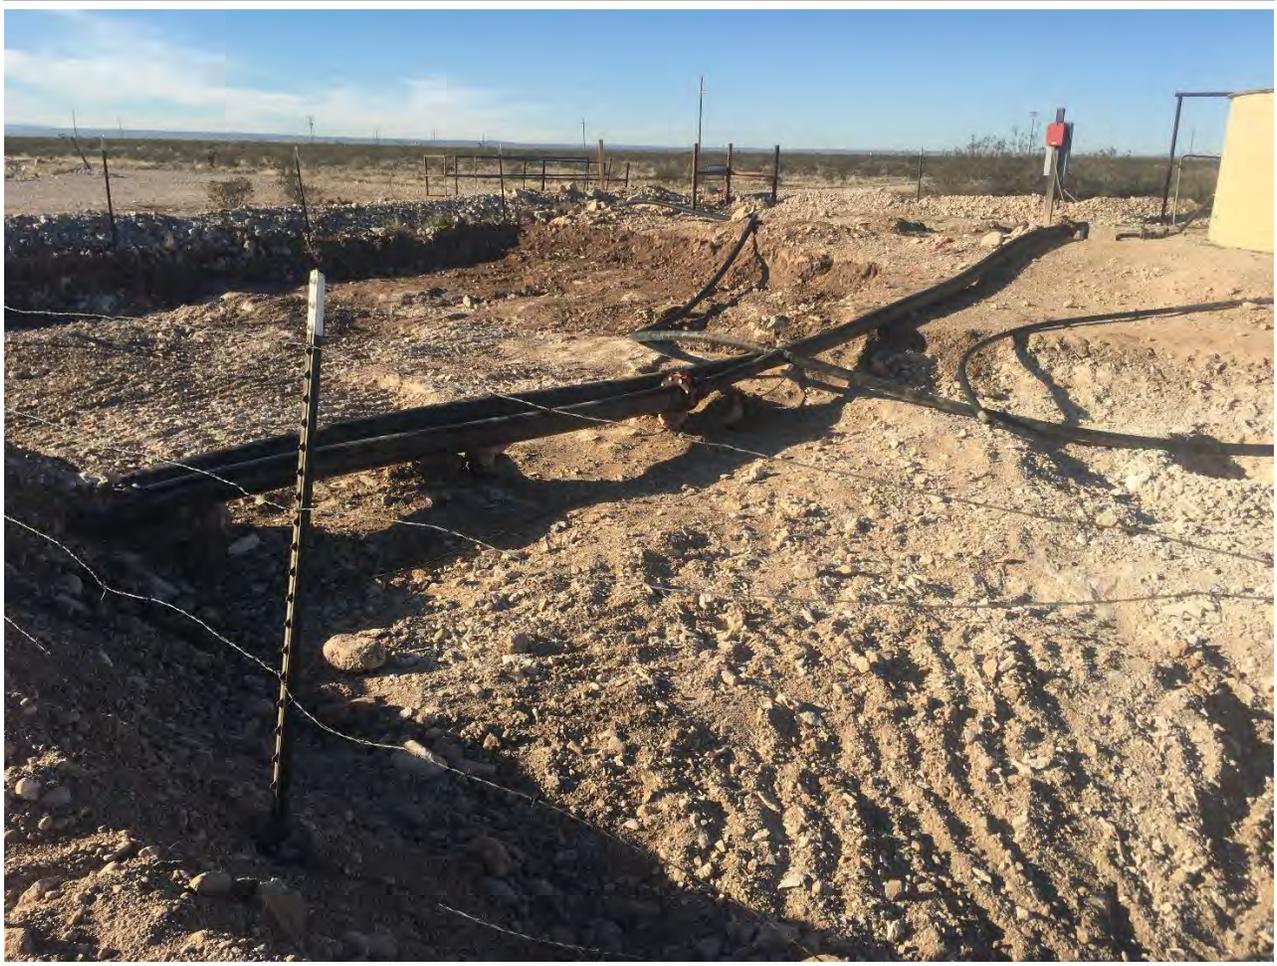
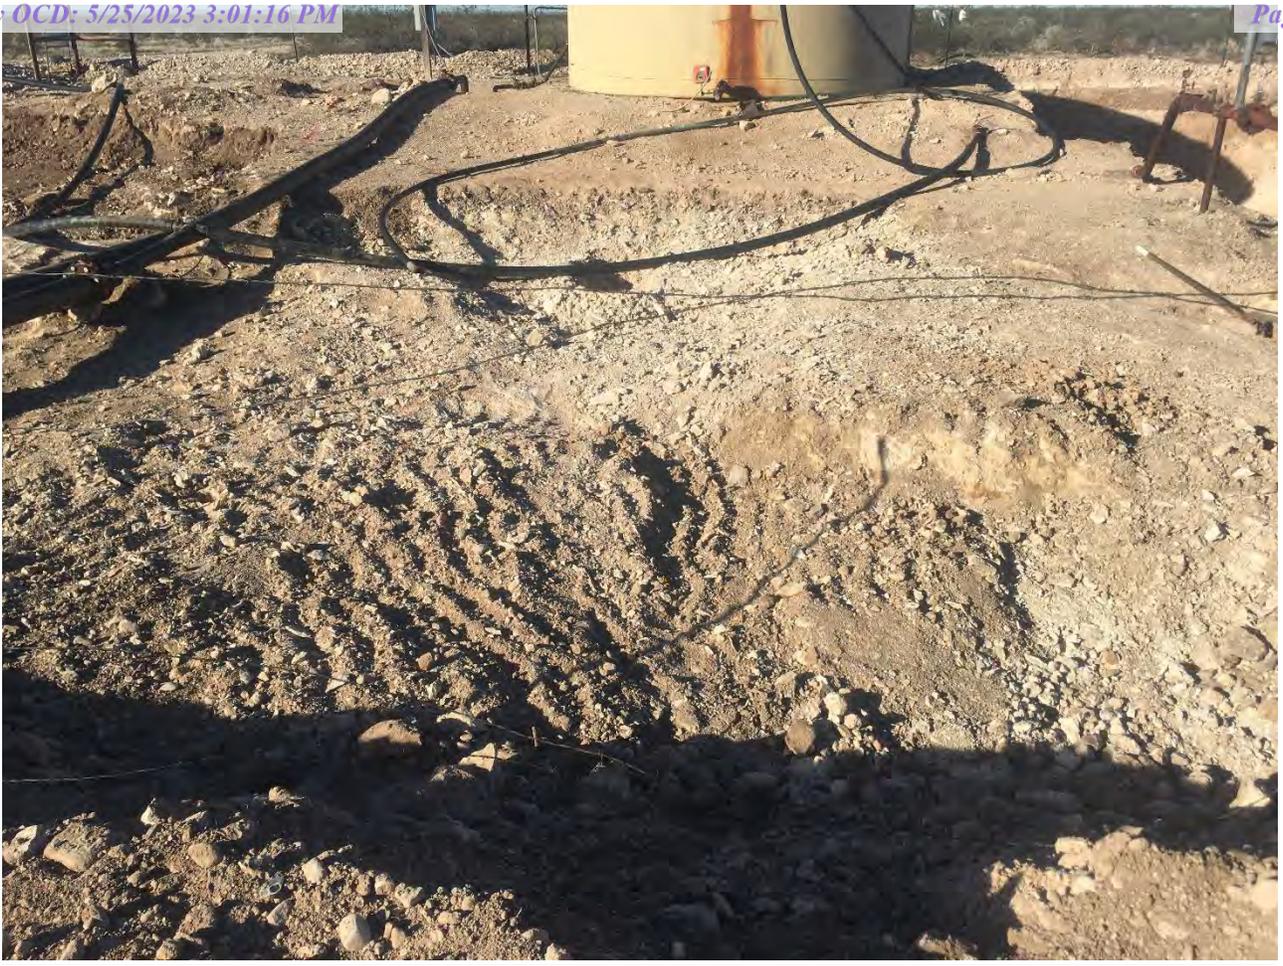
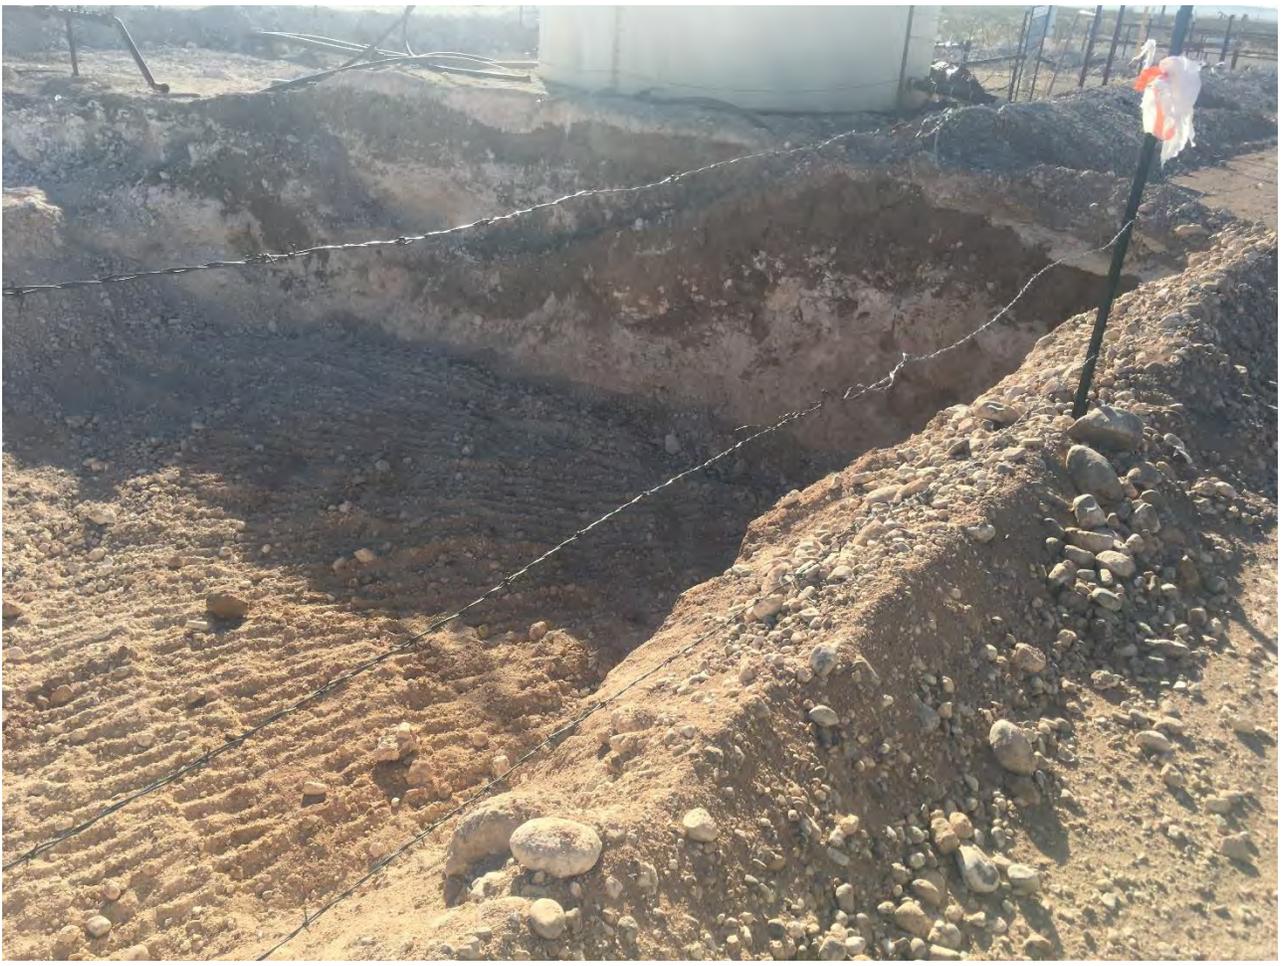
# Excavation Images

Initial excavation of the site began on October 11, 2019. Activities included the removal of saturated and visibly impacted soils with those soils being hauled to a NMOCD approved disposal facility. The site was excavated to a depth of two (2) to three (3) feet with initial horizontal edges also determined by the initial excavation. Vertical delineation sampling was then conducted within the release area, which provided further vertical excavation guidance, including the removal of the production tanks and equipment within the battery once staining was discovered re-emerging from below the tanks between excavation activities. Confirmation vertical and horizontal sampling was then conducted after those excavation activities were complete. These samples displayed that there was need for more excavation vertically, as well as horizontally. Sample activities conducted December 12, 2019, identified that only 2 areas required further excavation. One horizontal area had not met the guidance of 19.15.29.13 NMAC with a resulting chloride concentration of 656 mg/kg, and one area needed further vertical excavation due to DRO concentration of 1500 mg/kg. The sidewall excavation was extended an additional foot and the vertical area was excavated an additional half foot. The confirmation samples collected on January 9, 2020, confirmed that all vertical sample results had achieved the Table 1 standards, and horizontal sample results confirmed that all sidewalls were within the guidelines for 19.15.29.13. All horizontal samples were collected by way of 5-point composite samples, and no vertical or horizontal samples were representative of more than 200 square feet.
