**Environmental Site Remediation Work Plan**

NMOCD District:	District 2	Incident ID:	nMCS0124838636
Landowner:	Private	RP Reference:	N/A
Client:	EOG Resources, Inc.	Site Location:	Federal AB-B Battery
Date:	May 25, 2023	Project #:	22E-00123-15
Client Contact:	Chase Settle	Phone #:	575.748.4171
Vertex PM:	Chance Dixon	Phone #:	575.988.1472

# Comprehensive Site Map

Federal AB-B Battery  
Closure Report  
#nMCS0124838636

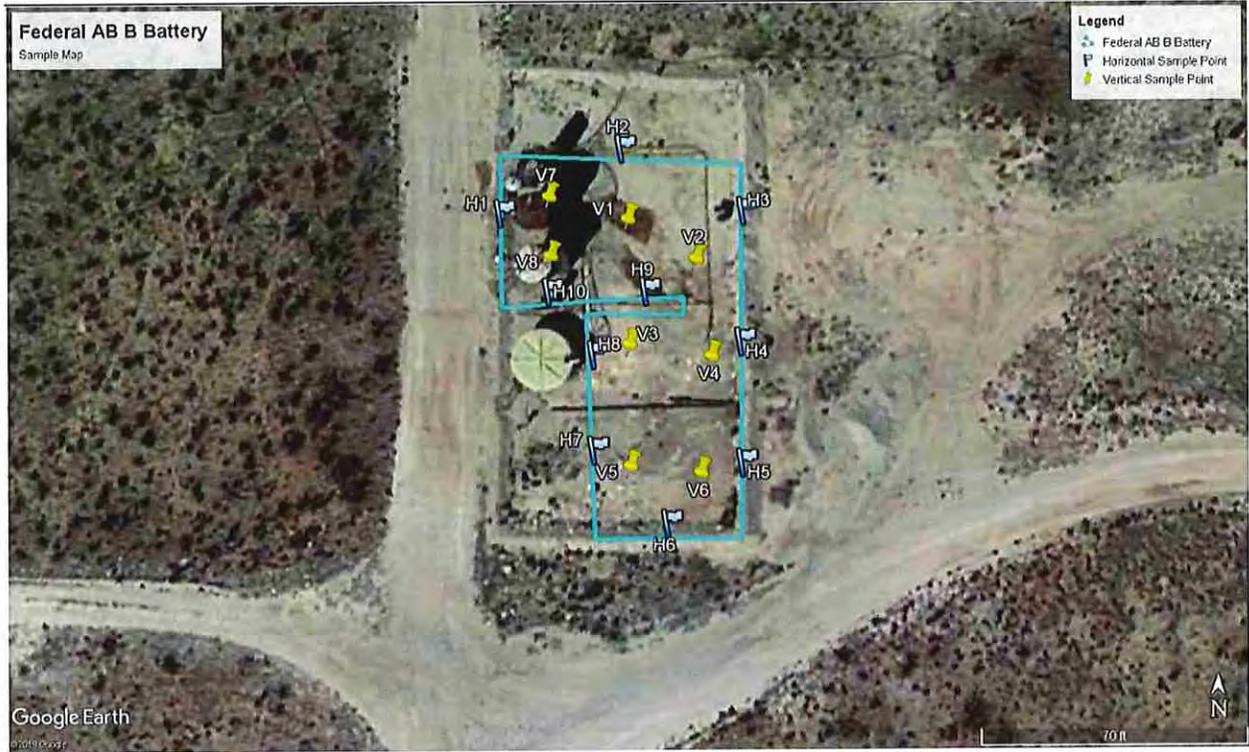
# Figure 1

## Site Map with Sample Points
