**Re: Release Characterization and Closure Request
ConocoPhillips
Heritage Concho
Myox 5 State Com #022H Release
Unit Letter O, Section 05, Township 26 South, Range 28 East
Eddy County, New Mexico
Incident ID# nAB1821442601**

Tetra Tech, Inc. (Tetra Tech) was contacted by ConocoPhillips to assess a Heritage Concho release that occurred at the tank battery located on the Myox 5 State Com #022H lease pad (API No. 30-015-43706). The release footprint is located in Public Land Survey System (PLSS) Unit Letter O, Section 05, Township 26 South, Range 28 East, in Eddy County, New Mexico (Site). The approximate release point occurred at coordinates 32.06501508°, -104.1082911°, as shown on Figures 1 and 2.

**MYOX 5 STATE COM #022H
TOPOGRAPHIC MAP**

**APPROXIMATE RELEASE EXTENT AND SITE ASSESSMENT WITH DTW
LOCATION (TT 2023)**

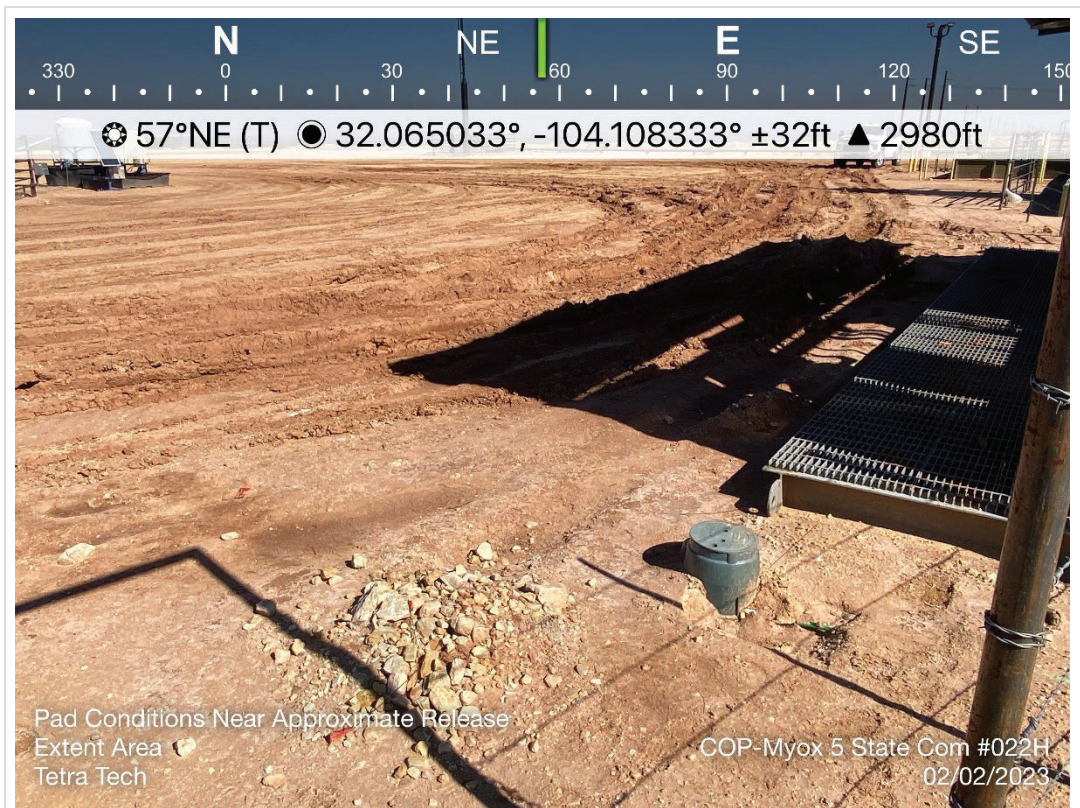
TETRA TECH, INC. PROJECT NO. 212C-MD-03004	DESCRIPTION	View northeast of pad conditions near release extent.	3
	SITE NAME	Myox 5 State Com #22H	2/2/2023

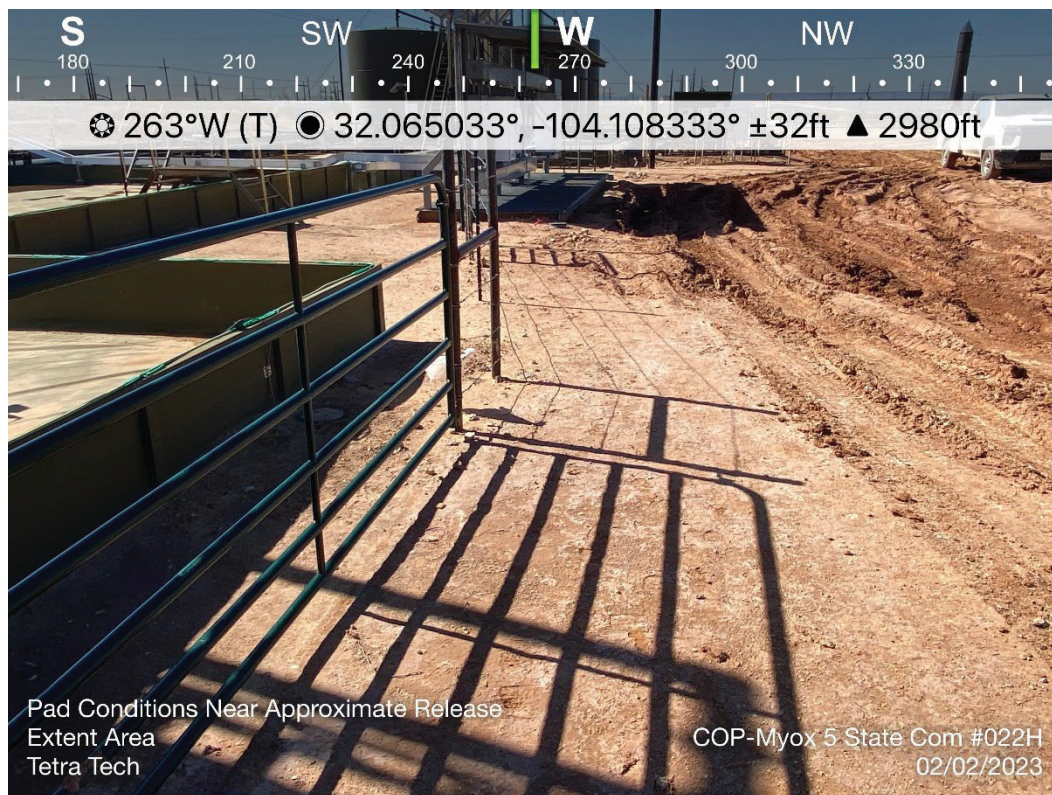
TETRA TECH, INC. PROJECT NO. 212C-MD-03004	DESCRIPTION	View west of pad conditions near release extent.	4
	SITE NAME	Myox 5 State Com #22H	2/2/2023
