## Release Notification

## CLOSURE REPORT

**Trunk E (09/21/22)  
Unit Letter D, S33 T31N R8W  
San Juan County, New Mexico**

**New Mexico EMNRD OCD Incident ID No. NAPP2226445914**

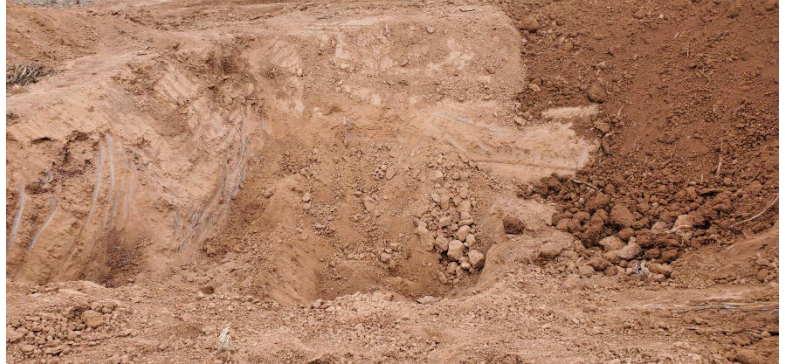
**Photograph 1**

Photograph Description: View of the in-process excavation activities.

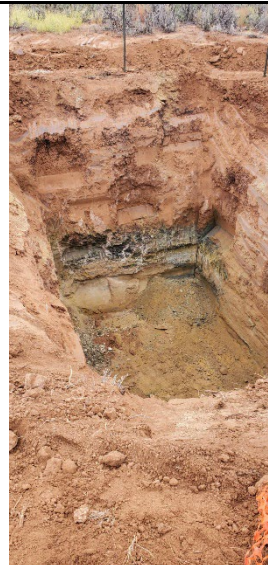
**Photograph 2**

Photograph Description: View of the in-process excavation activities.

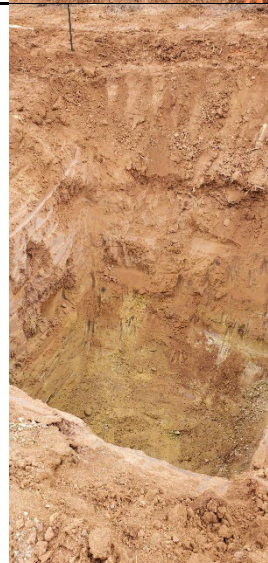
**Photograph 3**

Photograph Description: View of the in-process excavation activities.

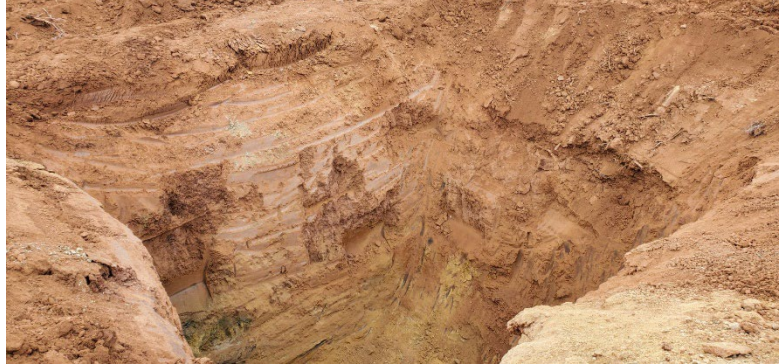
**Photograph 4**

Photograph Description: View of the in-process excavation activities.

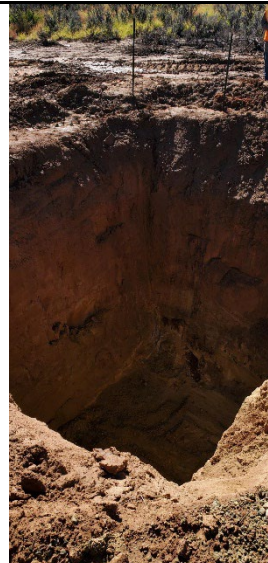
**Photograph 5**

Photograph Description: View of the in-process excavation activities.

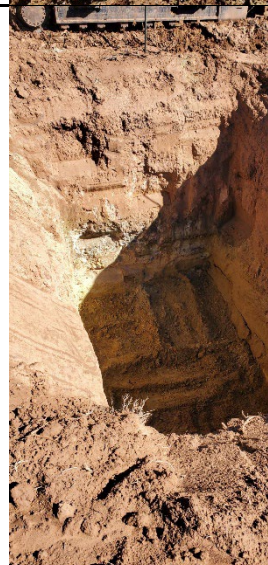
**Photograph 6**

Photograph Description: View of the final excavation.

The final excavation measured approximately 13 feet long and 9 feet wide at the maximum extents. The maximum depth of the excavation measured approximately 12 feet bgs. The lithology encountered during the completion of remediation activities consisted primarily of clay and shale.

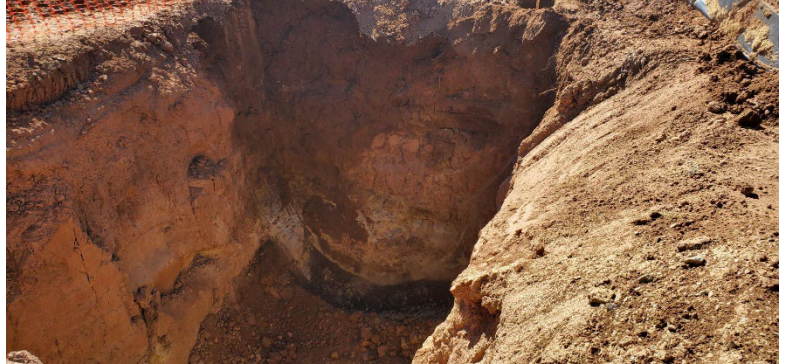
**Photograph 7**

Photograph Description: View of the final excavation.

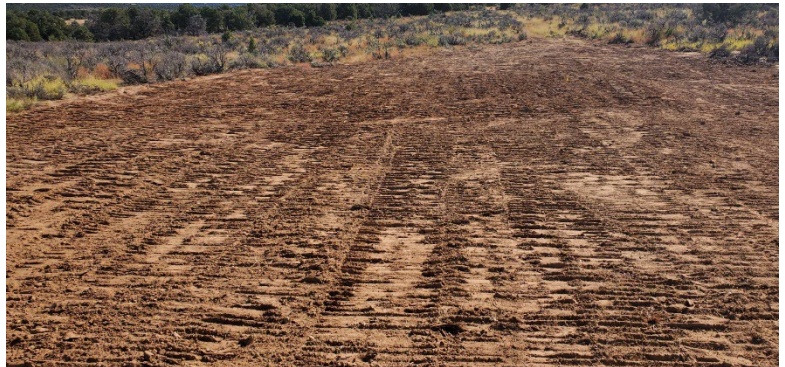
**Photograph 8**

Photograph Description: View of the site after initial restoration.

Approximately 152 cubic yards (yd<sup>3</sup>) of petroleum hydrocarbon affected soils and 115 barrels (bbls) of hydro-excavation soil cuttings and water were transported to the Envirotech, Inc., (Envirotech) landfarm near Hilltop, NM for disposal/remediation. The executed C-138 solid waste acceptance form is provided in **Appendix C**. The excavation was backfilled with imported fill and was subsequently contoured to the surrounding topography.
