### Report Type: Closure Report (1RP-5125)

Site:	Mars 10 SC 506					
Company:	EOG Resources					
Section, Township and Range	Unit M	Sec. 3	T 24S	R 33E		
County:	Lea County, NM					
GPS:	32.24140			-103.5662		
Surface Owner:	State of New Mexico

**Re: Closure Report  
EOG Resources  
Mars 10 SC 506  
Unit M, Section 3, Township 24 South, Range 33 East  
Lea County, New Mexico  
1RP-5125  
Incident Id: NOY1819840745**

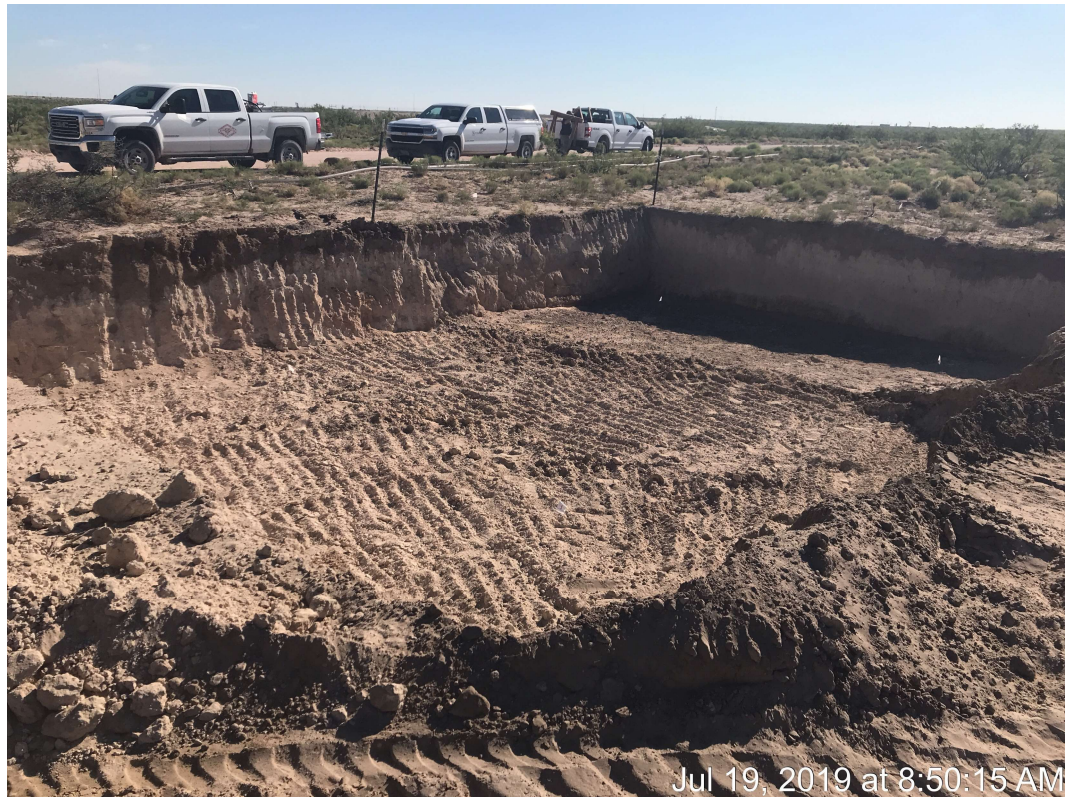
View of the Northern Excavated Area

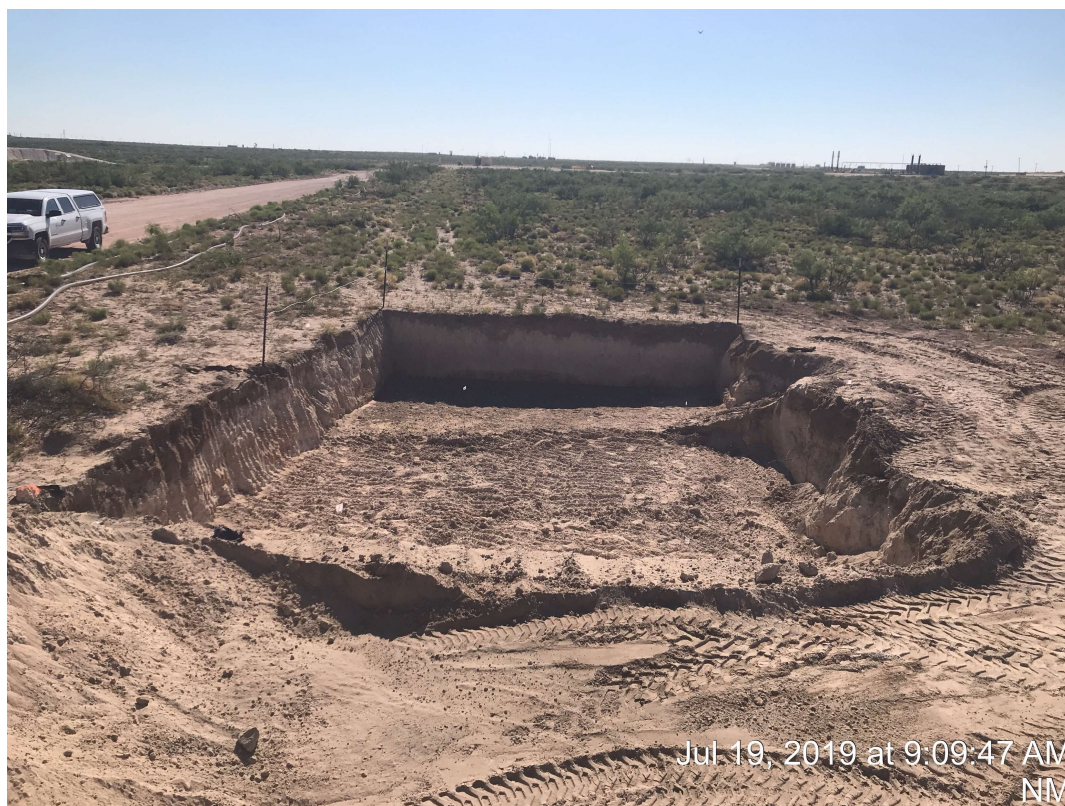
View of the Northern Excavated Area

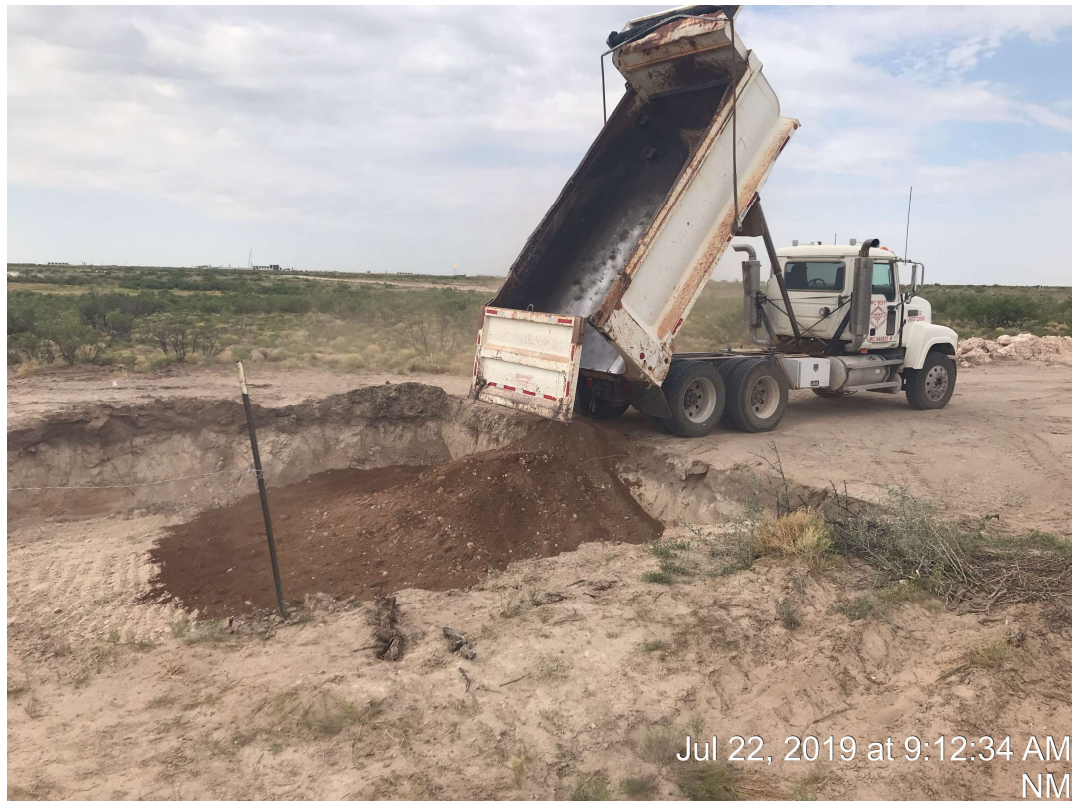
View of the backfilling of the northern excavated area.

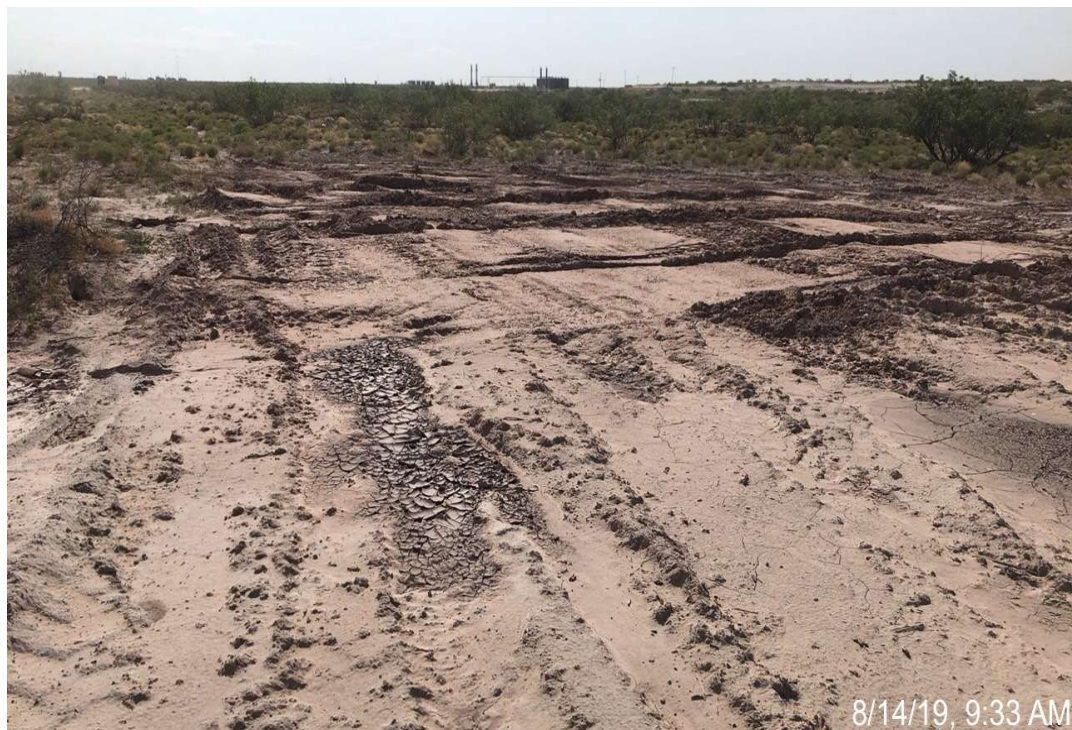
View of the backfilling of excavated northern area.

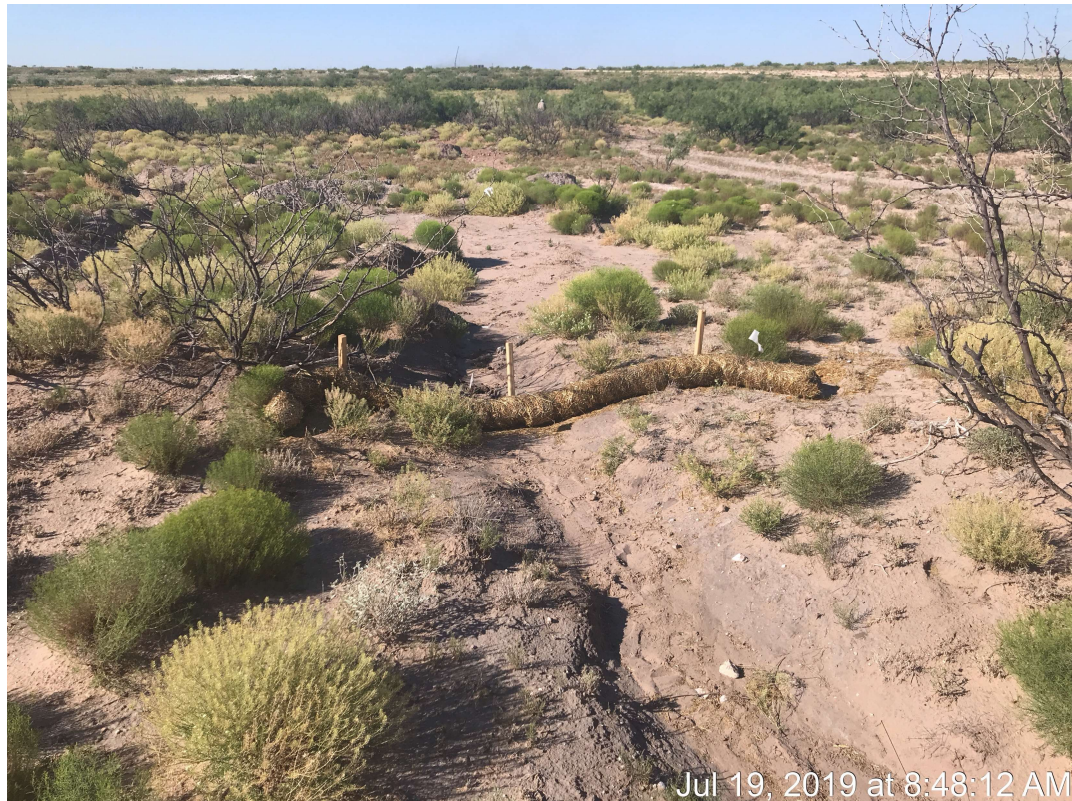
View of the Remediation Activities (Wattles).

On July 19, 2019 Tetra Tech supervised the placing of seven (7) wattles in the locations shown on Figure 4. Backfilling of southern area (near playa-lake) was supervised using topsoil from a nearby area and the placement of the erosion control blanket was observed. Besides, large boulders were placed south of the access road at the edge of existing vegetation to serve as a "road" block. On June 22, 2019 backfilling of the northern area was conducted.

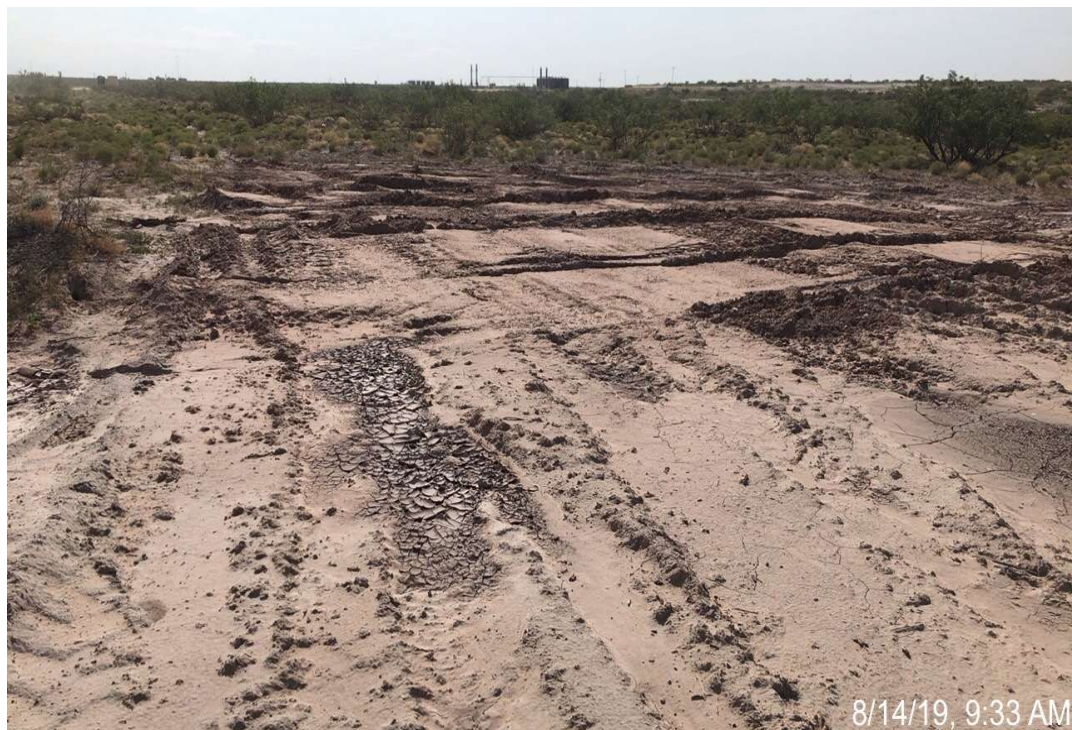
View of the backfilling of excavated northern area.

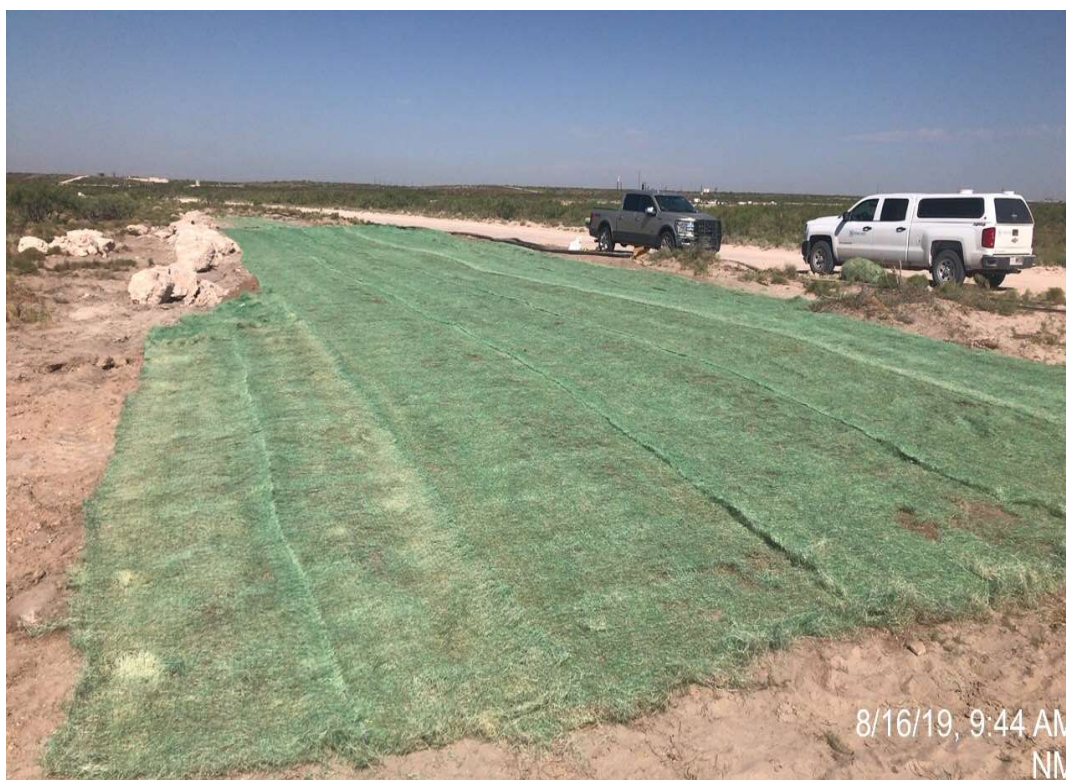
View of the remediation activities (placement of erosion control blanket and boulders) .

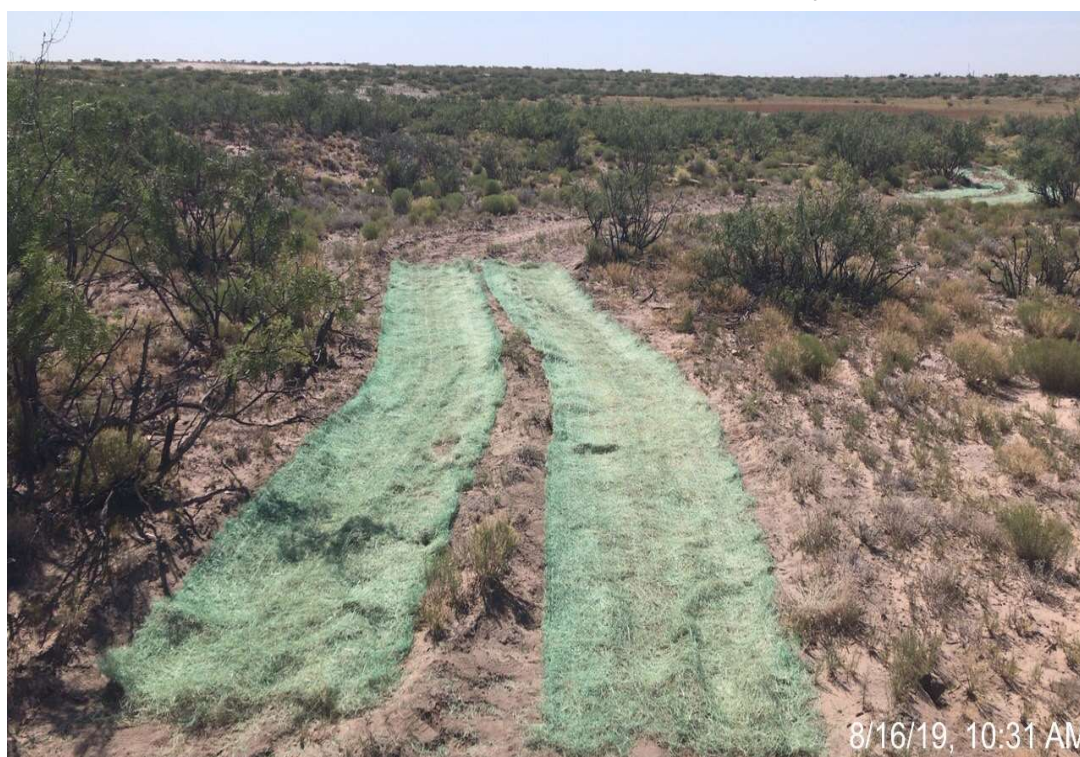
View of the remediation activities (placement of erosion control blanket at the two-track path) . .

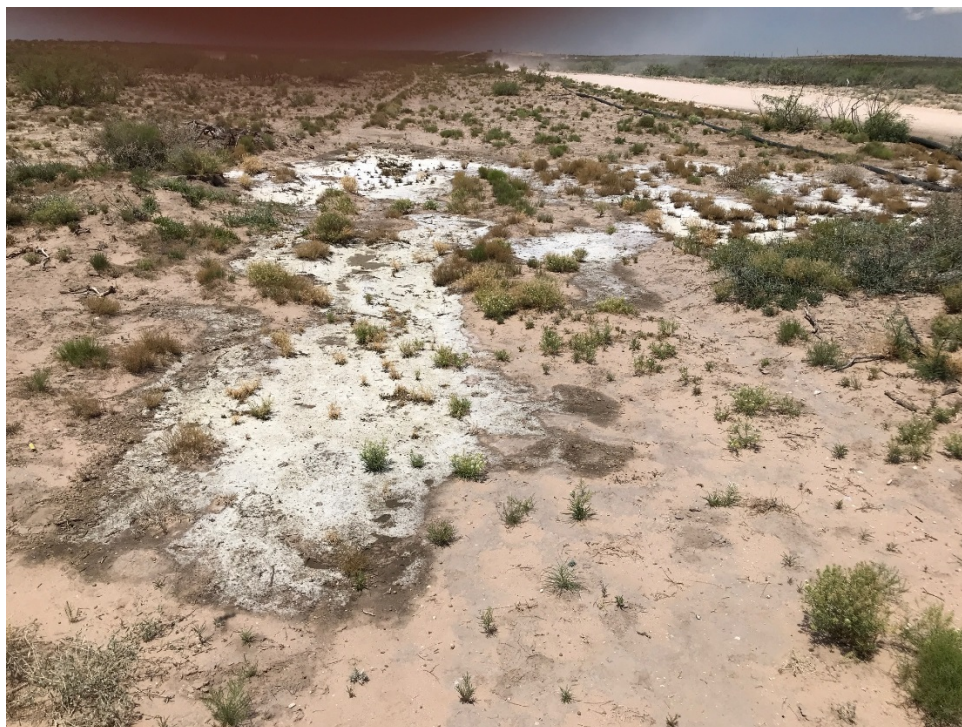
Photo 1 - Third party release point

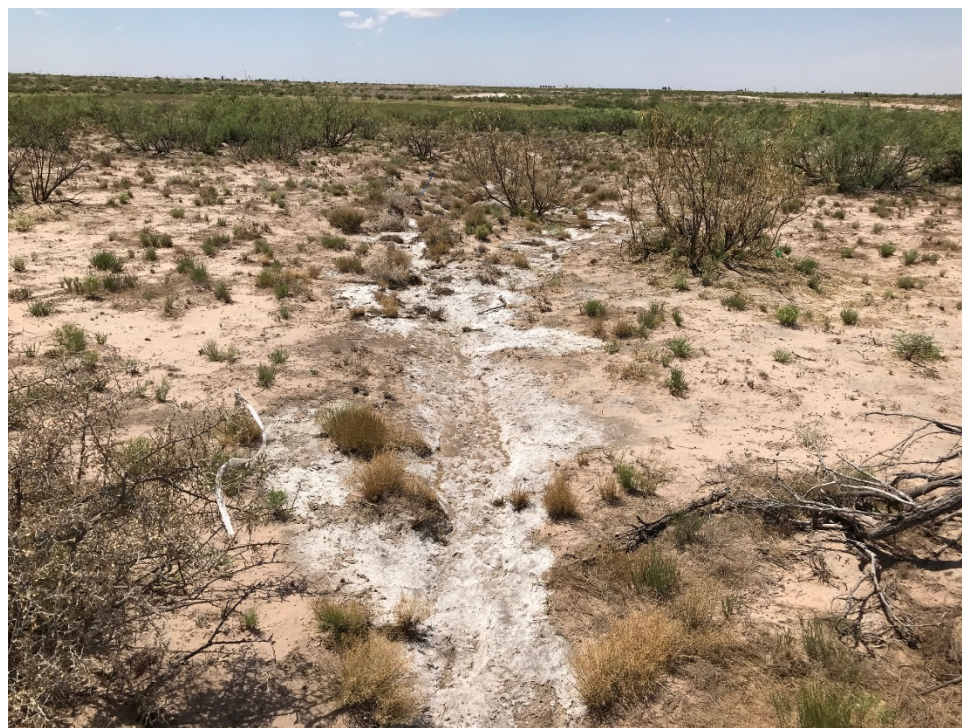
Photo 2 - Looking south towards the playa

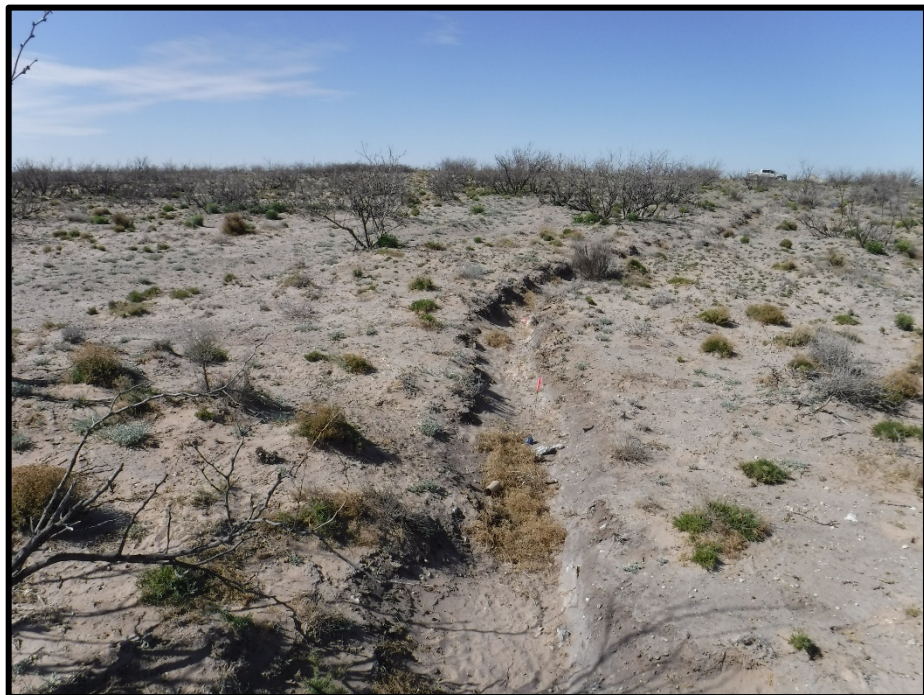
<b>Photo #:</b> 3	<b>Date:</b> 5 March 2019
Description: Erosional Drainage Located Immediately South of Northern Blade Scrape, Facing North

A photograph of an erosional drainage in a desert landscape. The terrain is sandy and sparsely vegetated with low-lying shrubs. A distinct, narrow, and deep erosional channel runs vertically down the center of the slope. The sky is clear and blue.

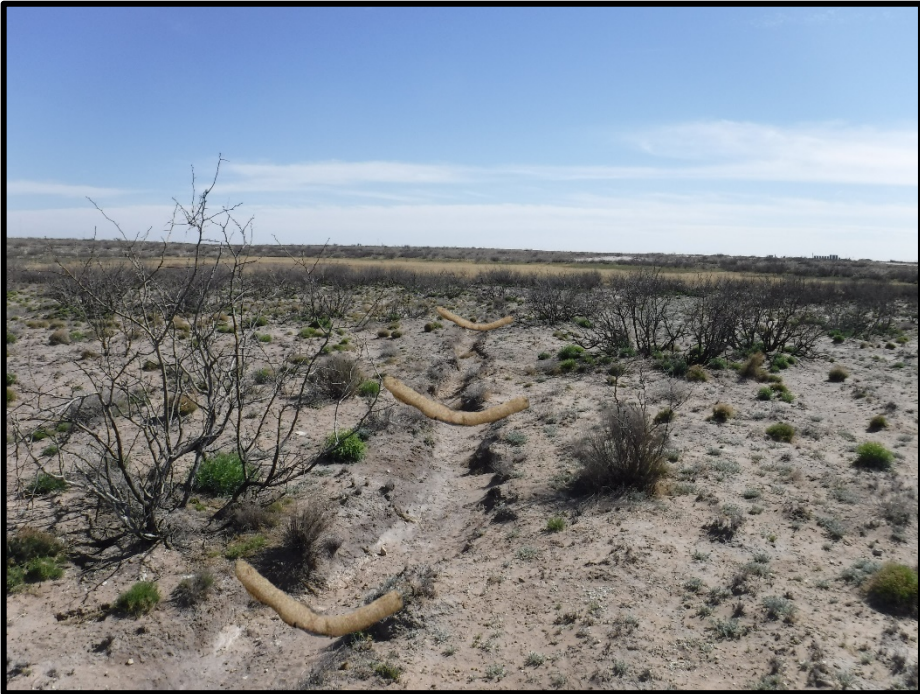
<b>Photo #:</b> 4	<b>Date:</b> 5 March 2019
Description: Wattles in Erosional Drainage: Concept

A photograph of a desert landscape showing erosion control measures. Three long, yellow, cylindrical wattles are placed in a line across a sandy, eroded path. The surrounding area is arid with sparse, dry vegetation and a clear blue sky.

Wattles will be constructed of a polypropylene netting (photodegradable) that is filled with either straw or aspen excelsior both of which are biodegradable. Aspen excelsior typically is much less palatable by livestock and will not typically be destroyed or consumed. After installation, the wattles will degrade over time and continue to reduce water velocity along the linear drainage.

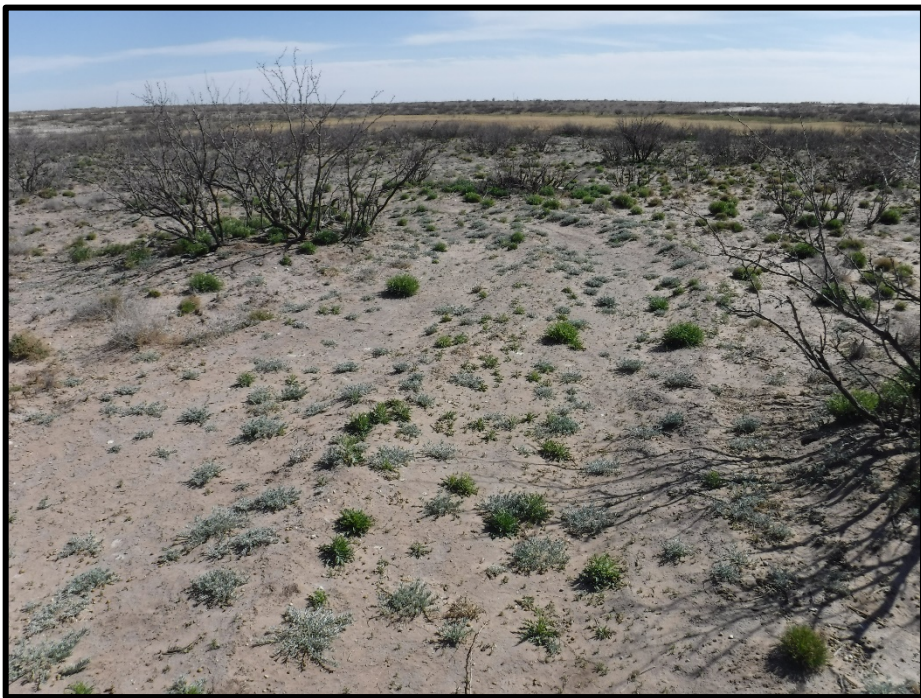
<b>Photo #:</b> 5	<b>Date:</b> 5 March 2019
Description: Two-Track Path with Vegetation Regrowth, Facing South

A wide-angle photograph of a desert landscape. The foreground is sandy with scattered low-lying green and greyish shrubs. A few larger, bare, dark shrubs are prominent. The background shows a flat horizon under a clear blue sky with some light clouds.

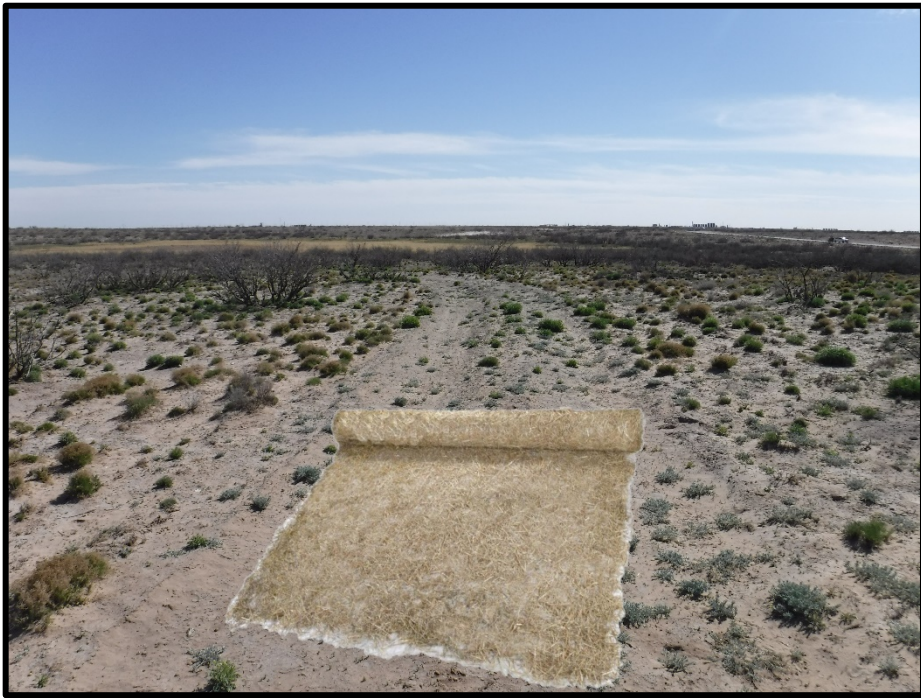
<b>Photo #:</b> 6	<b>Date:</b> 5 March 2019
<b>Description:</b> Concept: Erosion Control Blanket Covering Seeding Effort along Two-Track Path

A photograph of a desert landscape. In the foreground, a large, rectangular, light-brown erosion control blanket (straw mat) is laid out on the sandy ground. The blanket is partially unrolled, showing its fibrous texture. The ground is sandy with sparse, low-lying desert vegetation. In the background, there is a dirt path, more desert vegetation, and a clear blue sky with some distant structures.

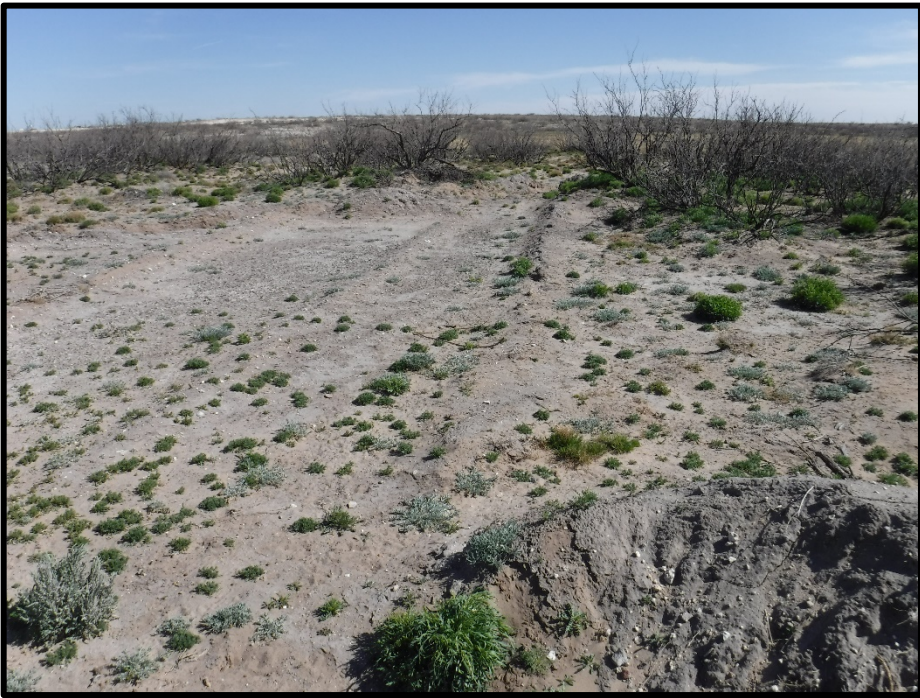
<b>Photo #:</b> 7	<b>Date:</b> 5 March 2019

<b>Description:</b> Southern Blade Scrape, Facing Southeast
