Closure Report

Bola 7 Federal # 2
Lea County, New Mexico
API ID # 30-025-35381
Incident # NSAP0122604881

Subject: **Closure Report**
Bola 7 Federal # 2
Lea County, New Mexico
API # 30-025-35381
Incident # NSAP0122604881

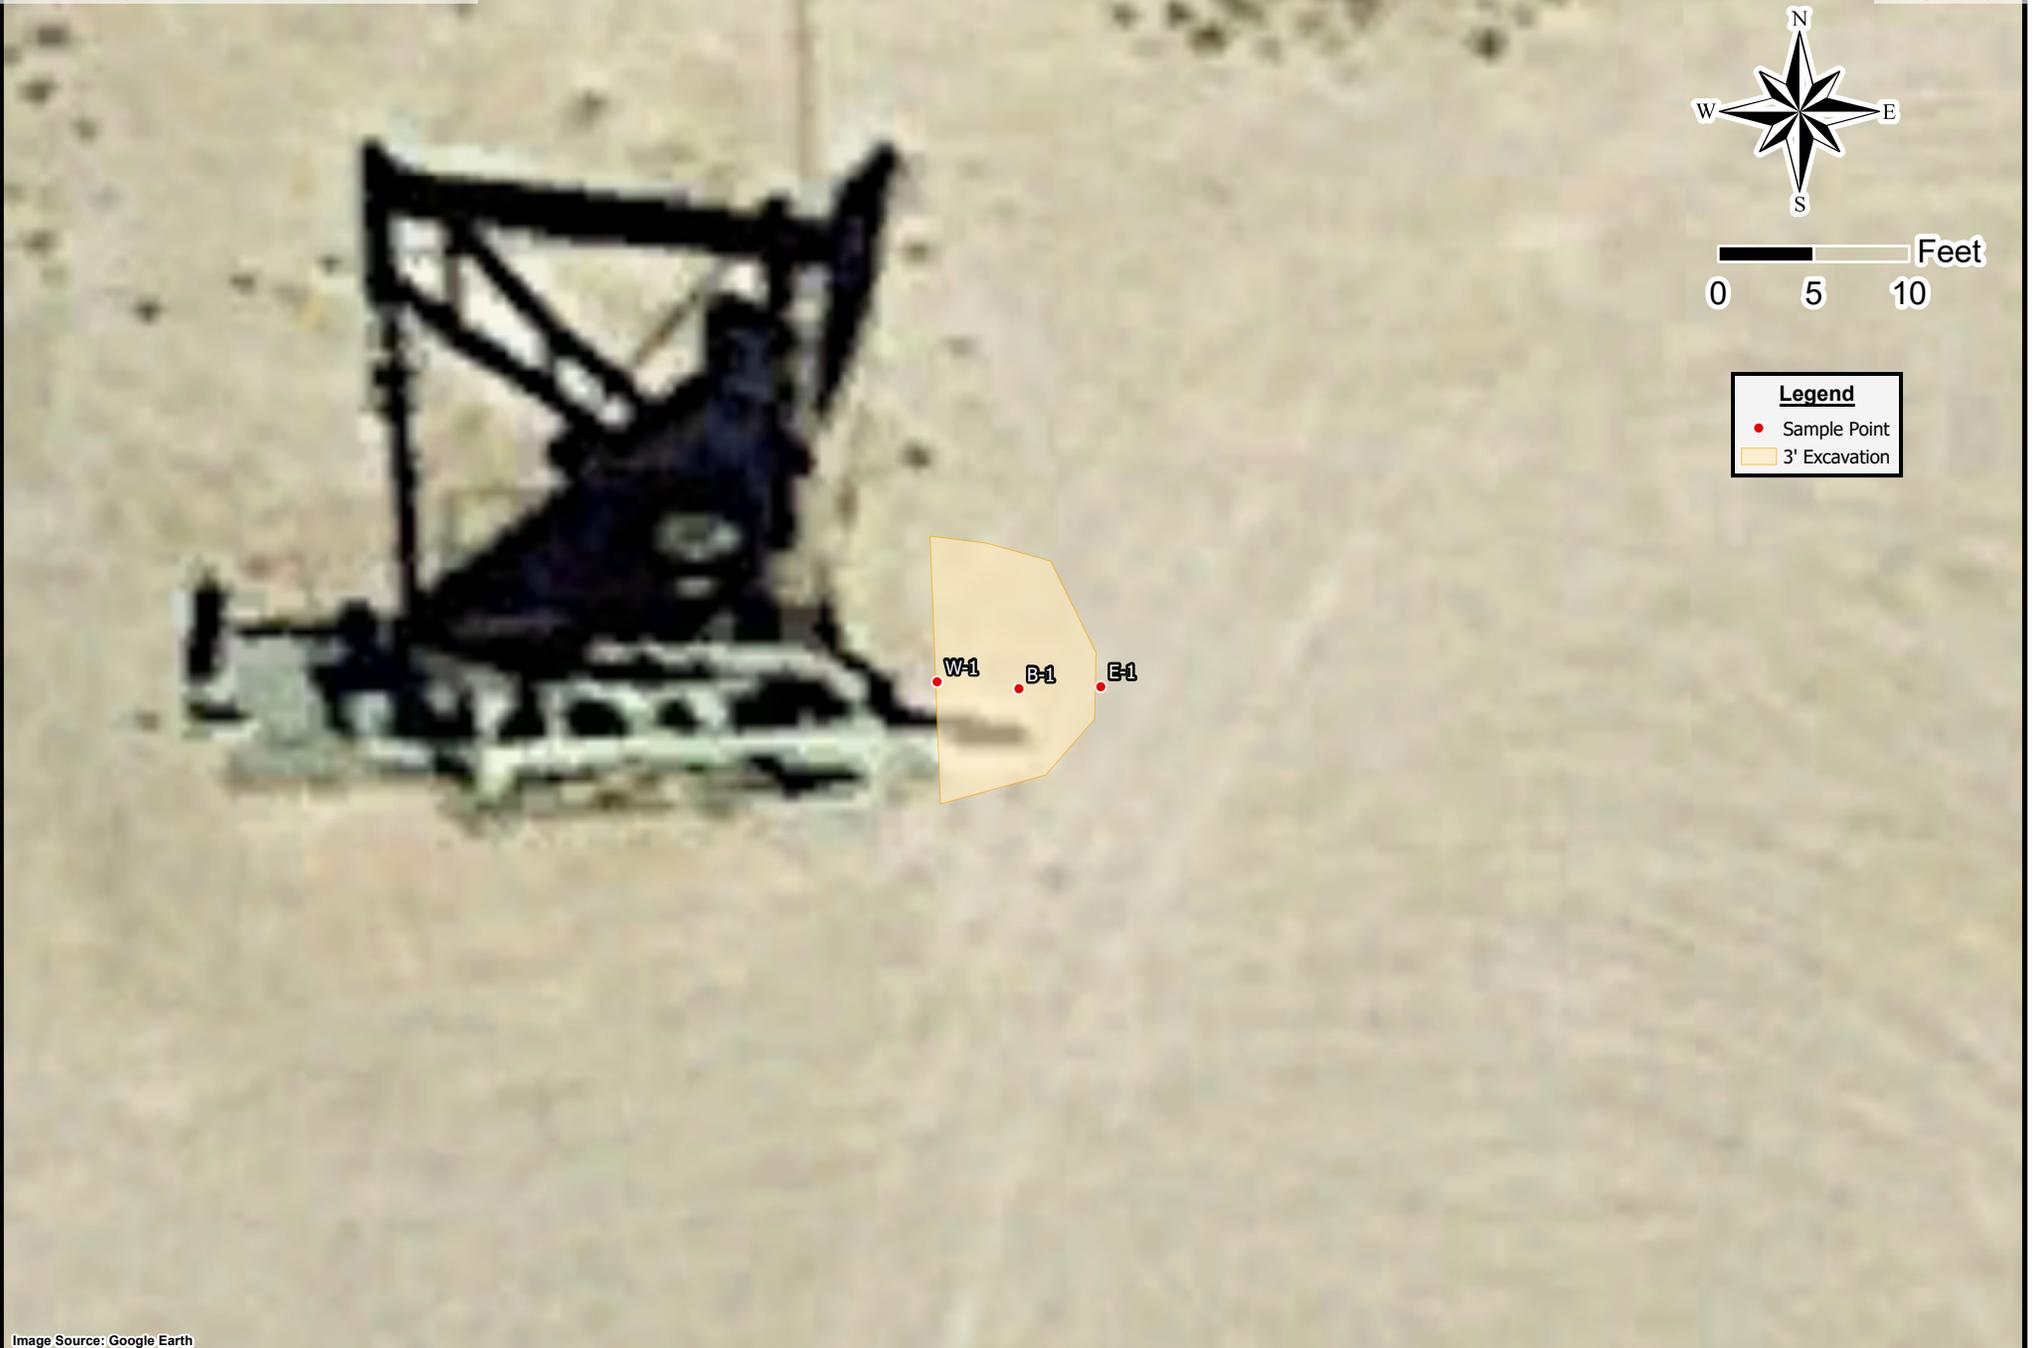
Matador
 Bola 7 Federal #2
 Eddy County, New Mexico
 Excavation Map

On April 6, 2023, based on the laboratory results from the initial site assessment and upon client authorization, Talon personnel and third party equipment mobilized to the site to continue delineation of the impacted area with hydr-vac. The impacted area was excavated to 3.5 feet bgs at the locations shown on Figure 2, site excavation map and the analytical results from those efforts presented in table 2. All soil confirmation samples were properly collected and preserved for transport to Cardinal Laboratories for analysis. The soil sample results from the laboratory are tabulated below. Sample locations are illustrated on Figure 2 (Appendix I).

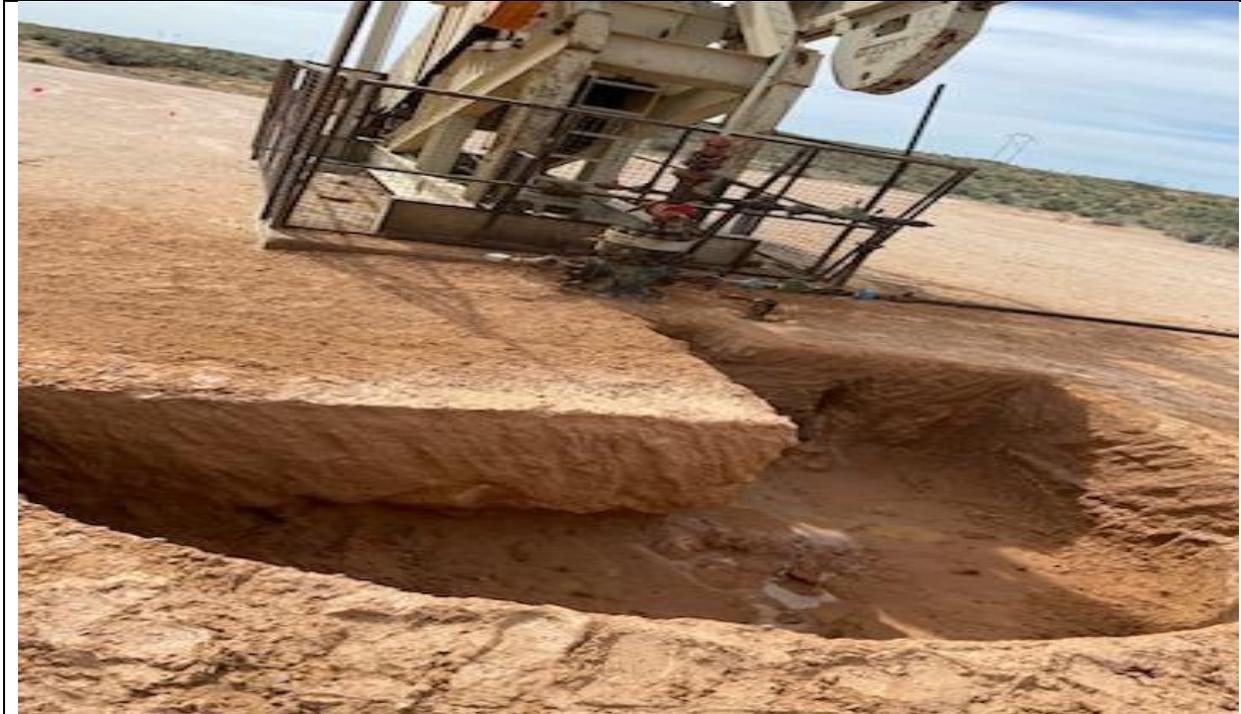
Photograph No.1
Description: Bola 7 Fed 2

Hydra-Vac remediation around wellhead removing contaminated soil.

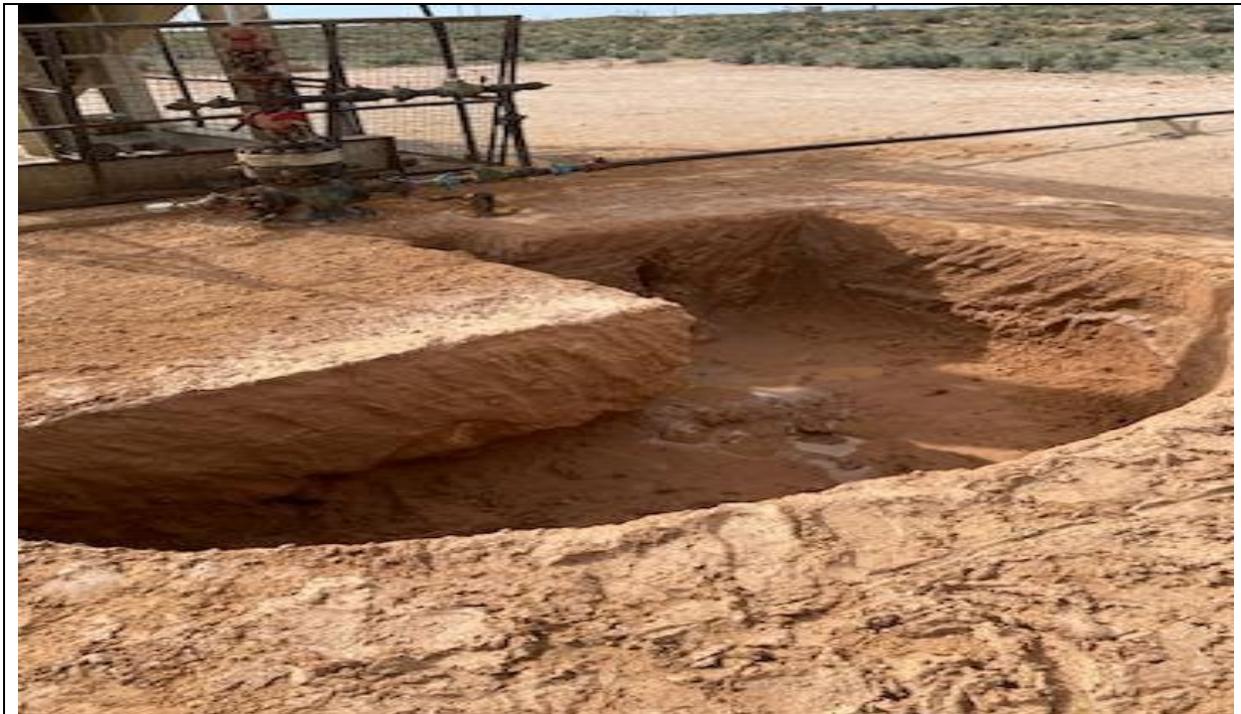
Photograph No.2
Description: Bola 7 Fed 2

Hydra-Vac remediation around wellhead removing contaminated soil.

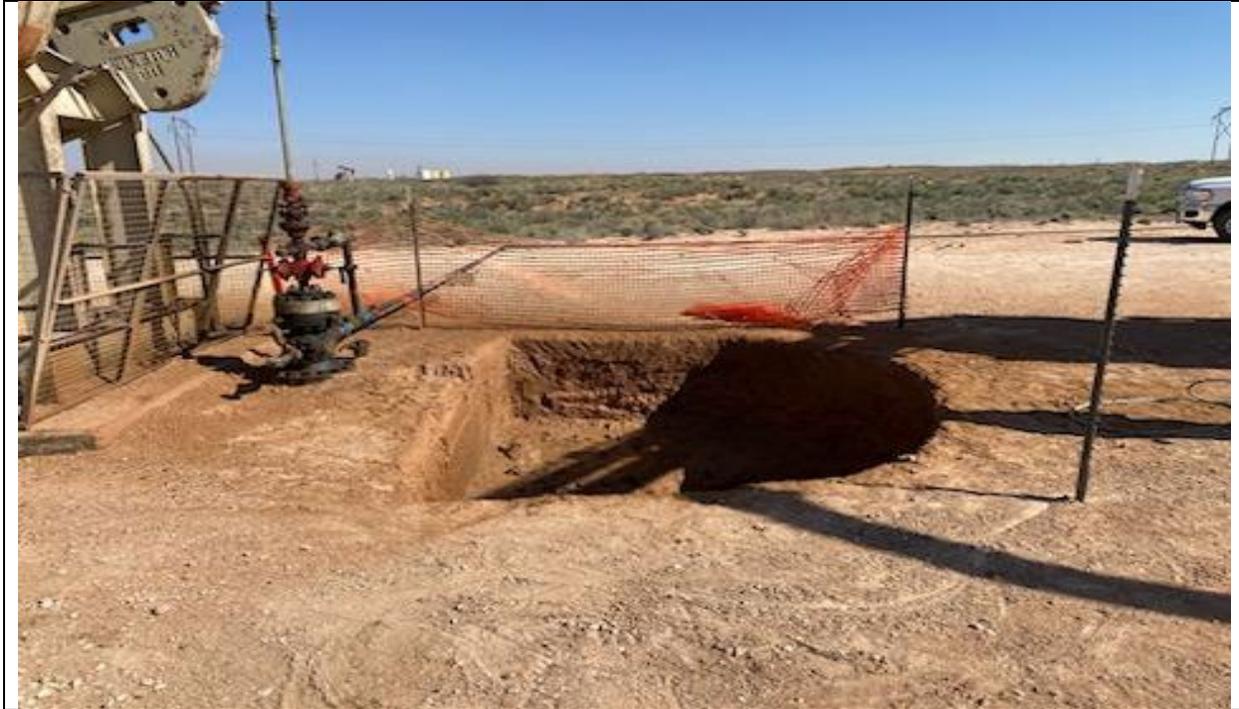
Photograph No.3
Description: Bola 7 Fed 2

Hydra-Vac remediation around wellhead removing contaminated soil. Full excavation.

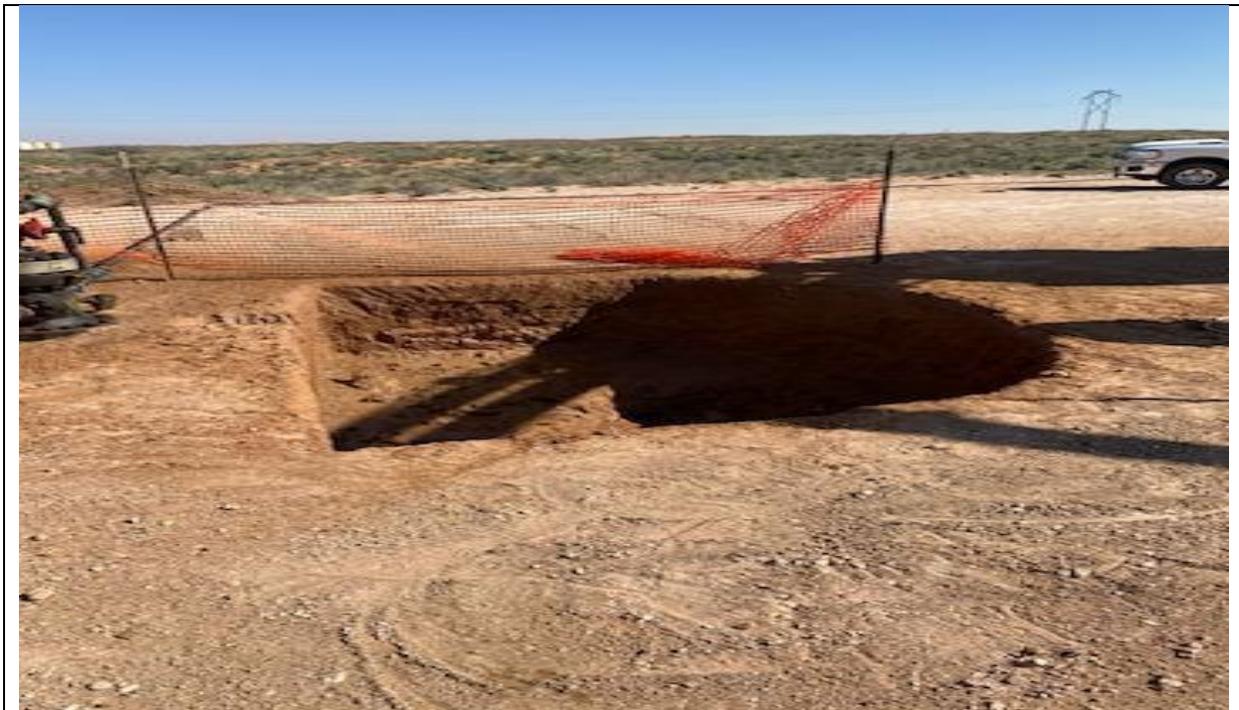
Photograph No.4
Description: Bola 7 Fed 2

Hydra-Vac remediation around wellhead removing contaminated soil. Full excavation.

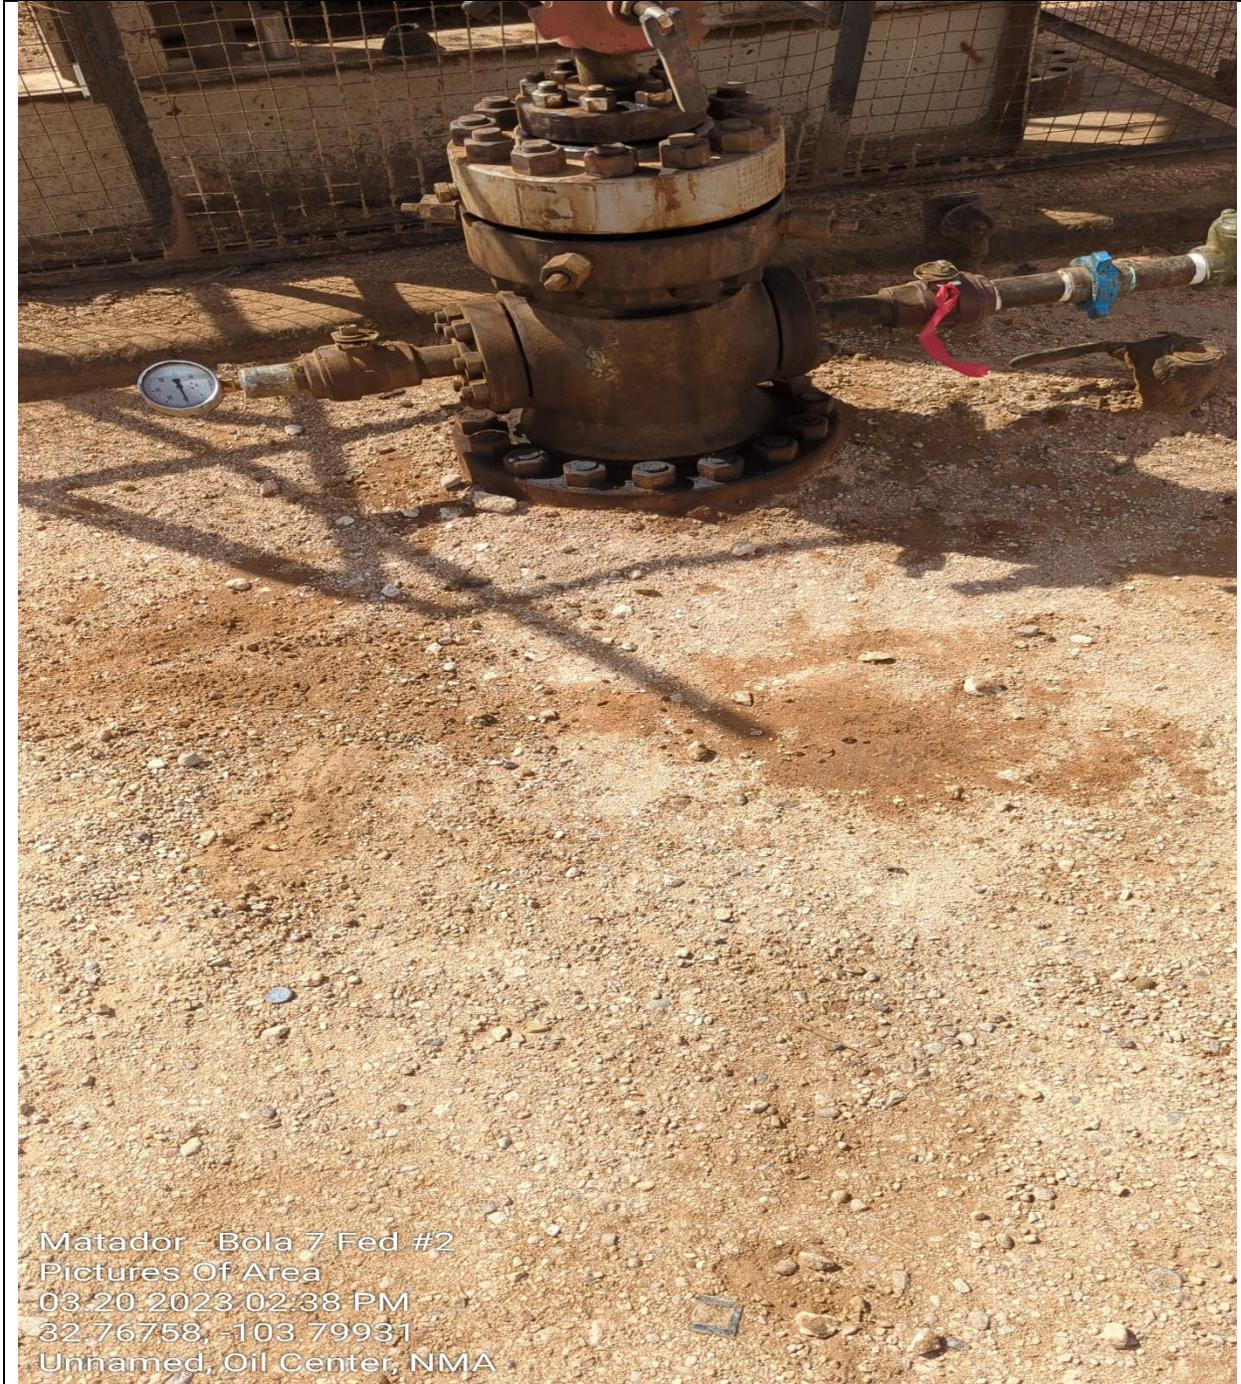
Photograph No.5

Matador - Bola 7 Fed #2
Pictures Of Area
03.20.2023 02:38 PM
32.76758, -103.79931
Unnamed, Oil Center, NMA
