**Re: Revised Closure Report
ConocoPhillips
Heritage Concho
SRO SWD #101 Illegal Dump Release
Unit Letter M, Section 4, Township 26 South, Range 28 East
Eddy County, New Mexico
Incident ID# nAB1523932511
2RP-3223**

Revised Closure Request
February 17, 2023

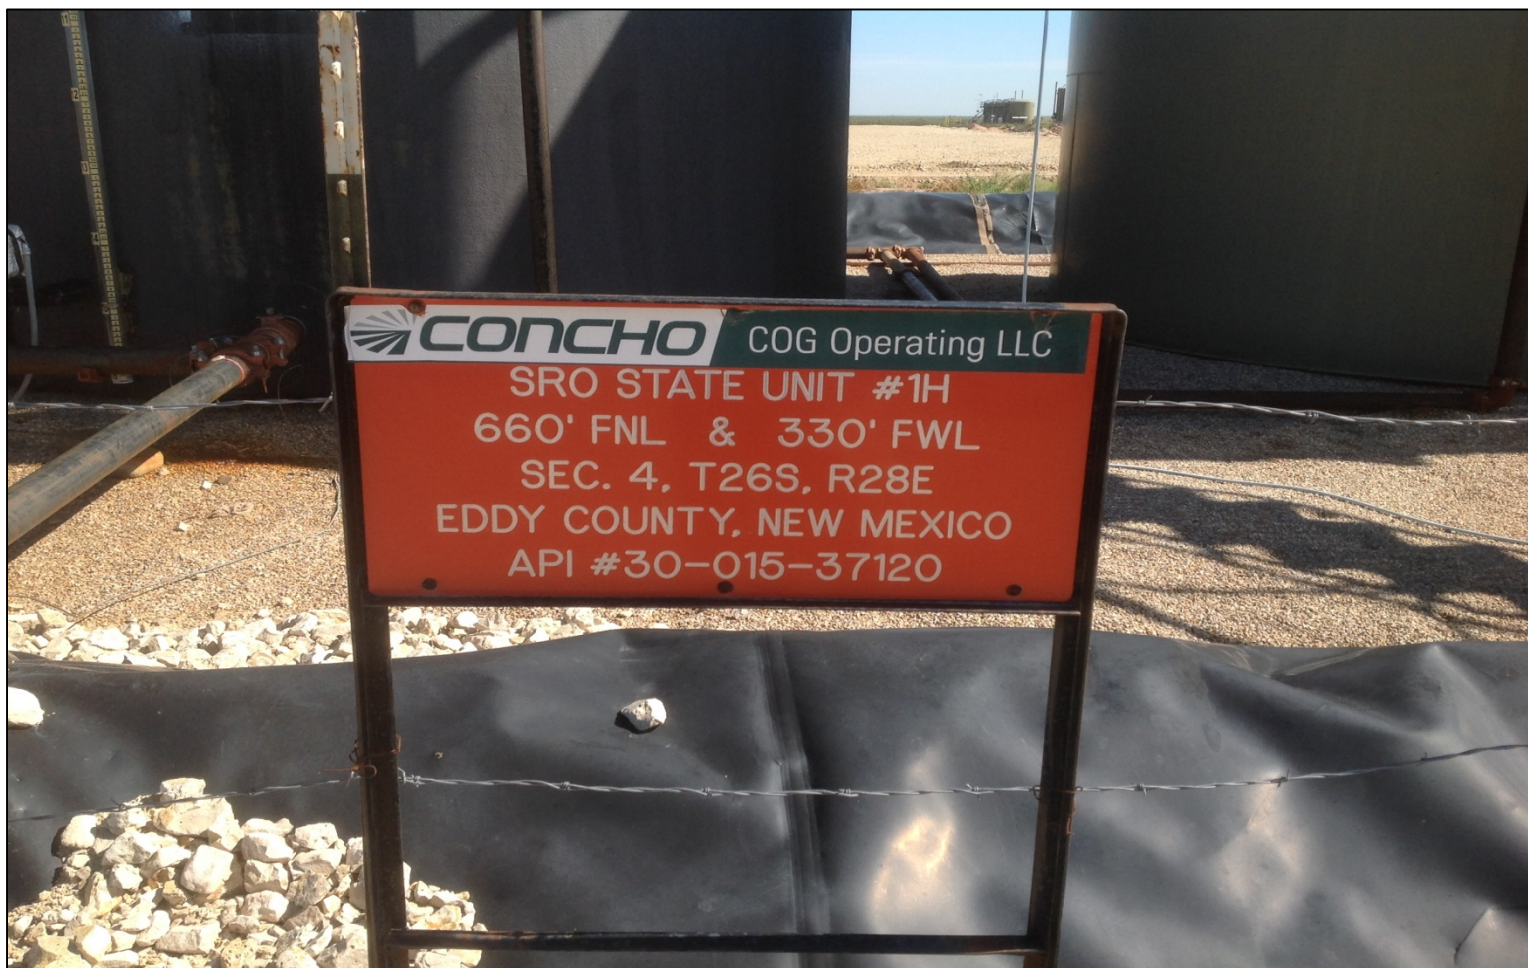
Photo Point 1

Description: On Monday, 7/13/2015 I discovered evidence of a produced water release originating from a poly pipeline connected to the SRO State Unit #1H. The line has been repaired.

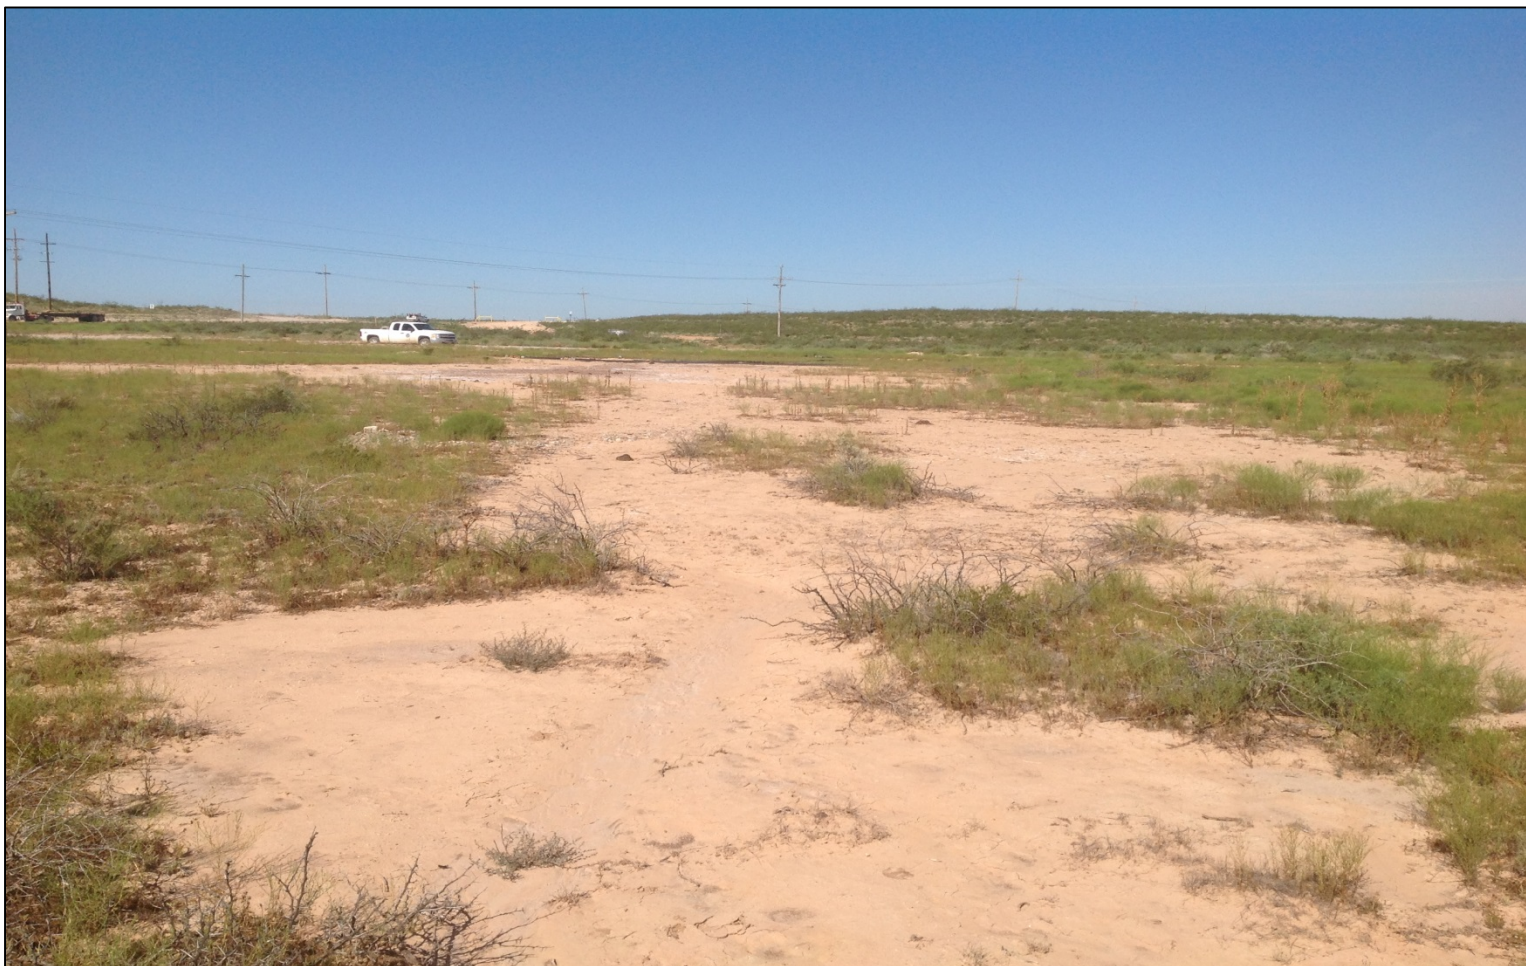
Photo Point 3: View of Spill Site #2 Lat: 32.709307° Lon: -104.199400°

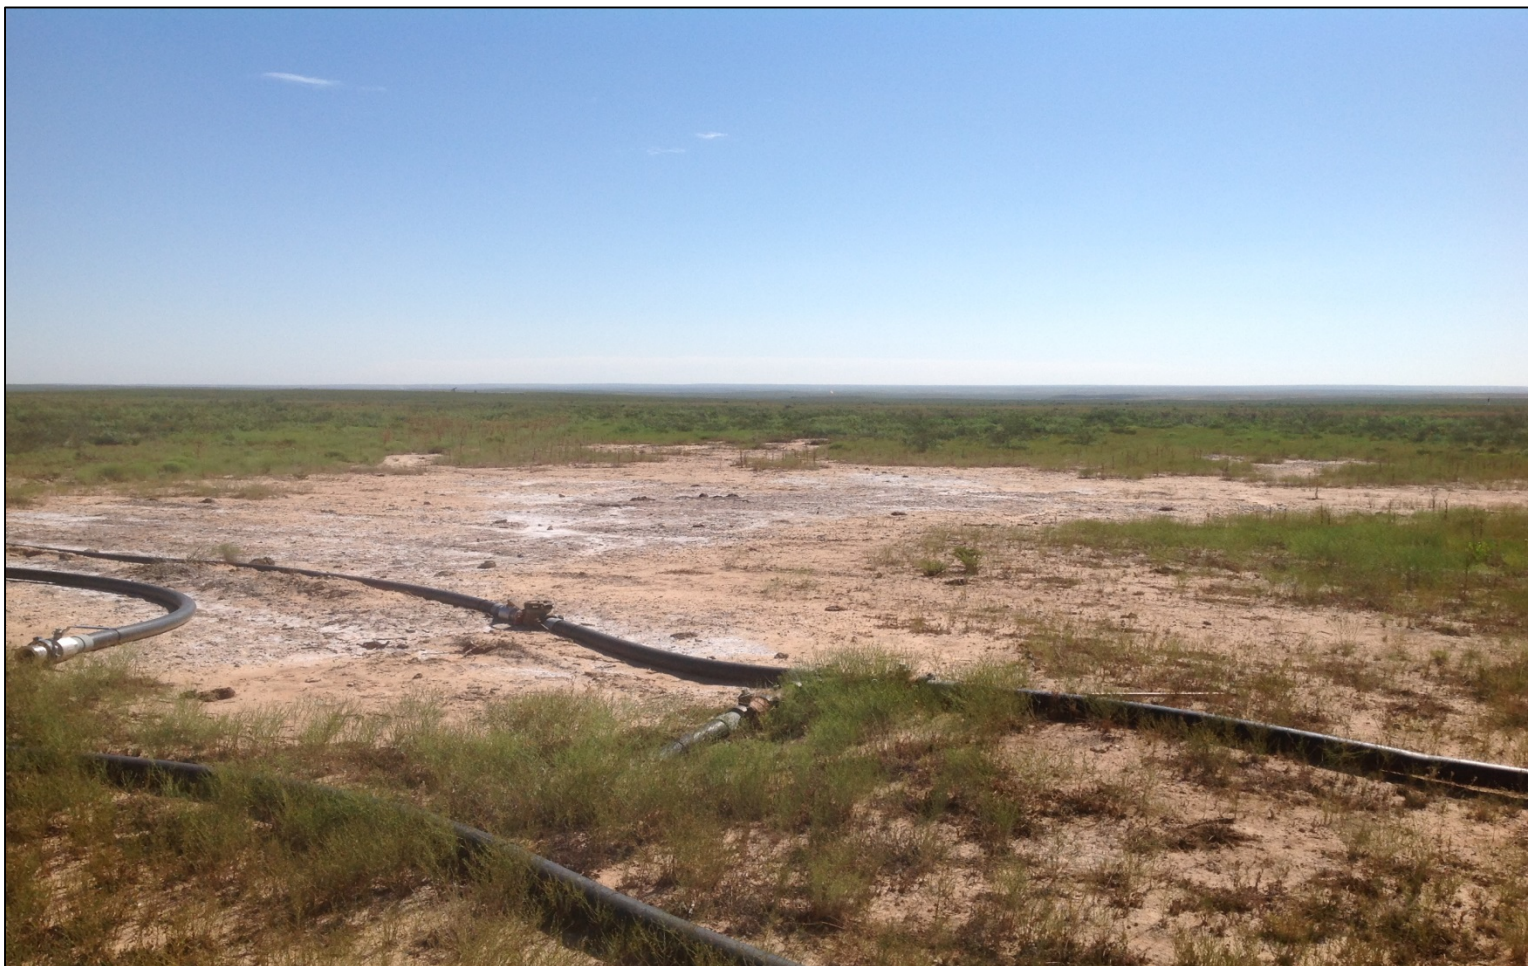
Photo Point 4: View of released water escaping via north side of berm

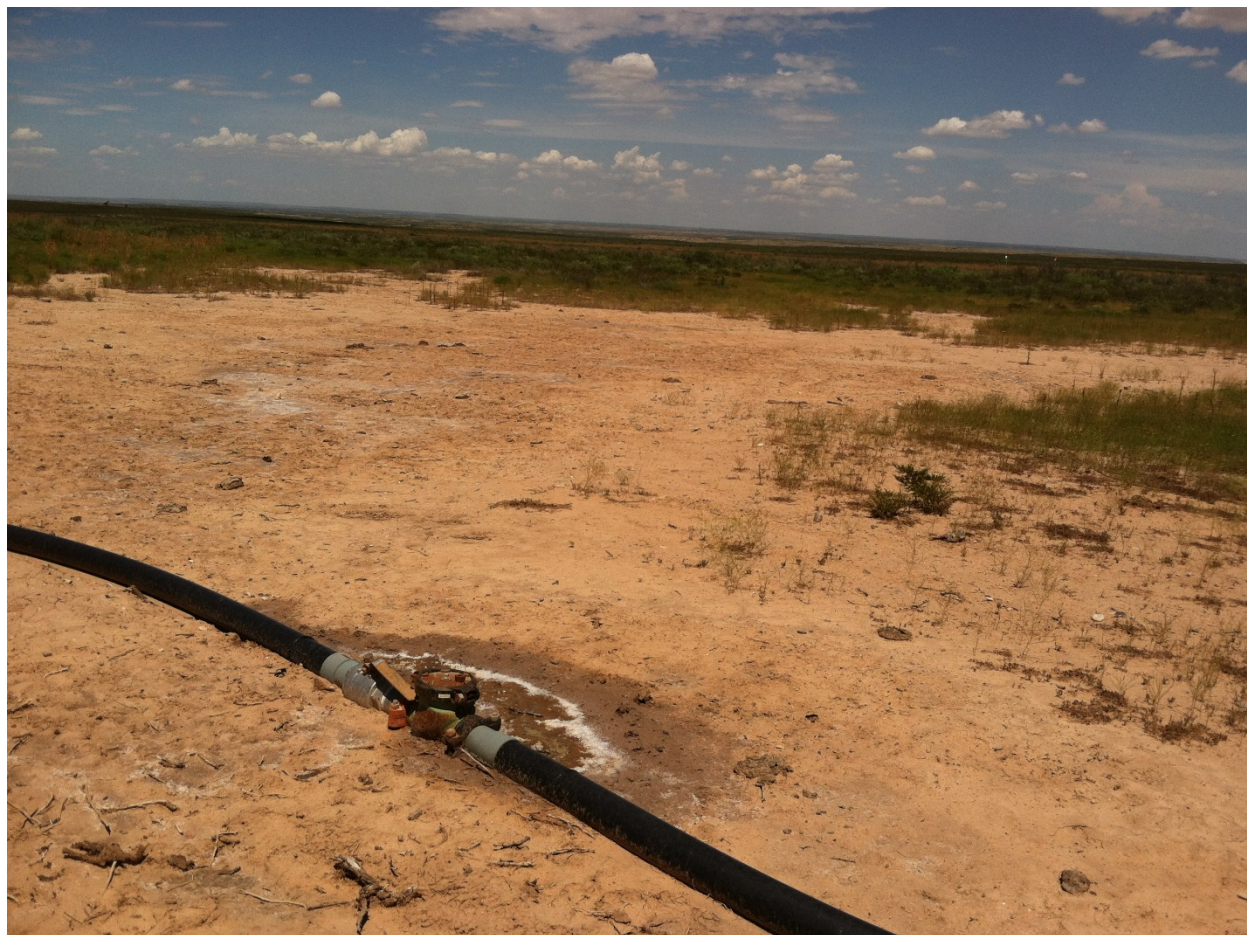
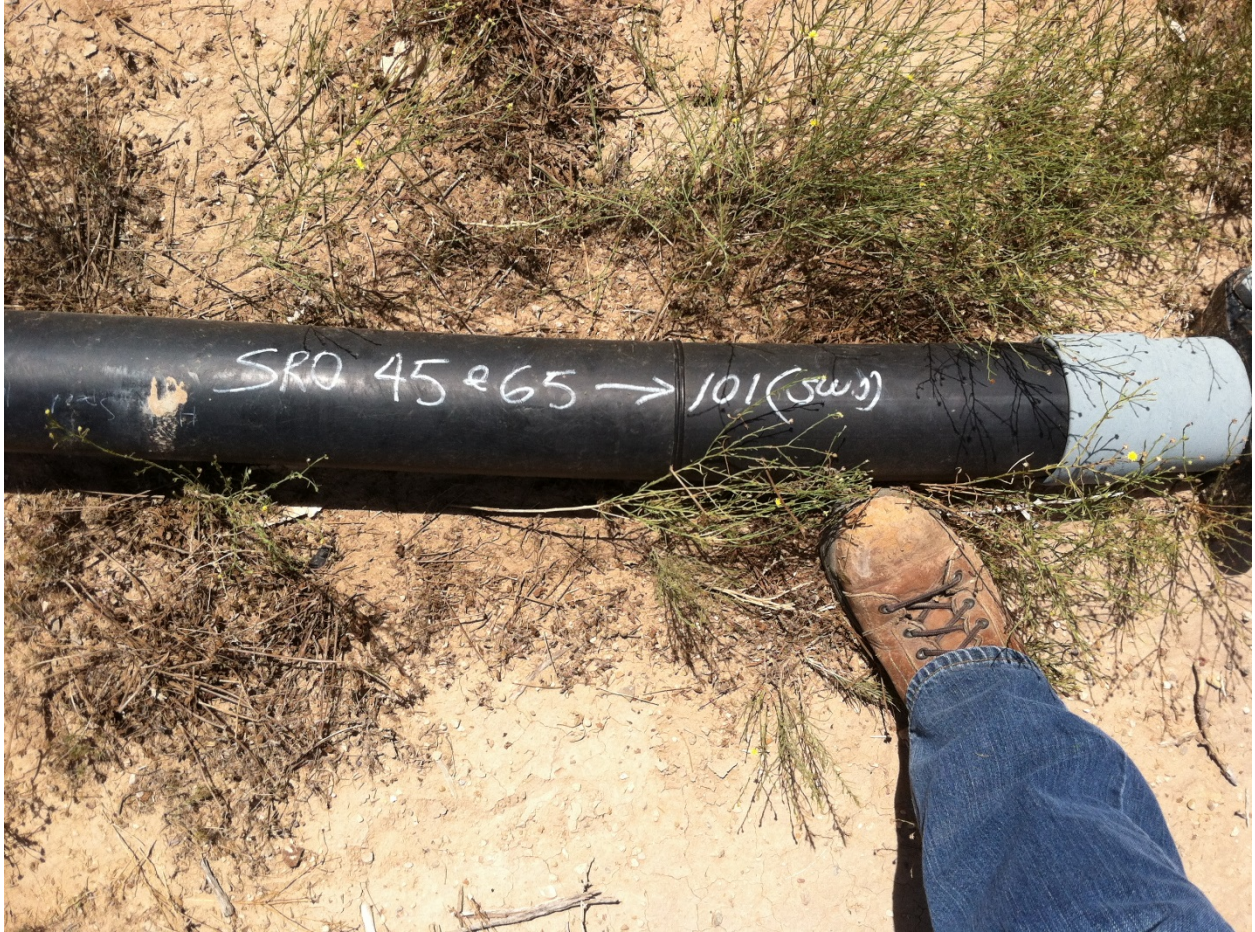
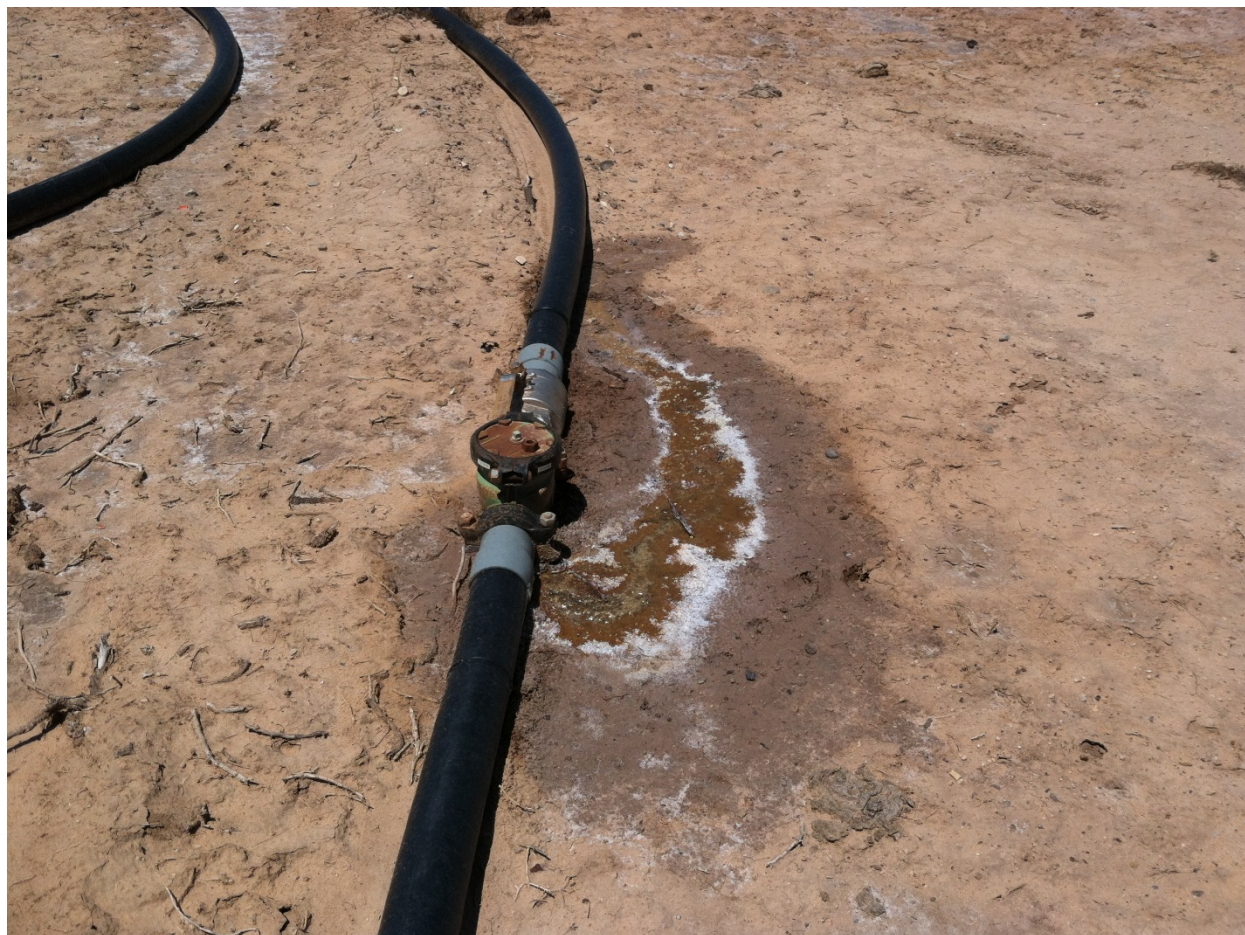
I visited the site yesterday and confirmed the line is indeed a Concho SWD line. The poly line is marked "SRO 45&65->101(SWD)." The line is still leaking from what appears to be a valve and judging from the scar on the land, it has been leaking for quite some time. If you could address this issue ASAP I'd appreciate it. I've attached pics from yesterday. As always, feel free to call me with questions.

After speaking with field personal it was determined the impacted area was most likely caused by an illegal dump. Given its proximity to our lines we will address the release. We had the small leak in our line repaired. I spoke with Heather about the incident and will be filing a C-141 with them. If you have any additional questions or concerns please feel free to contact me.

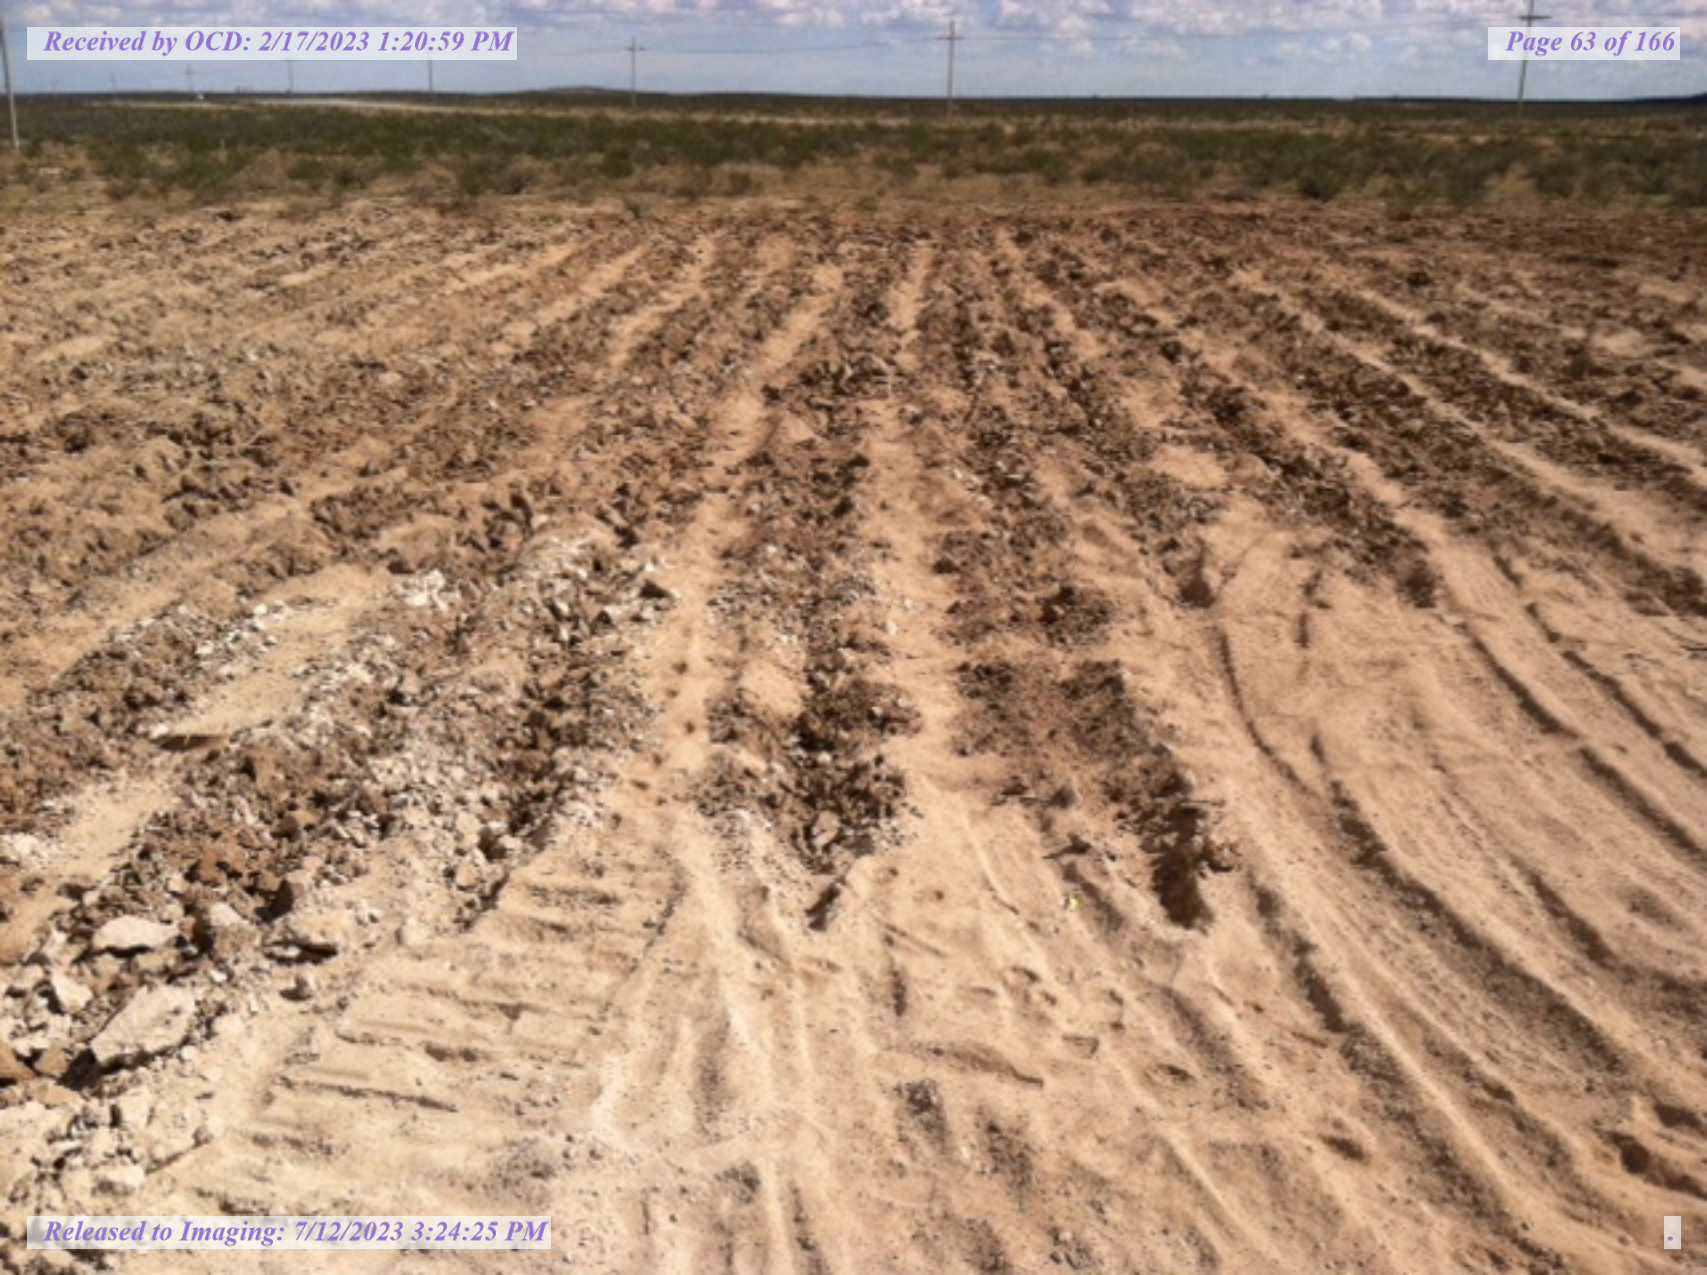
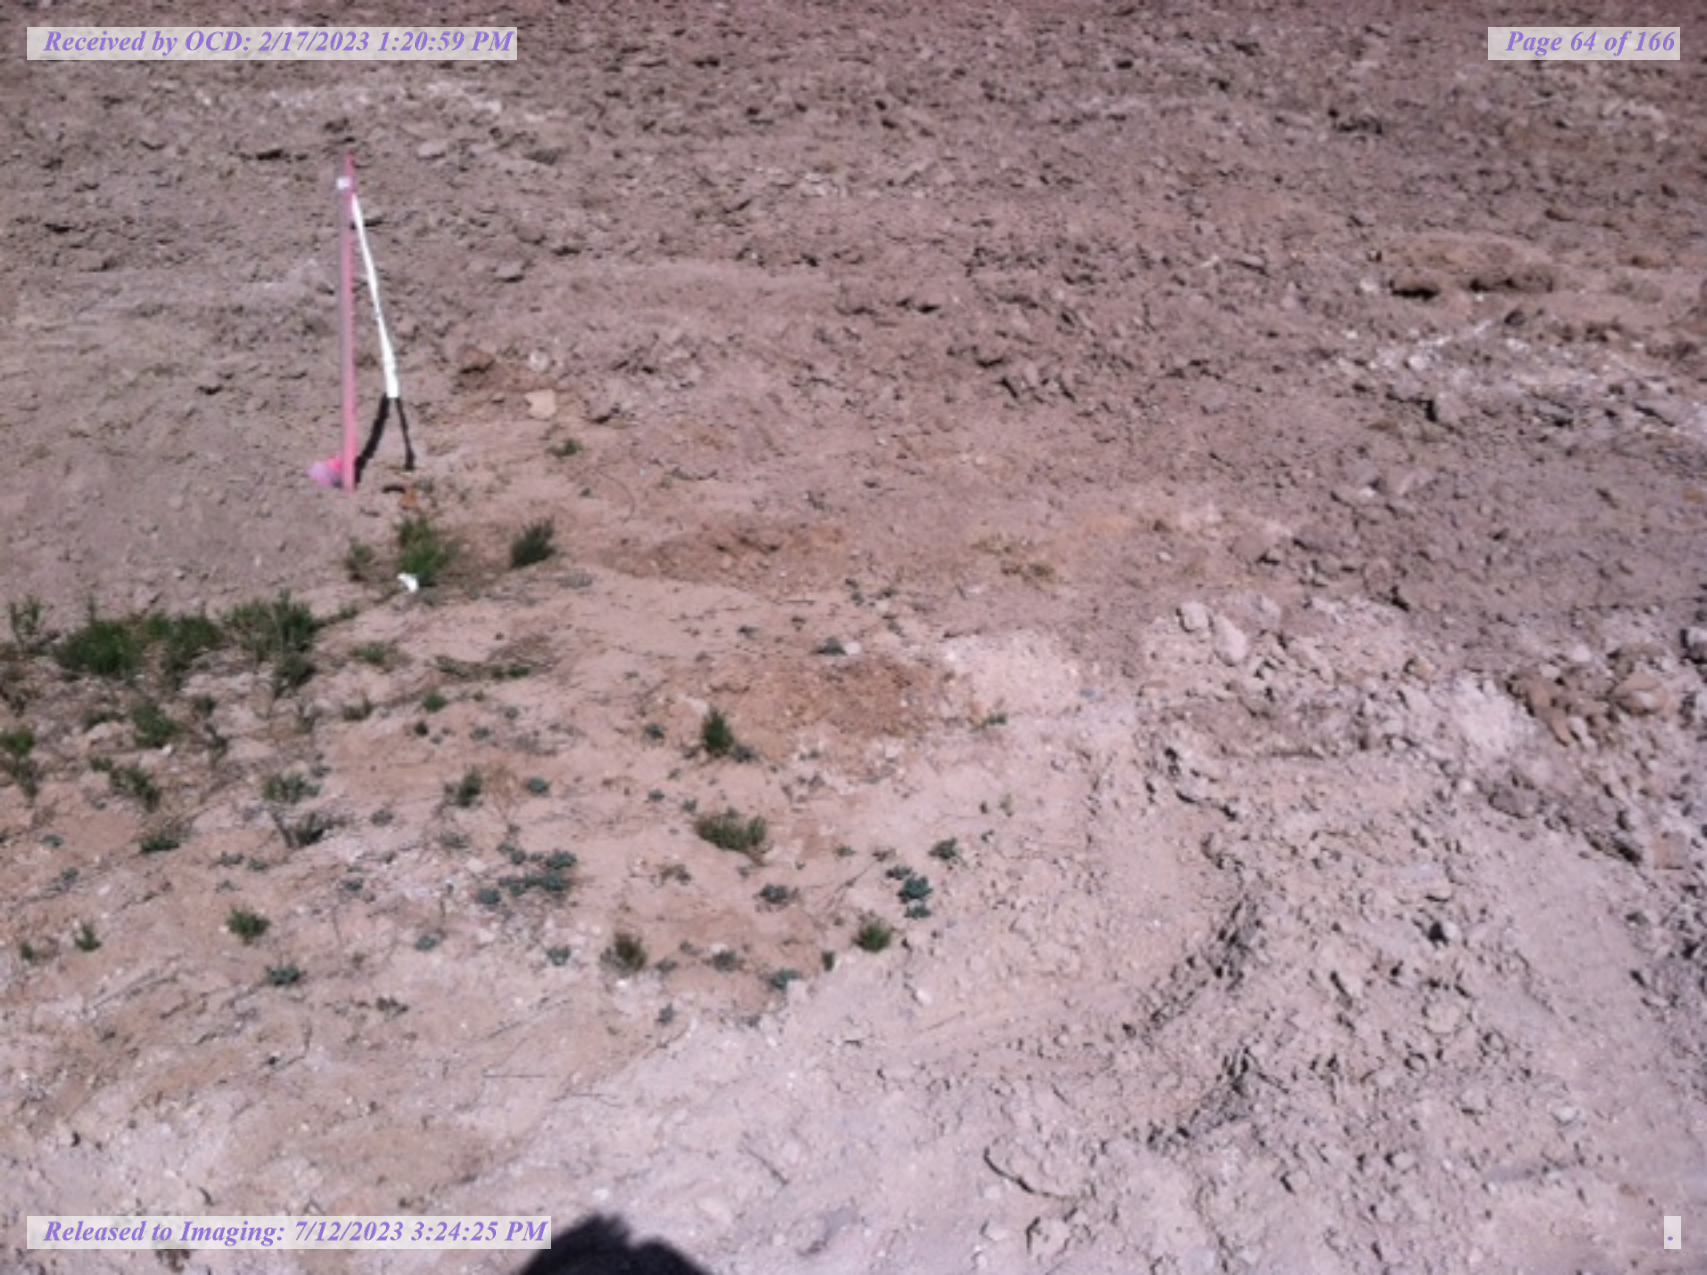
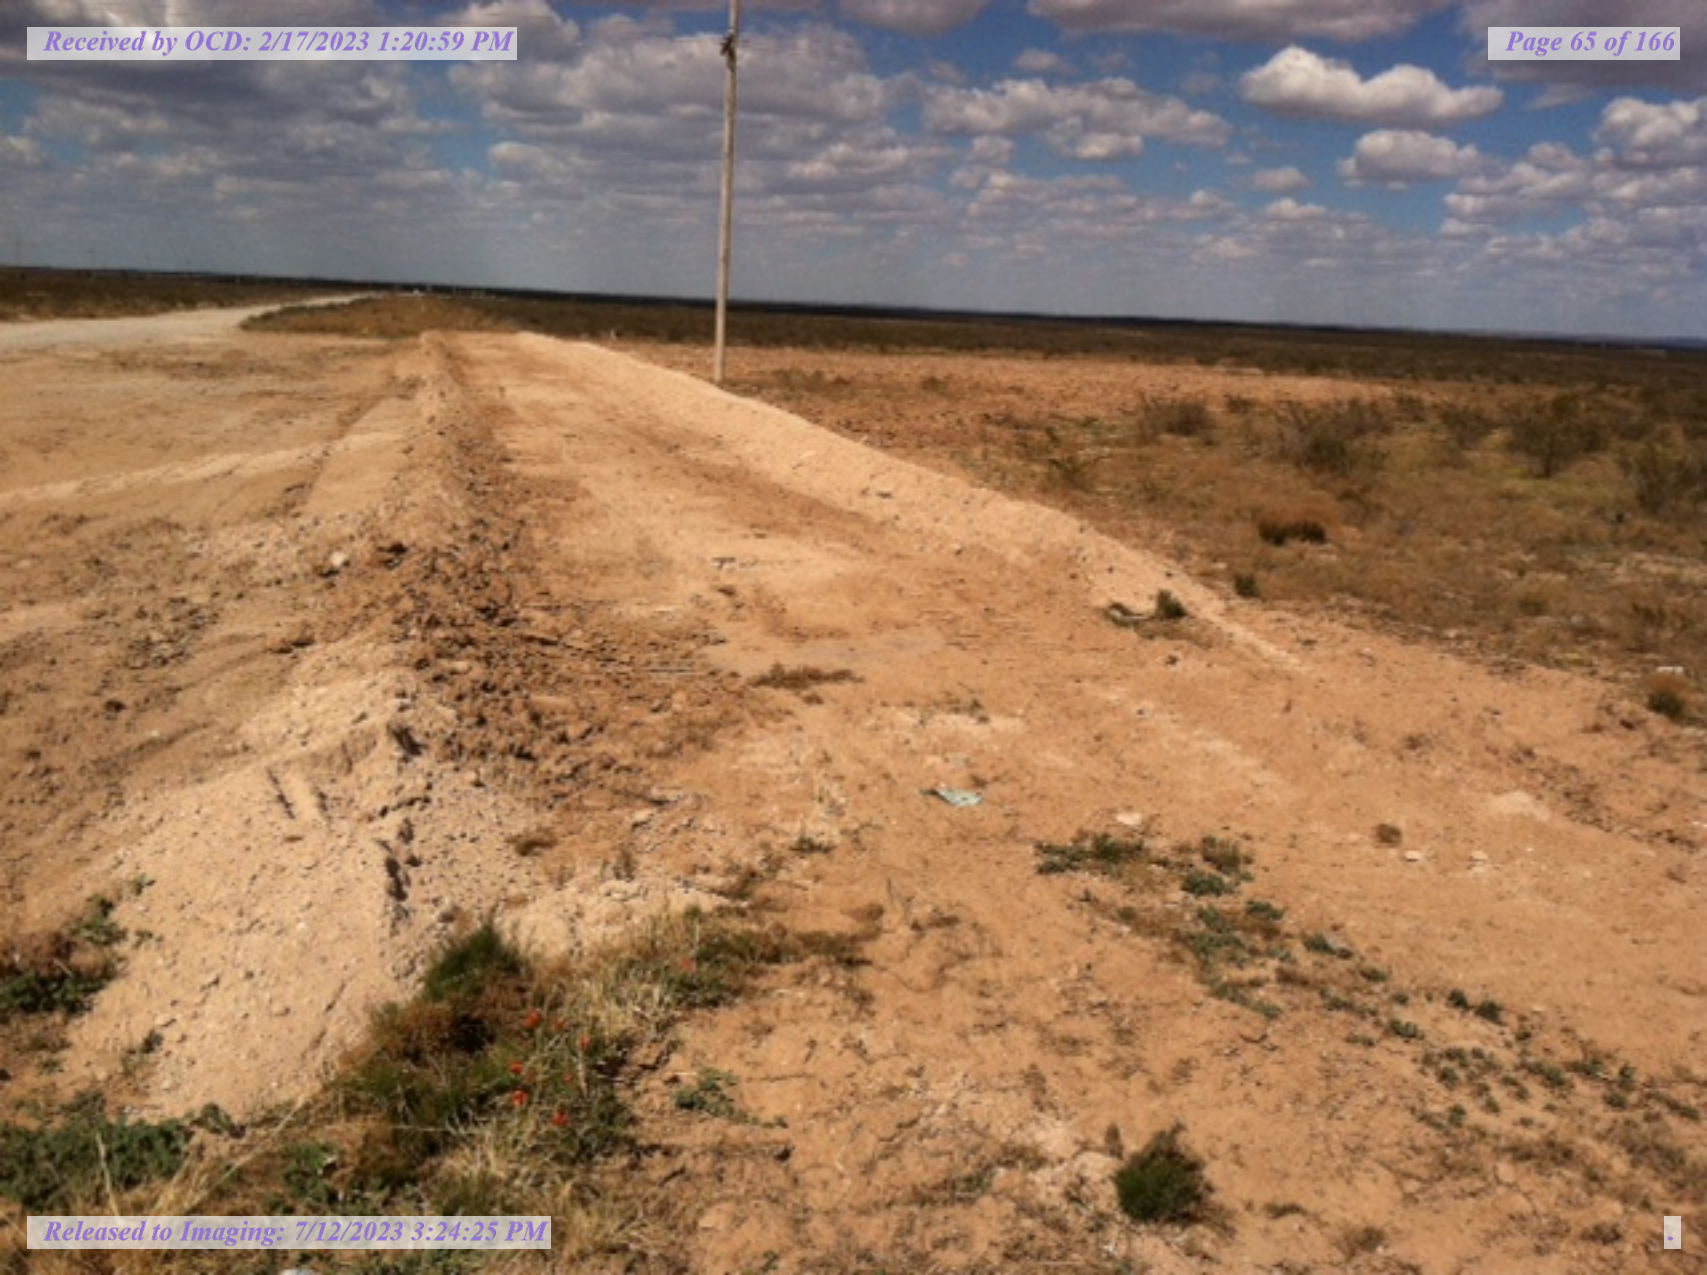
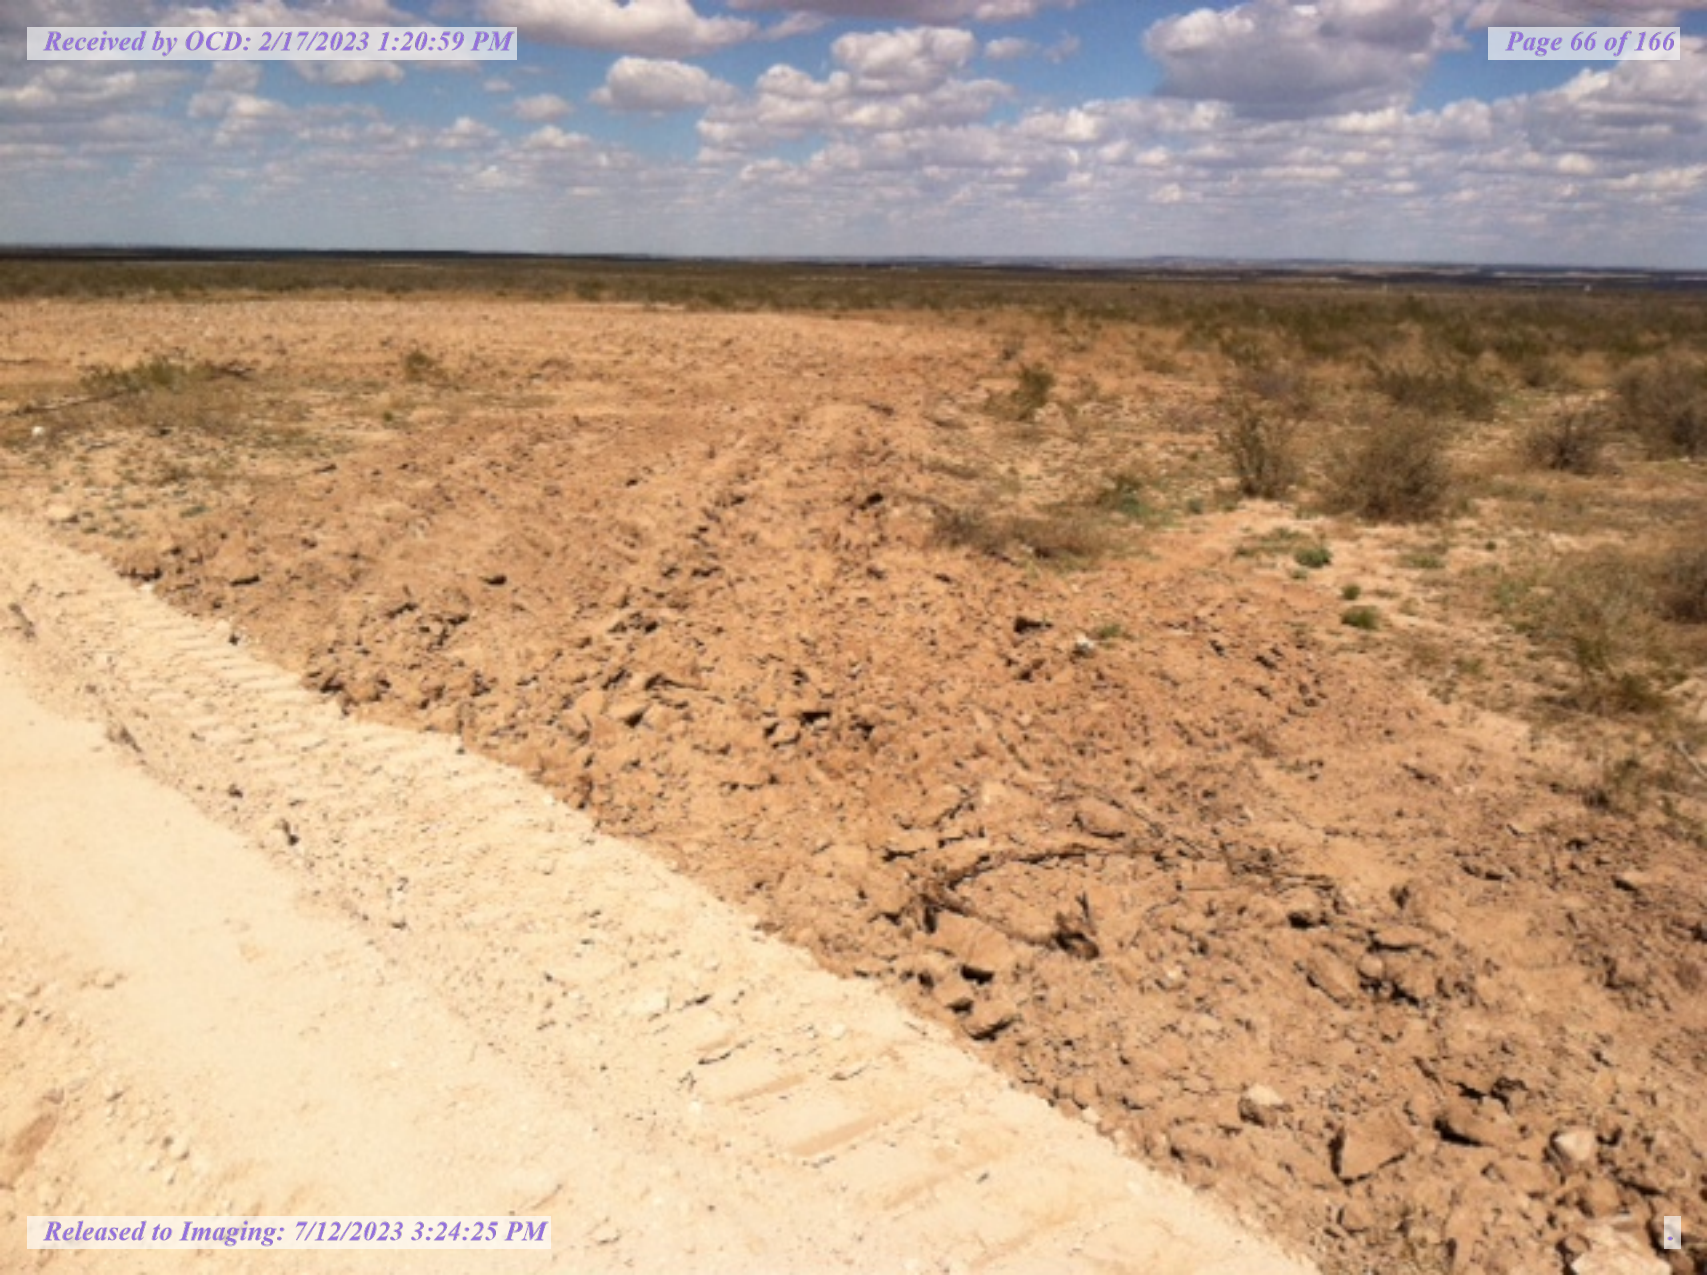
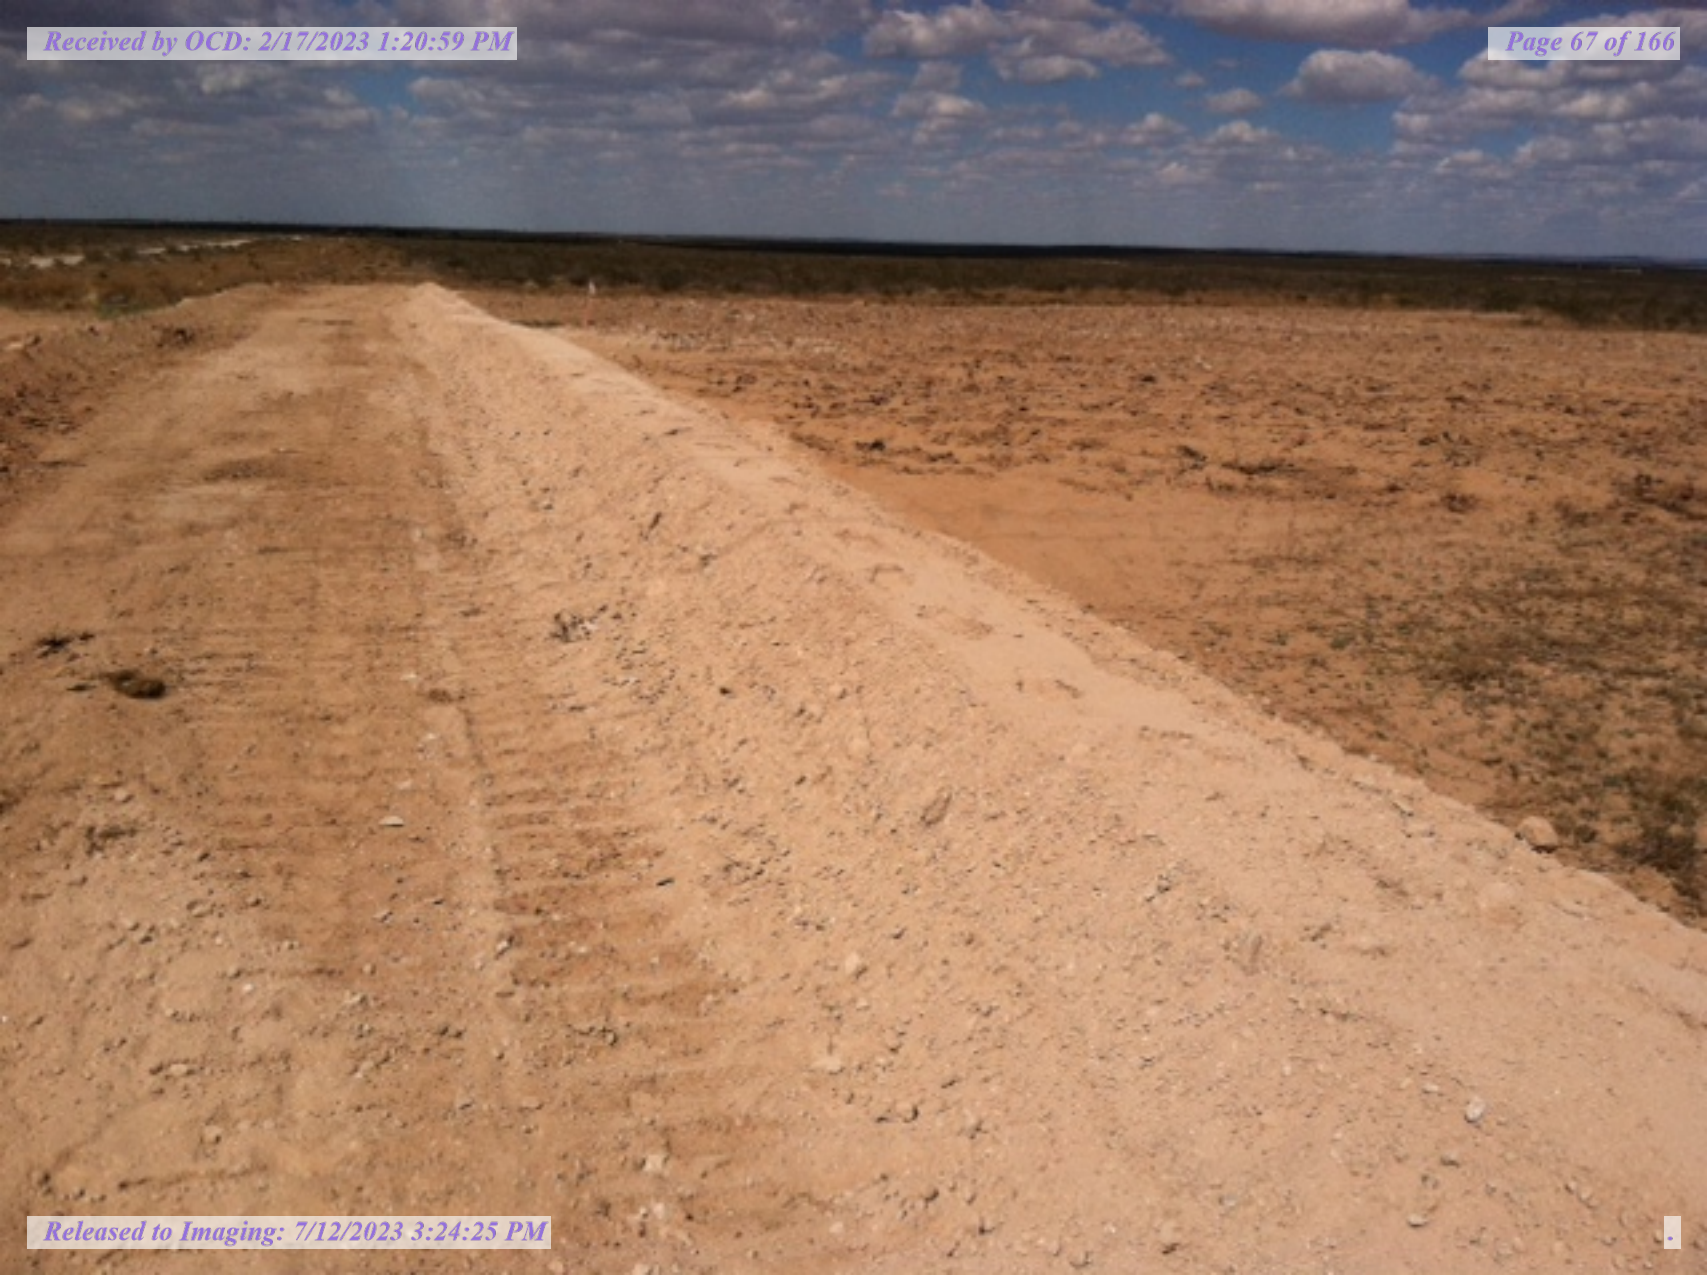
I spoke to Lupe about this. He said they already did the excavation and backfill, but they had packed it hard and the soil was wet at the time, so he had them rip it so it could be properly seeded. He also put up the berm to keep trucks from parking on it.
