**Re: Revised Closure Report
ConocoPhillips
Heritage Concho
SRO SWD #101 Illegal Dump Release
Unit Letter M, Section 4, Township 26 South, Range 28 East
Eddy County, New Mexico
Incident ID# nAB1523932511
2RP-3223**

Revised Closure Request
February 17, 2023

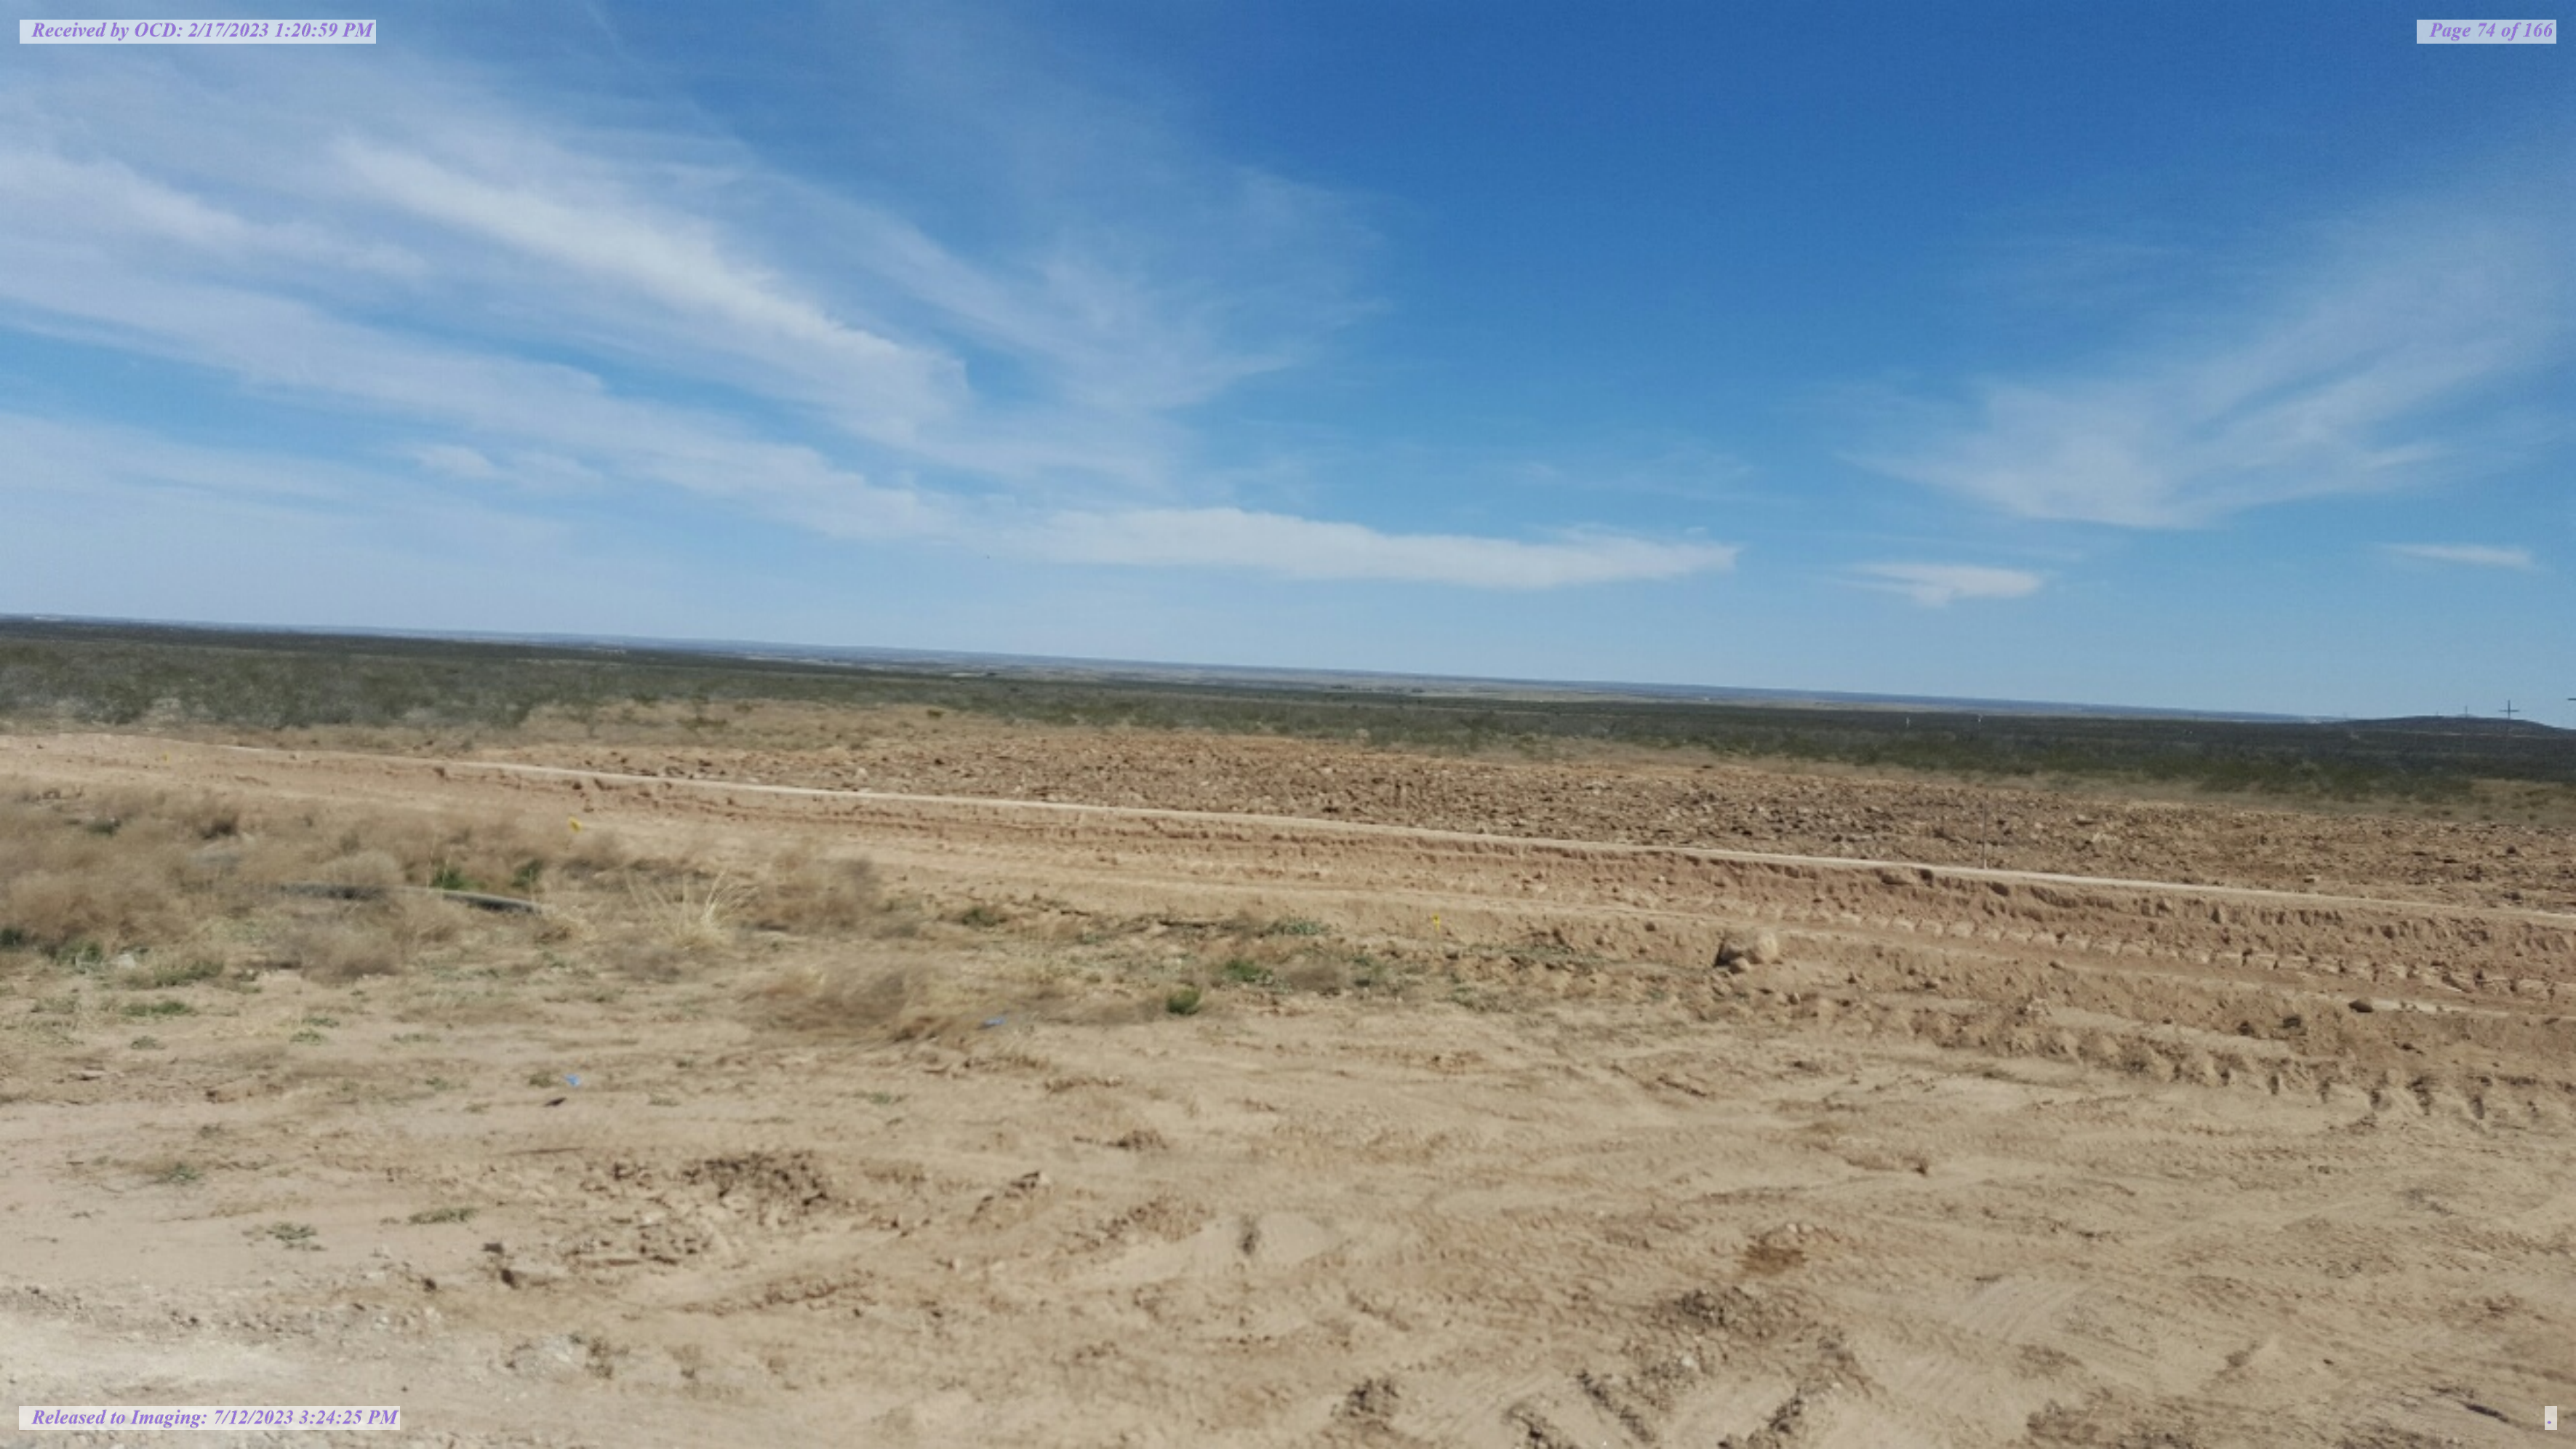
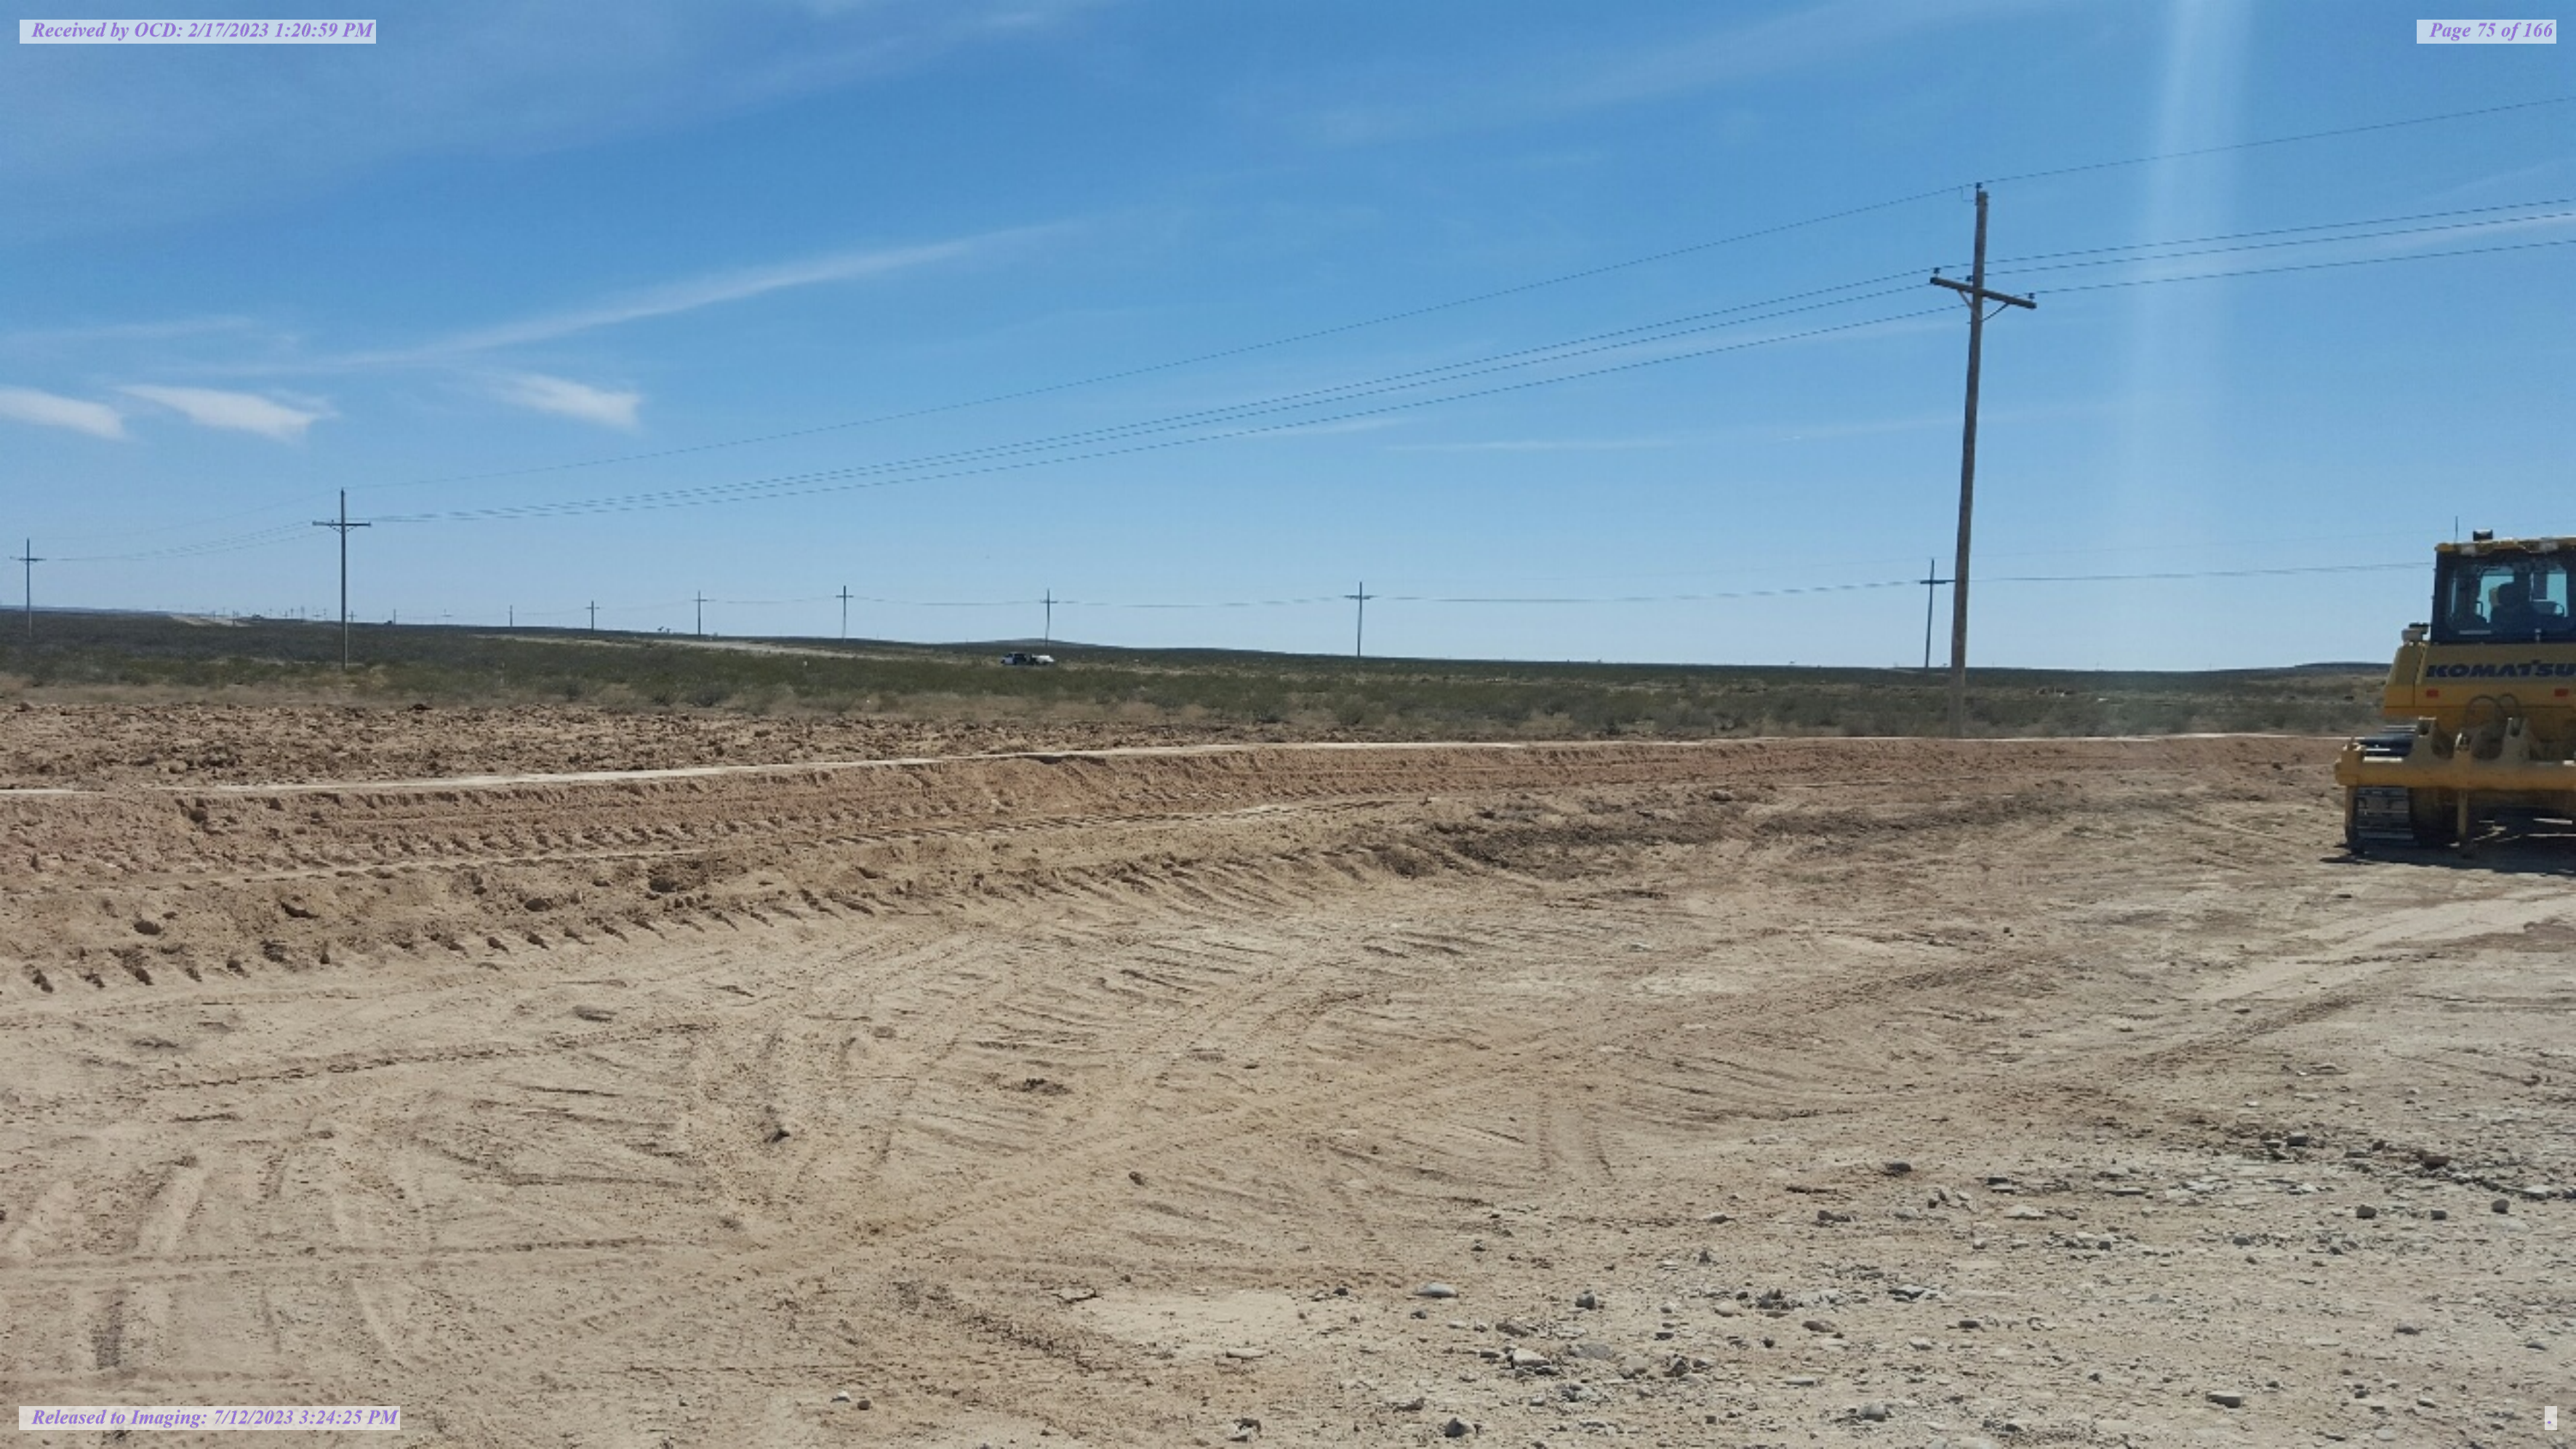
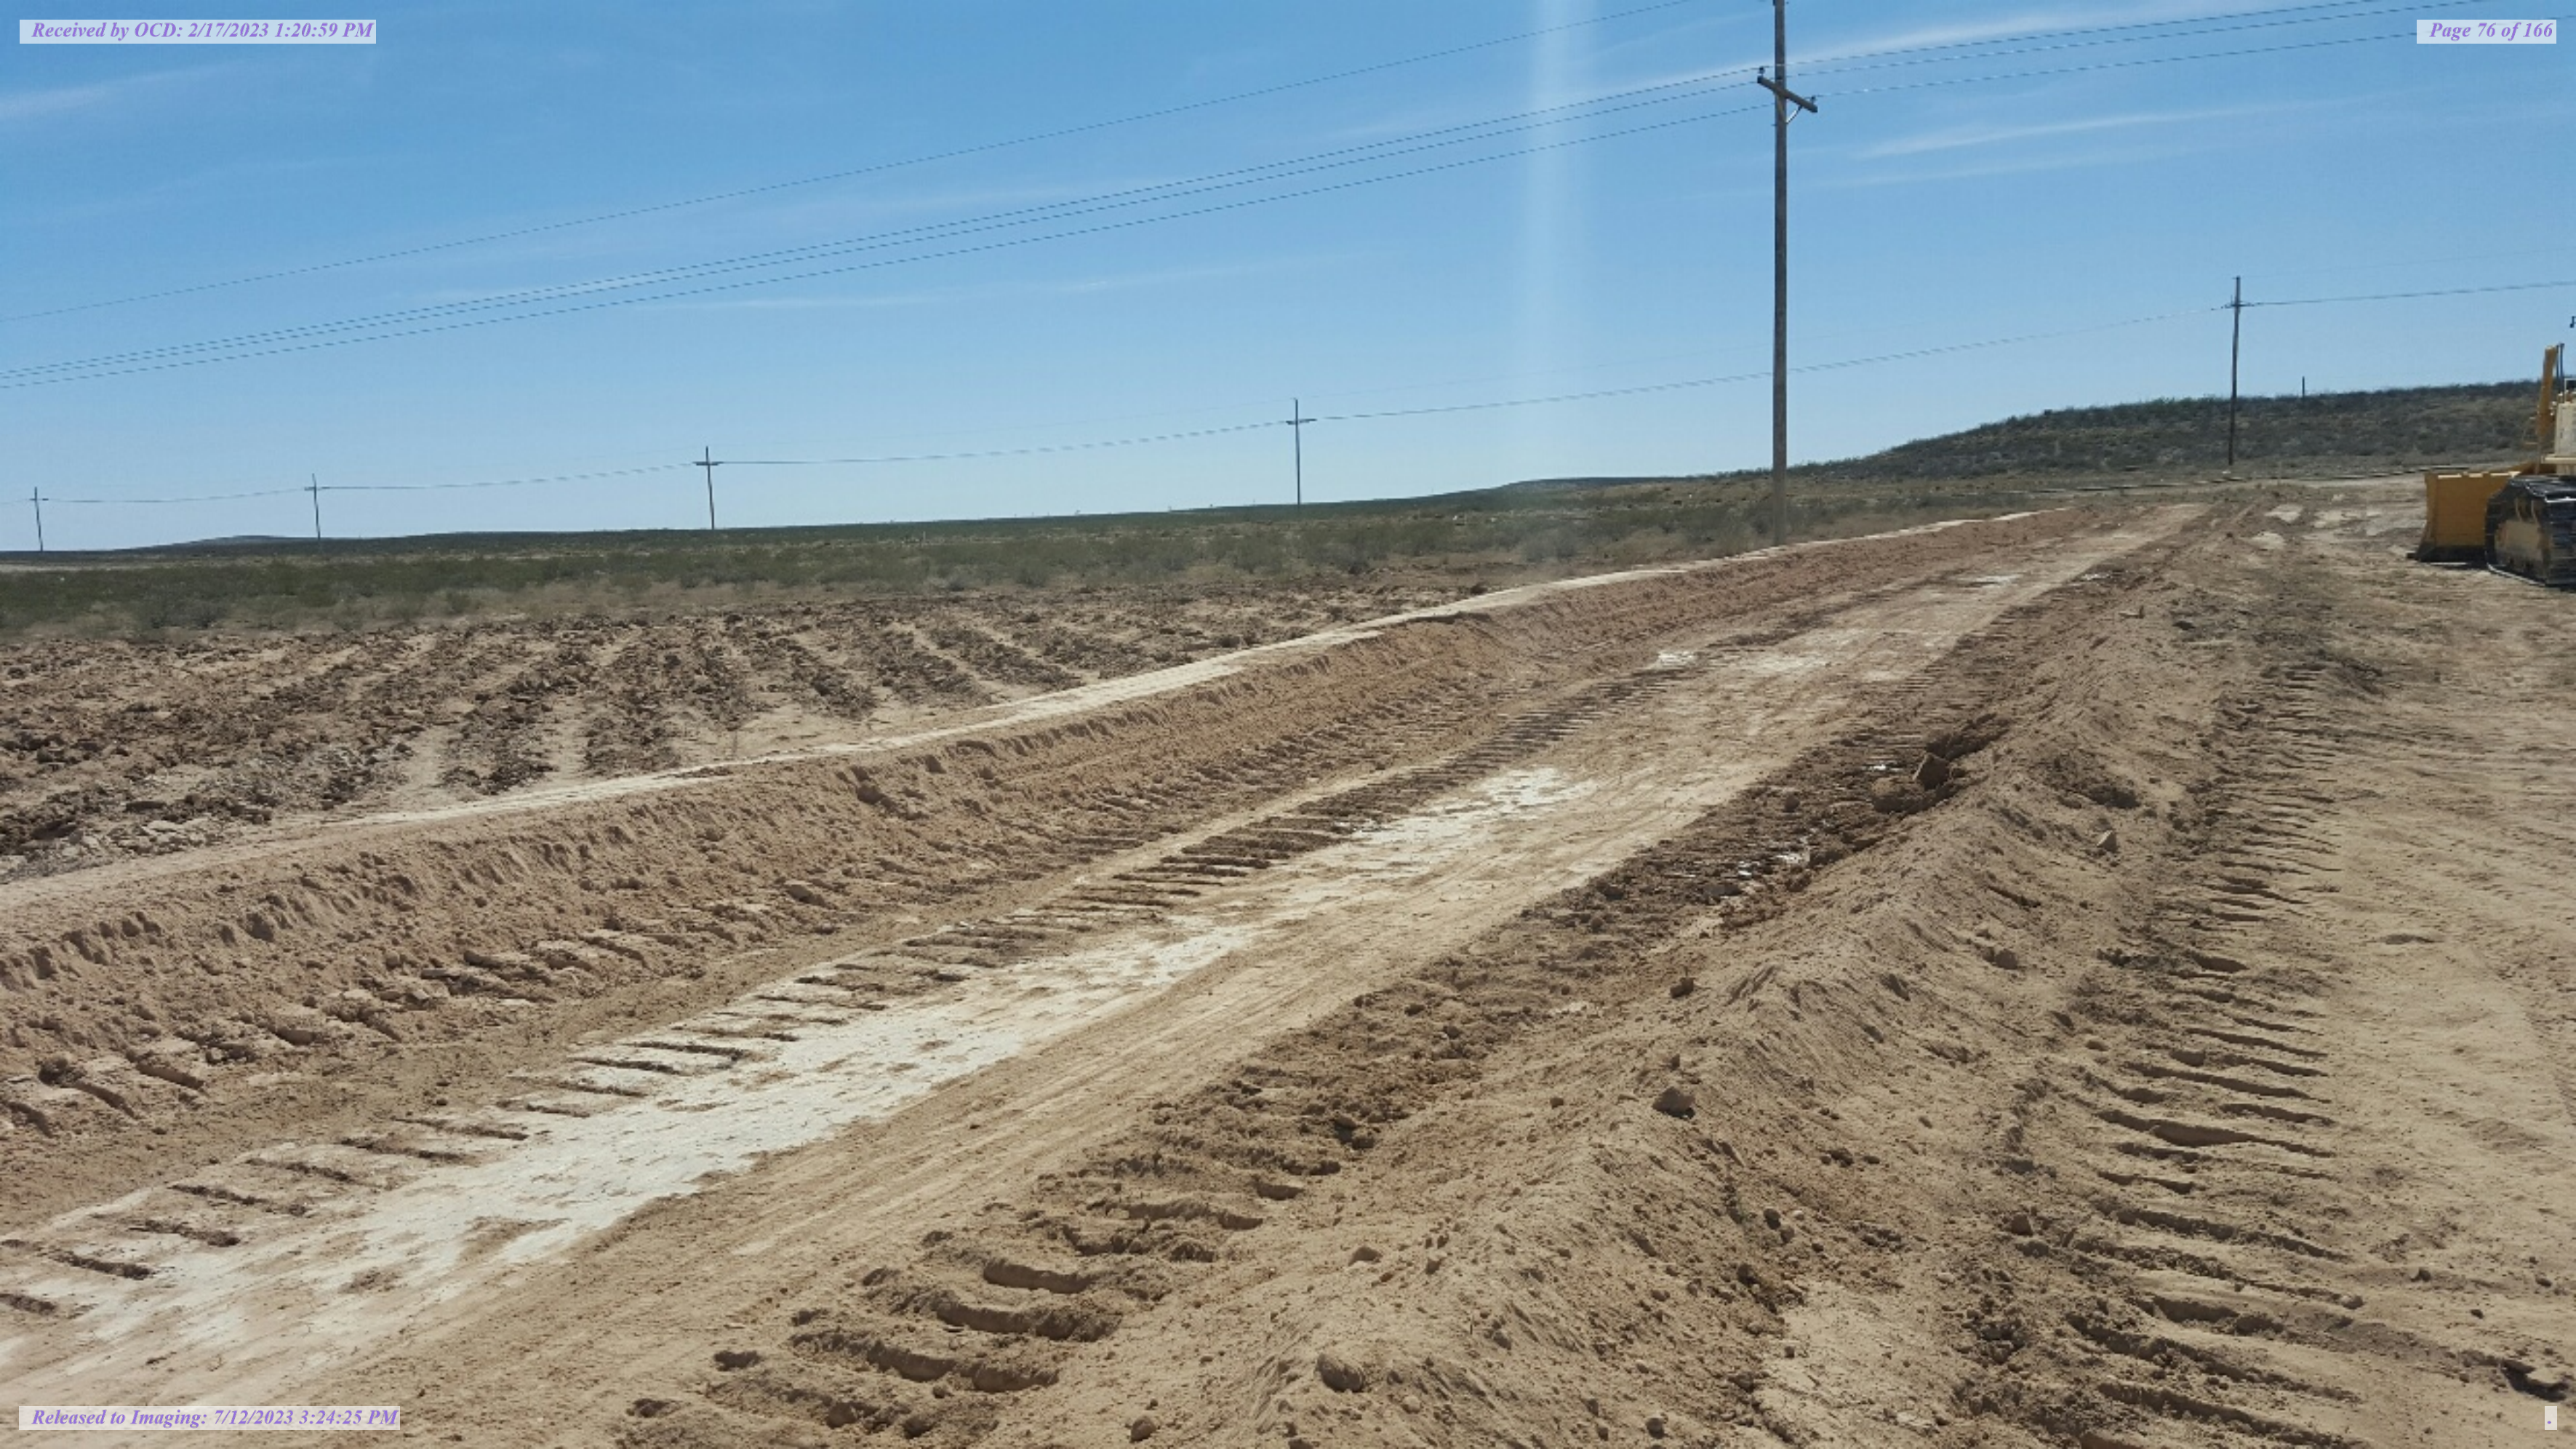
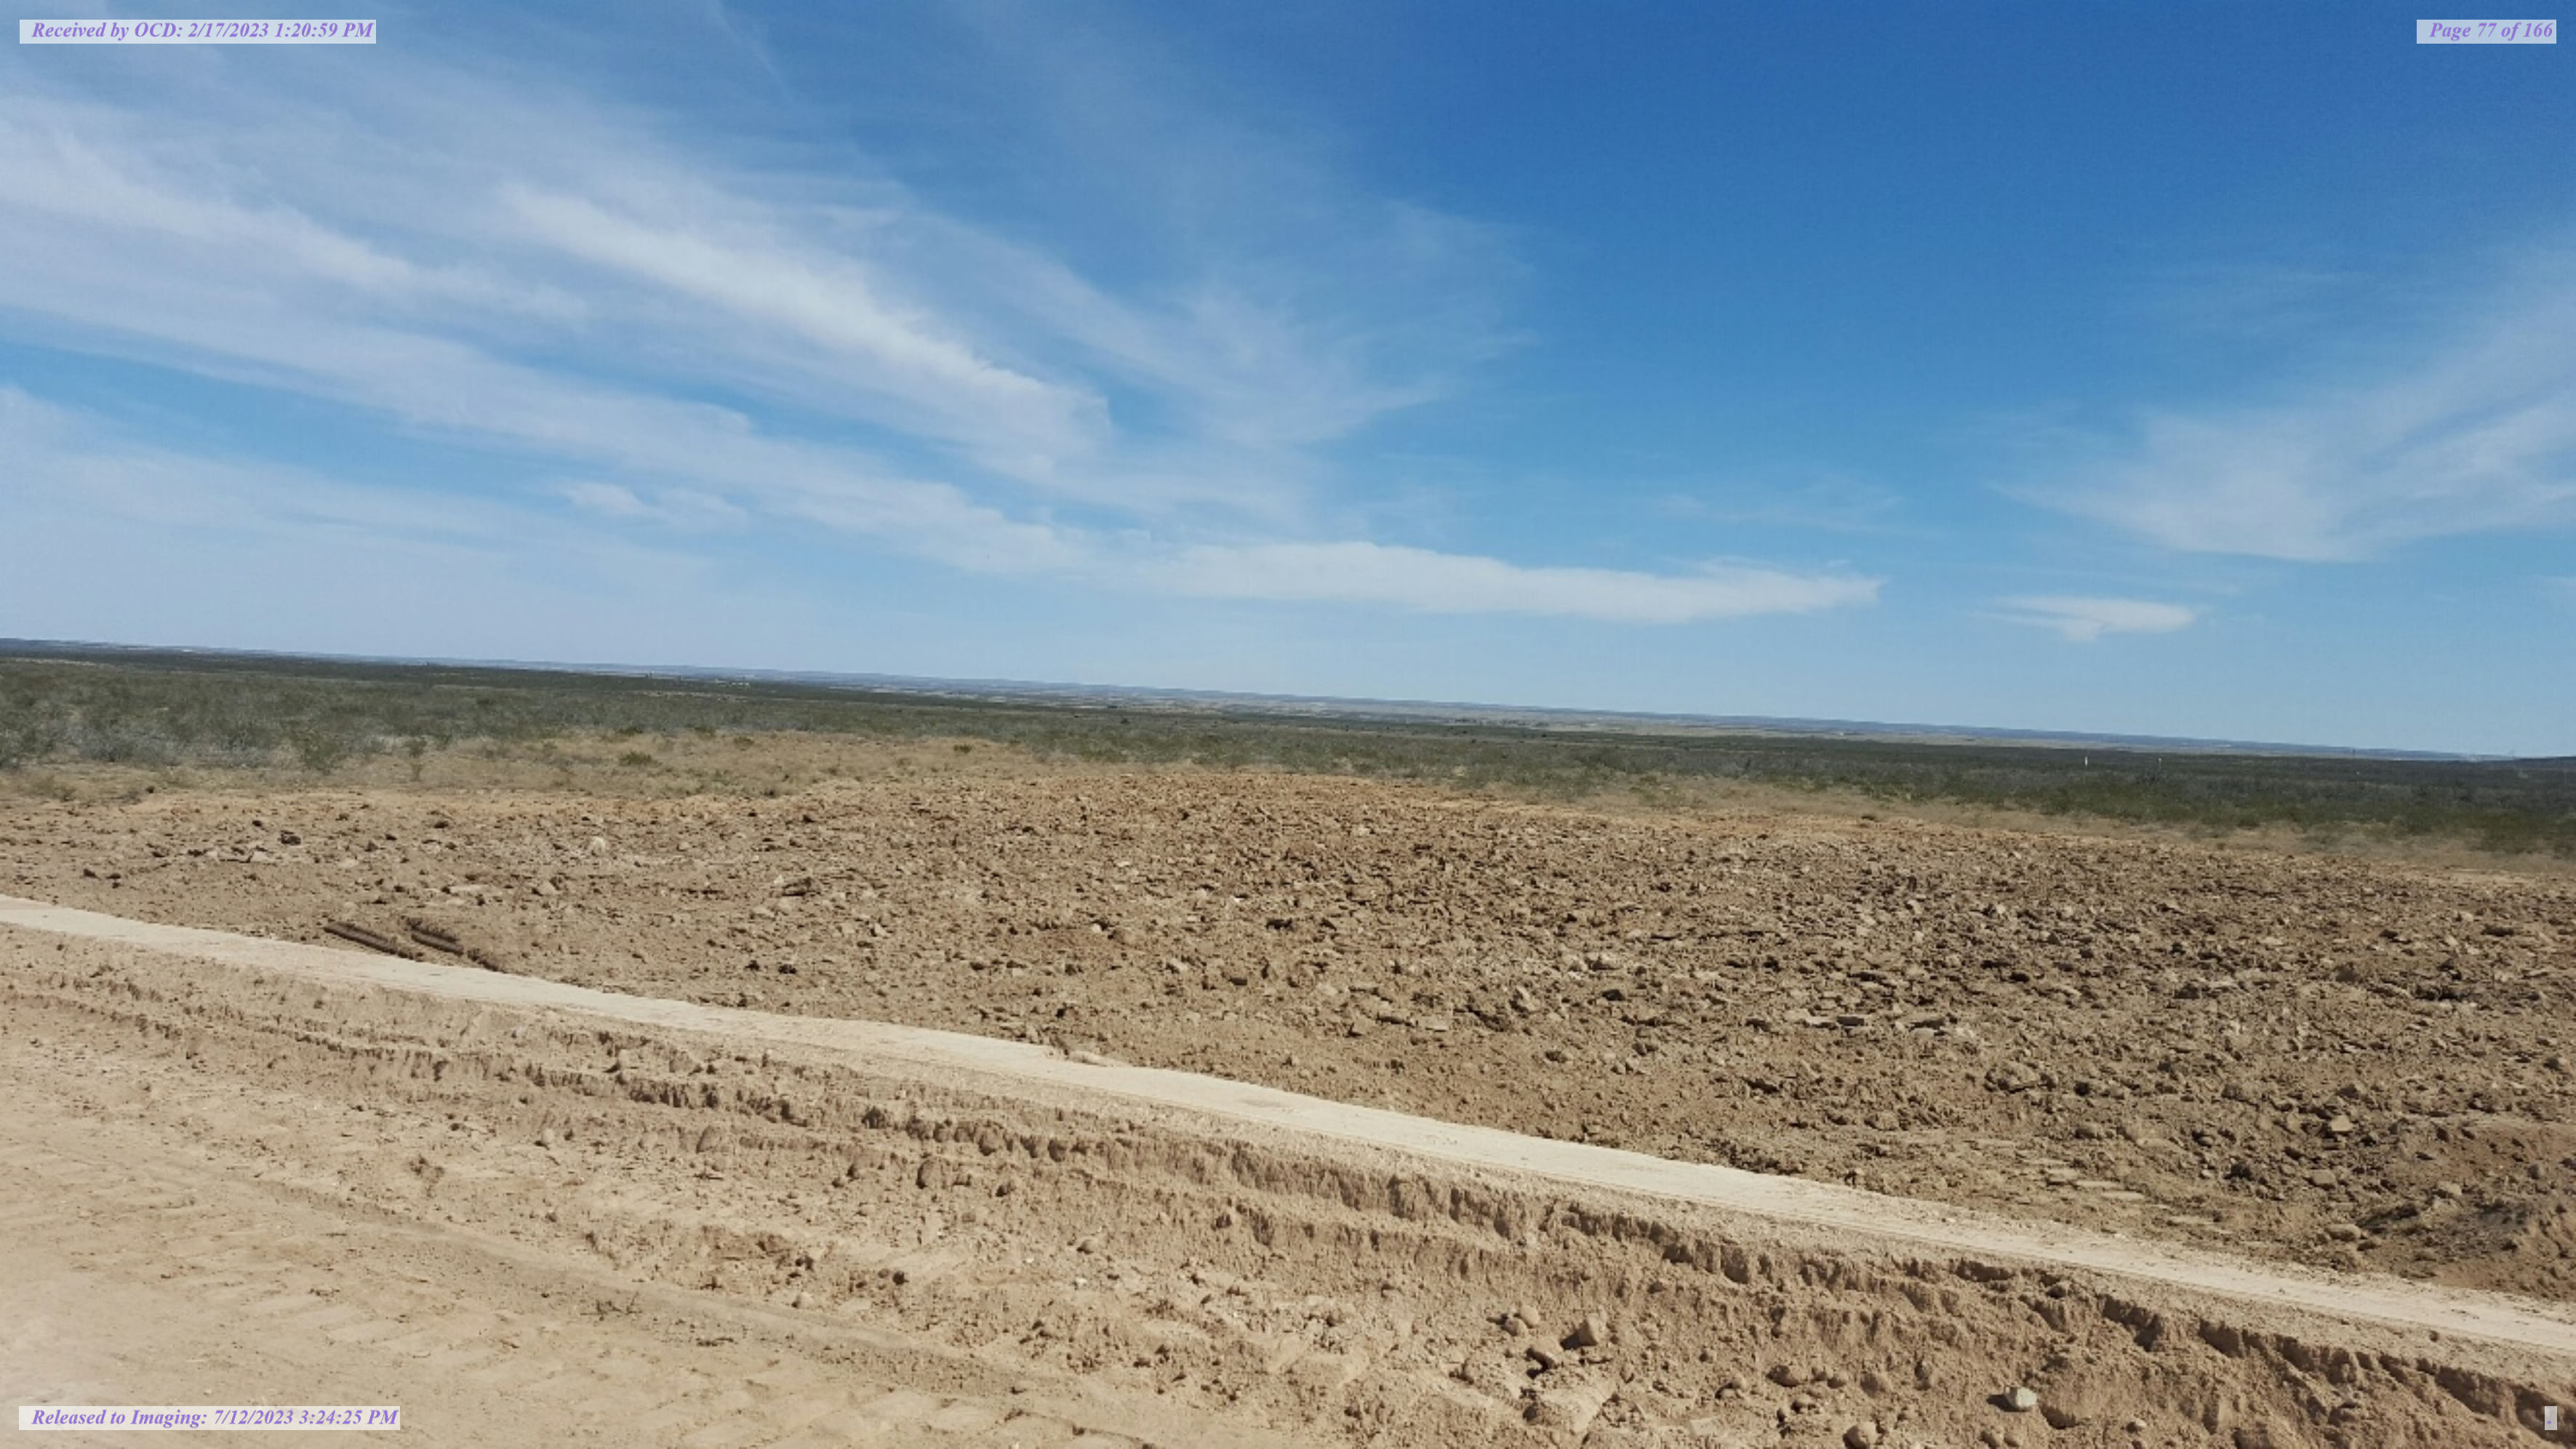
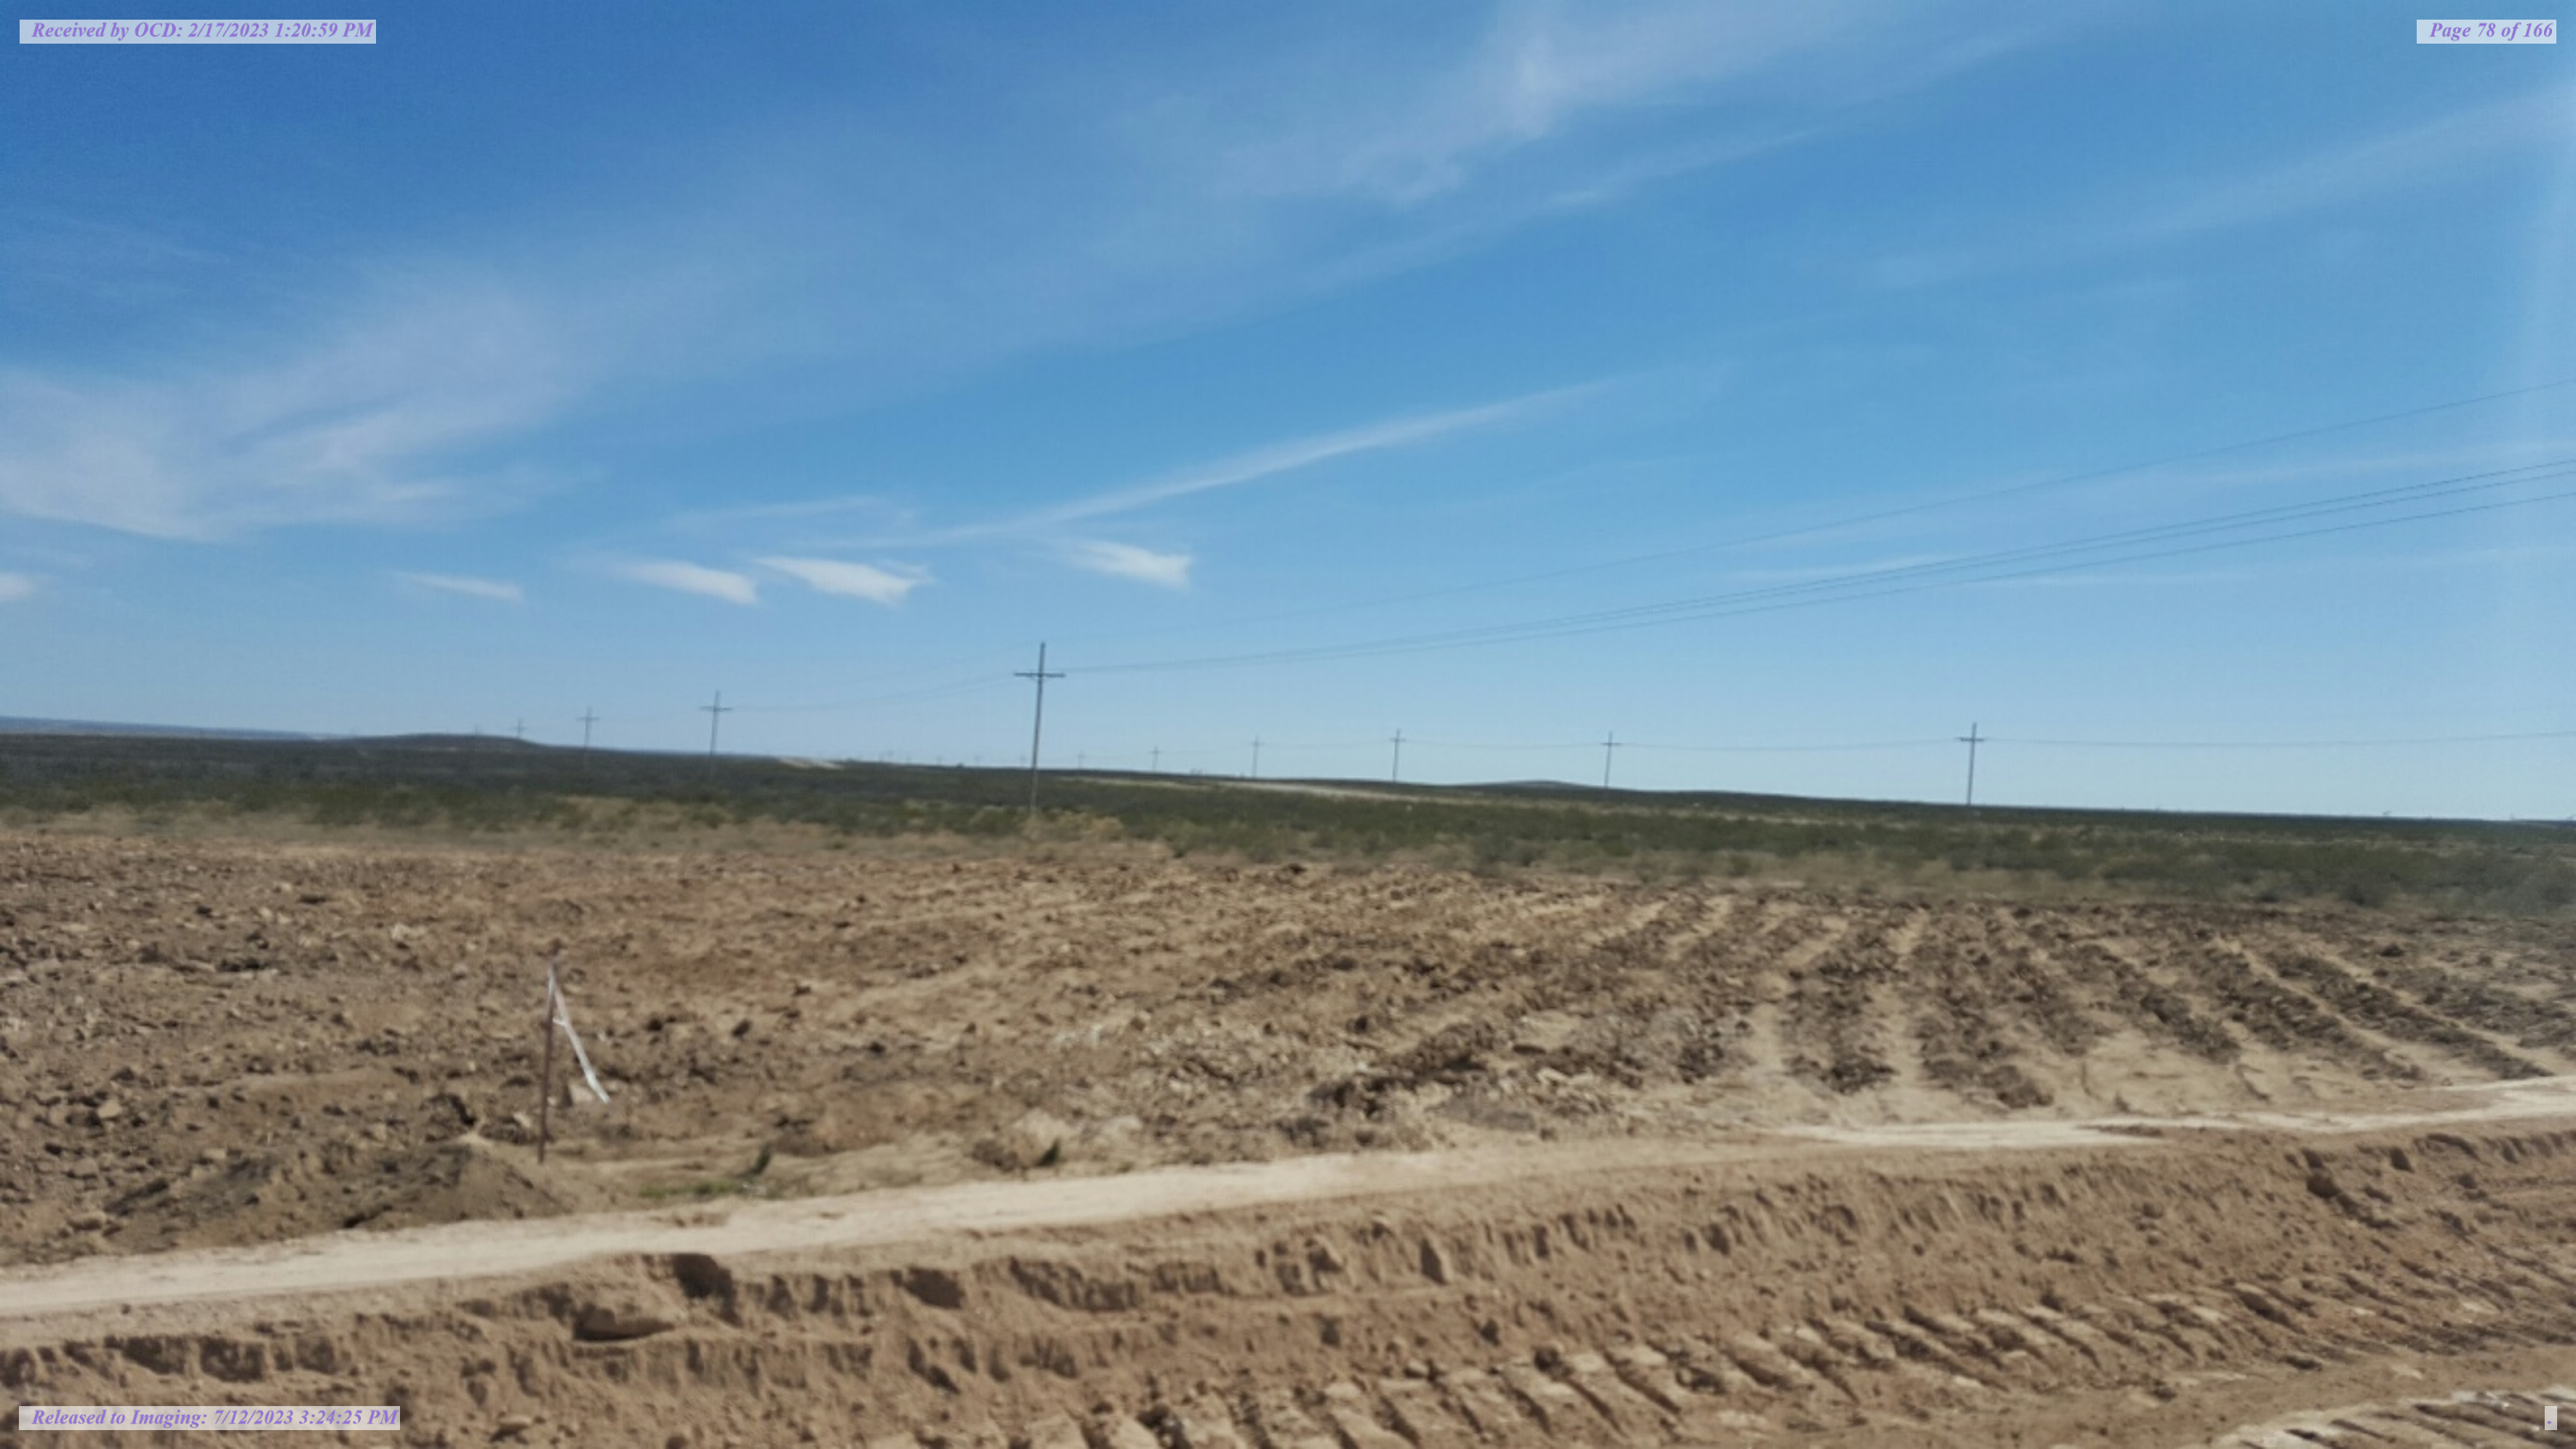
I have attached pictures of the completed work. I did have pictures of the excavation, but I have misplaced them. As per our conversation, all work was done as presented in the approved work plan. Due to compaction during backfill, the remediated area was cross ripped against the contour of the land and the berm was placed to detour traffic over the remediated area. The placement of the berm was chosen based on the existing Regency right of way. The area will be reseeded in June of 2016 with the BLM #3 seed mixture unless otherwise noted. Please let me know if you have any questions or concerns.

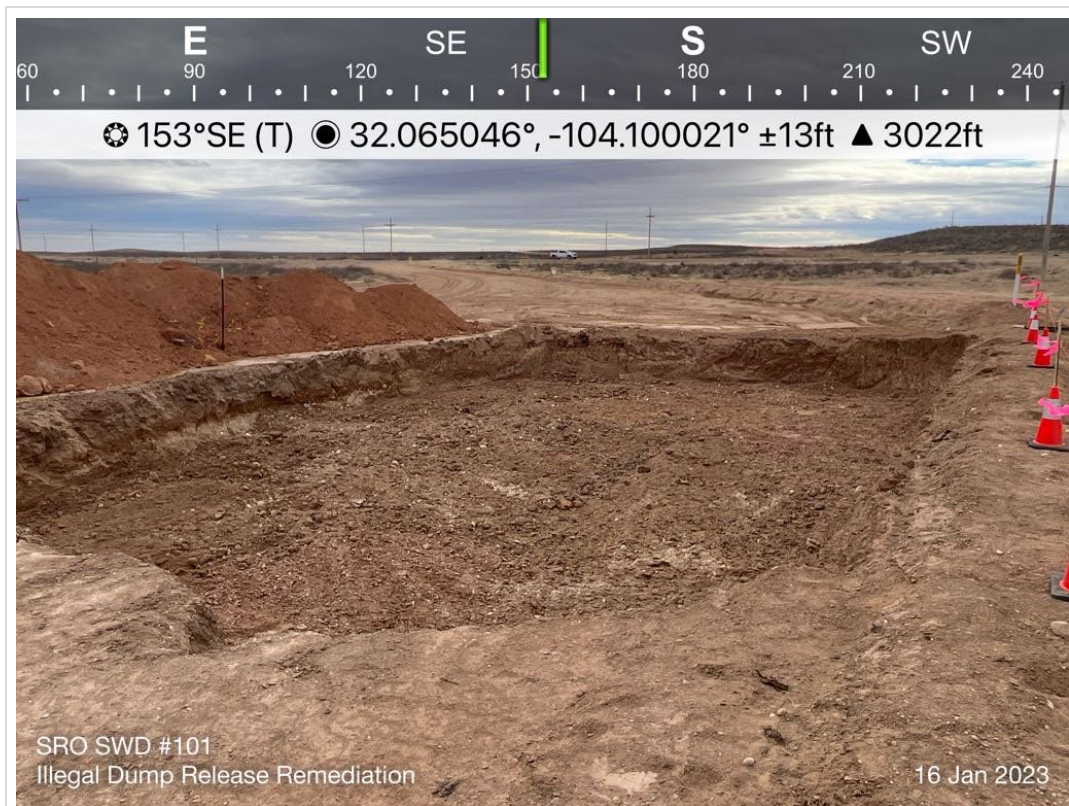
TETRA TECH, INC. PROJECT NO. 212C-MD-02932	DESCRIPTION	Northwest corner of the completed excavation looking southeast.	5
	SITE NAME	ConocoPhillips SRO SWD #101 Illegal Dump	01/16/2023

Based on the rejection and the associated NMOCD conditions, ConocoPhillips elected to remediate the area surrounding BH-1 to meet reclamation requirements. From January 12 to January 17, 2023, Tetra Tech personnel were onsite to supervise the remediation activities at the Site, including excavation, disposal, and confirmation sampling. Impacted soils were excavated until a representative sample from the walls and bottom of the excavation had a field screening value inferred as lower than the RRALs for the Site. Prior to confirmation sampling, the NMOCD district office was notified via email in accordance with Subsection D of 19.15.29.12 NMAC. Documentation of associated regulatory correspondence is included in Appendix C.

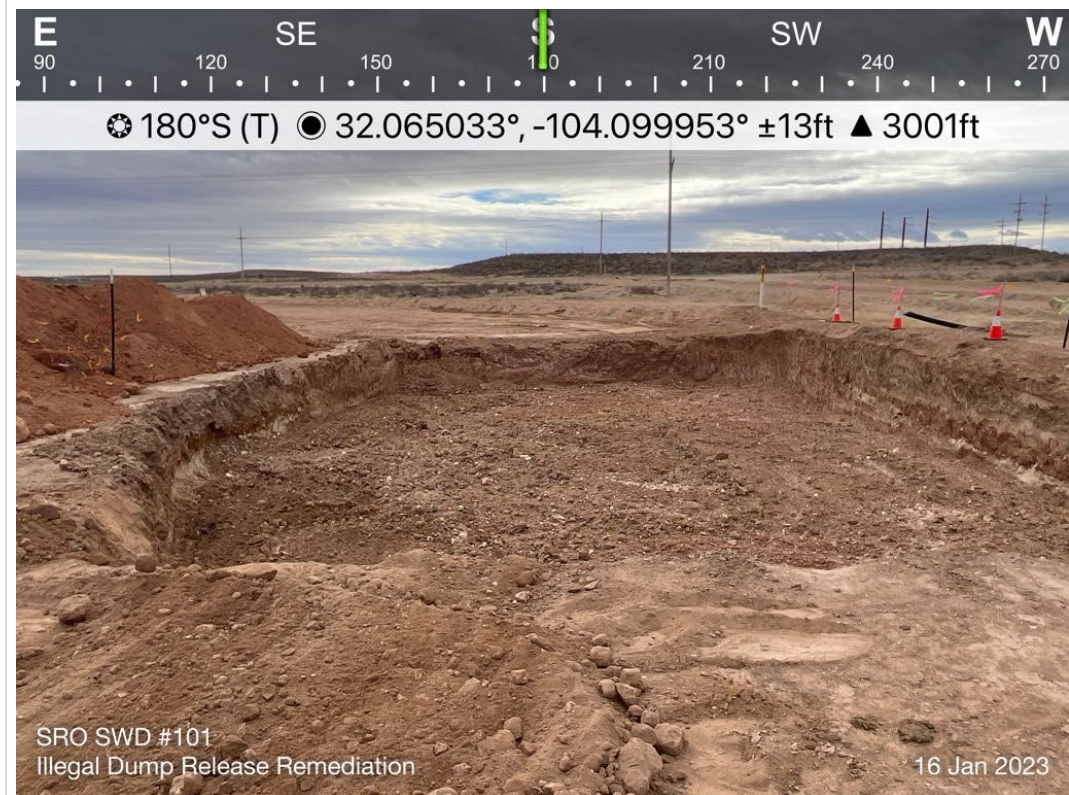
TETRA TECH, INC. PROJECT NO. 212C-MD-02932	DESCRIPTION	Northern edge of the completed excavation looking south.	6
	SITE NAME	ConocoPhillips SRO SWD #101 Illegal Dump	01/16/2023

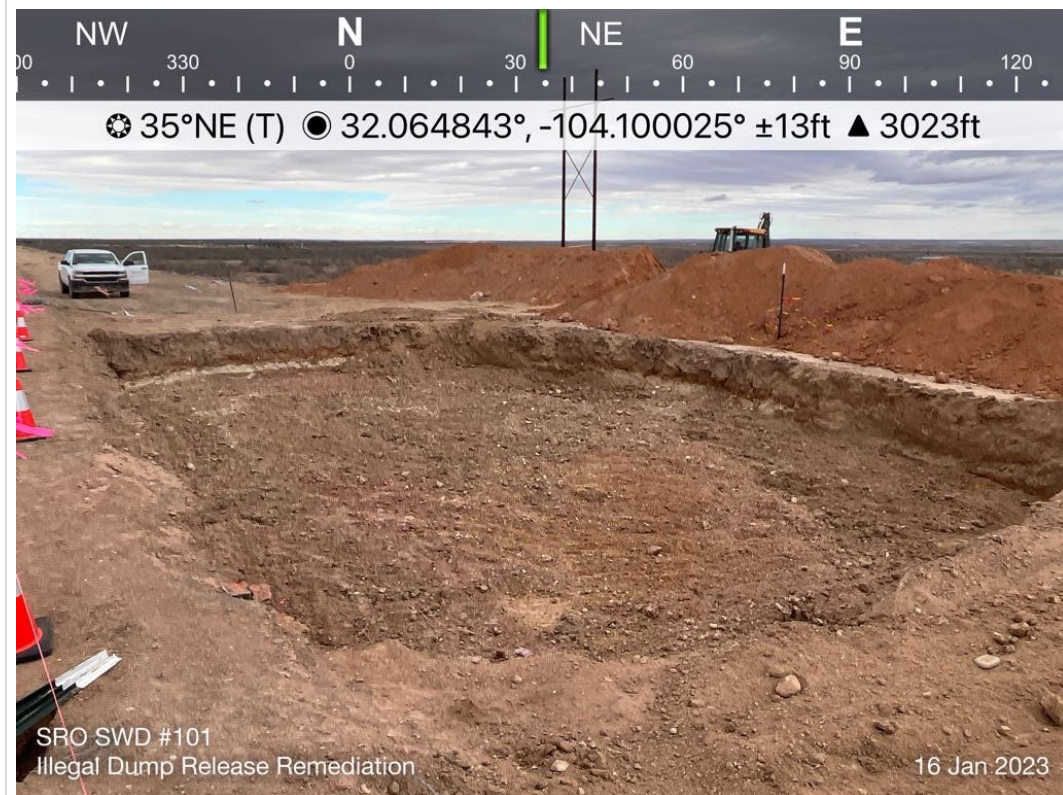
TETRA TECH, INC. PROJECT NO. 212C-MD-02932	DESCRIPTION	Southwestern corner of the completed excavation looking northeast.	8
	SITE NAME	ConocoPhillips SRO SWD #101 Illegal Dump	01/16/2023

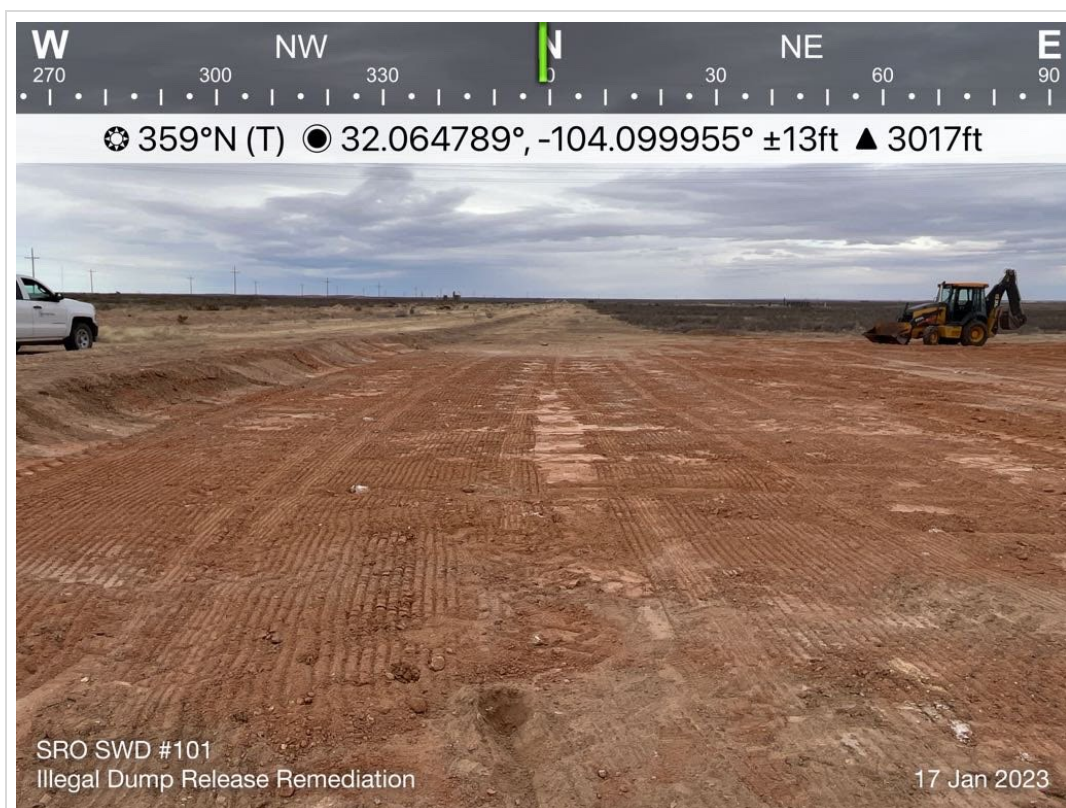
TETRA TECH, INC. PROJECT NO. 212C-MD-02932	DESCRIPTION	View north of backfilled and seeded excavation.	9
	SITE NAME	ConocoPhillips SRO SWD #101 Illegal Dump	01/17/2023
