**Re: Revised Closure Report
ConocoPhillips
Heritage Concho
SRO SWD #101 Illegal Dump Release
Unit Letter M, Section 4, Township 26 South, Range 28 East
Eddy County, New Mexico
Incident ID# nAB1523932511
2RP-3223**

Revised Closure Request
February 17, 2023

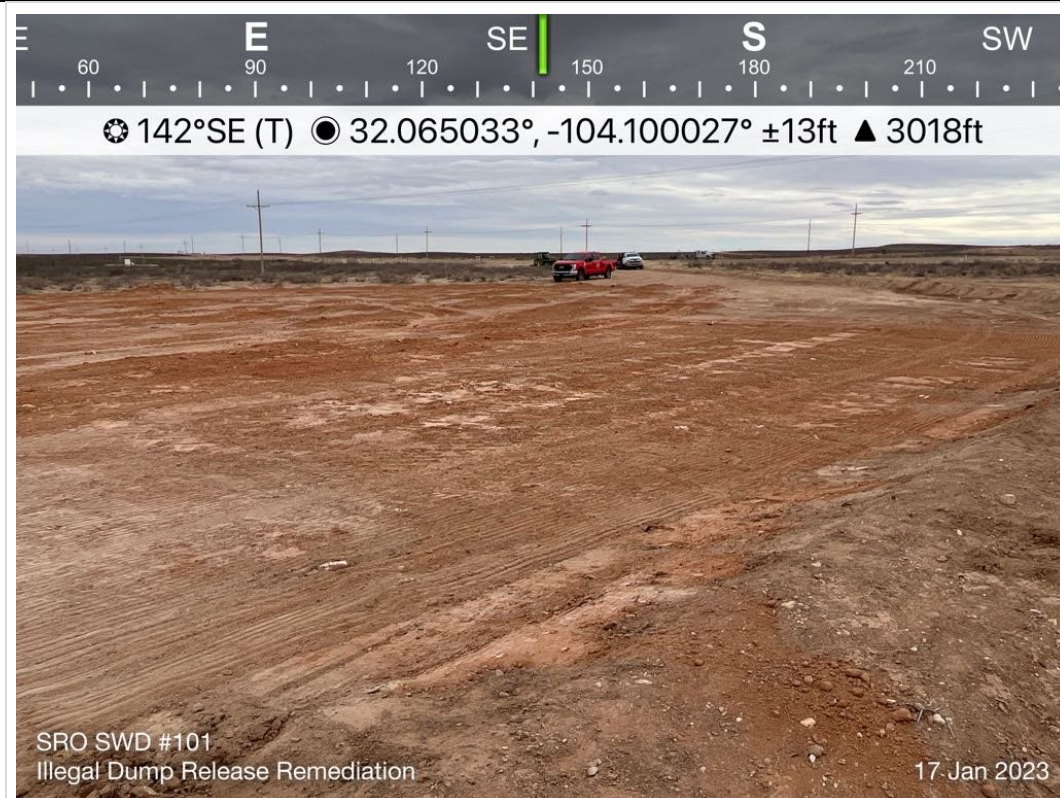
TETRA TECH, INC. PROJECT NO. 212C-MD-02932	DESCRIPTION	View southeast of backfilled and seeded excavation.	10
	SITE NAME	ConocoPhillips SRO SWD #101 Illegal Dump	01/17/2023

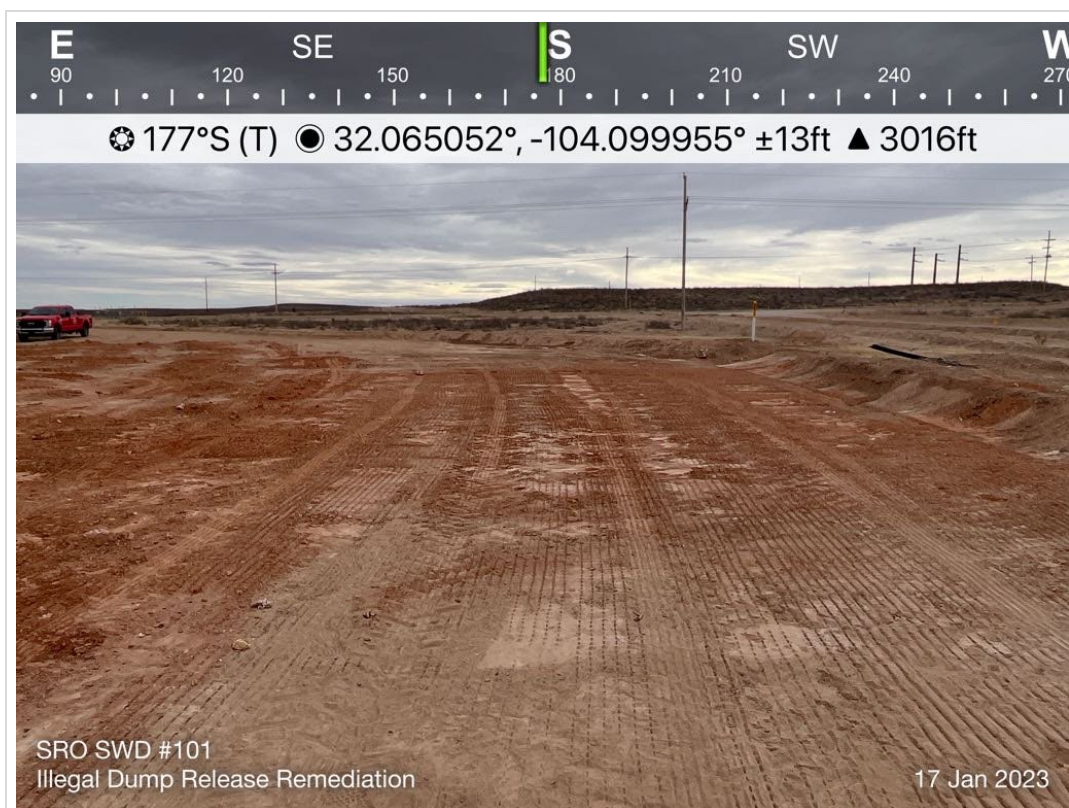
TETRA TECH, INC. PROJECT NO. 212C-MD-02932	DESCRIPTION	View south of backfilled and seeded excavation.	11
	SITE NAME	ConocoPhillips SRO SWD #101 Illegal Dump	01/17/2023
