On September 11, 2022, during hydraulic fracturing (frac) operations, a hose failed from the manifold, resulting in the release of approximately 7 barrels (bbls) of produced water treated with FR into the temporary lined containment and onto the pad. A vacuum truck was immediately dispatched to the Site to recover free-standing fluids; 6.5 bbls of fluids were recovered. XTO reported the release to the New Mexico Oil Conservation Division (NMOCD) and submitted a Release Notification Form C-141 (Form C-141) on September 20, 2022. The release was assigned Incident Number NAPP2226341236.

Site Receptor Map

Remuda 25N 704H
XTO ENERGY, INC
Incident Number: NAPP2226341236
Unit E, Sec 30, T23S, R30E
Eddy County, New Mexico

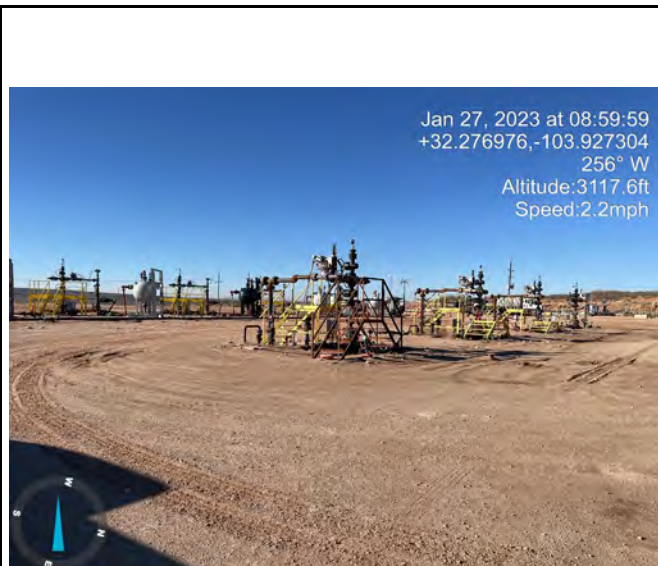
Photograph 2

Description: View of initial site visit facing southwest

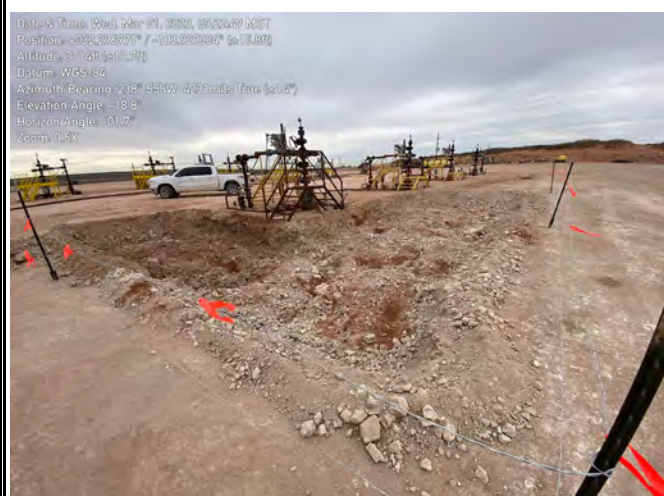
Photograph 3

Description: View of excavation extent facing southwest

Impacted soil was excavated from the release area as indicated by visible staining and elevated field screening results within the release extent. Excavation activities were performed using a backhoe, transport vehicle, and hydrovac. The excavation occurred on the well pad where the frac equipment had been staged. Following removal of impacted soil, Ensolum personnel collected 5-point composite soil samples representing a maximum of 200 square feet from the sidewalls and floor of the excavation. The 5-point composite samples were collected by placing five equivalent aliquots of soil into a 1-gallon, resealable plastic bag and homogenizing the samples by thoroughly mixing. Composite soil samples FS01 through FS04 were collected from the floor of the excavation at a depth of 1.5 feet bgs. Due to the shallow nature of the excavation, sidewall wall samples were incorporated into the final floor samples to represent soil remaining following the excavation. The excavation soil samples were collected, handled, and analyzed following the same procedures as described above. The excavation extent and excavation soil sample locations are presented on Figure 3.
