Durango Midstream, LLC
Hnulik 6 Lateral #2
32.80203°, -104.33728°
NMOCD Reference # nAPP2214535072
Terracon Project # AR227116

RE: **Amended Release Investigation and Closure Plan**
Hnulik 6 Lateral #2
Unit M, Section 25, Township 17 South, Range 26 East
32.80203°, -104.33728°
Eddy County, New Mexico
Terracon Project No. AR227116

RE: **Release Investigation and Closure Plan**
Hnulik 6 Lateral #2
Unit M, Section 25, Township 17 South, Range 26 East
32.80203°, -104.33728°
Eddy County, New Mexico
Terracon Project No. AR227116

Hnulik 6 – Lateral #2 ■ Eddy County, New Mexico
November 9, 2022 ■ Terracon Project No. AR227116

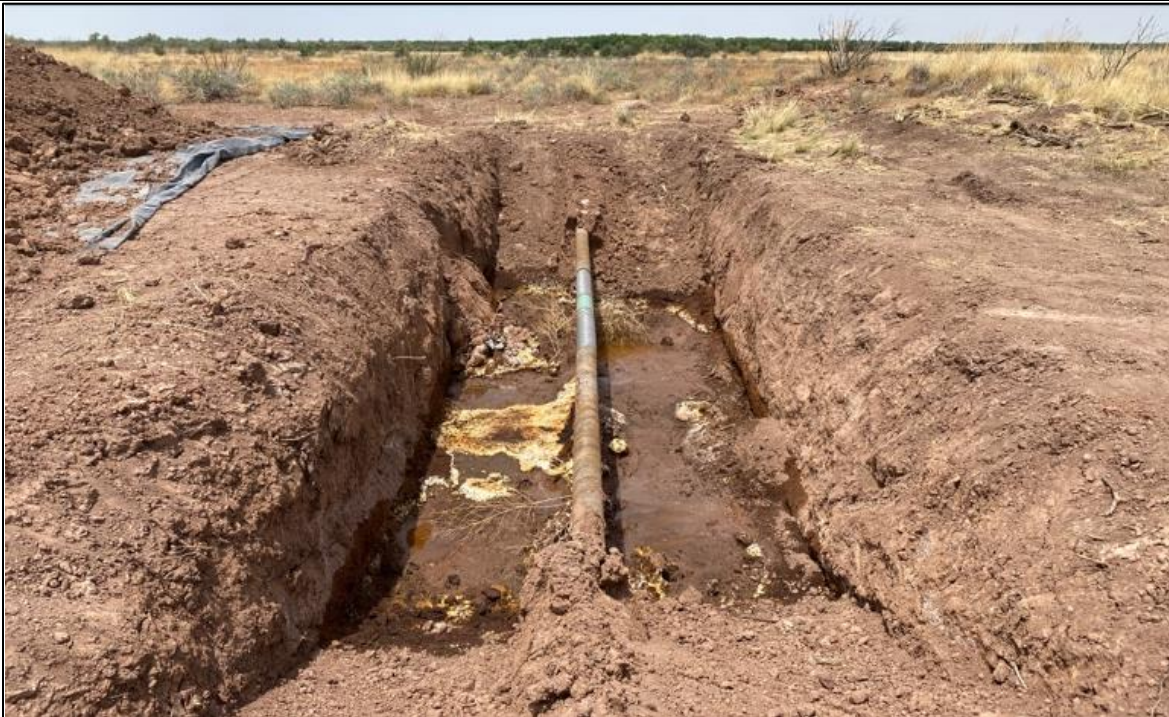
PHOTO 1: View of area prior to remediation from the West.

- 3) Terracon conducted soil removal activities in the area where the release occurred. In total 260 cubic yards of soil were excavated during remedial activities. Excavated material was stockpiled on-site atop a polyethylene liner pending waste characterization and disposal under an approved Form C-138. Excavated materials were disposed of at Lea Land Landfill.

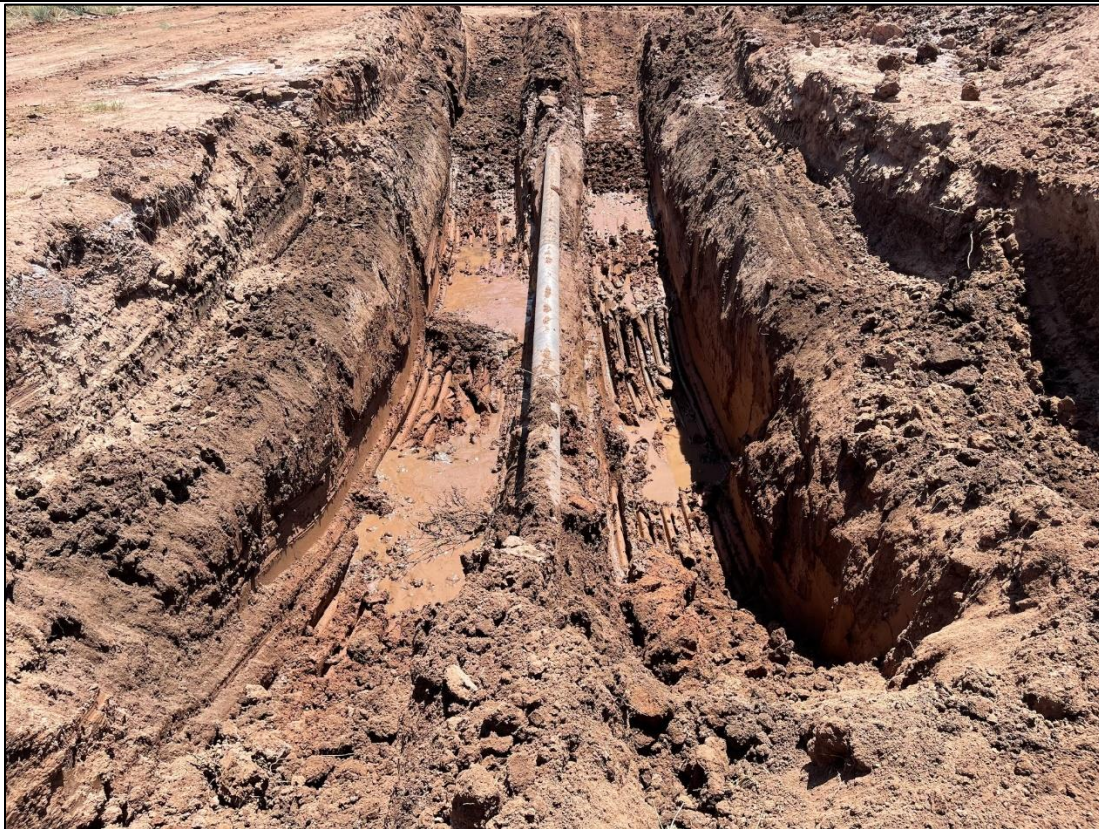
PHOTO 2: View of area following Excavation from the East.
