Incident Number: nAPP2310024728

Harvard Petroleum – Tom Cat 16 State Facility

Oil & Produced Water Spill Clean Up

Tom Cat 16 State Facility – Remediation & Delineation Report

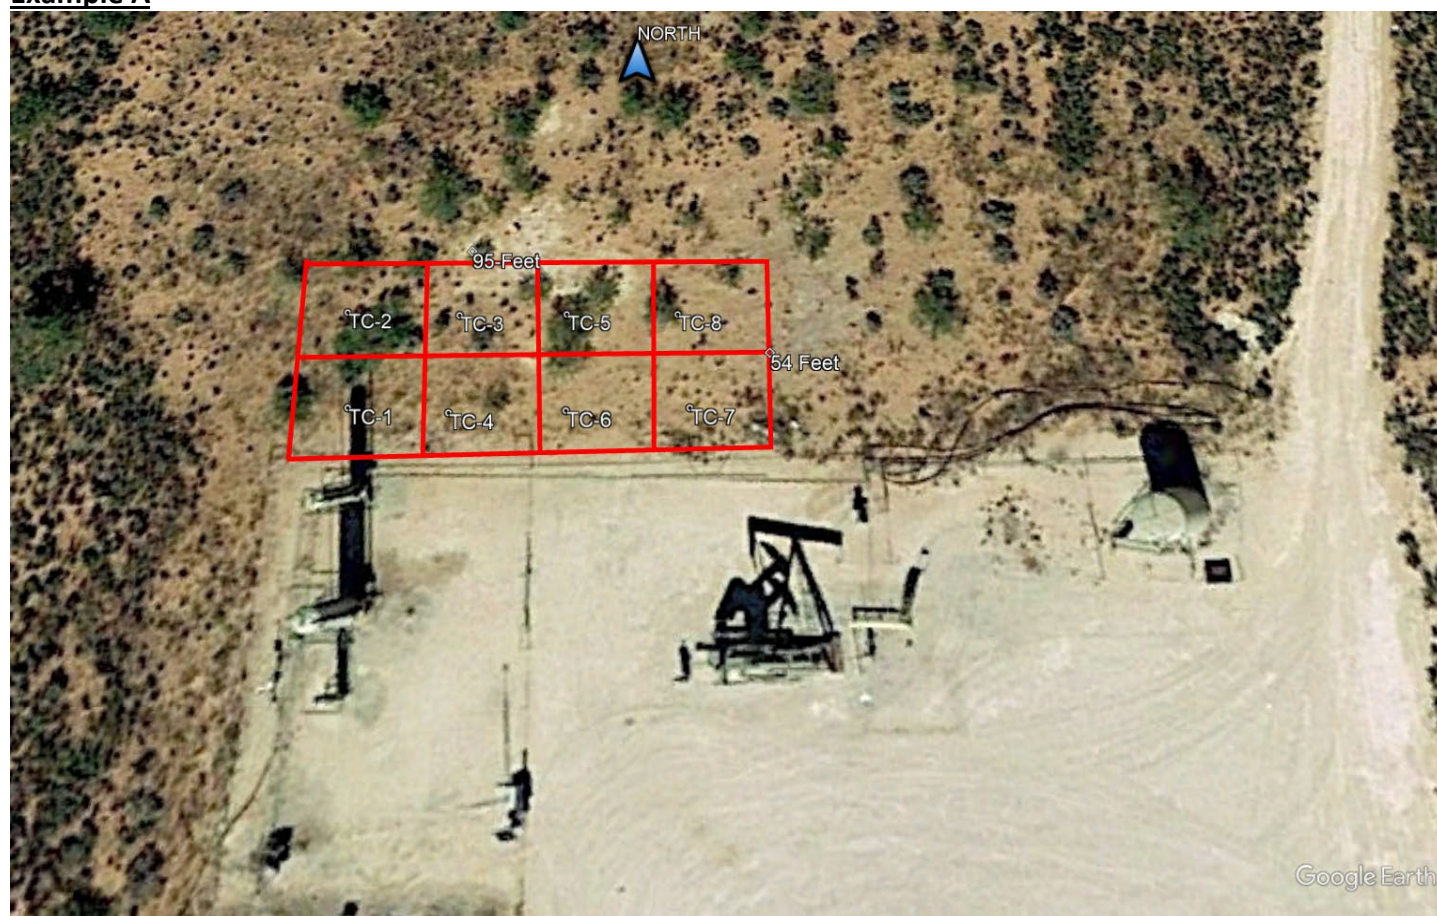
Example A

Provided below is the satellite image of the Tom Cat 16 battery located in Eddy County New Mexico. The spill area measured approximately 95-feet long and 54-feet wide and was a surface only spill, with all freestanding oil and produced water being removed after the initial spill; the spill area has been highlighted and labeled with test points. (See Example "A" Below)

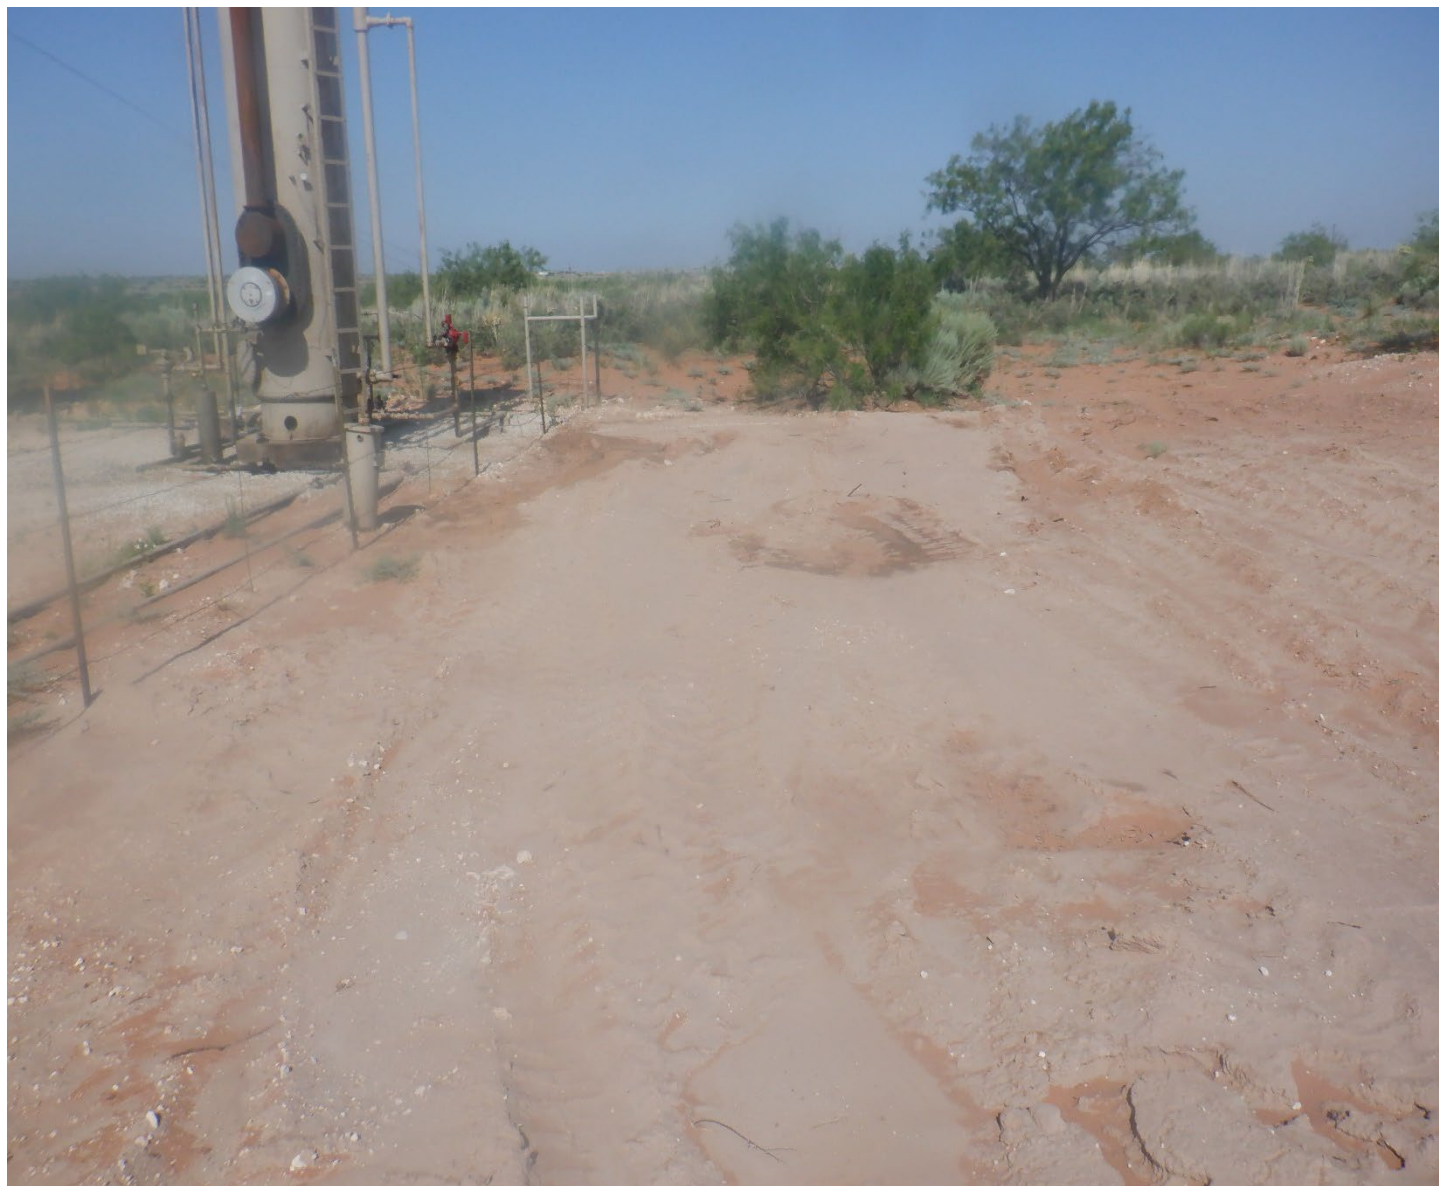
SPILL PHOTO #1 – Before Remediation:

Spill area description:	The spill area is approximately 95-feet long and 54-feet wide.
	Adjacent land to this facility is used for:	Open Land & Oil Production
	The terrain for this facility is:	Flat to Moderate
	Spillage direction of flow:	South
	Are there ANY water sources visible from the facility?	Yes; Water well located 2,058-feet southwest of the spill area.
	LOCATION AND FACILITY NOTES:	None

The spill area was dry and free of all surface liquids. Excavation began, and approximately 3 to 6 inches of contaminated soil was removed. All soil containing TPH and chlorides exceeding State of New Mexico OCD thresholds was excavated and hauled to Ace Land Farm in Lea County New Mexico. Field testing indicated that all test areas were below State of New Mexico thresholds for TPH and chloride and (8) samples were collected and delivered to Cardinal Laboratories in Hobbs, New Mexico. 40 yards of contaminated soil was hauled to Ace Land Farm for disposal.
