# BL-1 LINE LEAK

## Remediation Summary & Closure Report

NMOCD Incident No. nAPP2306049630  
UL "C", Sec. 18, T23S, R34E  
32.31127°, -103.512386°  
Lea County, New Mexico

Re: Remediation Summary & Closure Report  
BL-1 Line (02.27.23)  
UL "C", Section 18, Township 23 South, Range 34 East  
Lea County, New Mexico  
NMOCD Incident No. nAPP2306049630  
Tasman Project No. 5348

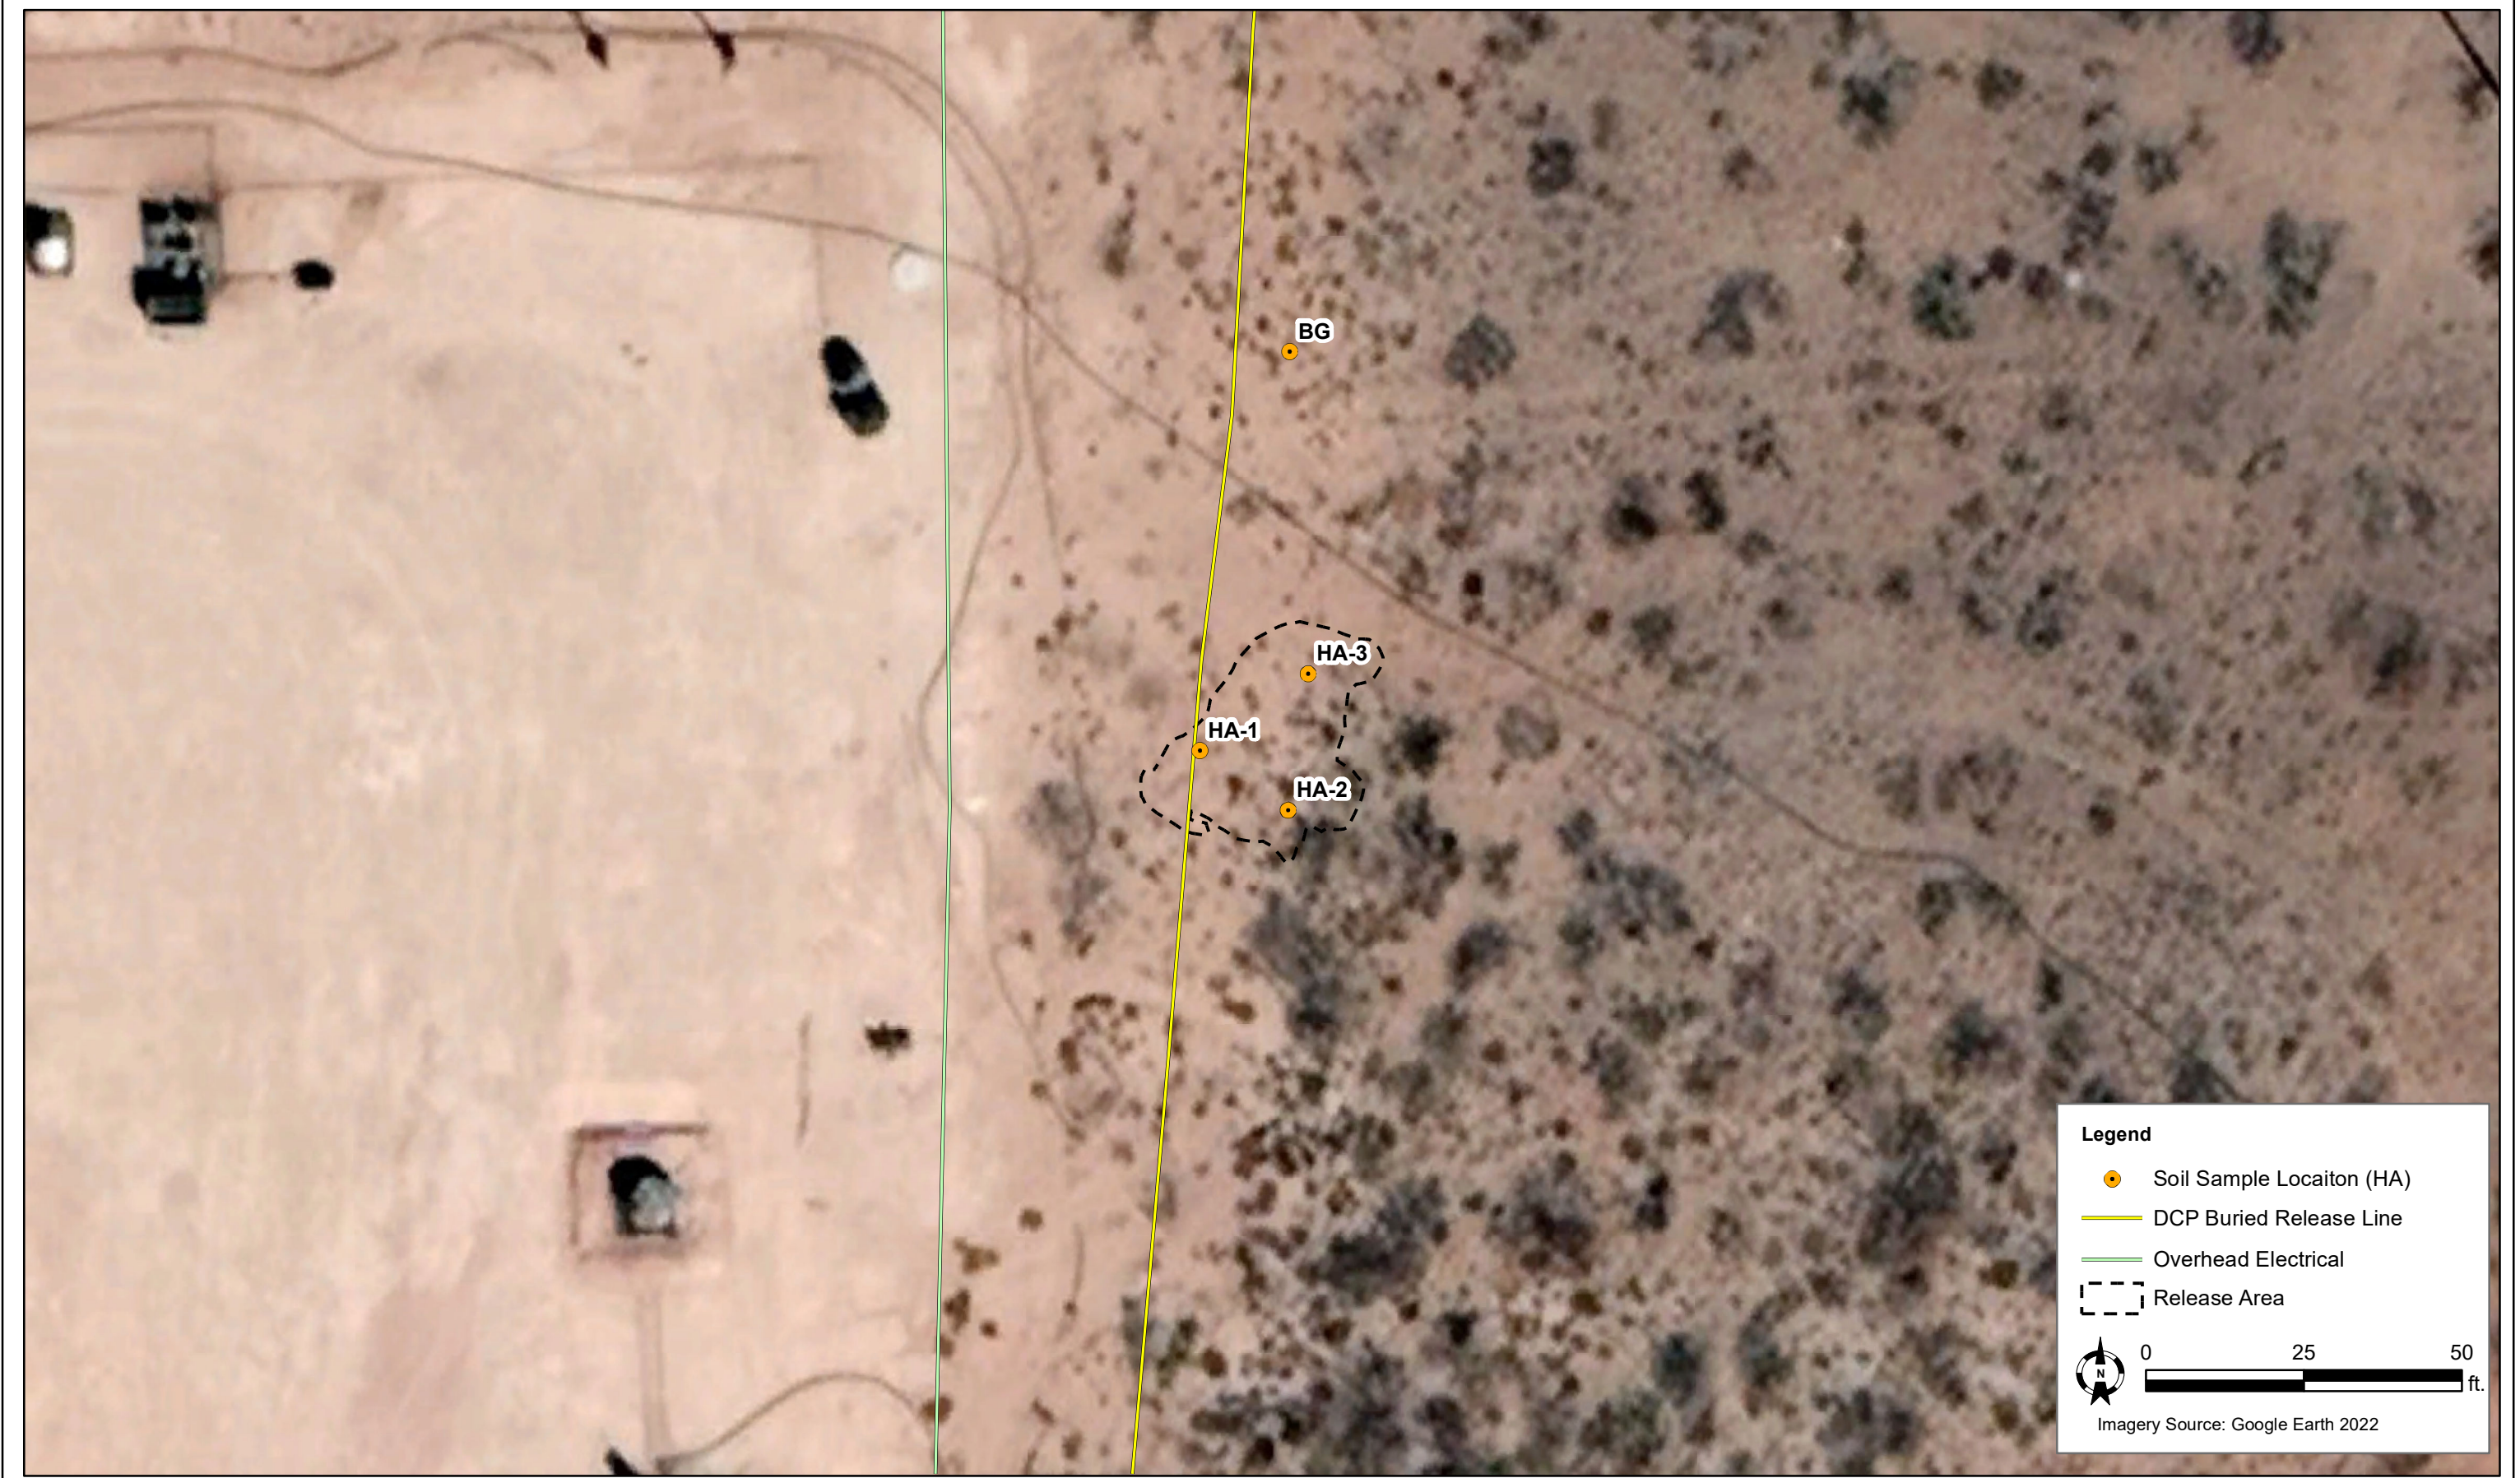
Figure  
2

Assessment Overview Map
