**Re: Site Assessment, Remediation, and Closure Report**  
**Fighting Okra 18 CTB 2**  
**GPS: Latitude 32.024271 Longitude -103.305947**  
**UL -- E, Sec. 18, T26S, R34E**  
**Lea County, NM**  
**NMOCD Ref. No. NRM1926054913**

# Fighting Okra 18 CTB 2

# SITE PHOTOGRAPHS DEVON ENERGY FIGHTING OKRA 18 CTB 2

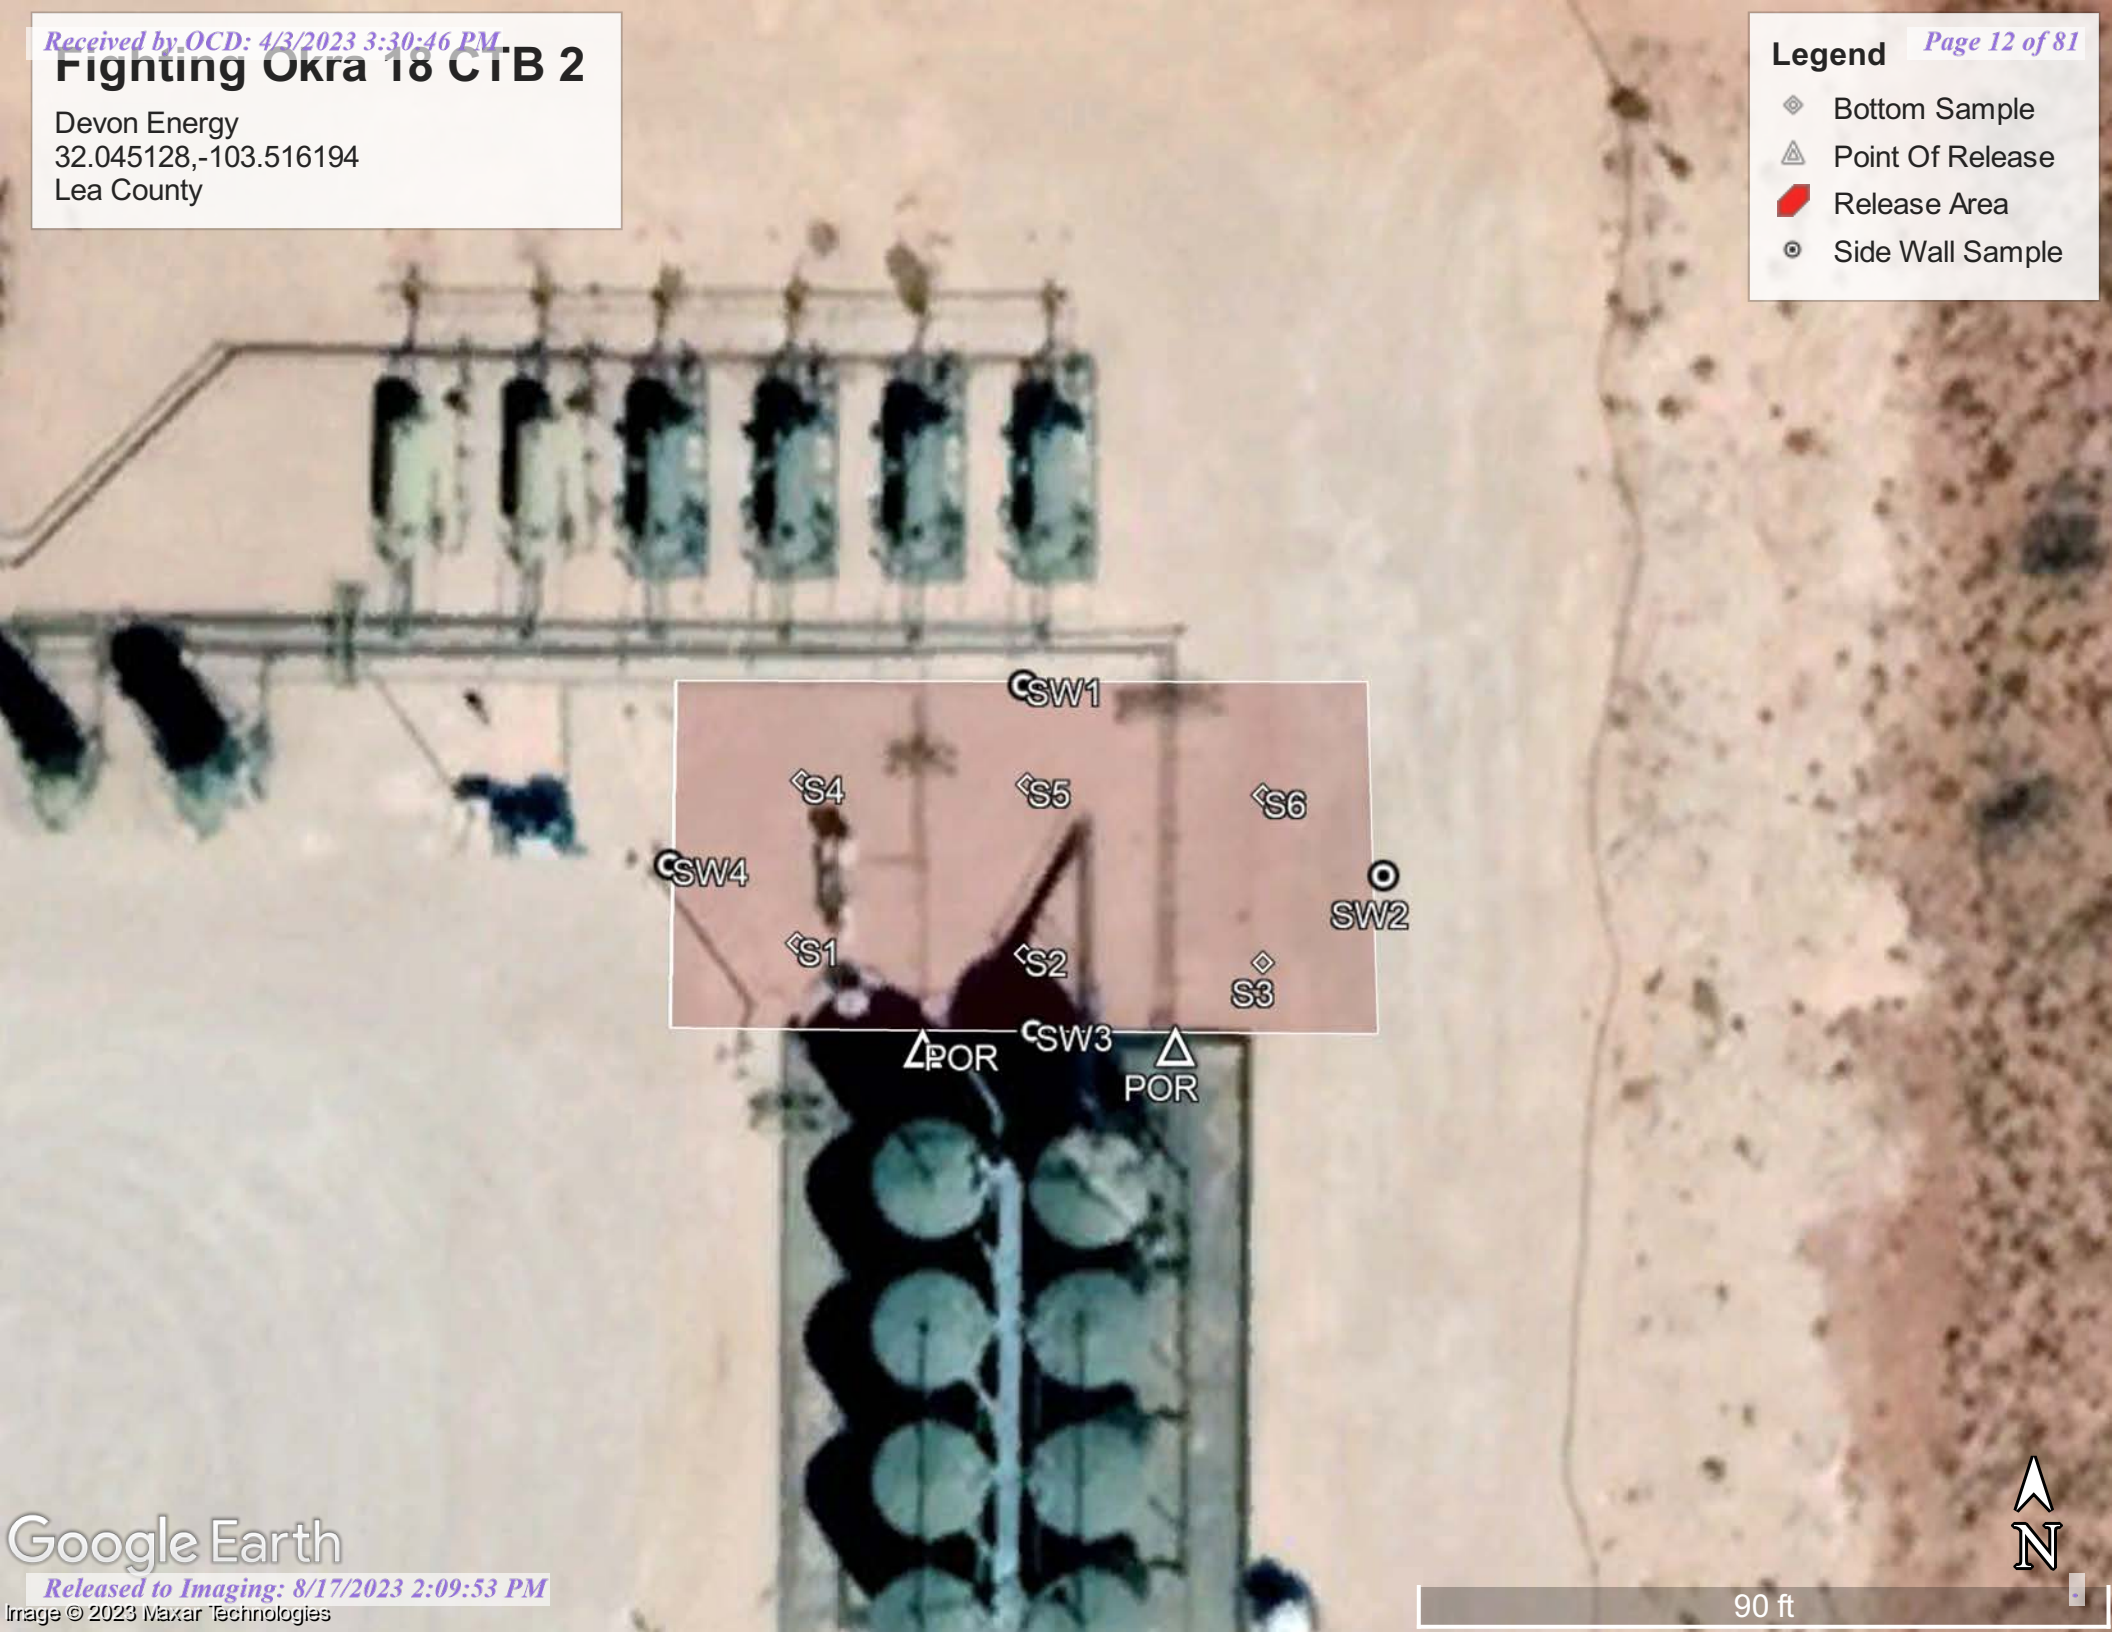
# Fighting Okra 18 CiB 2

On March 8<sup>th</sup>, 2023, Pima Environmental mobilized personnel to assess the impacted area. Pima sampled the areas surrounding the release area and collected a total of twenty-three soil samples for laboratory analysis. Six bottom samples (S1-S6) were collected at depths of 1, 2 and 4 feet to determine vertical delineation. Additionally, side wall samples (SW1-SW4) were collected at a depth of 6 inches to determine horizontal delineation. One background sample was collected to obtain a representation of naturally occurring chlorides surrounding the Fighting Okra. An initial site map can be found in Figure 4.

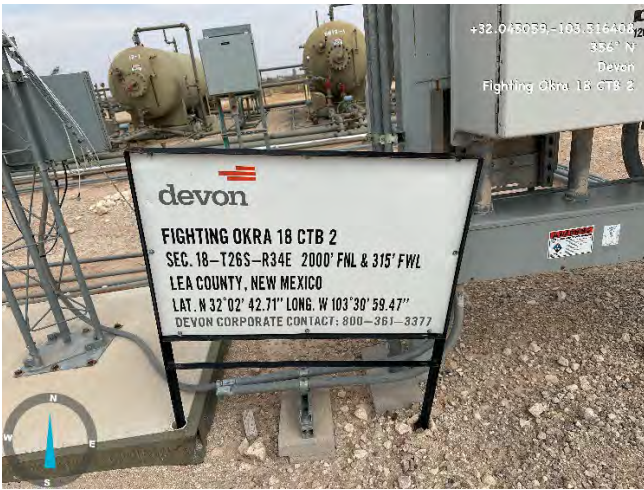
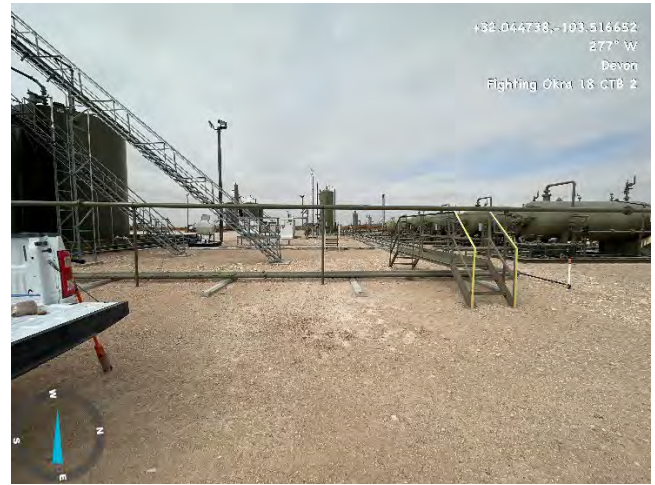
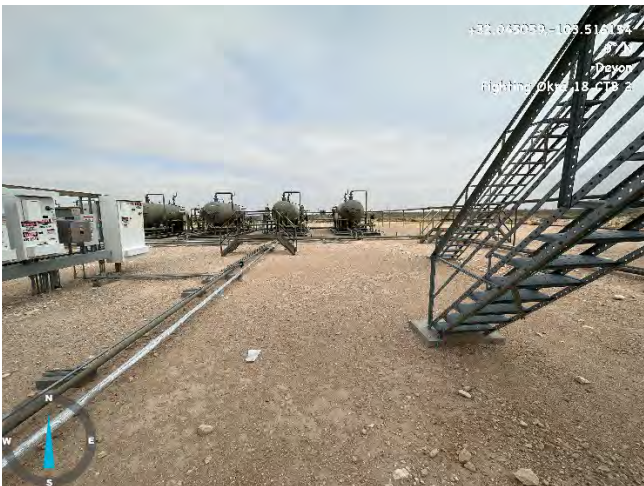
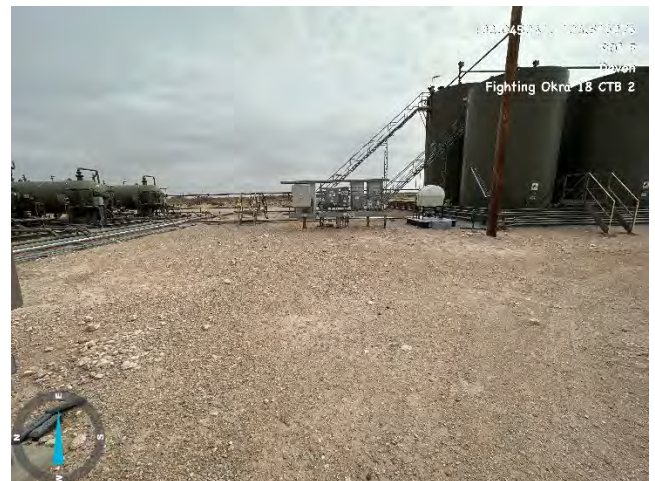
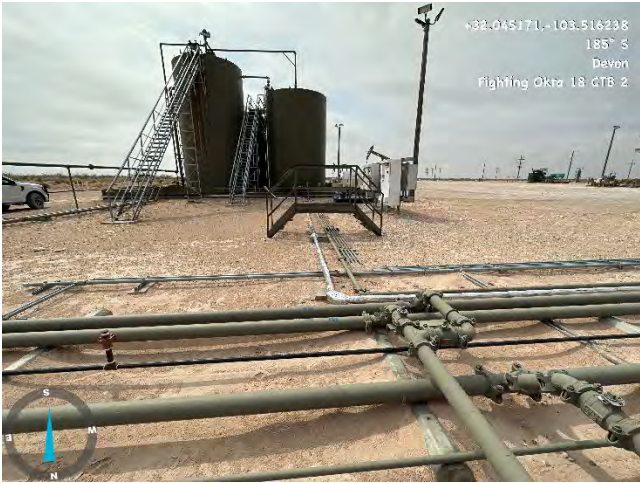
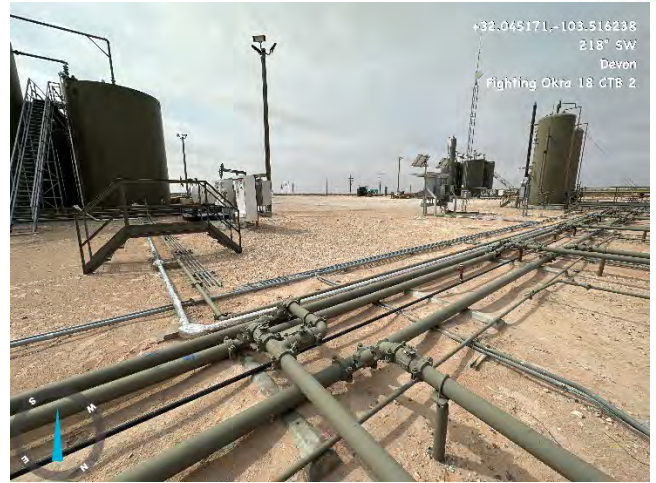
## Site Assessment

Based on the sample results, the bottoms and sidewalls are below NMOCD Closure Criteria 19.15.29 NMAC. See Appendix D for Photographic Documentation.

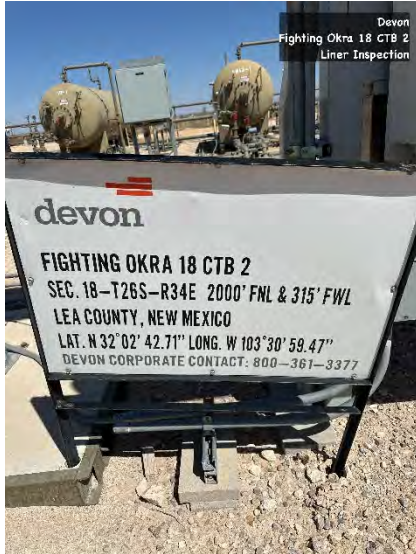
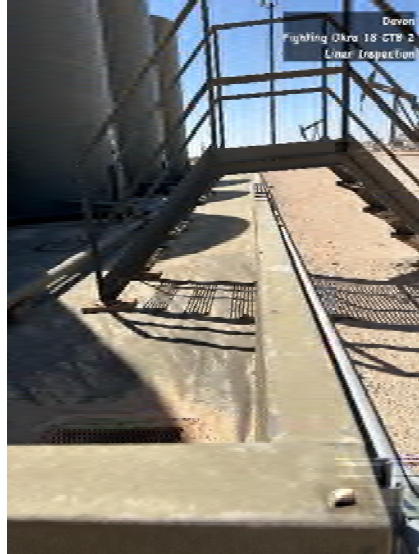
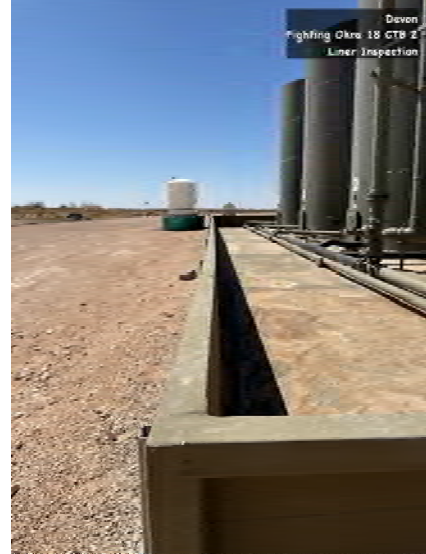
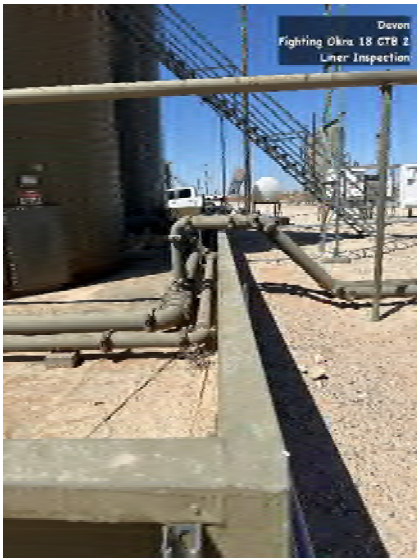
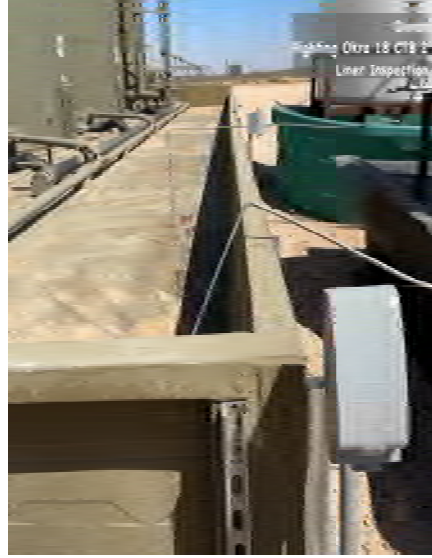
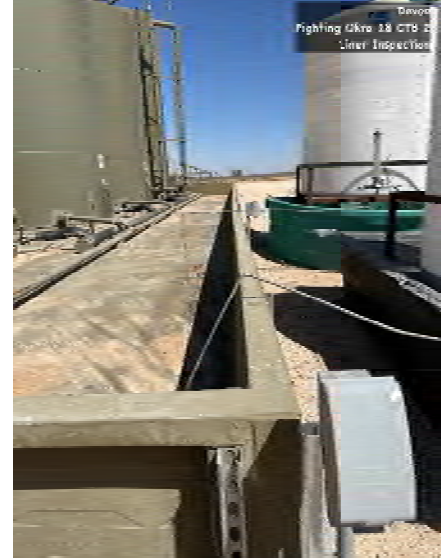
## Liner Inspection

On March 27<sup>th</sup>, 2023, after sending the 48-hour notification via email, Pima Environmental conducted a liner inspection at this location. We concluded that this liner and containment maintained its integrity and was able to retain the fluids. The liner inspection form and photographic documentation can be found in Appendix C and F.

Visualization	Yes	No	Comments
Is there a tear in the liner?		X	
Are there holes in the liner?		X	
Is the liner retaining any fluids?		X	
Does the liner have integrity to contain a leak?	X
