## Closure Report

Cooper 3 #006  
Lea County, New Mexico  
API ID # 30-025-35204  
**Incident #** nPAC0734734930

**August 9, 2023**

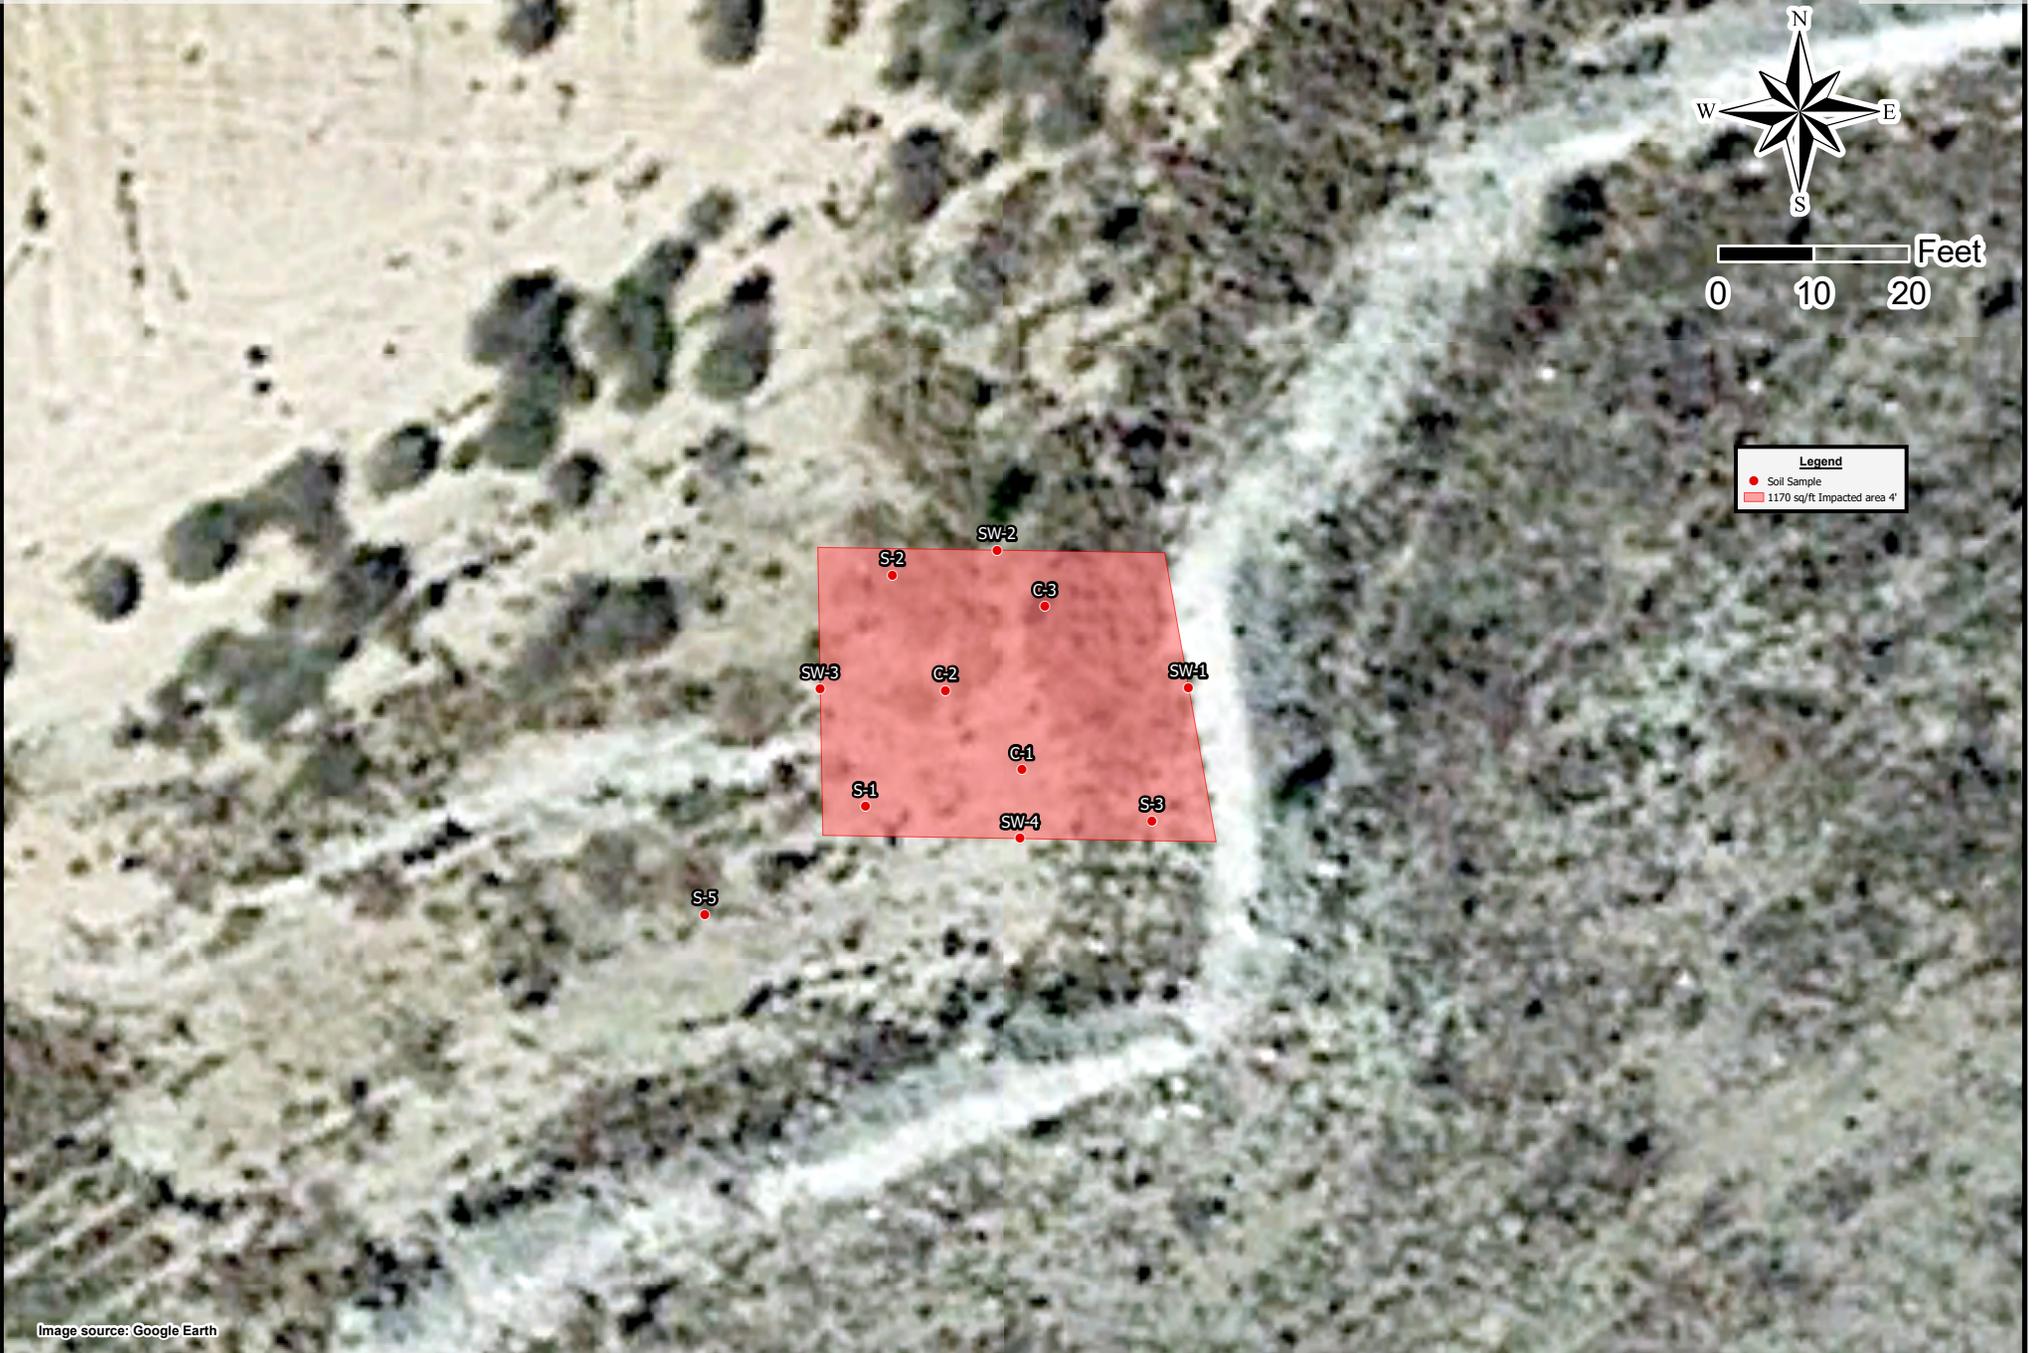
Figure 1

On January 10th, 2023, Talon personnel mobilized to the site to conduct an initial site assessment of the area where the former heater treater resided. The impacted area was photographed, sampled utilizing a hand auger, and mapped. All soil samples were properly packaged, preserved, and transported to Eurofins laboratories with the chain of custody for analysis of Total Chlorides (Method SM4500Cl-B), TPH (EPA Method 8015M), and volatile organics (BTEX, EPA Method 8021B). Sample locations are shown on the attached Figure 2 ([Appendix I](#)) and the results of our sampling event are presented on the following data table.

Matador Resources  
 Cooper 3 #006  
 Eddy County, NM  
 Assessment Map

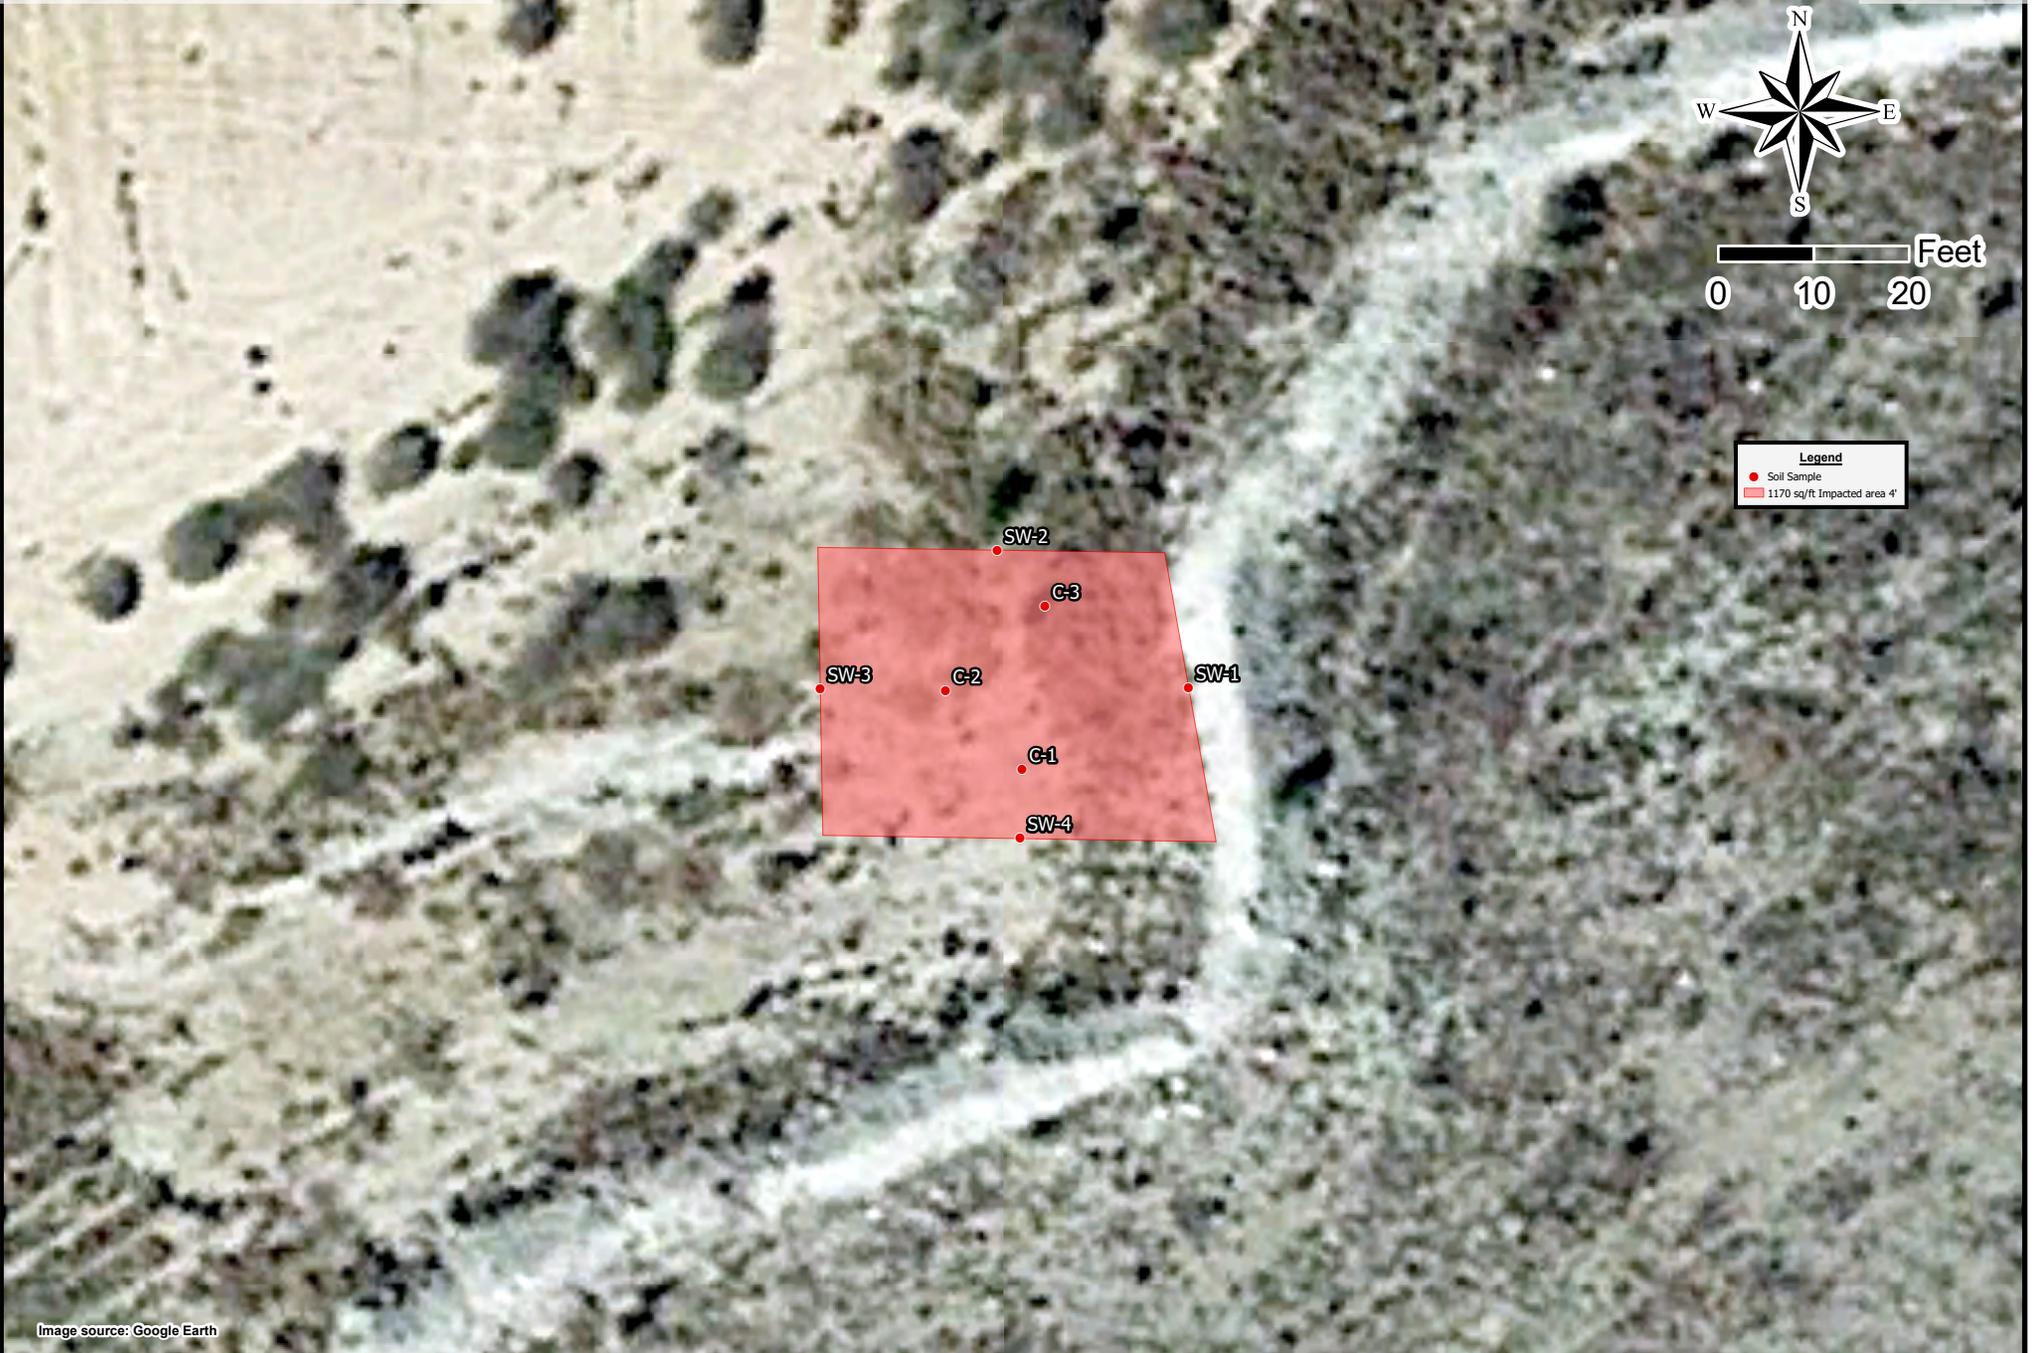
Figure 2

On June 22, 2023, Talon personnel returned to location to remove impacted soils located around suspected historical release area in pasture. Backhoe was used to excavate 3 feet bgs. of contaminated soils and composite samples were taken at this point. The samples were transported with the chain of custody to Cardinal Laboratories, for analysis of Total Chlorides (SM4500Cl-B), Total Petroleum Hydrocarbons (TPH, EPA Method 8015M) and Volatile Organics (BTEX, EPA Method 8021B).

On June 28, 2023, Talon personnel returned to location to remove an additional impacted soils located around C-1, SW-1, and SW-2. Composite samples were taken and were transported with the chain of custody to Cardinal Laboratories, for analysis of Total Chlorides (SM4500Cl-B), Total Petroleum Hydrocarbons (TPH, EPA Method 8015M) and Volatile Organics (BTEX, EPA Method 8021B).

On July 12, 2023, Talon personnel returned to location to remove an additional impacted soils located around SW-1 and returned also on the 28 to collect samples at C-2 and C-3. Composite samples were taken and were transported with the chain of custody to Cardinal Laboratories, for analysis of Total Chlorides (SM4500Cl-B), Total Petroleum Hydrocarbons (TPH, EPA Method 8015M) and Volatile Organics (BTEX, EPA Method 8021B).

Matador Resources  
 Cooper 3 #006  
 Eddy County, NM  
 Confirmation Map

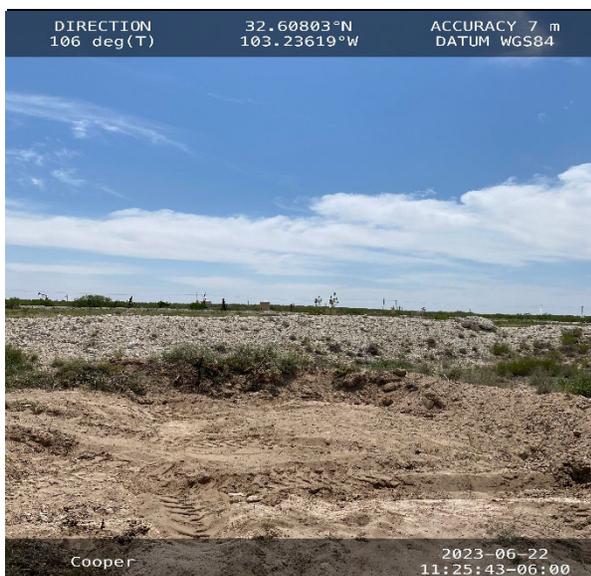
**Photograph No.1 Description:**

Remediation Activities

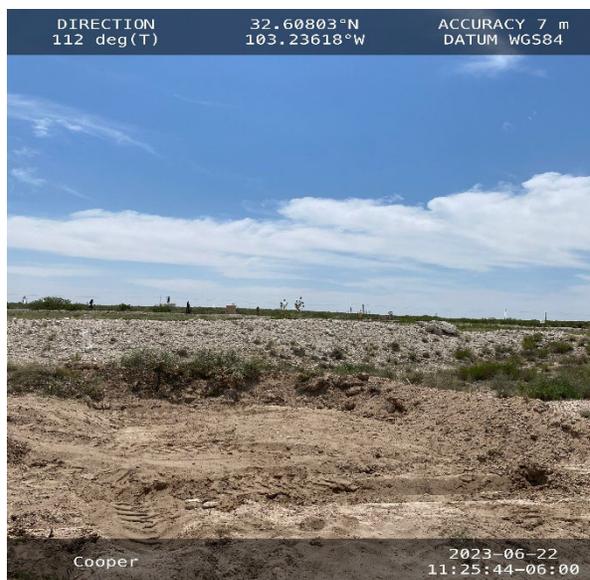
**Photograph No.2 Description:**

Remediation Activities

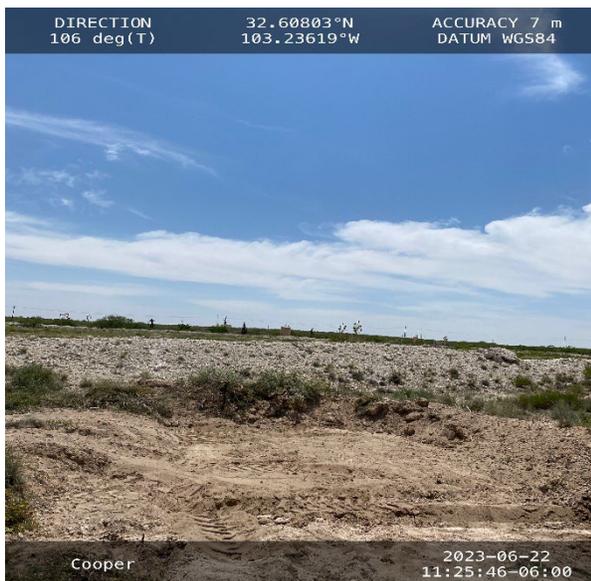
**Photograph No.3 Description:**

Remediation Activities

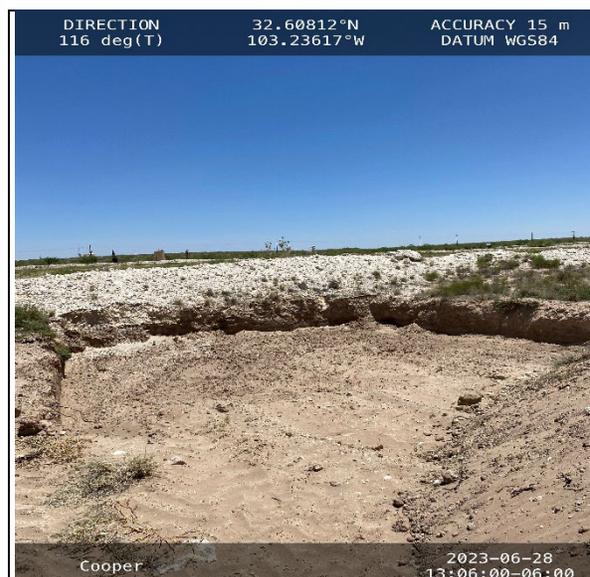
**Photograph No.4 Description:**

Remediation Activities
