Release Notification and Corrective Action

CLOSURE REQUEST ADDENDUM

Ross Draw Unit 12
Eddy County, New Mexico
Incident Number nAB1702749185

Prepared for:
WPX Energy Permian, LLC

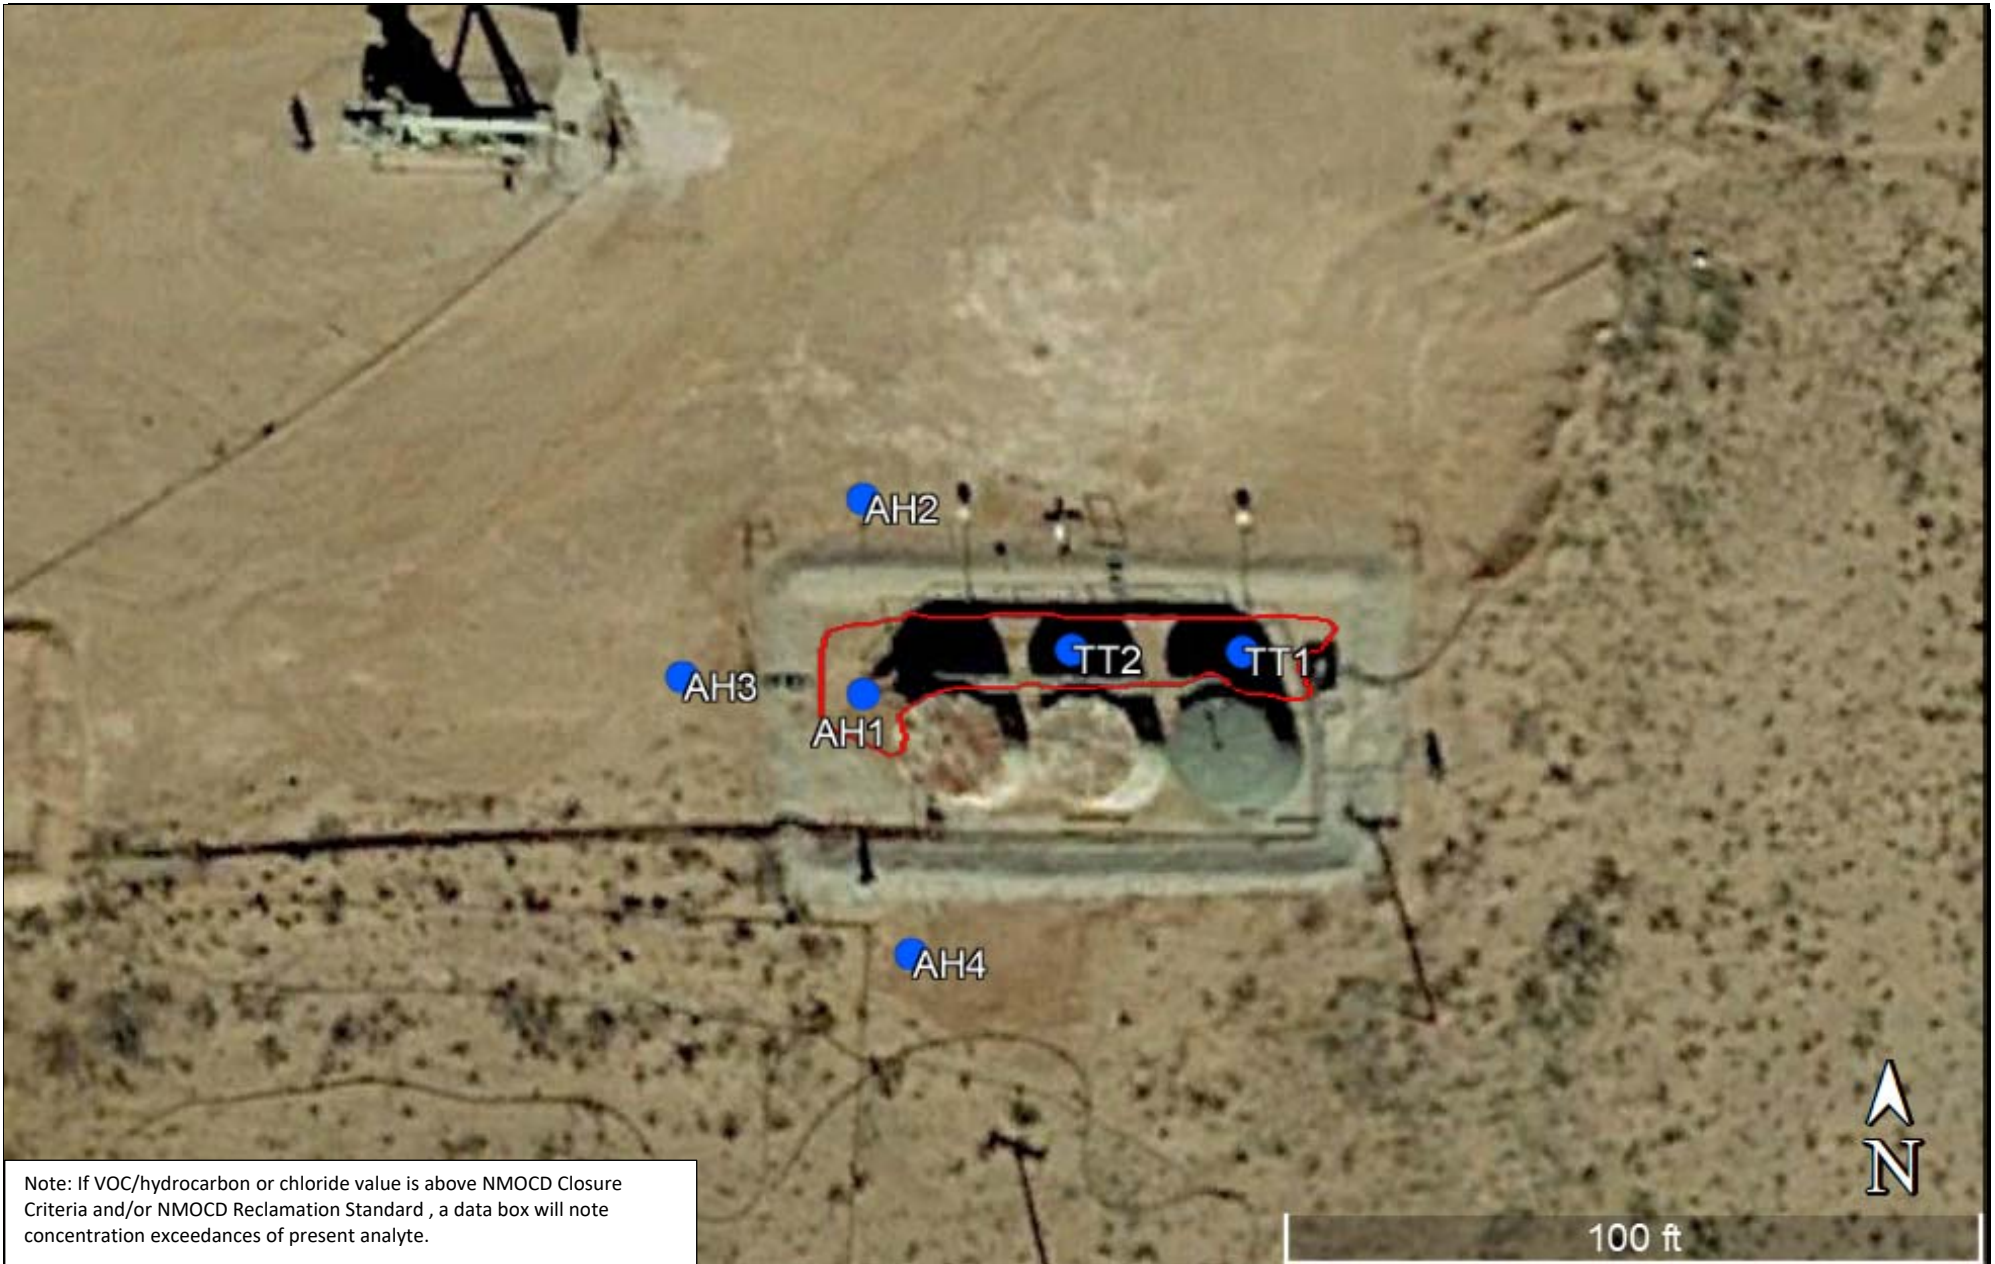
Figure 3

Site and Sample Location Map

Note: If VOC/hydrocarbon or chloride value is above NMOCD Closure Criteria and/or NMOCD Reclamation Standard , a data box will note concentration exceedances of present analyte.
