**Re: Closure Request
Vaca West Tank Battery-Manhole Gasket
Incident Number: nAPP2300347524
Lea County, New Mexico**

Ensolum, LLC (Ensolum), on behalf of BTA Oil Producers, LLC (BTA), has prepared this *Closure Request* to document assessment, excavation, and soil sampling activities performed at the Vaca West Tank Battery-Manhole Gasket (Site). The purpose of these remedial actions was to address impacts to soil resulting from a crude oil and produced water release at the Site. Based on excavation activities and laboratory analytical results from the soil sampling events, BTA is submitting this *Closure Request*, describing remediation that has occurred and requesting closure for Incident Number nAPP2300347524.

BTA Oil Producers
Closure Request
Vaca West Tank Battery-Manhole Gasket

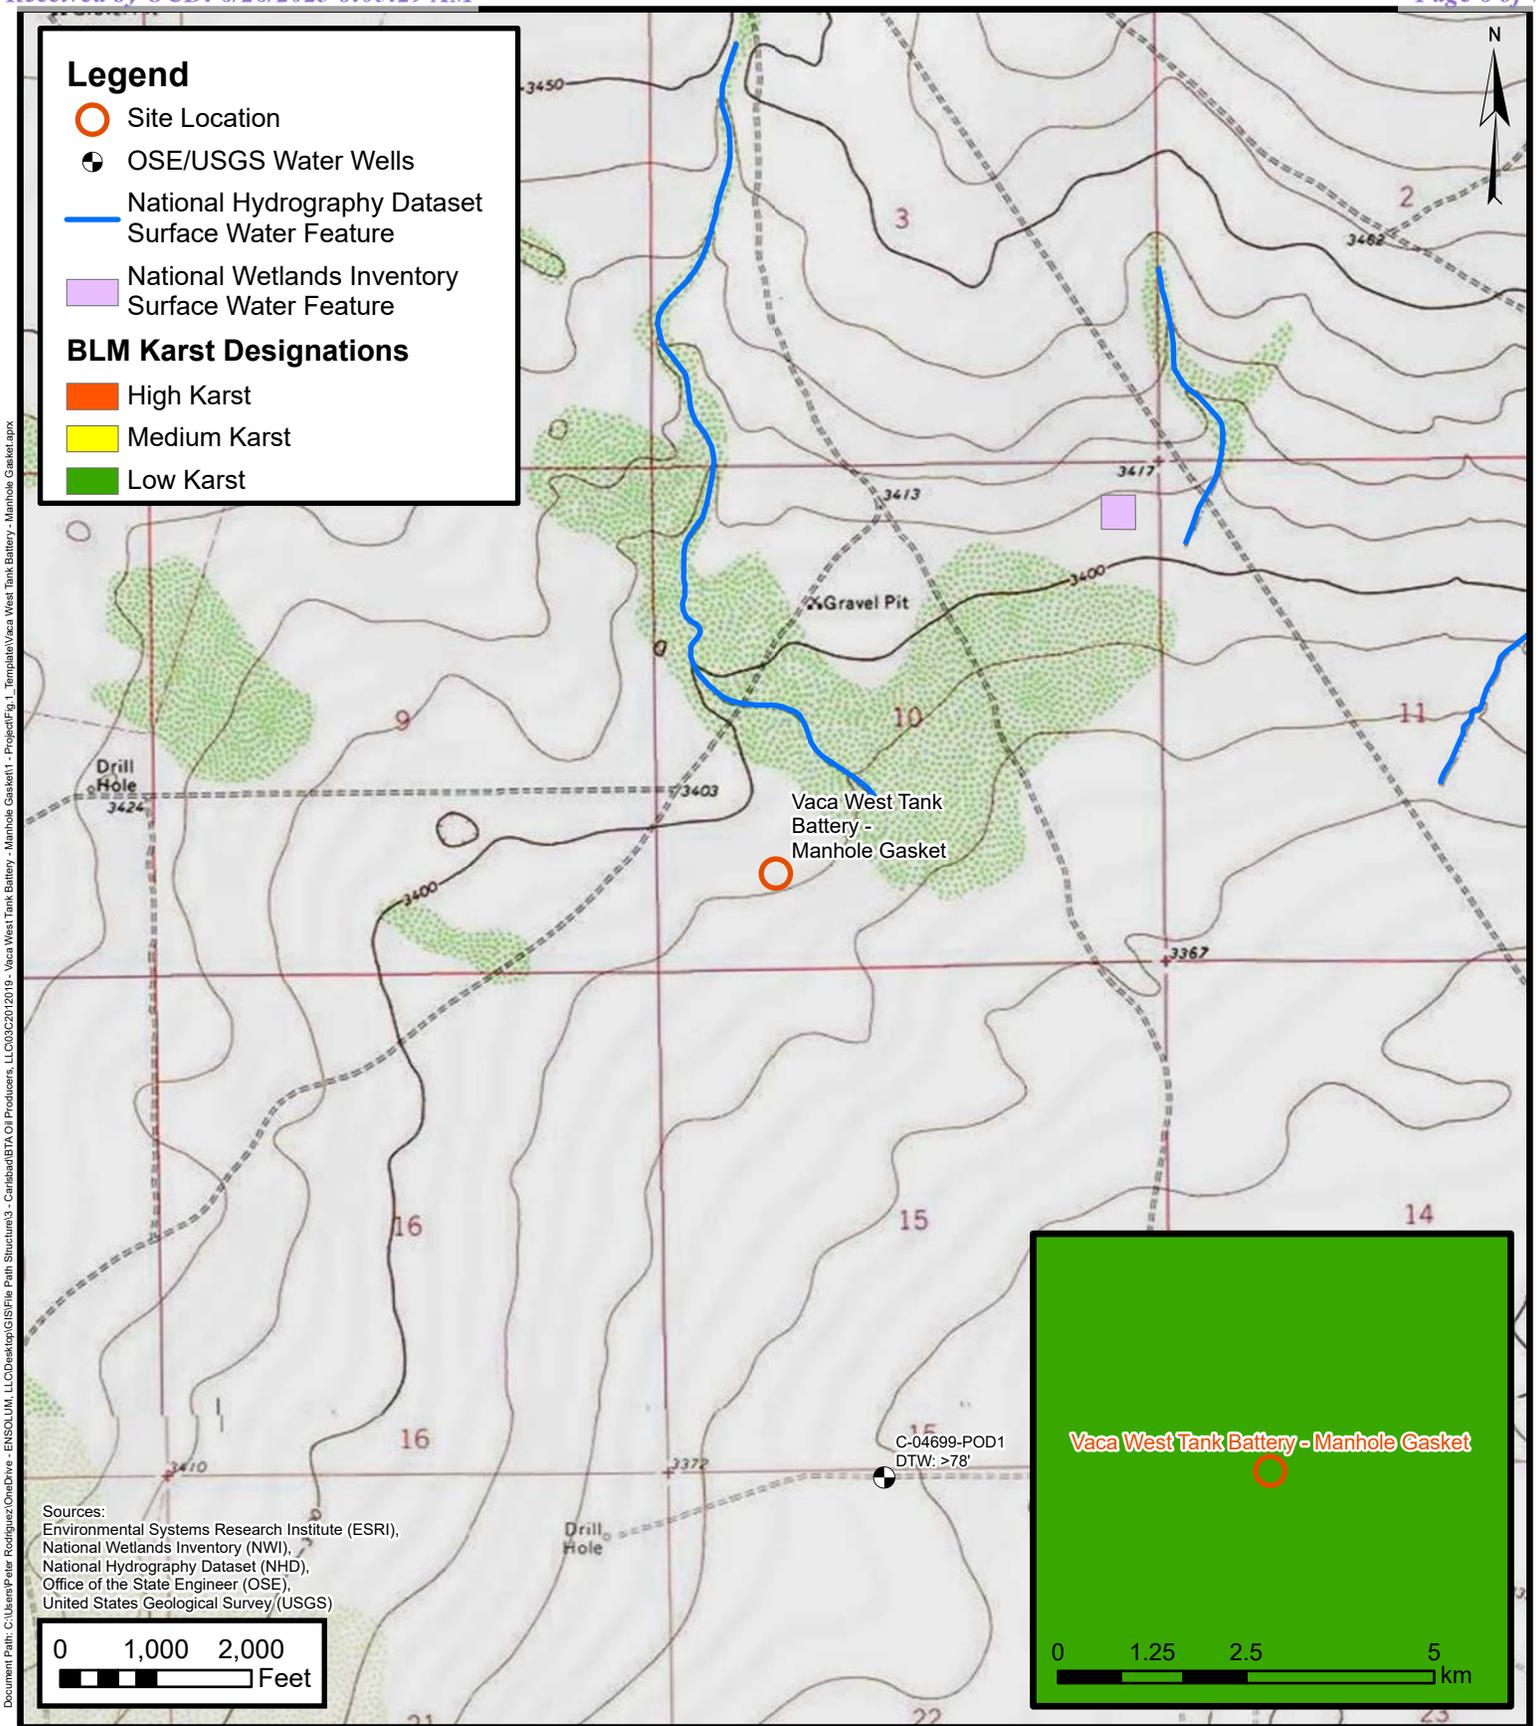
FIGURE
1

Site Receptor Map
 BTA Oil Producers, LLC
 Vaca West Tank Battery - Manhole Gasket
 Incident Number: NAPP2300347524
 Unit M, Sec 10, T25S, R33E
 Lea County, New Mexico

The Site was characterized to assess the applicability of Table I, Closure Criteria for Soils Impacted by a Release, of Title 19, Chapter 15, Part 29 (19.15.29) of the New Mexico Administrative Code (NMAC). Results from the characterization desktop review are presented on page 3 of the Form C-141, Site Assessment/Characterization. Potential Site receptors are identified on Figure 1.

miles south of the Site. The soil boring was drilled to a total depth of 78 feet bgs. No groundwater was encountered during drilling activities. The soil boring was subsequently plugged following approved NMOSE procedures. All wells used for depth to water determination are depicted on Figure 1 and the referenced well records are included in Appendix A.
