Remediation Summary and Closure Request

Frontier Field Services, LLC

8" Caviness to Bulldog

NMOCD Incident # nAPP2306545596

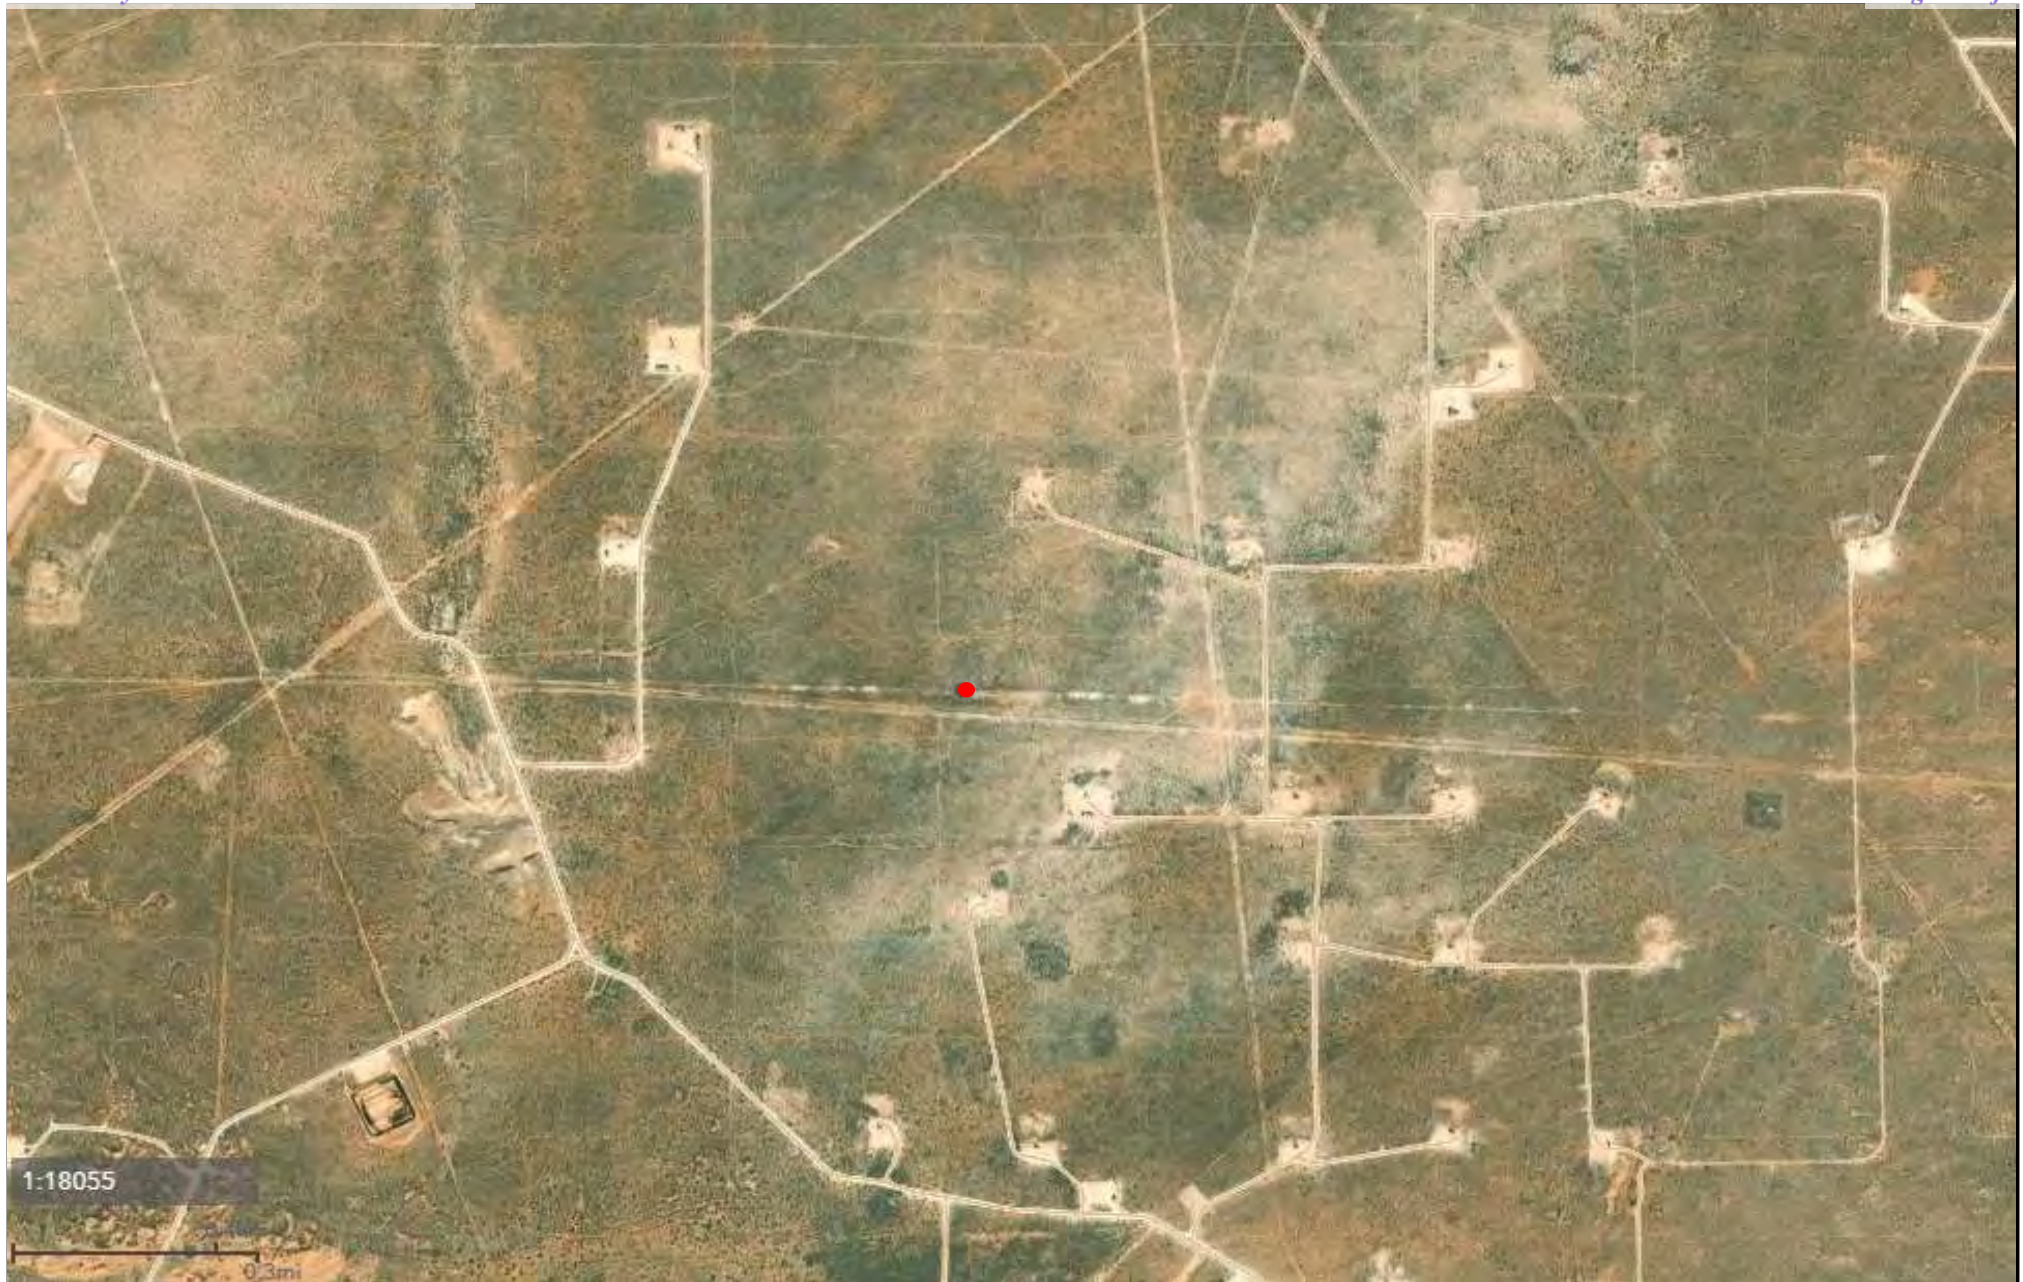
**Figure 2**

OSE POD Locations Map
Frontier Field Services, LLC
8" Caviness to Bulldog
GPS: 32.743027, -103.740731
Eddy County

A search of the New Mexico Office of the State Engineer (NMOSE) and United States Geological Survey (USGS) groundwater databases was completed in an effort to determine the horizontal distance to known water sources within a half mile radius of the Release Site. Approximate depth to groundwater was determined using maintained and published water well data. Karst mapping indicates the site is not located in a Karst designated area. Karst and Wetland Maps are provided as Attachment I. Depth to groundwater information is provided as Attachment IV and the results are depicted on Figures 2 & 3.

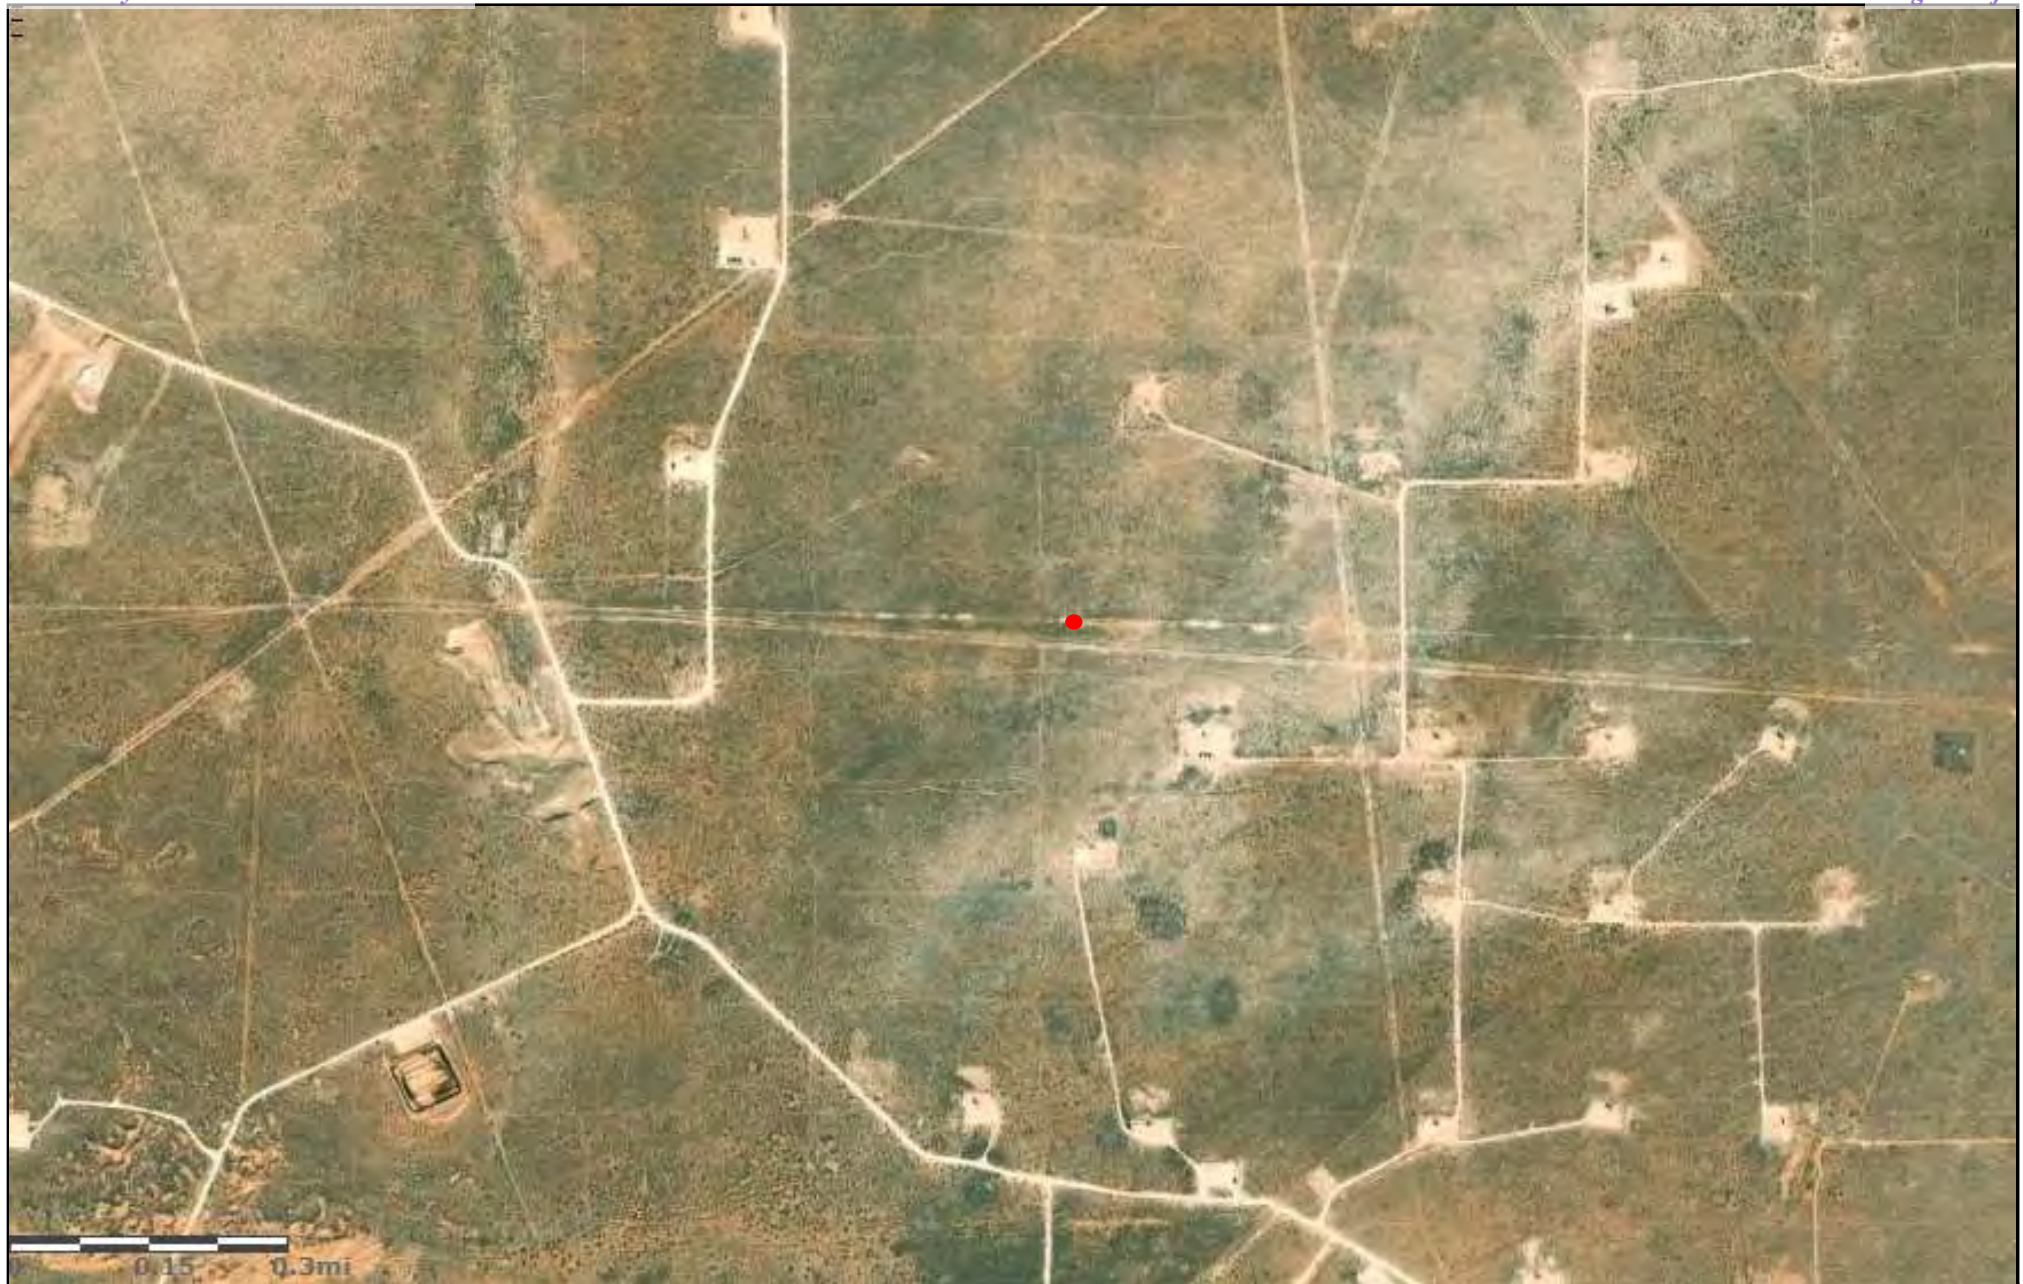
**Figure 3**

USGS Well Locations Map
Frontier Field Services, LLC
8" Caviness to Bulldog
GPS: 32.743027, -103.740731
Eddy County

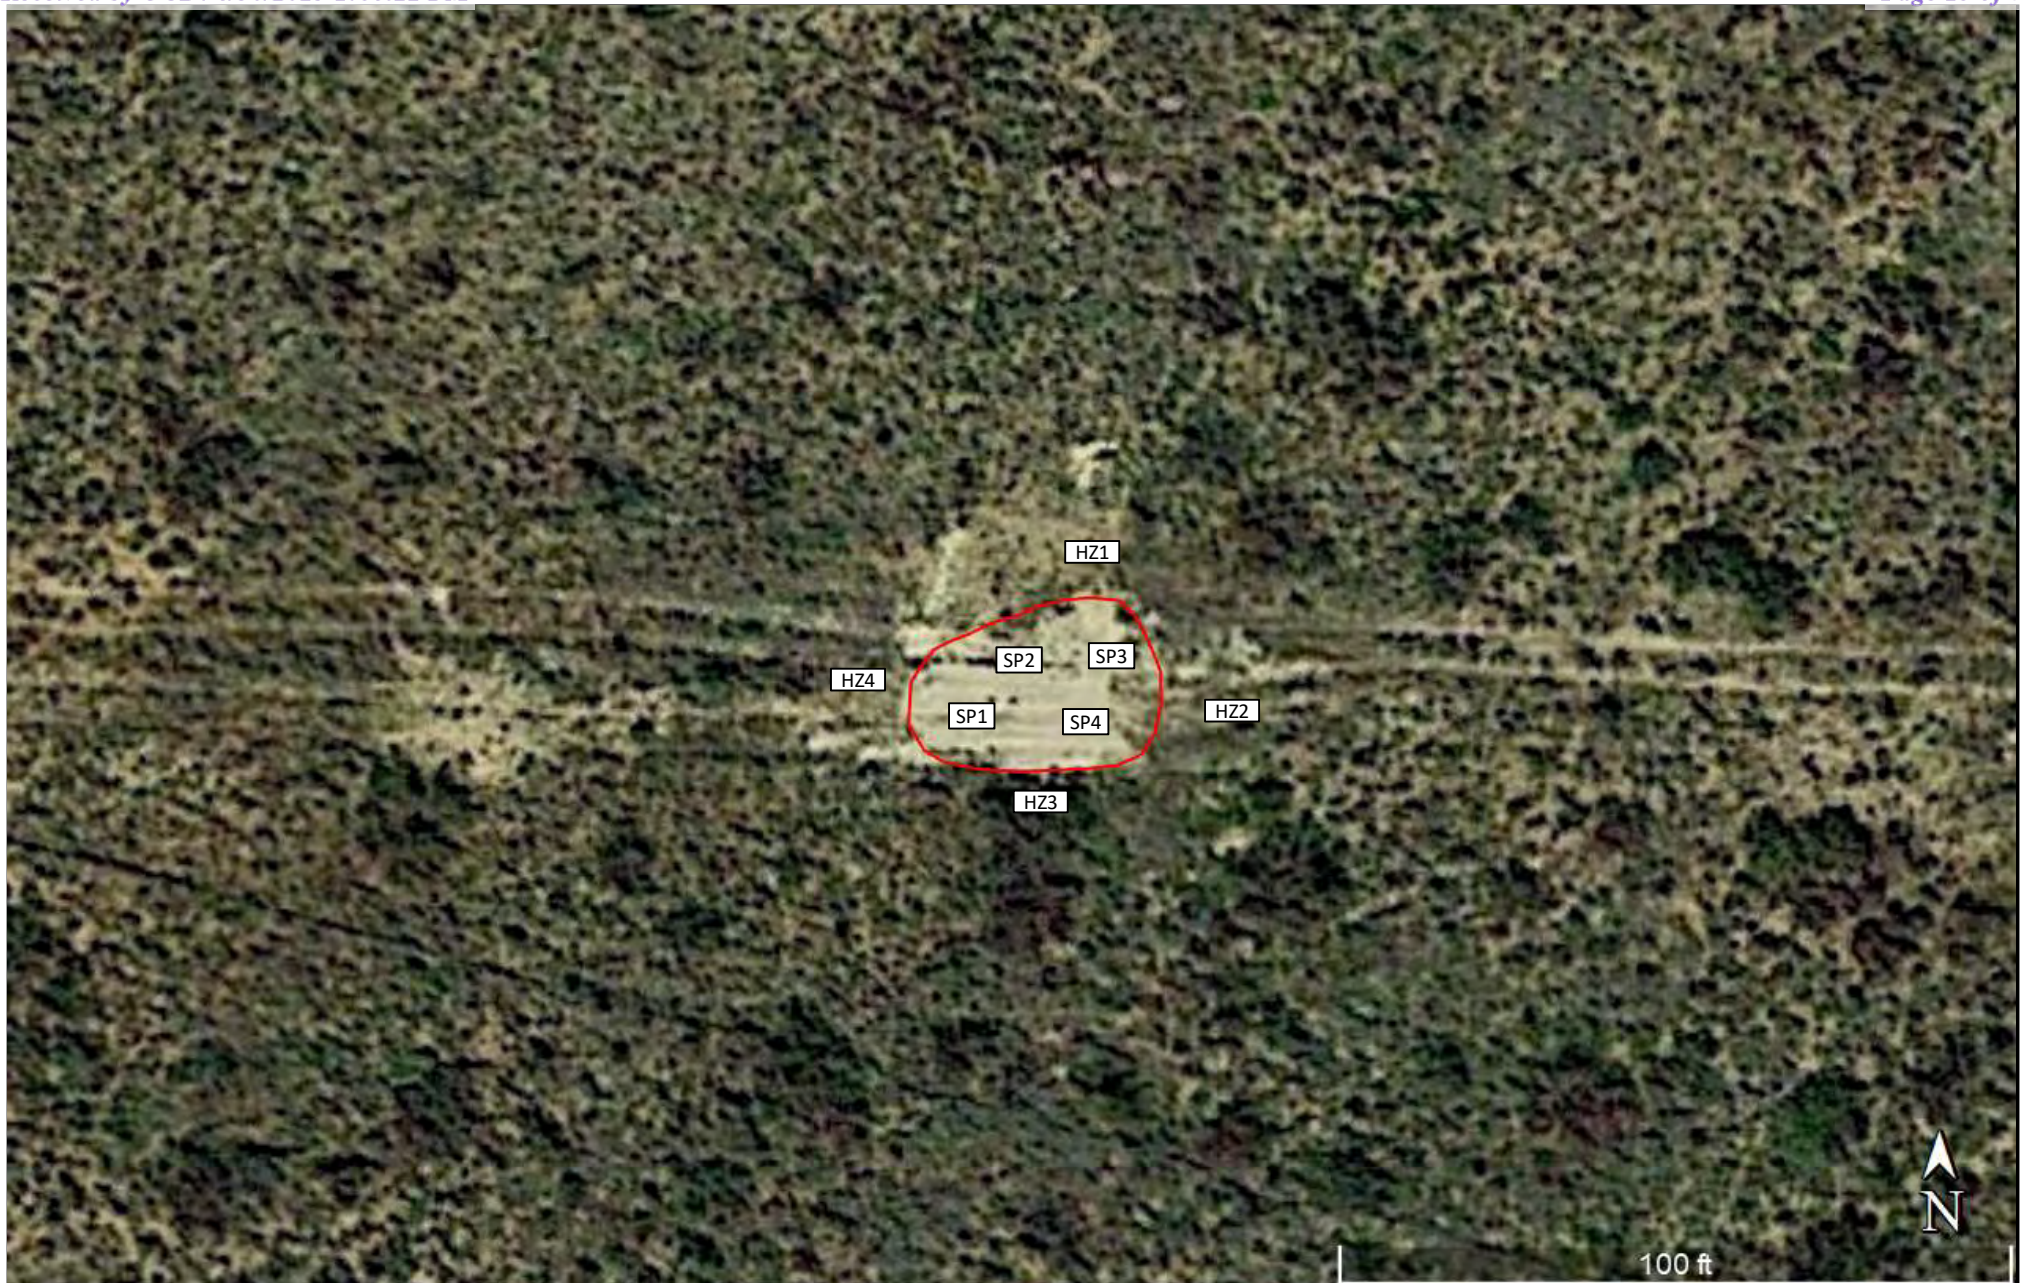
**Figure 4**

Delineation Sample Map
Frontier Field Services, LLC
8" Caviness to Bulldog
GPS: 32.743027, -103.740731
Eddy County

Based on field observations and field test data noted above and provided in Attachment V, sixteen representative soil samples were selected for laboratory analysis. Delineation soil samples SP1 through SP4, HZ1 through HZ4, were submitted to the laboratory for analysis of BTEX, TPH, and chloride. Laboratory analytical results indicated contaminant concentrations were below the NMOCD Closure Criteria in each of the submitted samples, with the exception of SP3 at Surface, which exhibited chloride concentrations in excess of the NMOCD Closure Criteria.

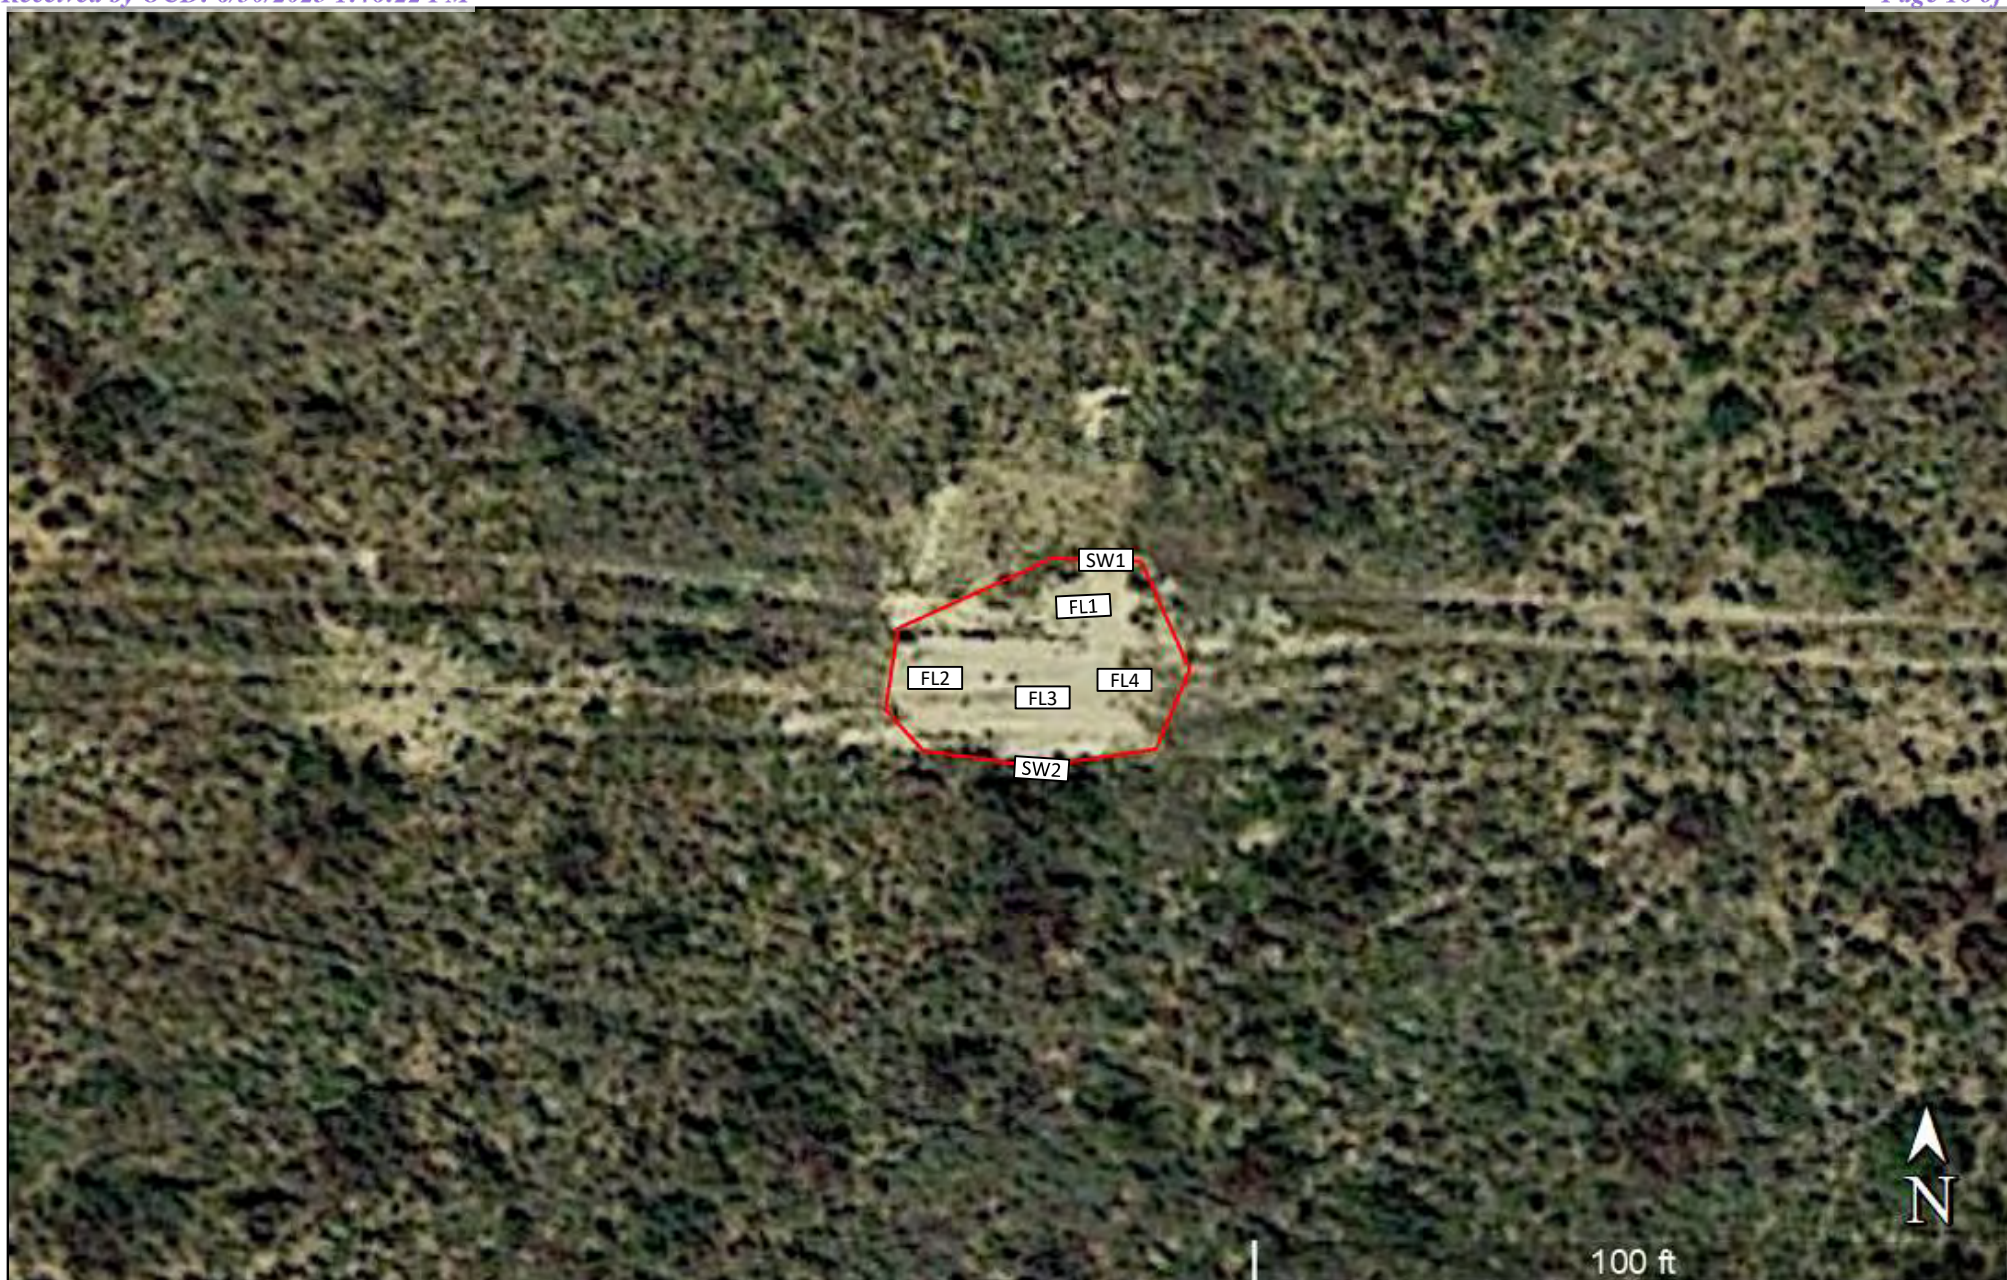
**Figure 5**

Excavation Sample Map
Frontier Field Services, LLC
8" Caviness to Bulldog
GPS: 32.743027, -103.740731
Eddy County
