SITE CHARACTERIZATION, ASSESSMENT, REMEDIATION AND CLOSURE REPORT

**SHUDDE 27 CTB – FRAC TANK AREA
32.722865, -104.360139
UNIT D, SECTION 26 T18S-R26E
EDDY COUNTY, NEW MEXICO
NMOCD INCIDENT ID # nAPP2302957665**

**SILVERBACK OPERATING
108 S 4TH STREET
ARTESIA, NEW MEXICO 88210**

**RANGER ENVIRONMENTAL SERVICES, LLC.
P.O. BOX 201179
AUSTIN, TEXAS 78720**

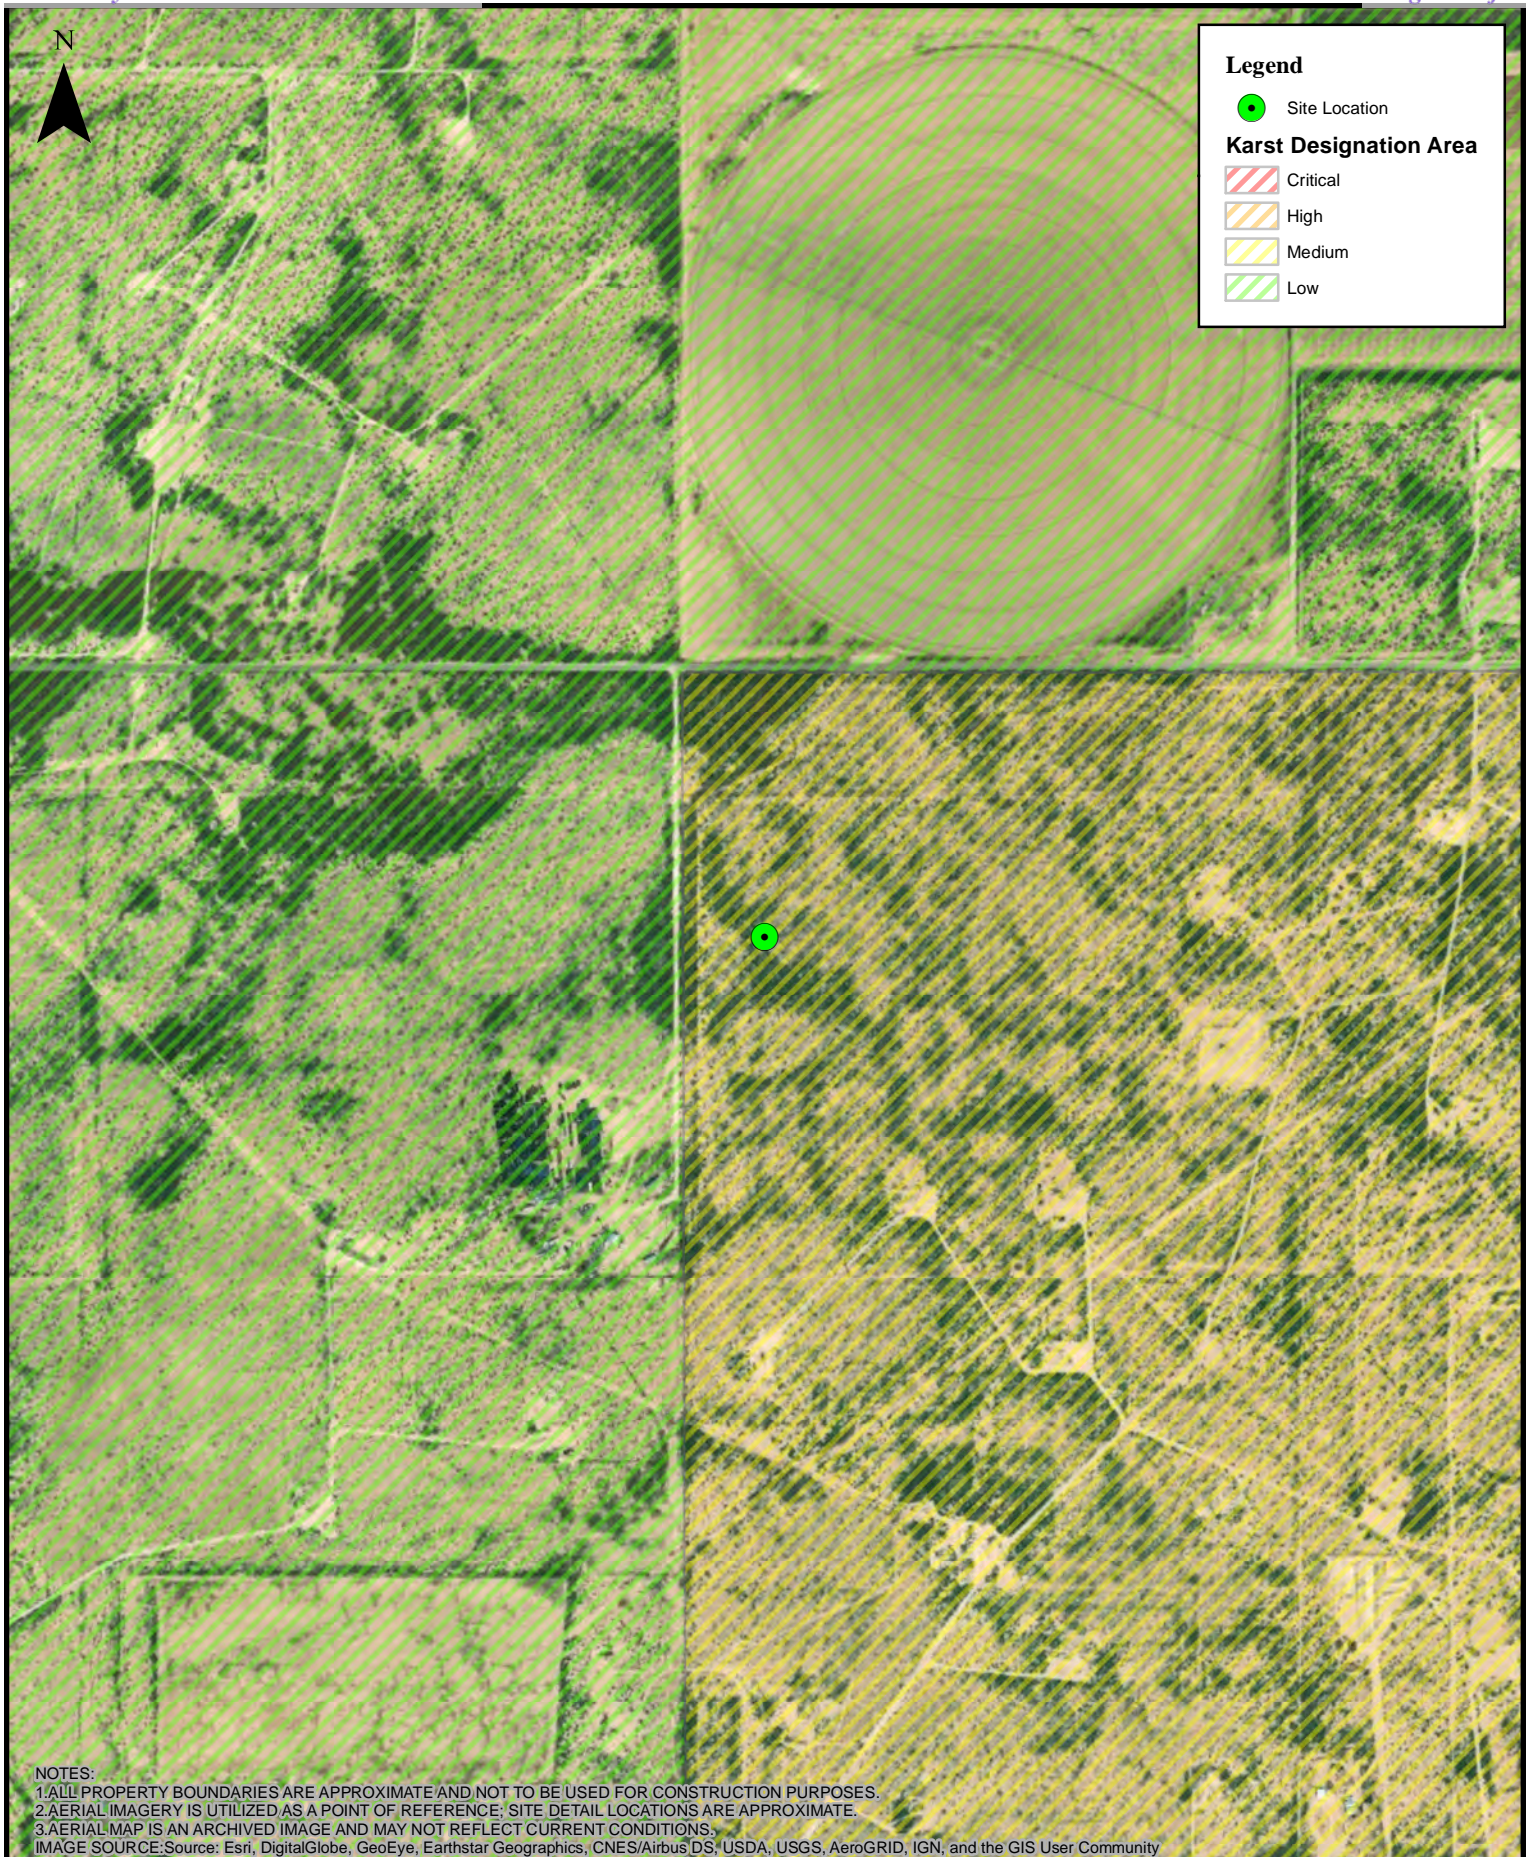
Karst Topography Map

The Site area is within an area of "Medium Karst" probability and is noted to be immediately adjacent to an area of "Low Karst" probability.

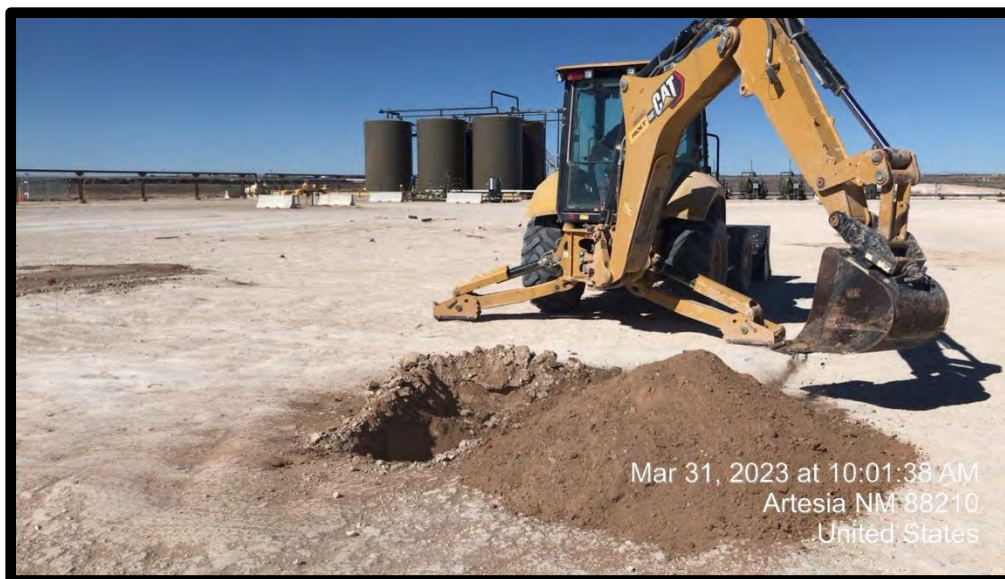
PHOTOGRAPH NO. 1 – A view collected at the Site during the assessment process on March 31, 2023. The view is towards the southwest.

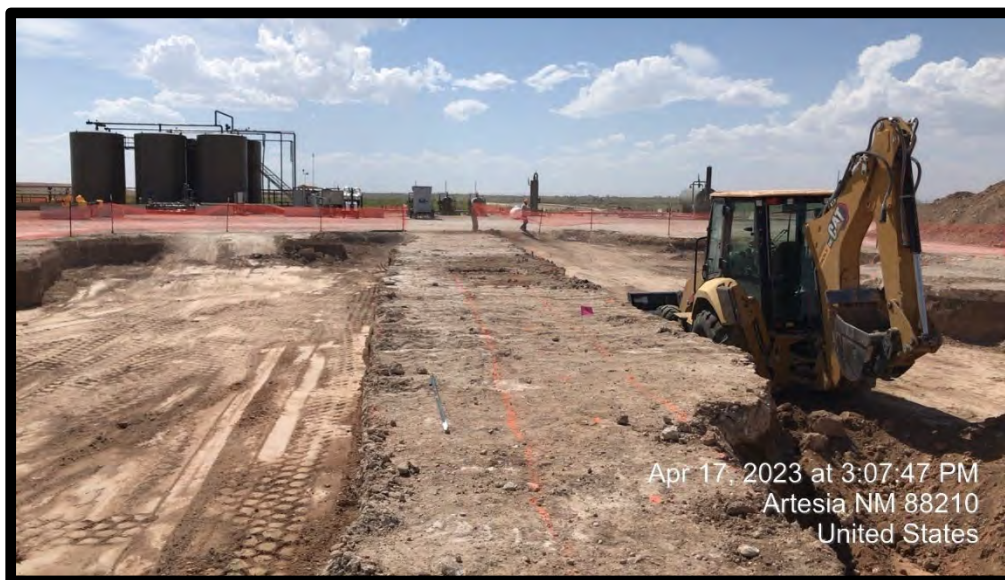
PHOTOGRAPH NO. 2 – A view Site during the remedial excavation activities on April 17, 2023. The view is towards the west.

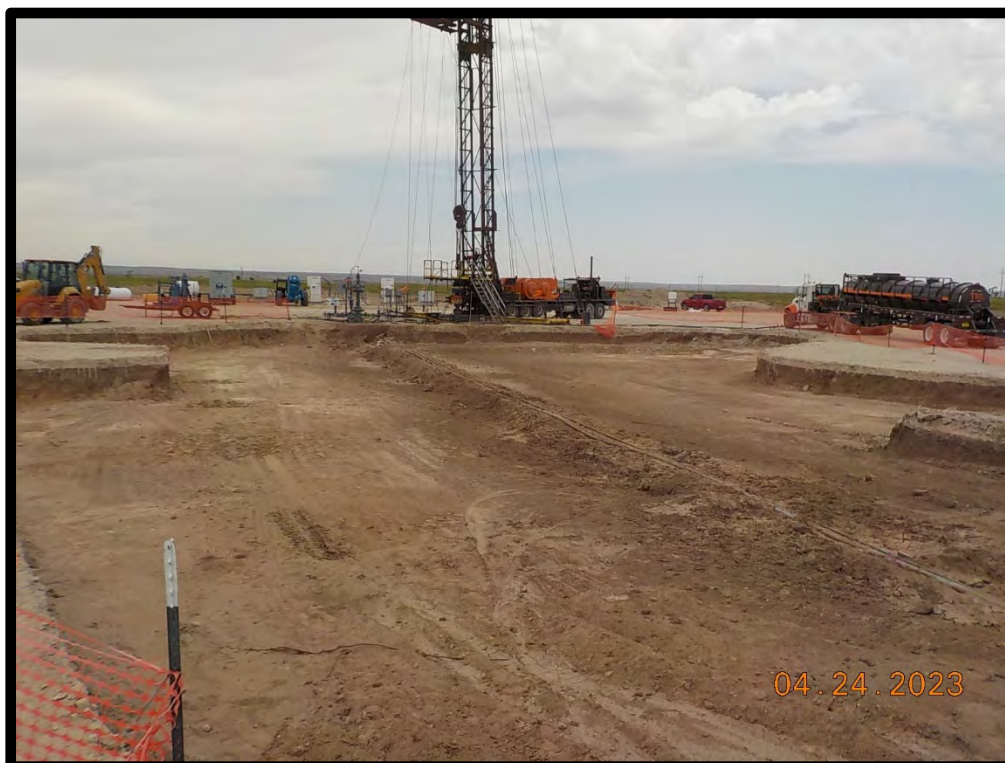
PHOTOGRAPH NO. 3 – A view of the excavation/remediation area upon completion of the remedial process. The view is towards the east.

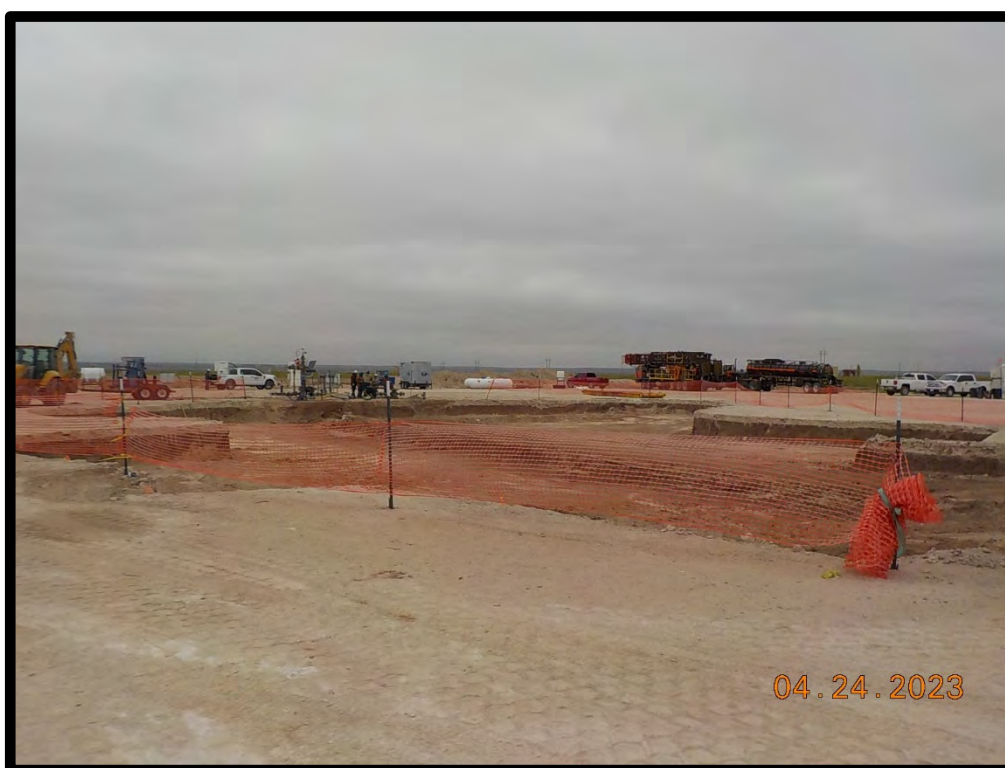
PHOTOGRAPH NO. 4 – An additional view of the excavation/remediation area upon completion of the remedial process. The view is towards the southeast.
