Incident ID	NGRL1031436824
District RP	
Facility ID	
Application ID

Based on the Release Notification C-141 Form, the release occurred on July 4<sup>th</sup>, 2010, due to internal corrosion which caused a hole to develop in the man way plate resulting in this spill. Approximately 80 barrels (bbls) of crude oil were released of which 77 bbls were recovered for an approximate net loss of 3 bbls of crude oil. Upon discovery, oil was contained in the berm but overflowed in an area approximately 15 feet (ft) x 40 ft area onto the adjacent pad. The release area is shown in Figure 3. The Release Notification, Site Assessment/Characterization, and Closure portions of Form C-141 for incident number NGRL1031436824 are attached to this report.

**SITE LOCATION MAP**  
**CLOSURE REPORT**  
**DEVON ENERGY PRODUCTION COMPANY**  
**RIO BLANCO 33 FEDERAL #001**  
**LEA COUNTY, NEW MEXICO**  
**32.3436928° -103.4783325°**

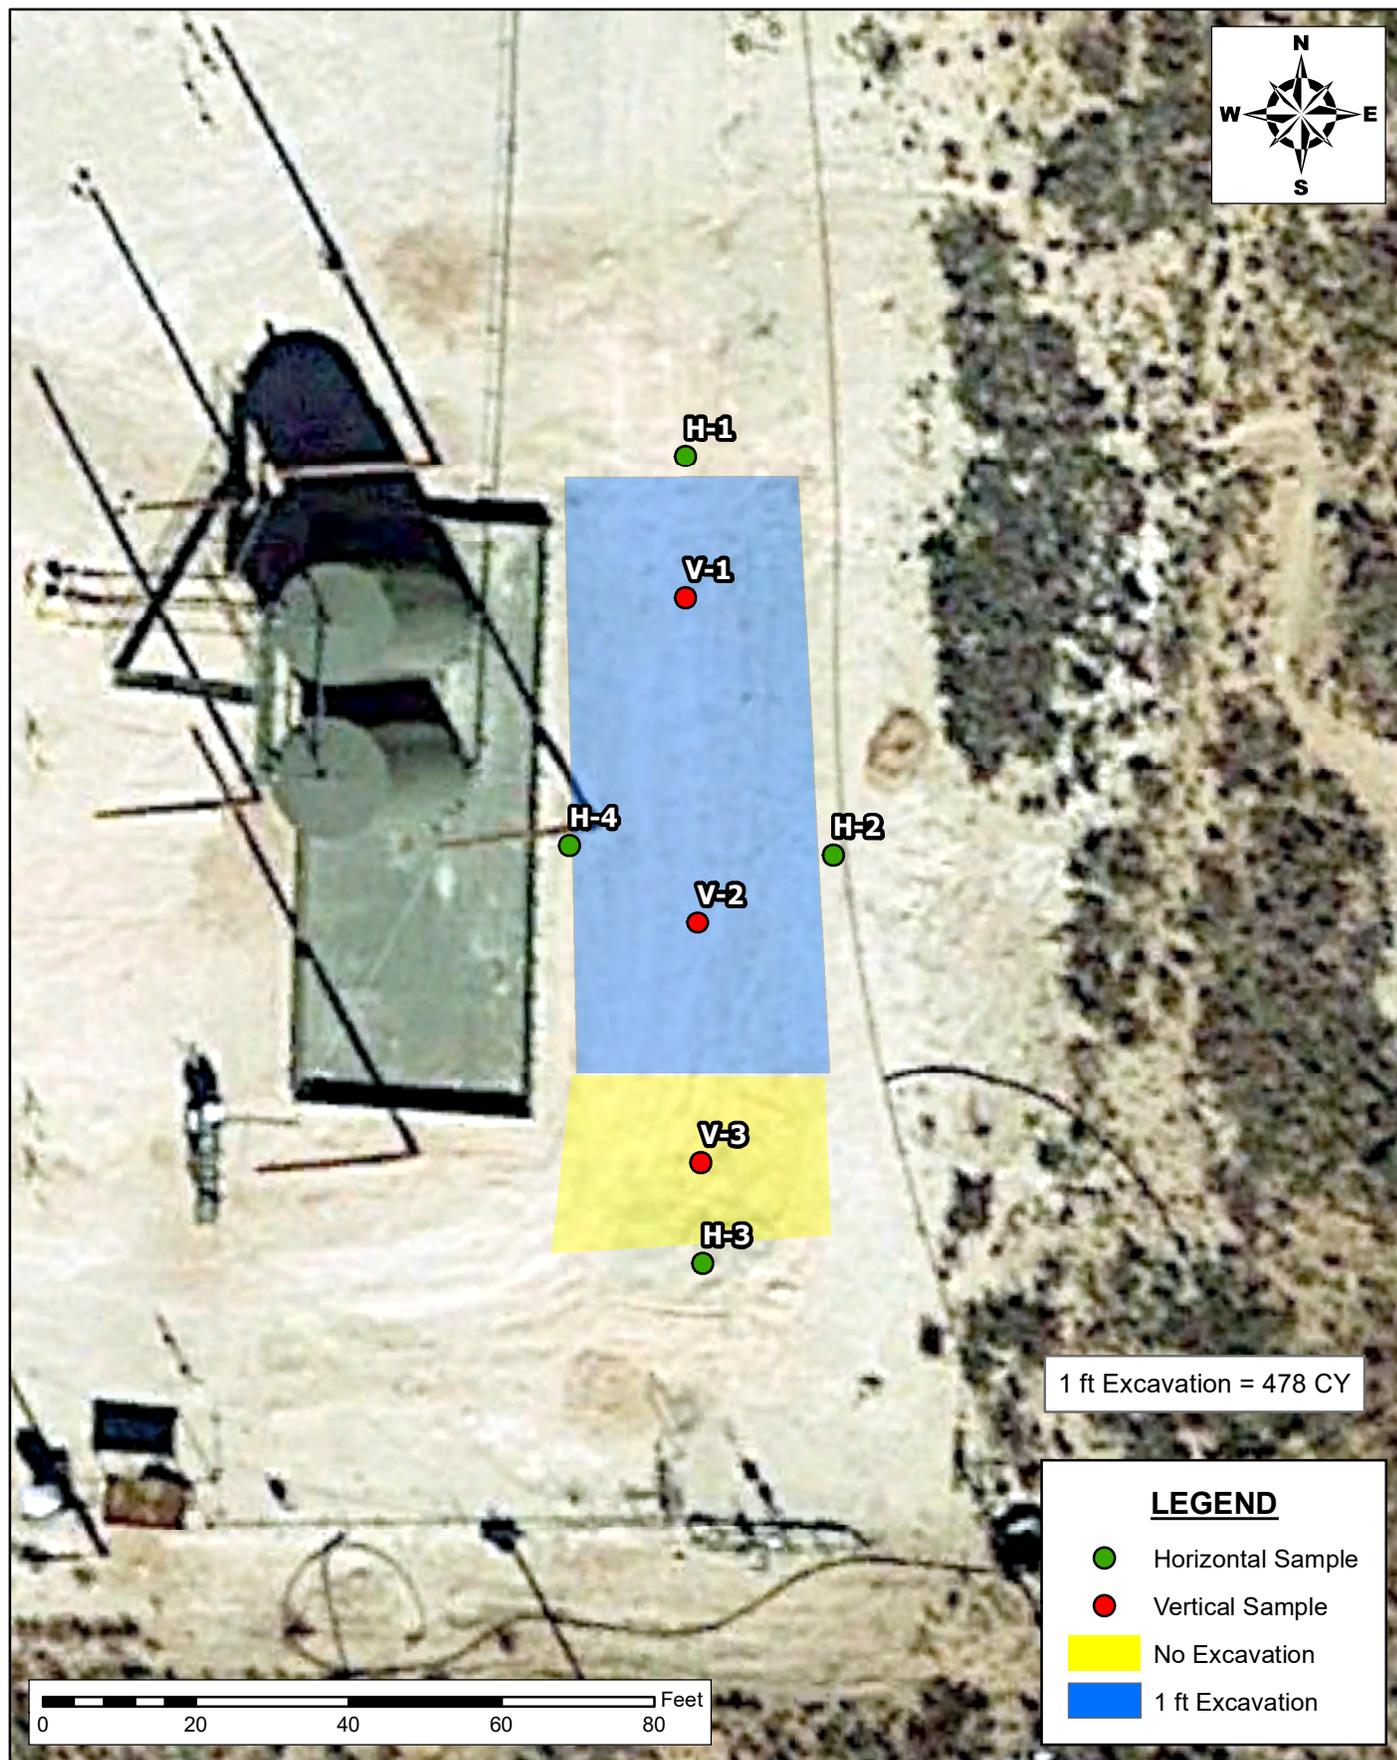
1 ft Excavation = 478 CY

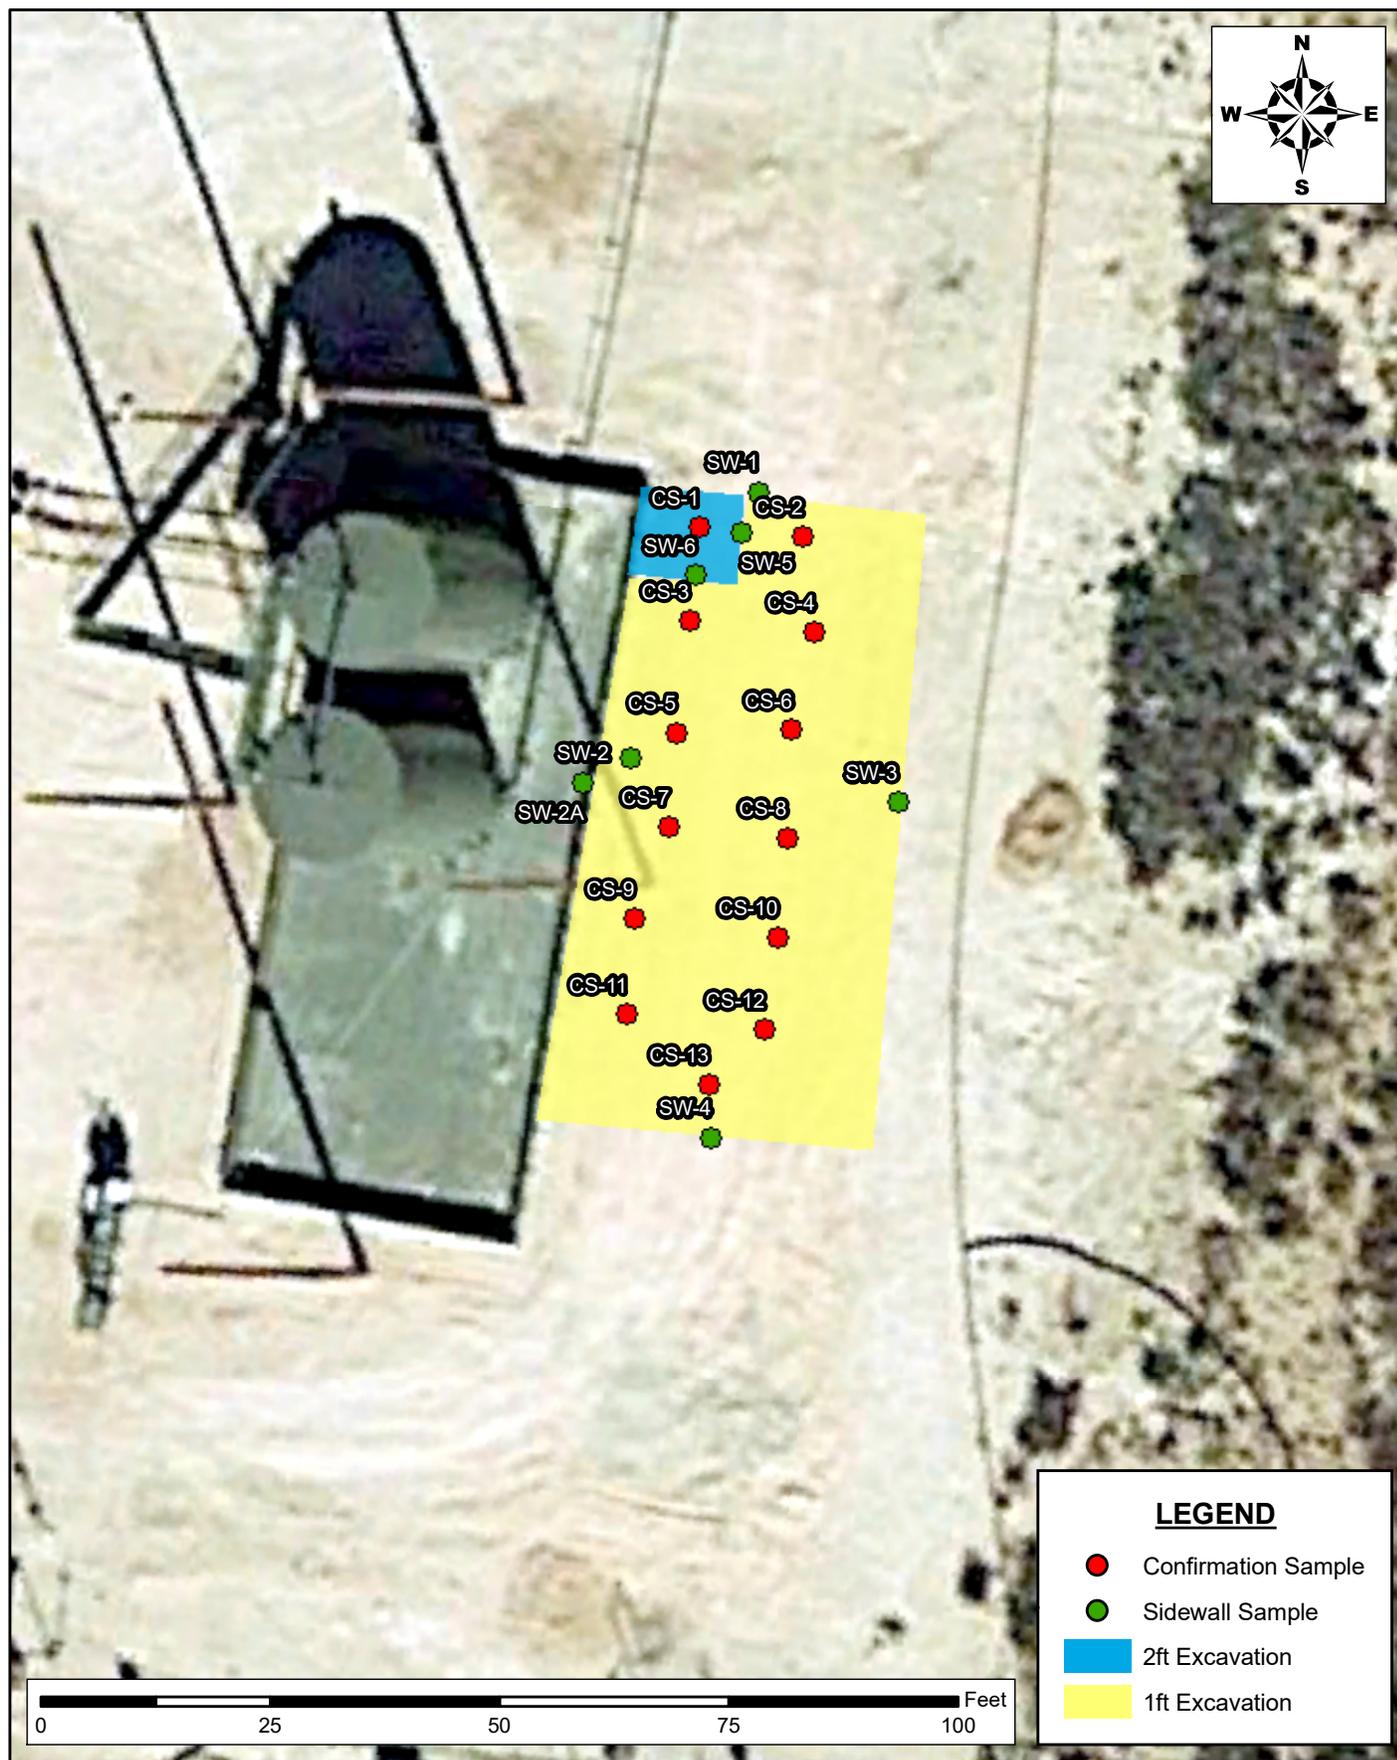
- Confirmation Sample
- Sidewall Sample
- 2ft Excavation
- 1ft Excavation

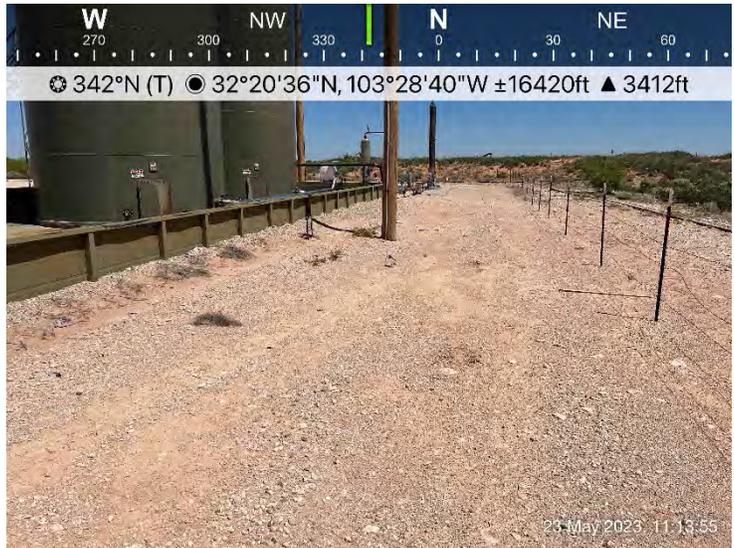
**Description:**  
View of Impacted area.

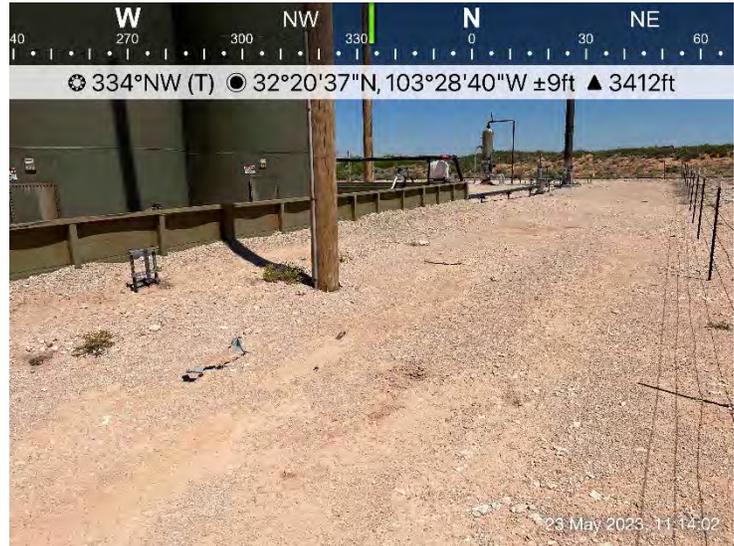
### Photograph No. 2

**Description:**  
View of Impacted area

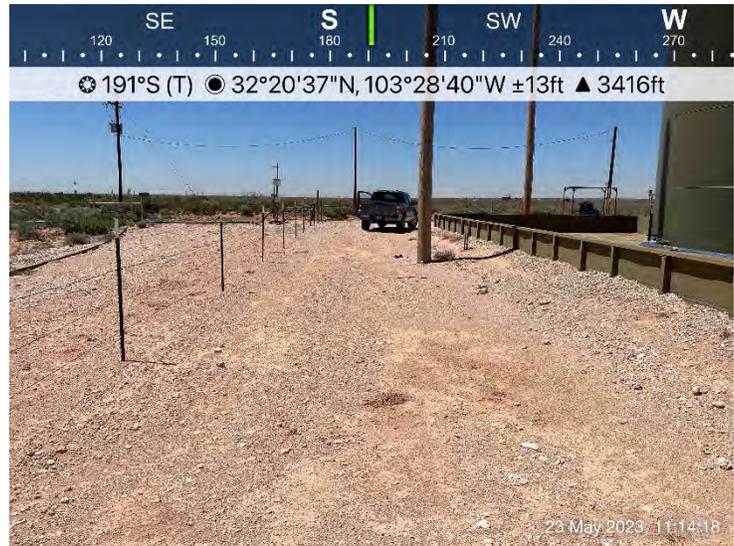
### Photograph No. 3

**Description:**  
View of impacted area.

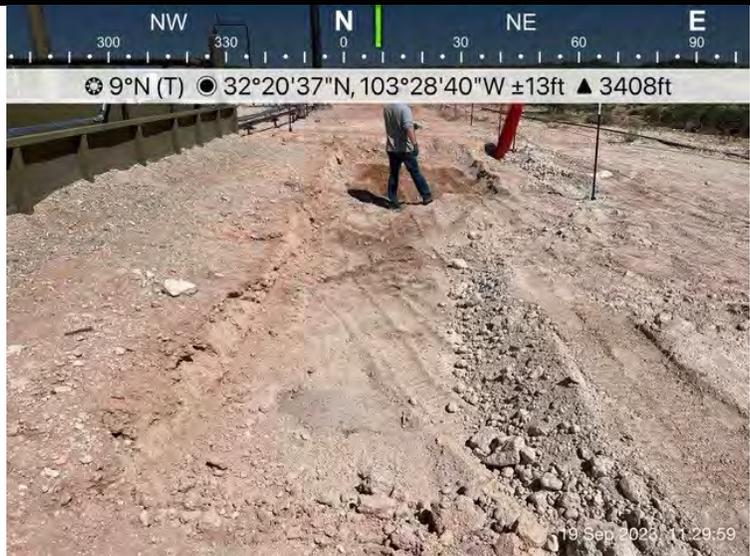
**Description:**  
View of excavation.

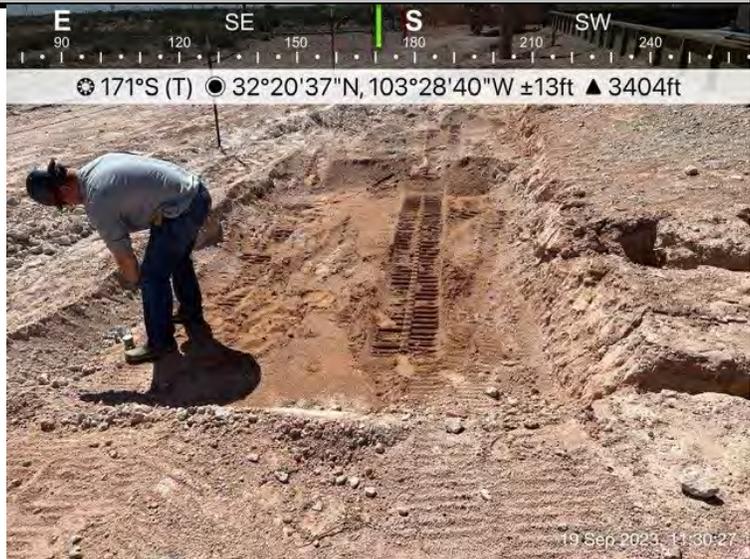
### Photograph No. 5

**Description:**  
View of excavation.

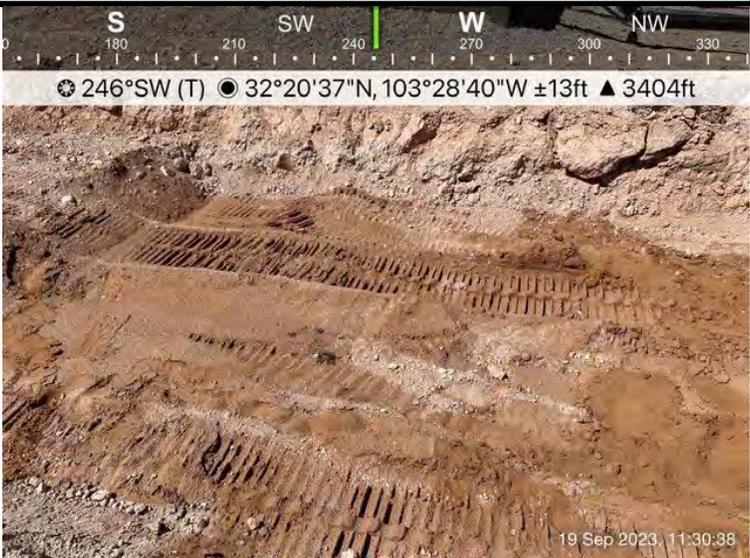
### Photograph No. 6

**Description:**  
View of excavation.
