# G-28-27-1-3 LINE LEAK

## Remediation Summary & Closure Report

**NMOCD Incident No. nAPP2218145440**  
**UL "M", Sec. 25, T23S, R36E**  
**32.271117°, -103.223455°**  
**Lea County, New Mexico**

November 3, 2023

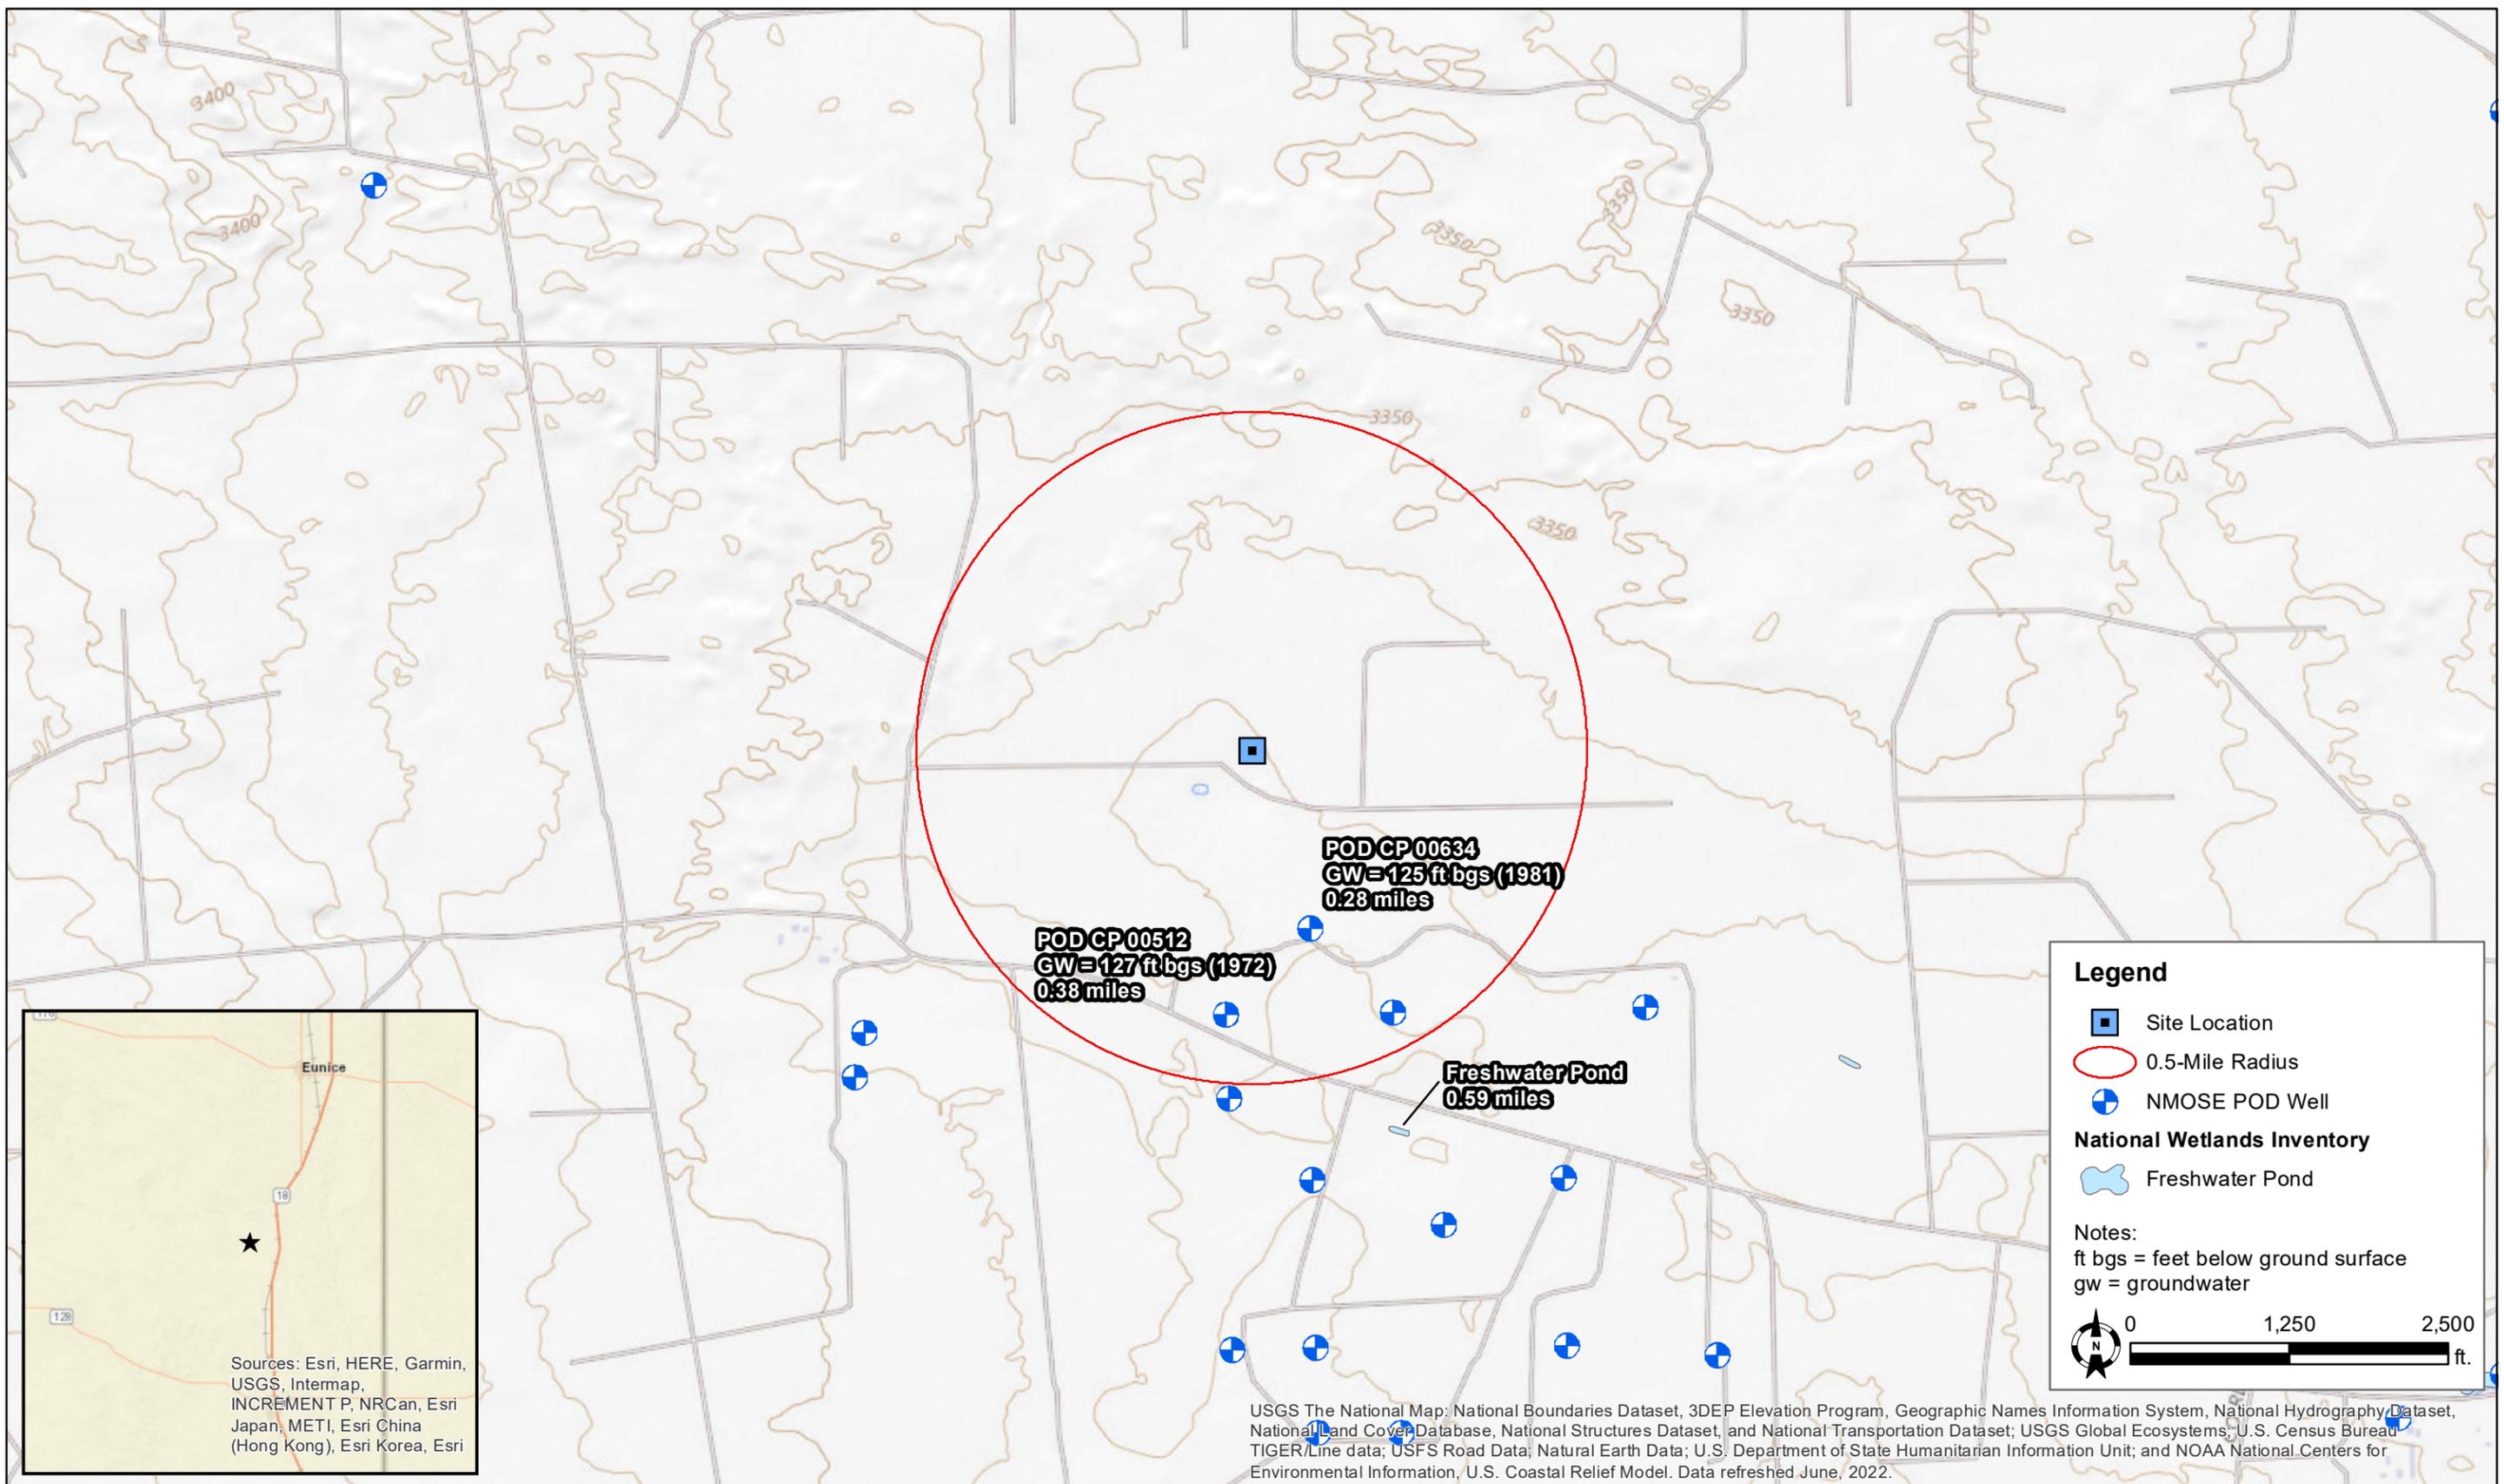
Figure  
 1

Site Location & Characteristics  
 Map

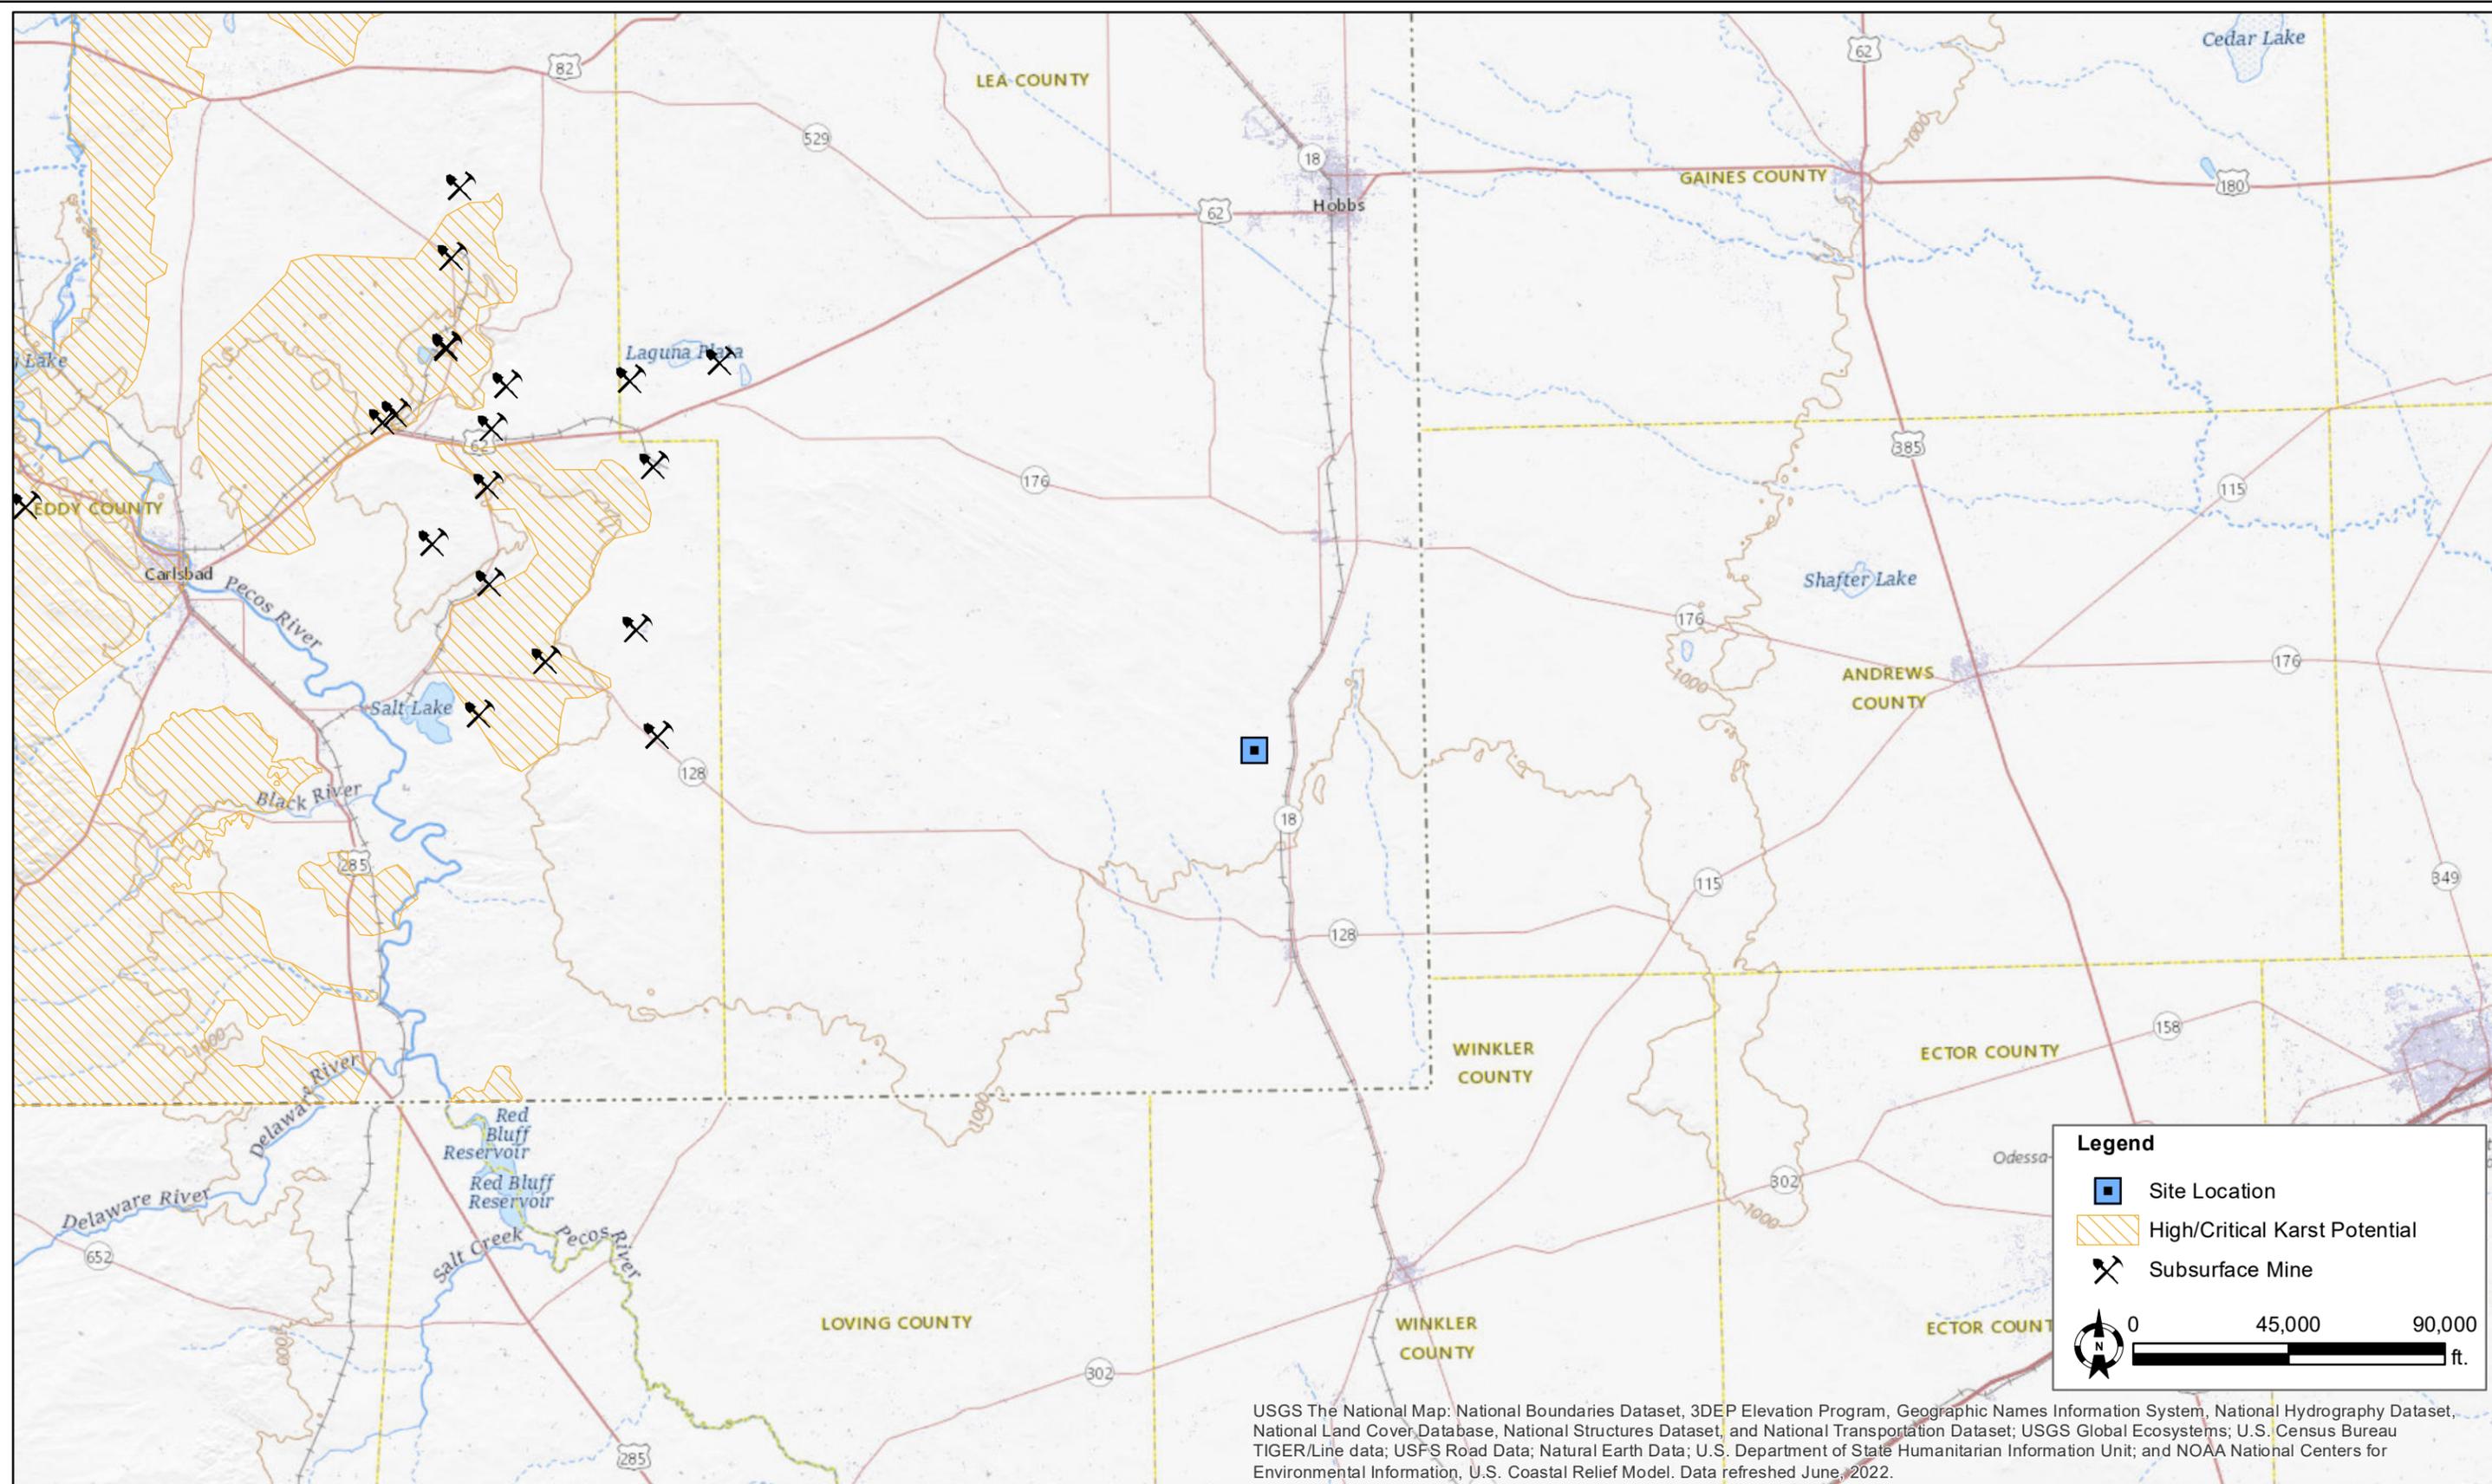
**Figure**  
**2**

Karst Potential & Subsurface  
 Mine Map

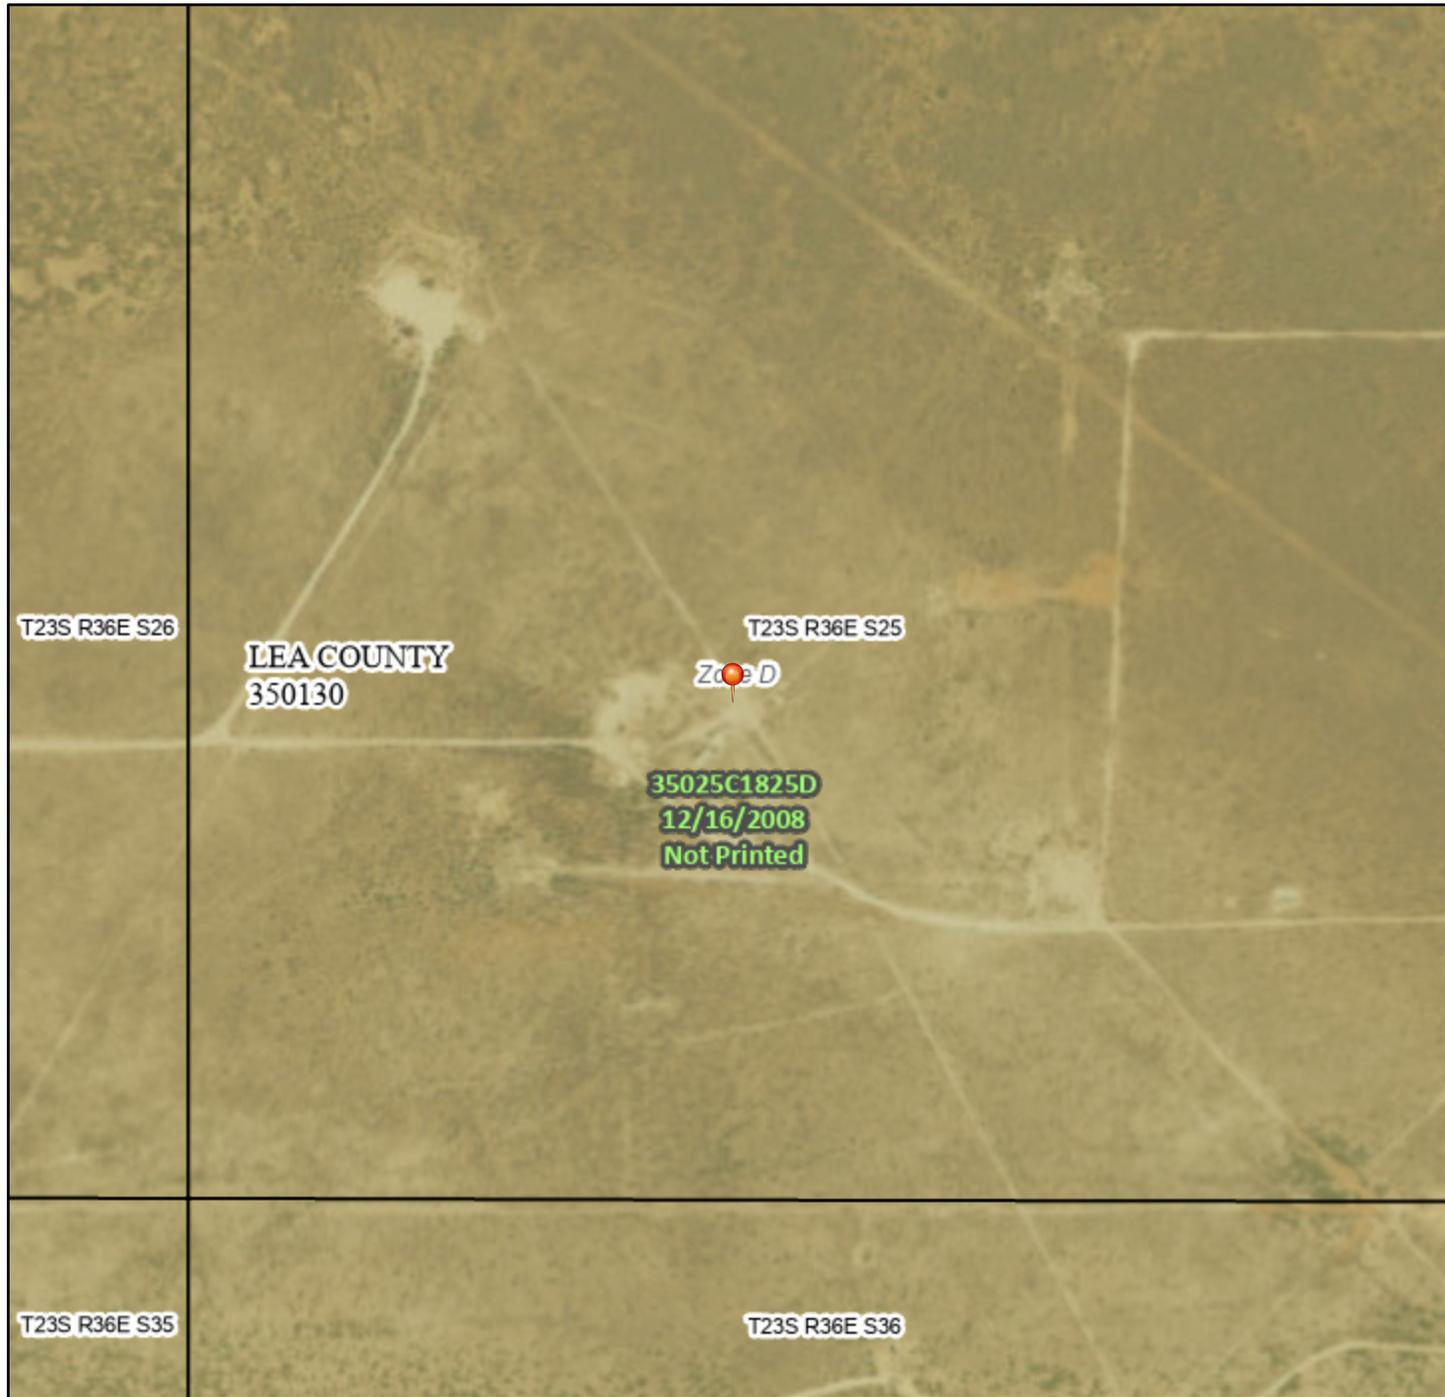
## Figure 4

# National Flood Hazard Layer FIRMette

Review of flood map data published by the Federal Emergency Management Agency (FEMA) indicates the site is not located within a 100-year floodplain. A copy of the FEMA FIRMet Map can be found attached as Figure 4.

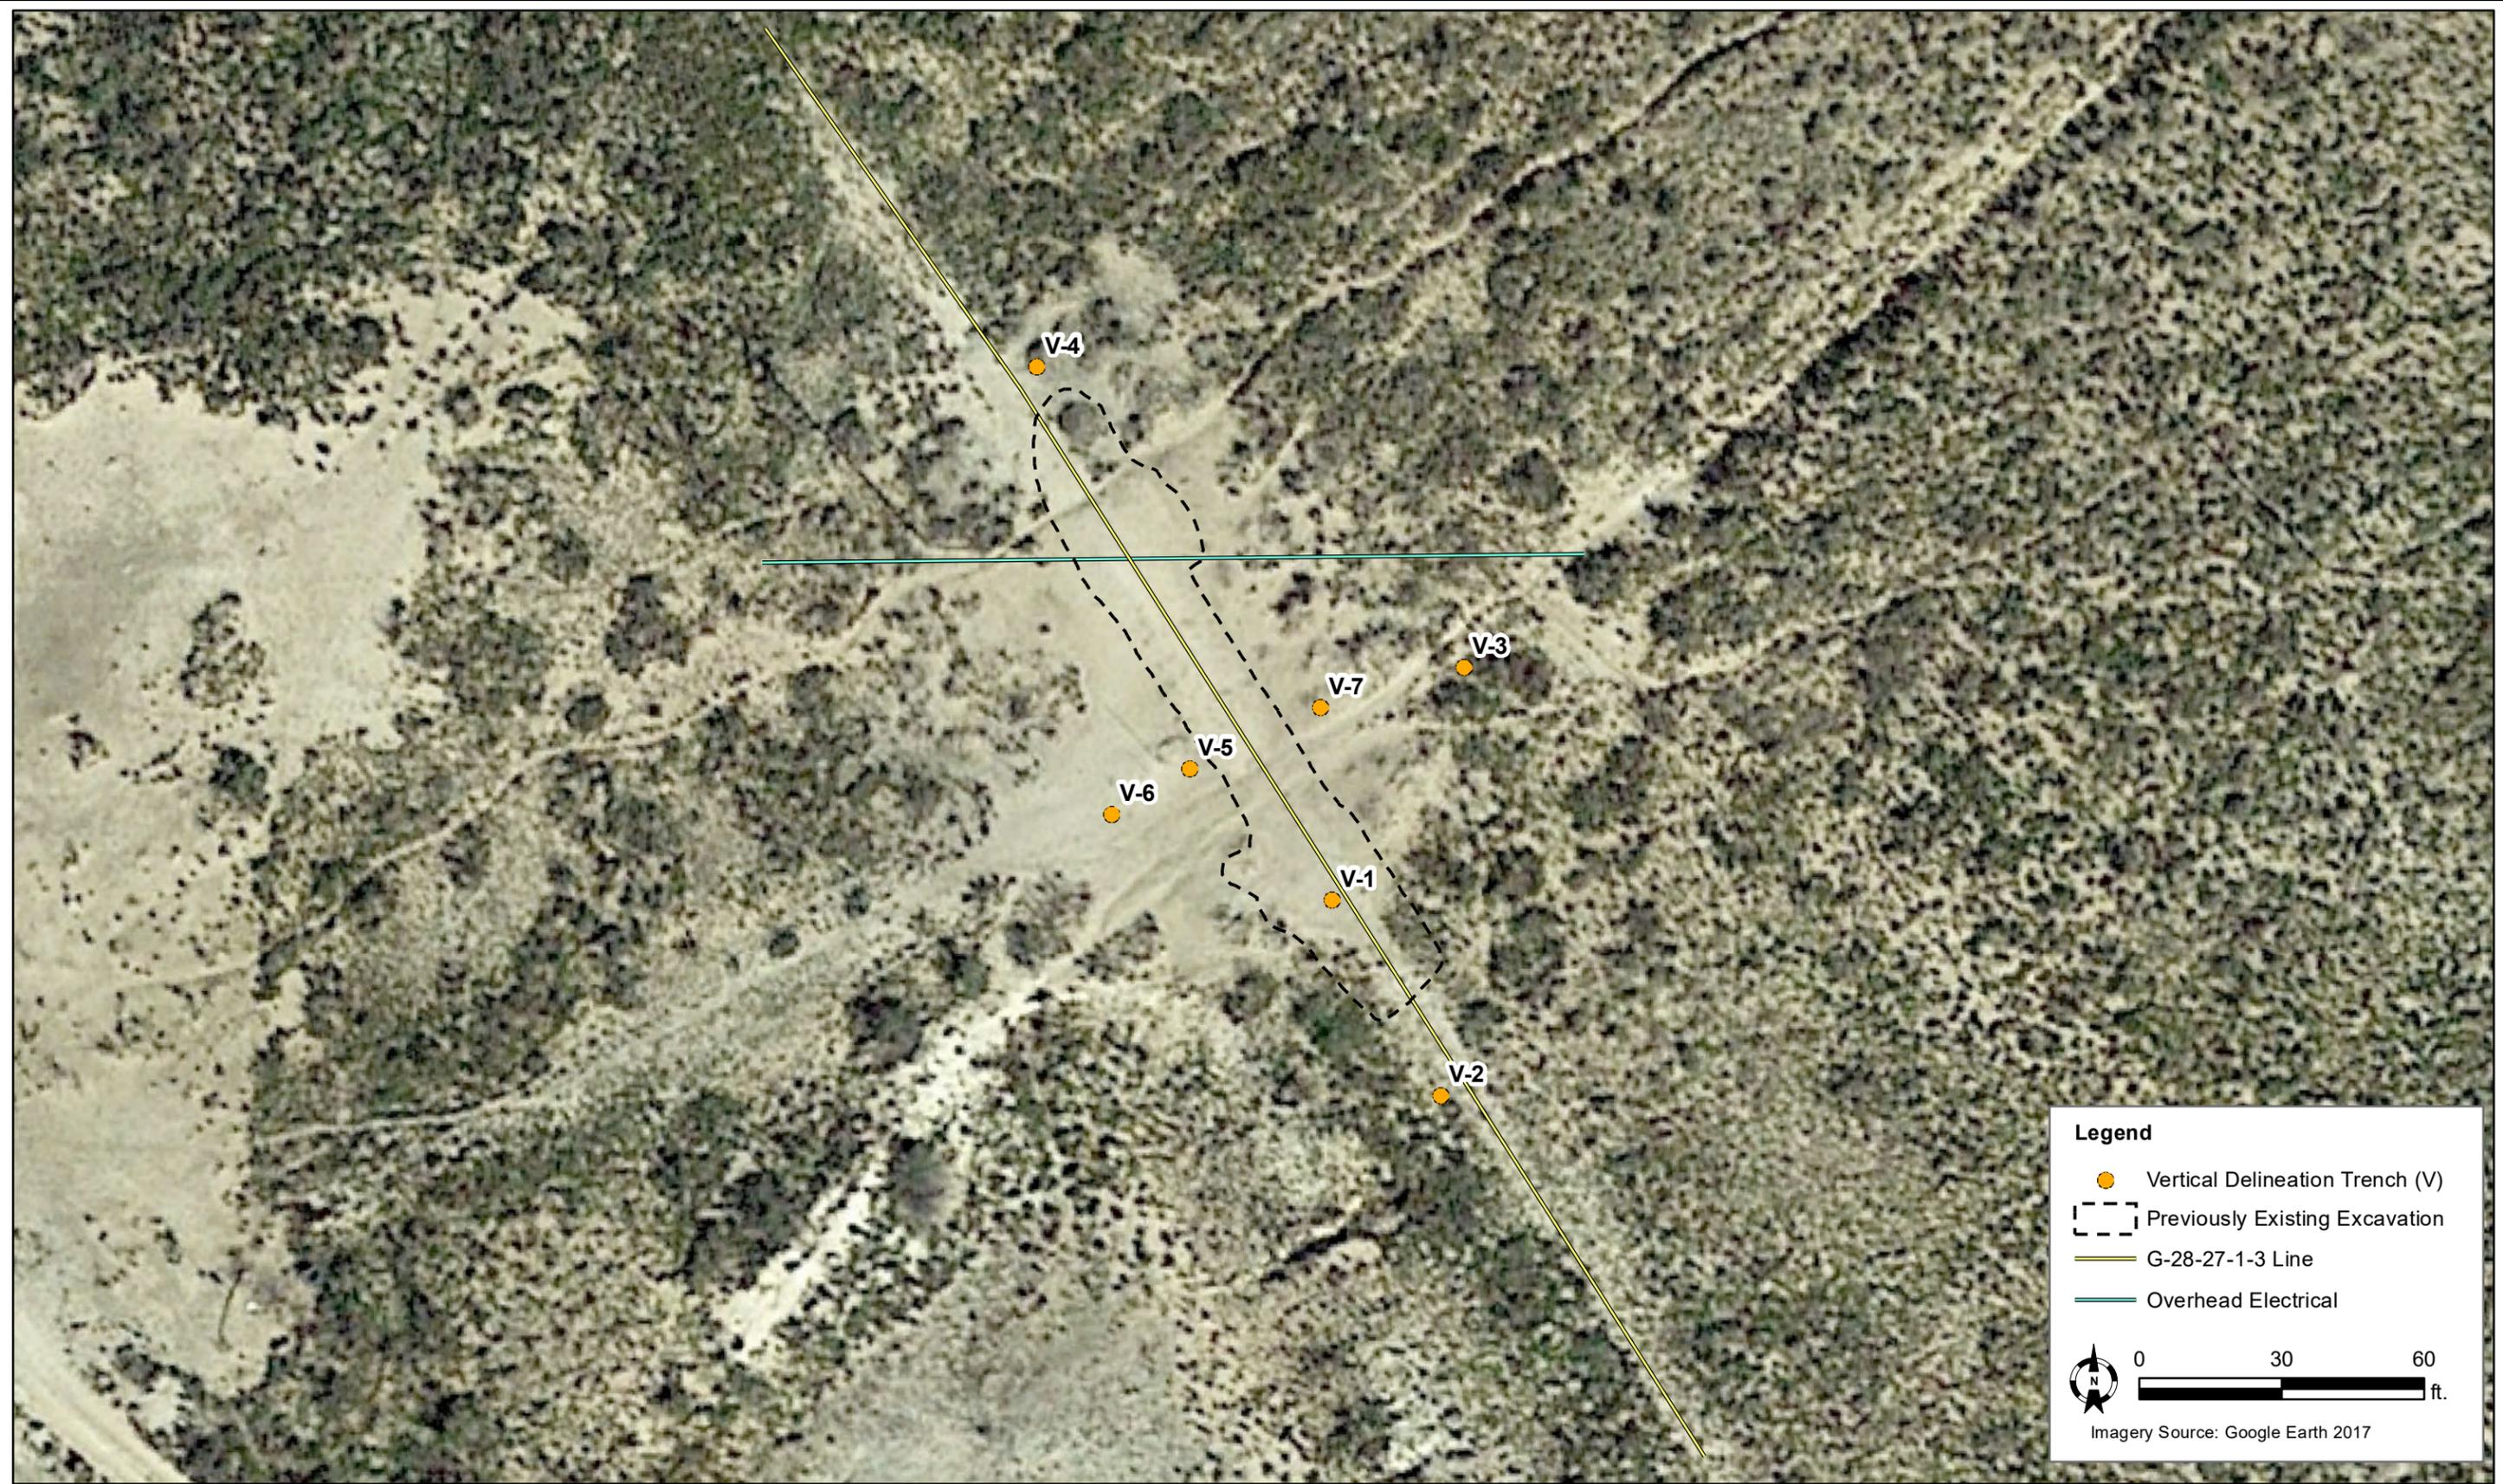
Figure  
5

Delineation Overview Map
