Release Notification

Site Name NEBU #229J	Site Type Off-Location Flowline
Date Release Discovered 10/16/2023	API# (if applicable) 30-045-32785

**RE: Northeast Blanco Unit 229J Site Closure
San Juan County, New Mexico**

NEBU #229J
Project Map
Simcoe LLC

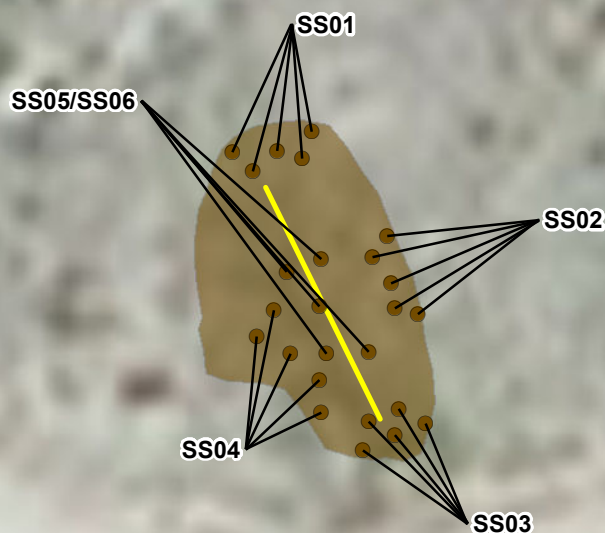
Notes: SS01-SS05 collected 10/16/2023. SS06 collected 11/1/2023. All samples are five-point composite samples.

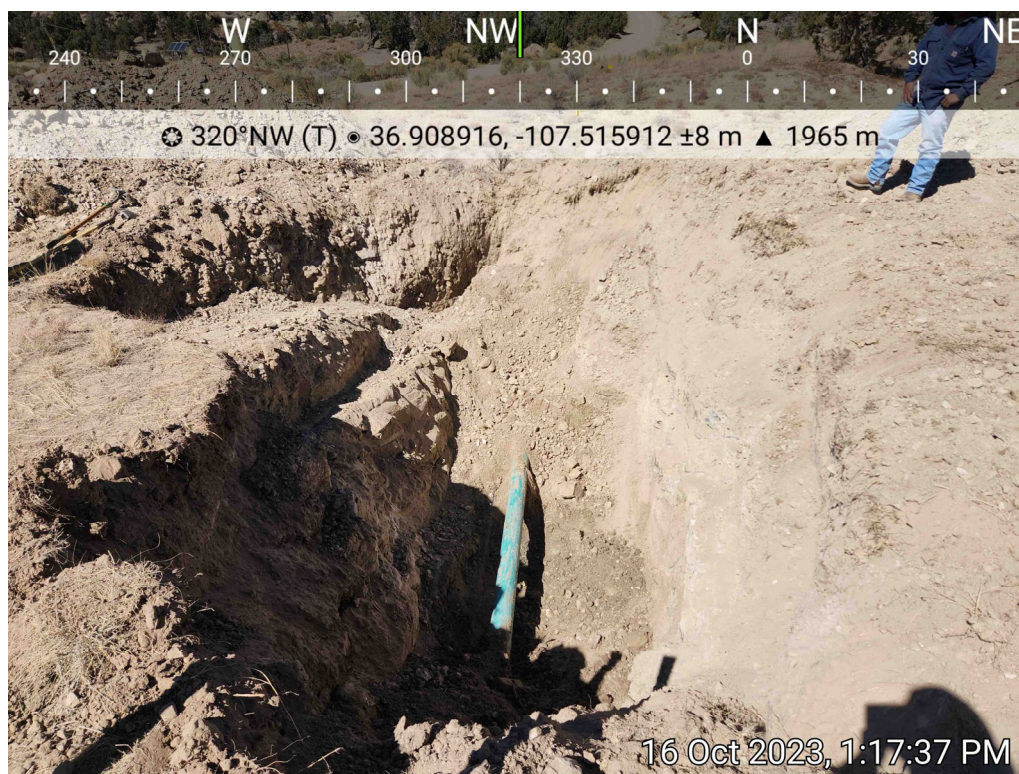
Photo 1: NEBU #229J excavation, 10/16/2023.

On October 16, 2023, Simcoe removed impacted soils via hydro-vac to determine the source of the release, then excavated via traditional methods to conduct pipeline repairs. Initial soil samples of the base and sidewalls were collected October 16, 2023 and backfilled material was sampled on November 1, 2023 to determine if impacted soil remained on site. Chloride, BTEX (benzene, toluene, ethylbenzene, and total xylenes), and TPH (total petroleum hydrocarbons) levels were below the NMOCD standard. The accompanying documentation demonstrates no significant impact to groundwater (demonstrated to be greater than 100 feet deep) with minimal lateral extents (200 square foot base of excavation). Approximately 18 cubic yards of soil were excavated.

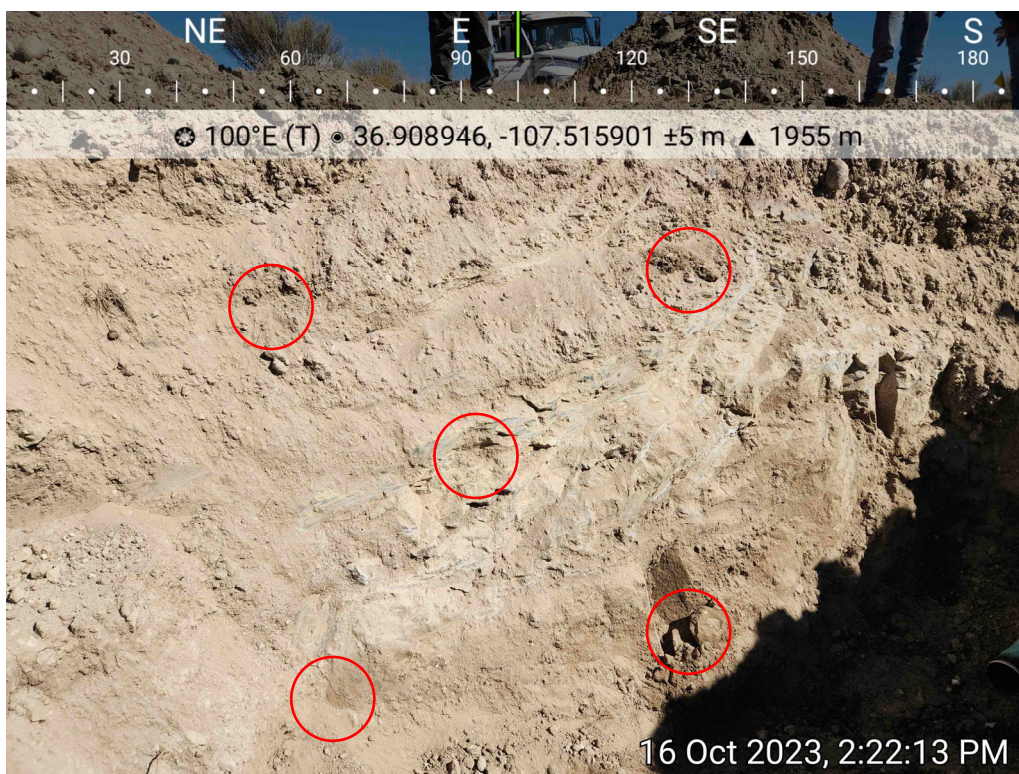
Photo 3: SS02 is a five-point composite sample collected from east sidewall, 10/16/2023.

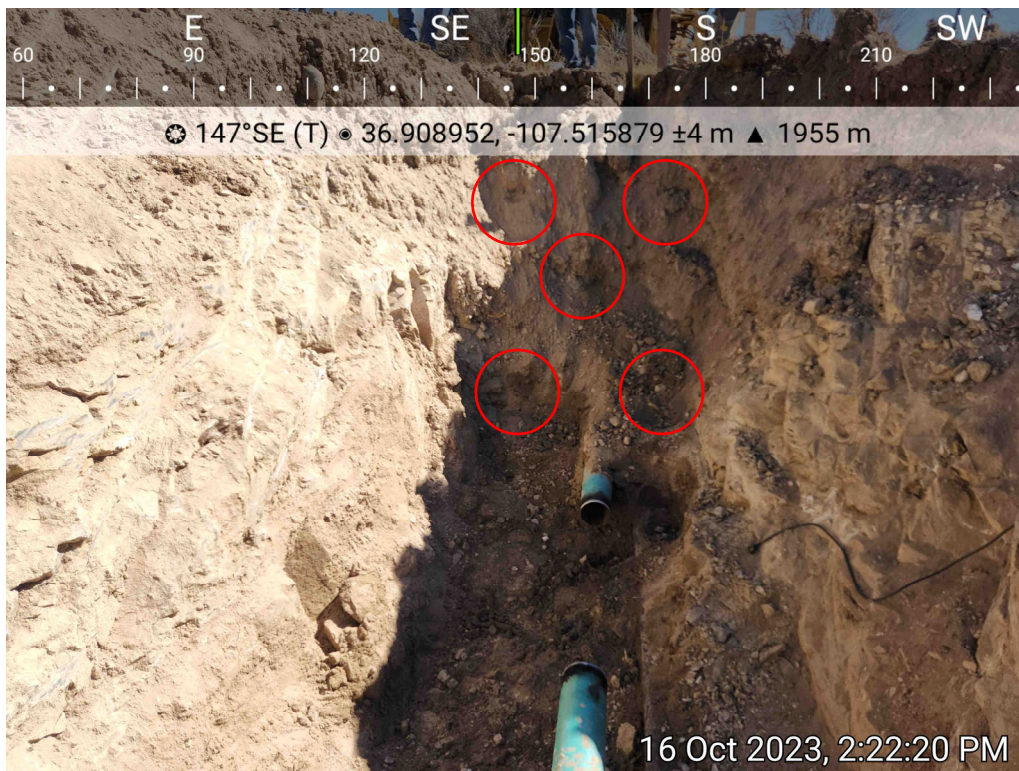
Photo 4: SS03 is a five-point composite sample collected from south sidewall, 10/16/2023.

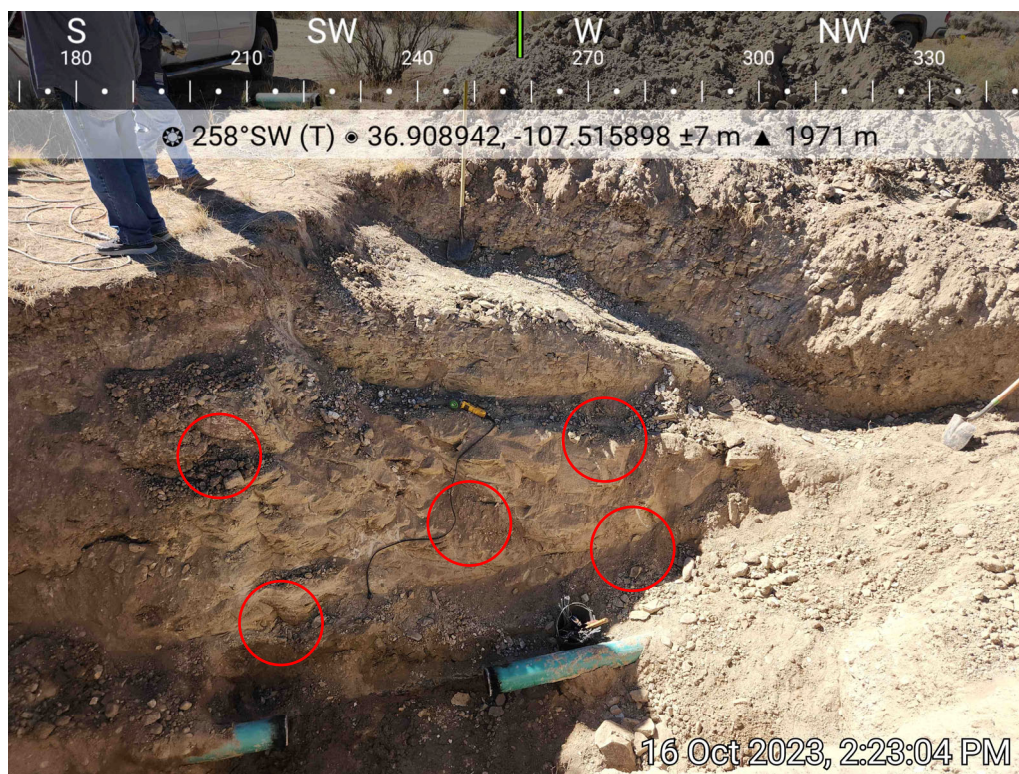
Photo 5: SS04 is a five-point composite sample collected from west sidewall, 10/16/2023.

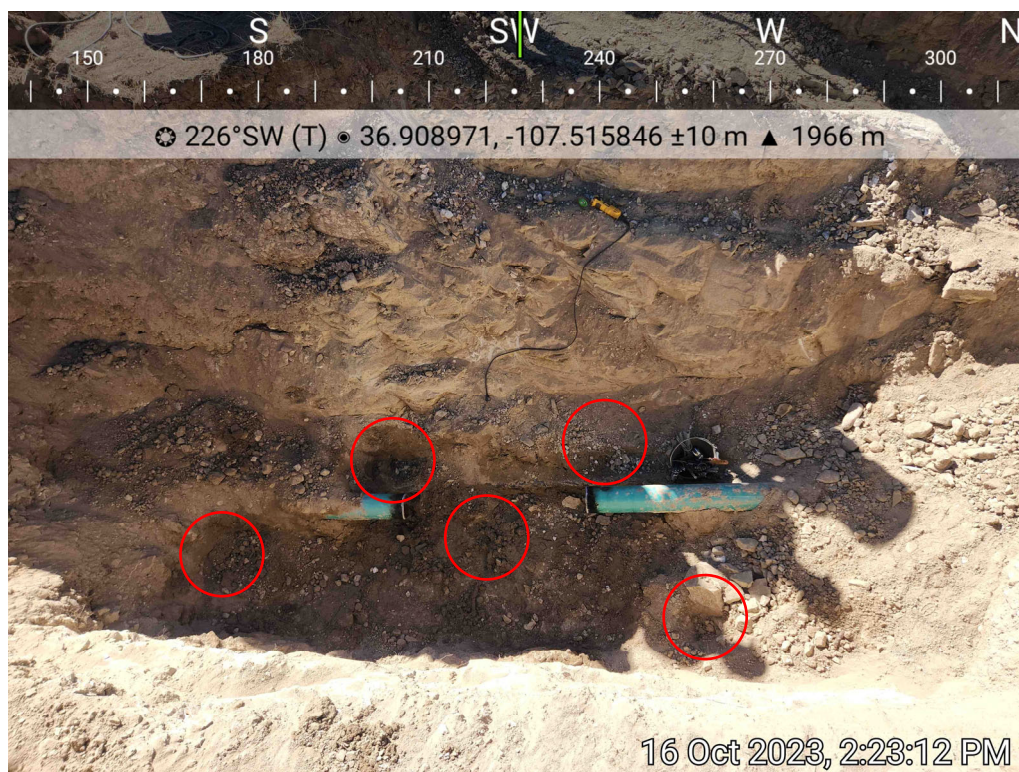
Photo 6: SS05 is a five-point composite sample collected from base of excavation, 10/16/2023.

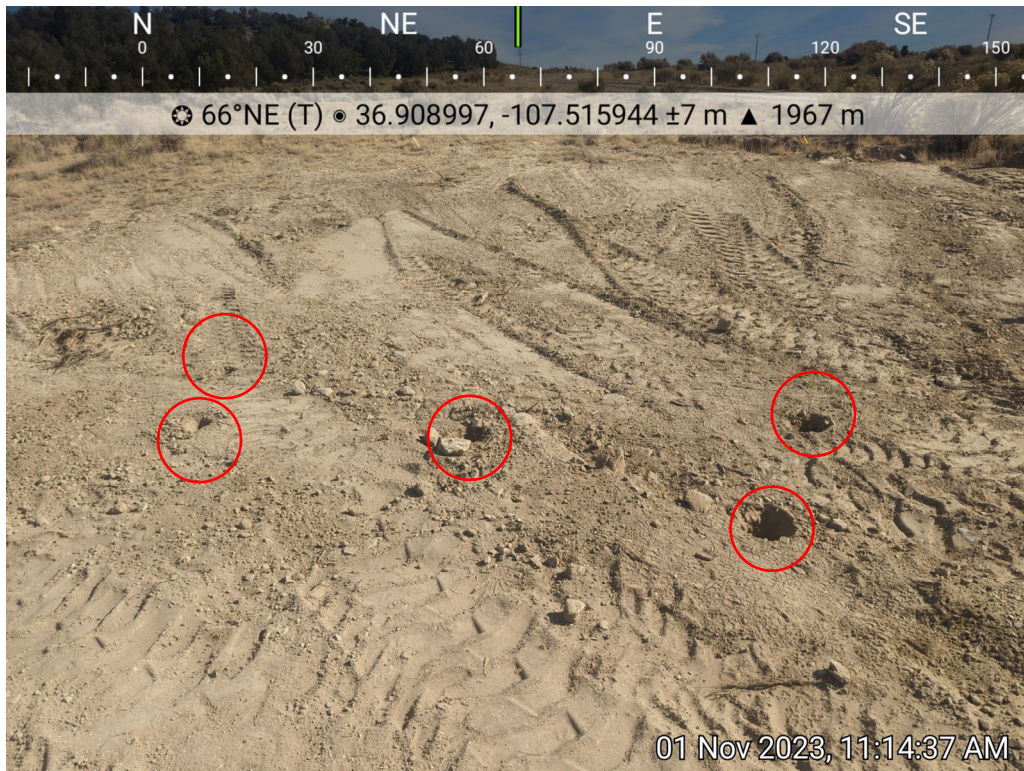
Photo 7: SS06 is a five-point composite sample collected from soil after backfilling activities, 11/1/2023.
