Release Notification and Corrective Action

Name of Company	RKI E&P, LLC	Contact	Zack Laird
Address	210 Park Ave. - Ste. 900, OKC, OK 73102	Telephone No.	405-742-2696
Facility Name	Yates Federal #1	Facility Type	Oil and Gas Well
Surface Owner	Federal	Mineral Owner	Federal
		API No.	30-015-24602

Yates Federal #001

Incident Numbers nAB1428734057 and NRM2011138650

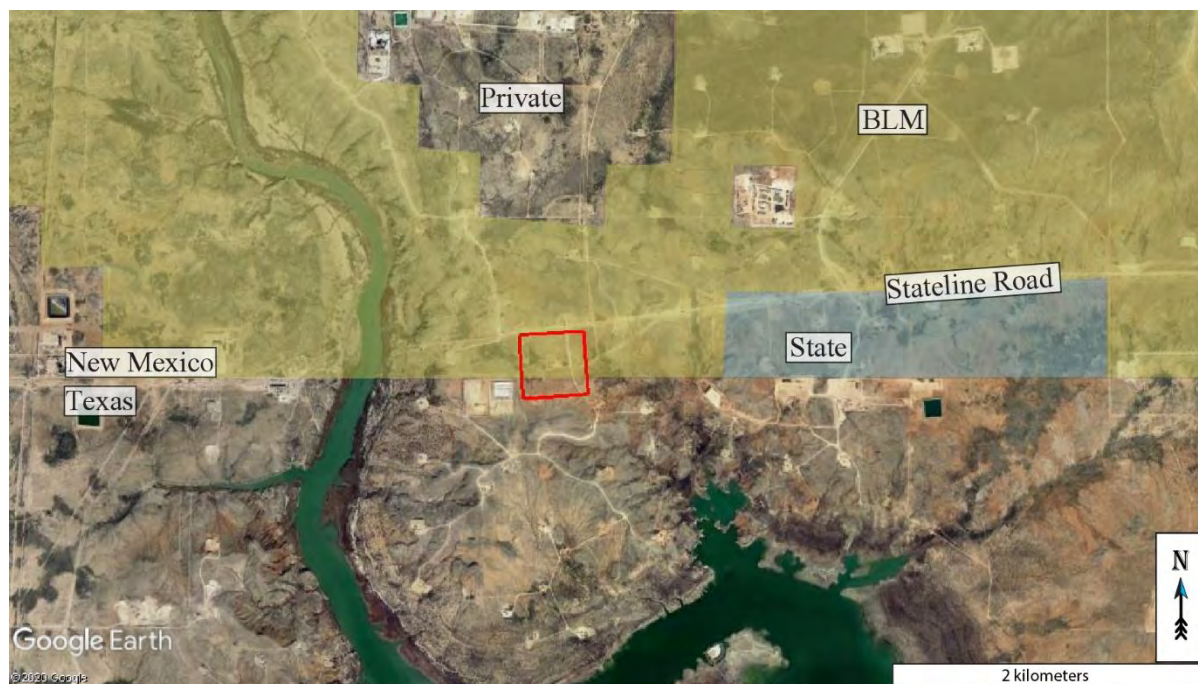
Figure 2: Land ownership overview. Yellow transparent area: BLM-CFO managed land. Blue transparent area: New Mexico State Land Office managed land. No color: private land. Background image credit: Google Earth. Image date: February 21, 2019. Datum: WGS-84.

The Yates project site is located in Eddy County, New Mexico, 26.7 kilometers (16.6 miles) south-southeast of Malaga, New Mexico, along the Texas-New Mexico border (**Figure 1** and **Figure 2**). The survey area is located within section 34 of NM T26S R29E. This area is within the Chihuahuan Desert Thornscrub defined by the Southwestern Regional ReGAP Vegetation map^[3] and the vegetation consists mostly of areas of grass, sparse creosote, and sparse yucca with very good visibility in most locations. See section **2.2 Local Geology** for the geology of the area. The entirety of the project site and surrounding survey area is within a HKOZ (**Figure 1**). Seventy-two percent of the survey area is located in BLM-CFO managed lands, while the remaining 28% is within privately managed lands in Texas (**Figure 2**).

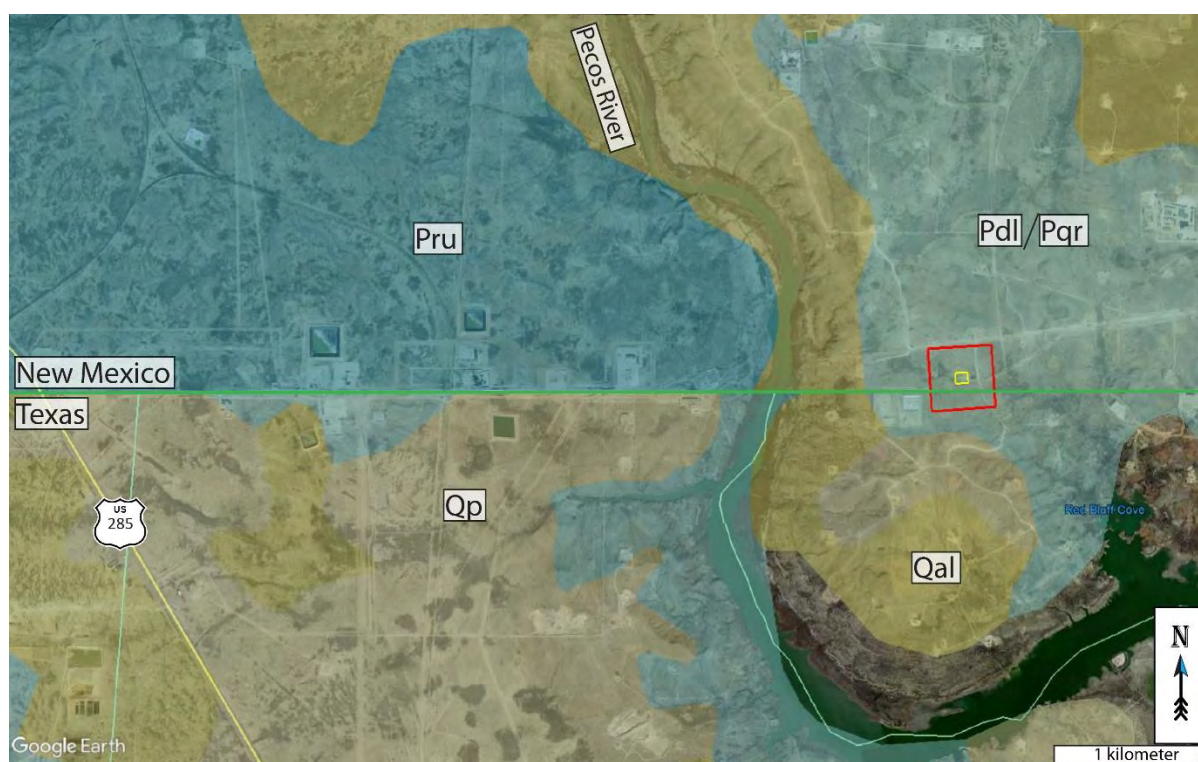
The area surveyed for the Yates project is located at an elevation of 880 meters (2,887 feet), ± 3 meters (10 feet), within an area underlain by the Permian Rustler and Dewey Lakes Formations (Pru and Pdl). The area is mantled by thin gypsiferous soils, and Quaternary alluvial sands and gravels (Qal and Qp)^[4] between 0 and 3 meters in depth (**Figure 3**). The Rustler Formation is an evaporite facies and is composed mainly of thin siltstones and sandstones interbedded with claystones, dolomite and gypsum^[5], and contains both karst-forming strata (the Forty-niner and Tamarisk Members) and two shallow aquifers (the Magenta and Culebra Dolomite Members). The Pru overlies the Permian Salado Formation (Psl, not shown on map), a layer of extremely soluble halite which can easily be dissolved to create caves, sinkholes, and other karst features^[6]. The Pru may be subject to collapse if a void has developed beneath it in the Salado Formation. The survey area is covered by the Geologic Map of New Mexico (2003) at 1:500,000 scale^[4], and the Geologic Atlas of Texas - Hobbs Sheet (1976) at 1:250,000 scale.

Figure 3: Geology overview. Pru: Permian Rustler Formation. Pdl/Pqr: Permian Dewey Lake Formation (formerly known as the Permian Quartermaster Formation). Qp: Quaternary piedmont deposits. Qal: Quaternary alluvium. Red polygon is the study area. Yellow polygon is the YATES pad perimeter. Map credit: Geologic Map of New Mexico (2003) at 1:500,000 scale, and Google Earth. Image date: February 21, 2019. Datum: WGS-84.

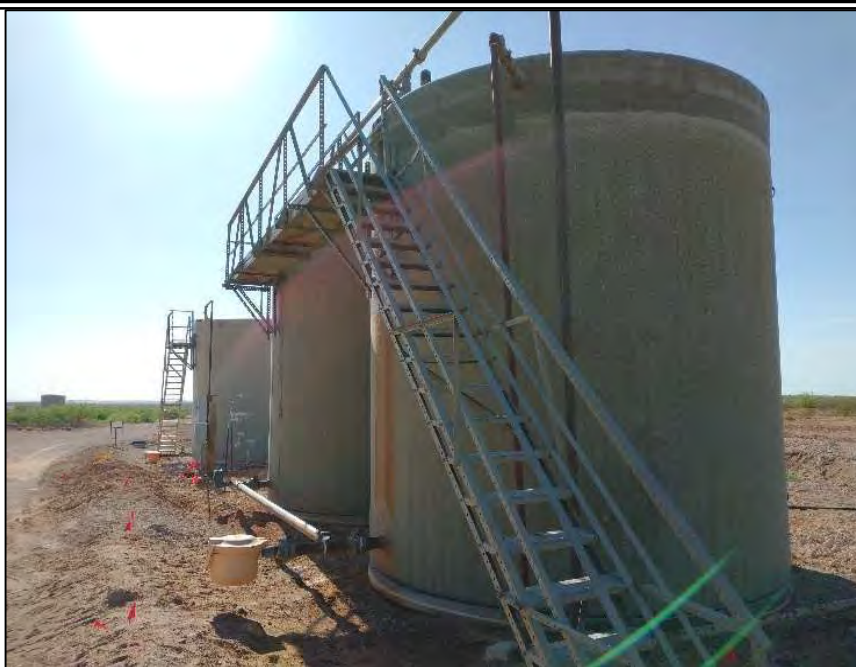
**Photograph 1****Date: 05/12/2022**

Description: Northeastern view of initial Site assesment, edge of earthen berm.

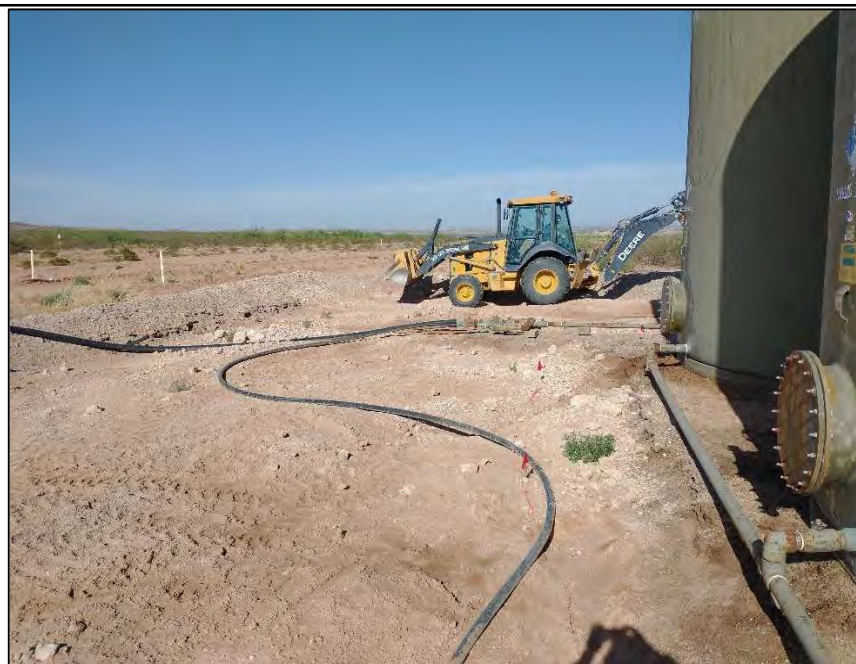
**Photograph 2****Date: 05/12/2022**

Description: Southeastern view of delineation activities location of PH02. South of battery containment.

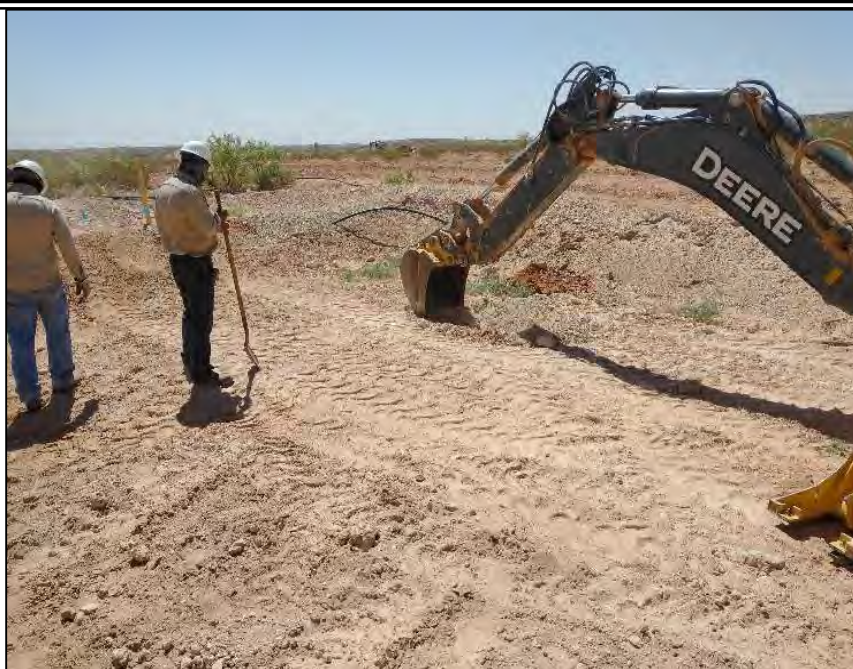
**Photograph 3****Date: 05/12/2022**

Description: Southwestern view of delineation activities location of PH02, southwest edge of earthen berm.
