Remediation Summary and Closure Request

Cedar Breaks 12"

Eddy County, New Mexico

NMOCD Incident # nAPP2301030161

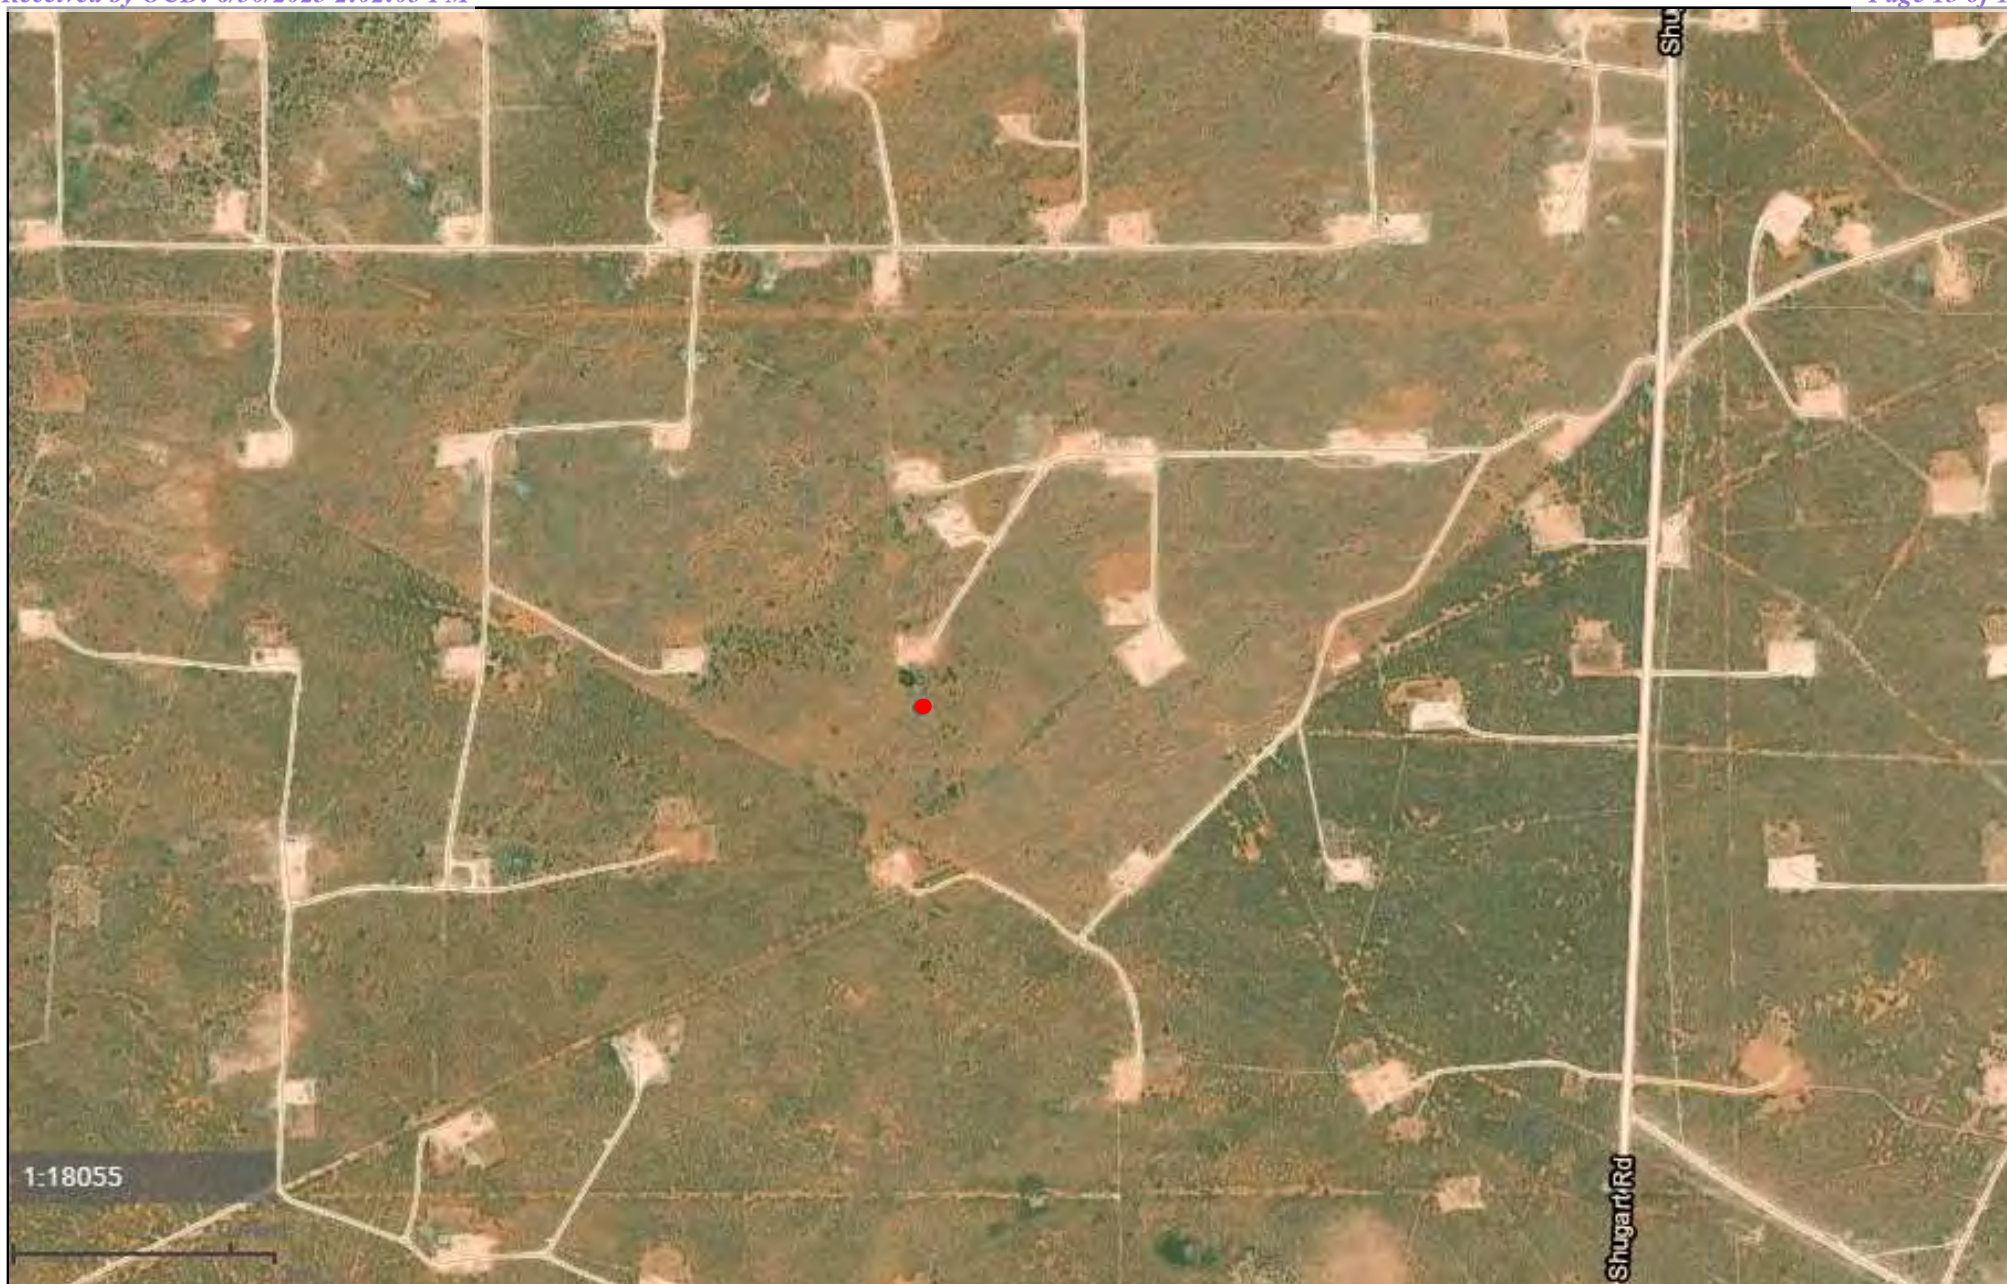
**Figure 2**

OSE POD Locations Map
Frontier Field Services, LLC
Cedar Breaks 12"
GPS: 32.762842, -103.897907
Eddy County

A search of the New Mexico Office of the State Engineer (NMOSE) and United States Geological Survey (USGS) groundwater databases was completed in an effort to determine the horizontal distance to known water sources within a half mile radius of the Release Site. Approximate depth to groundwater was determined using maintained and published water well data. Karst mapping indicates the site is not located in a Karst designated area. Karst and Wetland Maps are provided as Attachment I. Depth to groundwater information is provided as Attachment IV and the results are depicted on Figures 2 & 3.

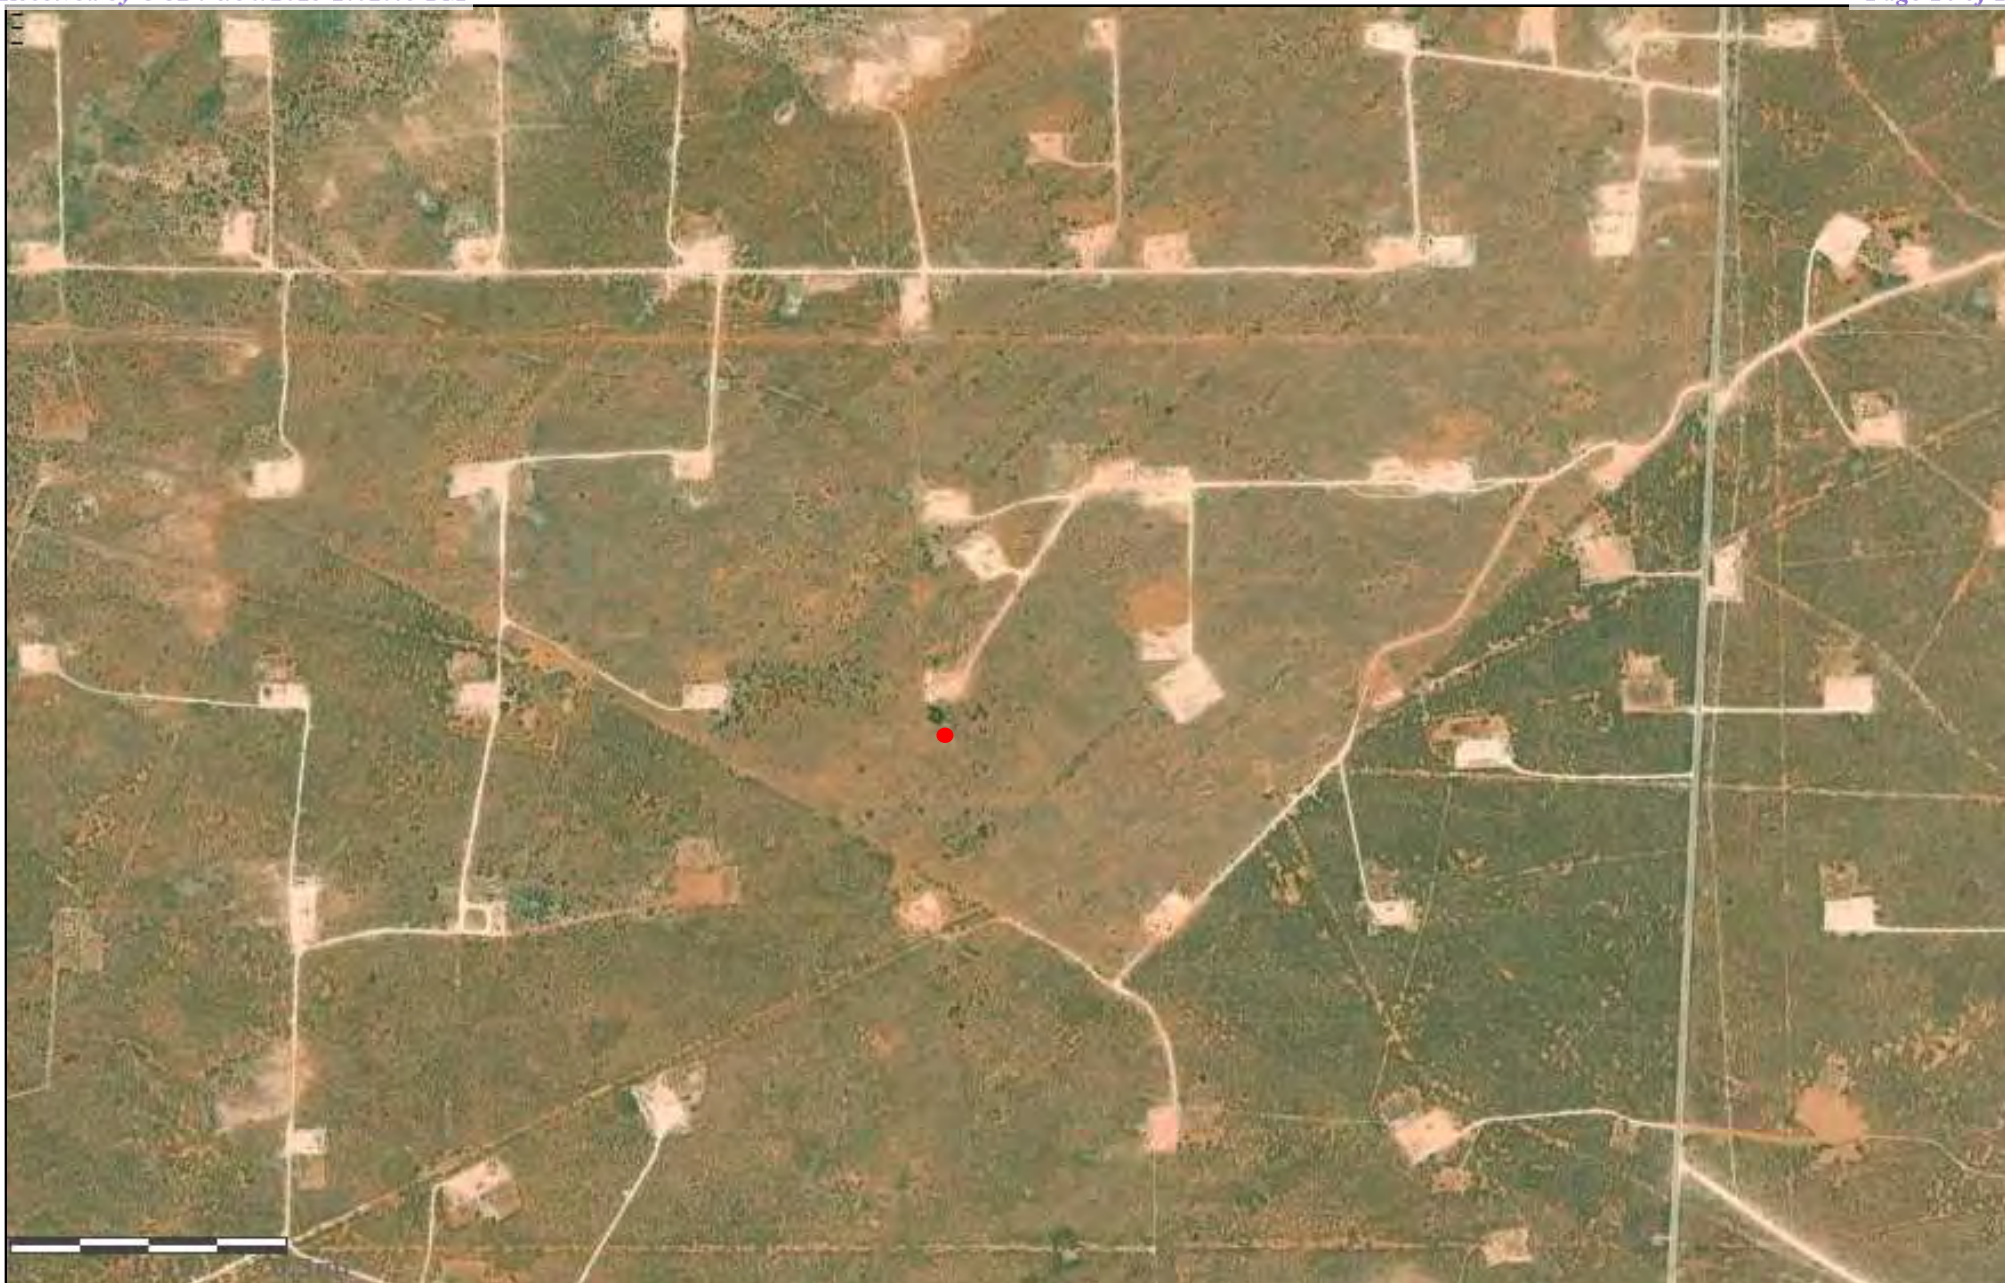
**Figure 3**

USGS Well Locations Map
Frontier Field Services, LLC
Cedar Breaks 12"
GPS: 32.762842, -103.897907
Eddy County

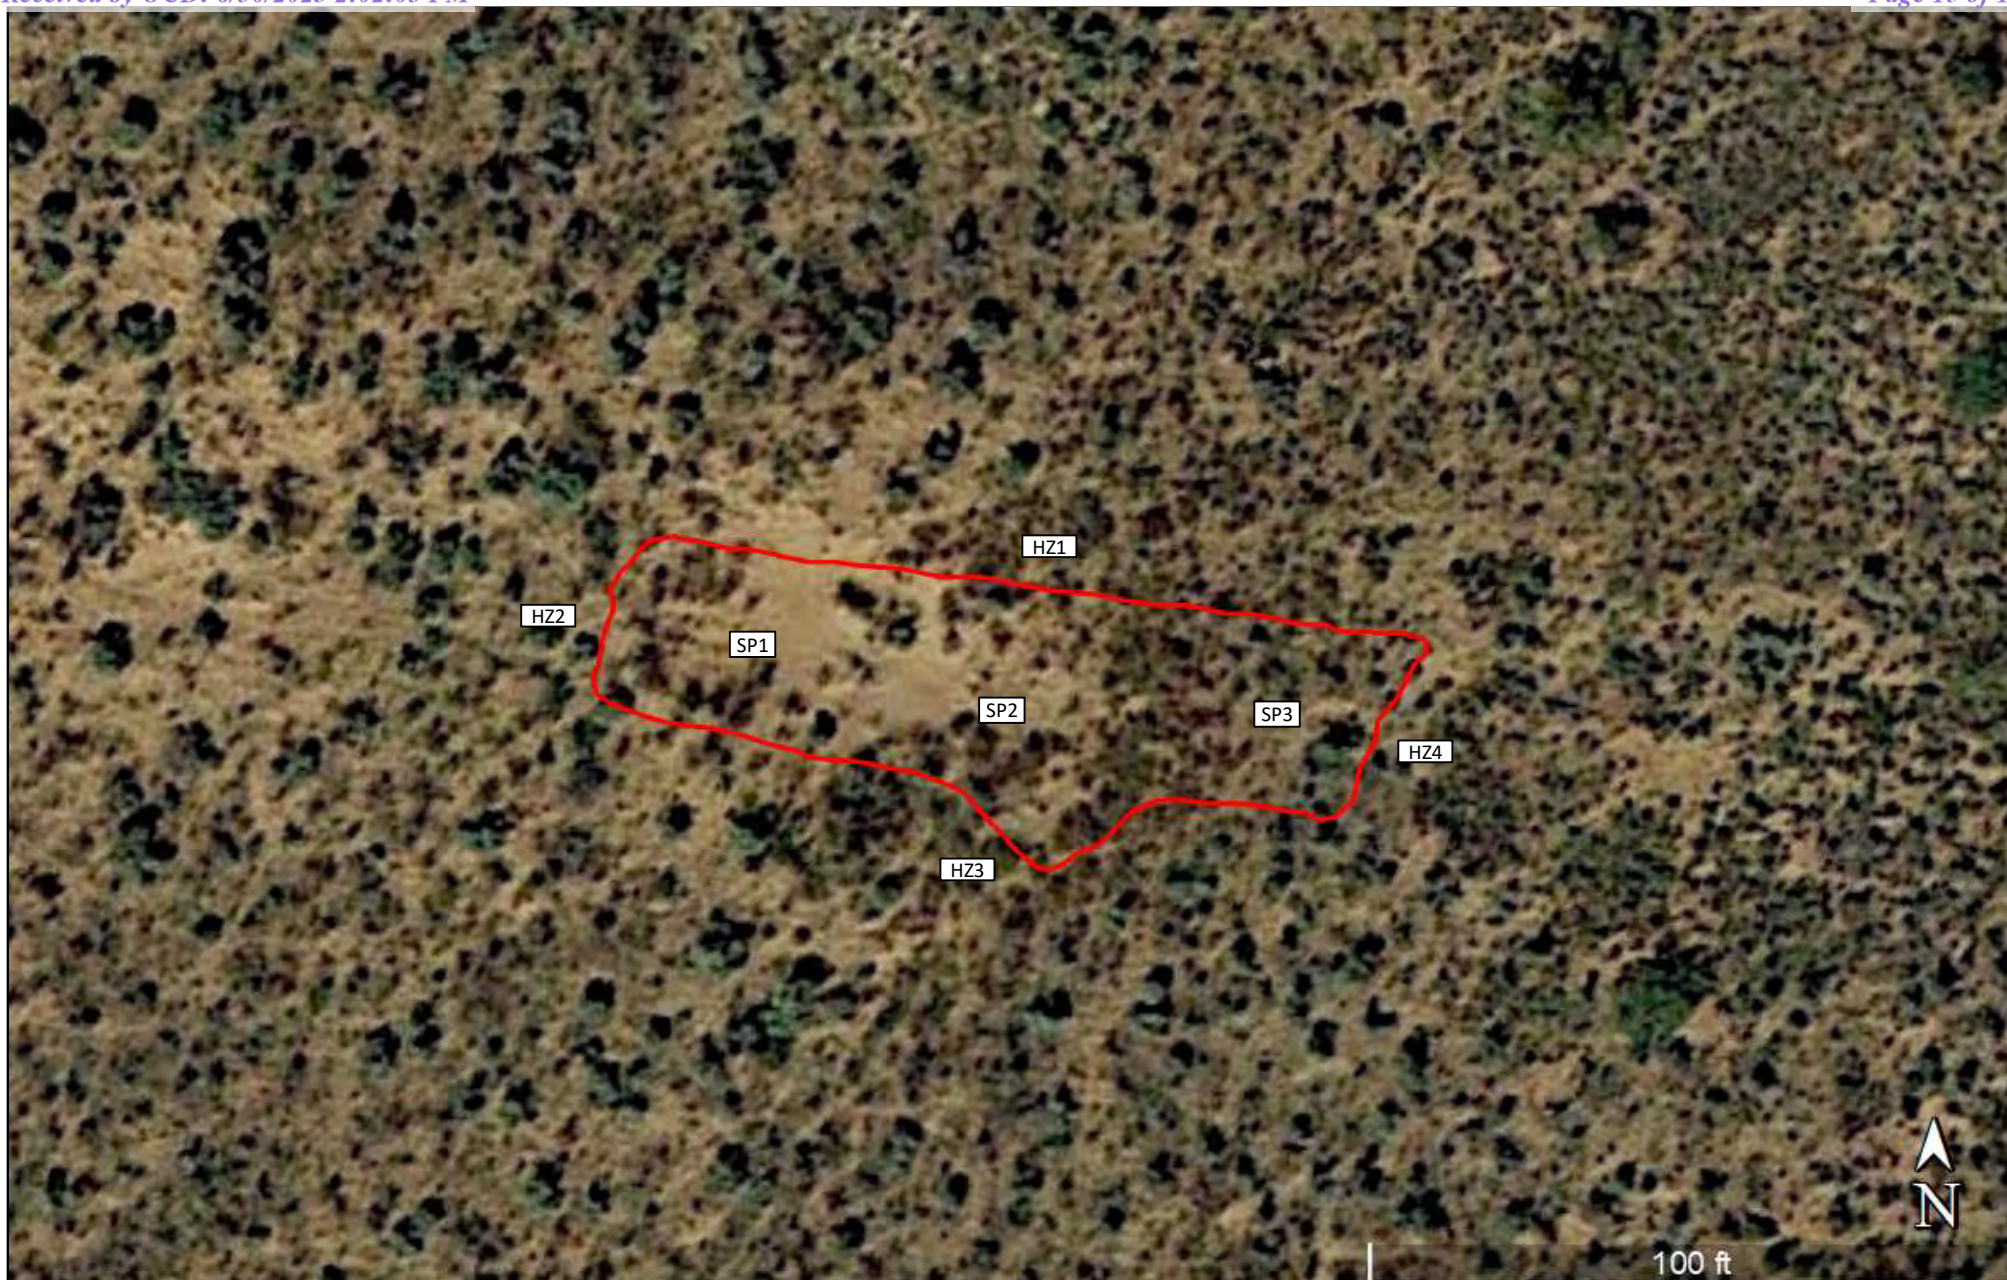
**Figure 4**

Delineation Sample Map
Frontier Field Services, LLC
Cedar Breaks 12"
GPS: 32.762842, -103.897907
Eddy County

Based on field observations and field test data noted above and provided in Attachment V, fourteen representative soil samples were selected for laboratory analysis. Delineation soil samples SP1 through SP3, and HZ1 through HZ4, were submitted to the laboratory for analysis of BTEX, TPH, and chloride. Laboratory analytical results indicated contaminant concentrations were below the NMOCD Closure Criteria in each of the submitted samples, with the exception of SP2 at Surface and four feet bgs, and SP3 at Surface, which exhibited TPH and/or chloride concentrations in excess of the NMOCD Closure Criteria.

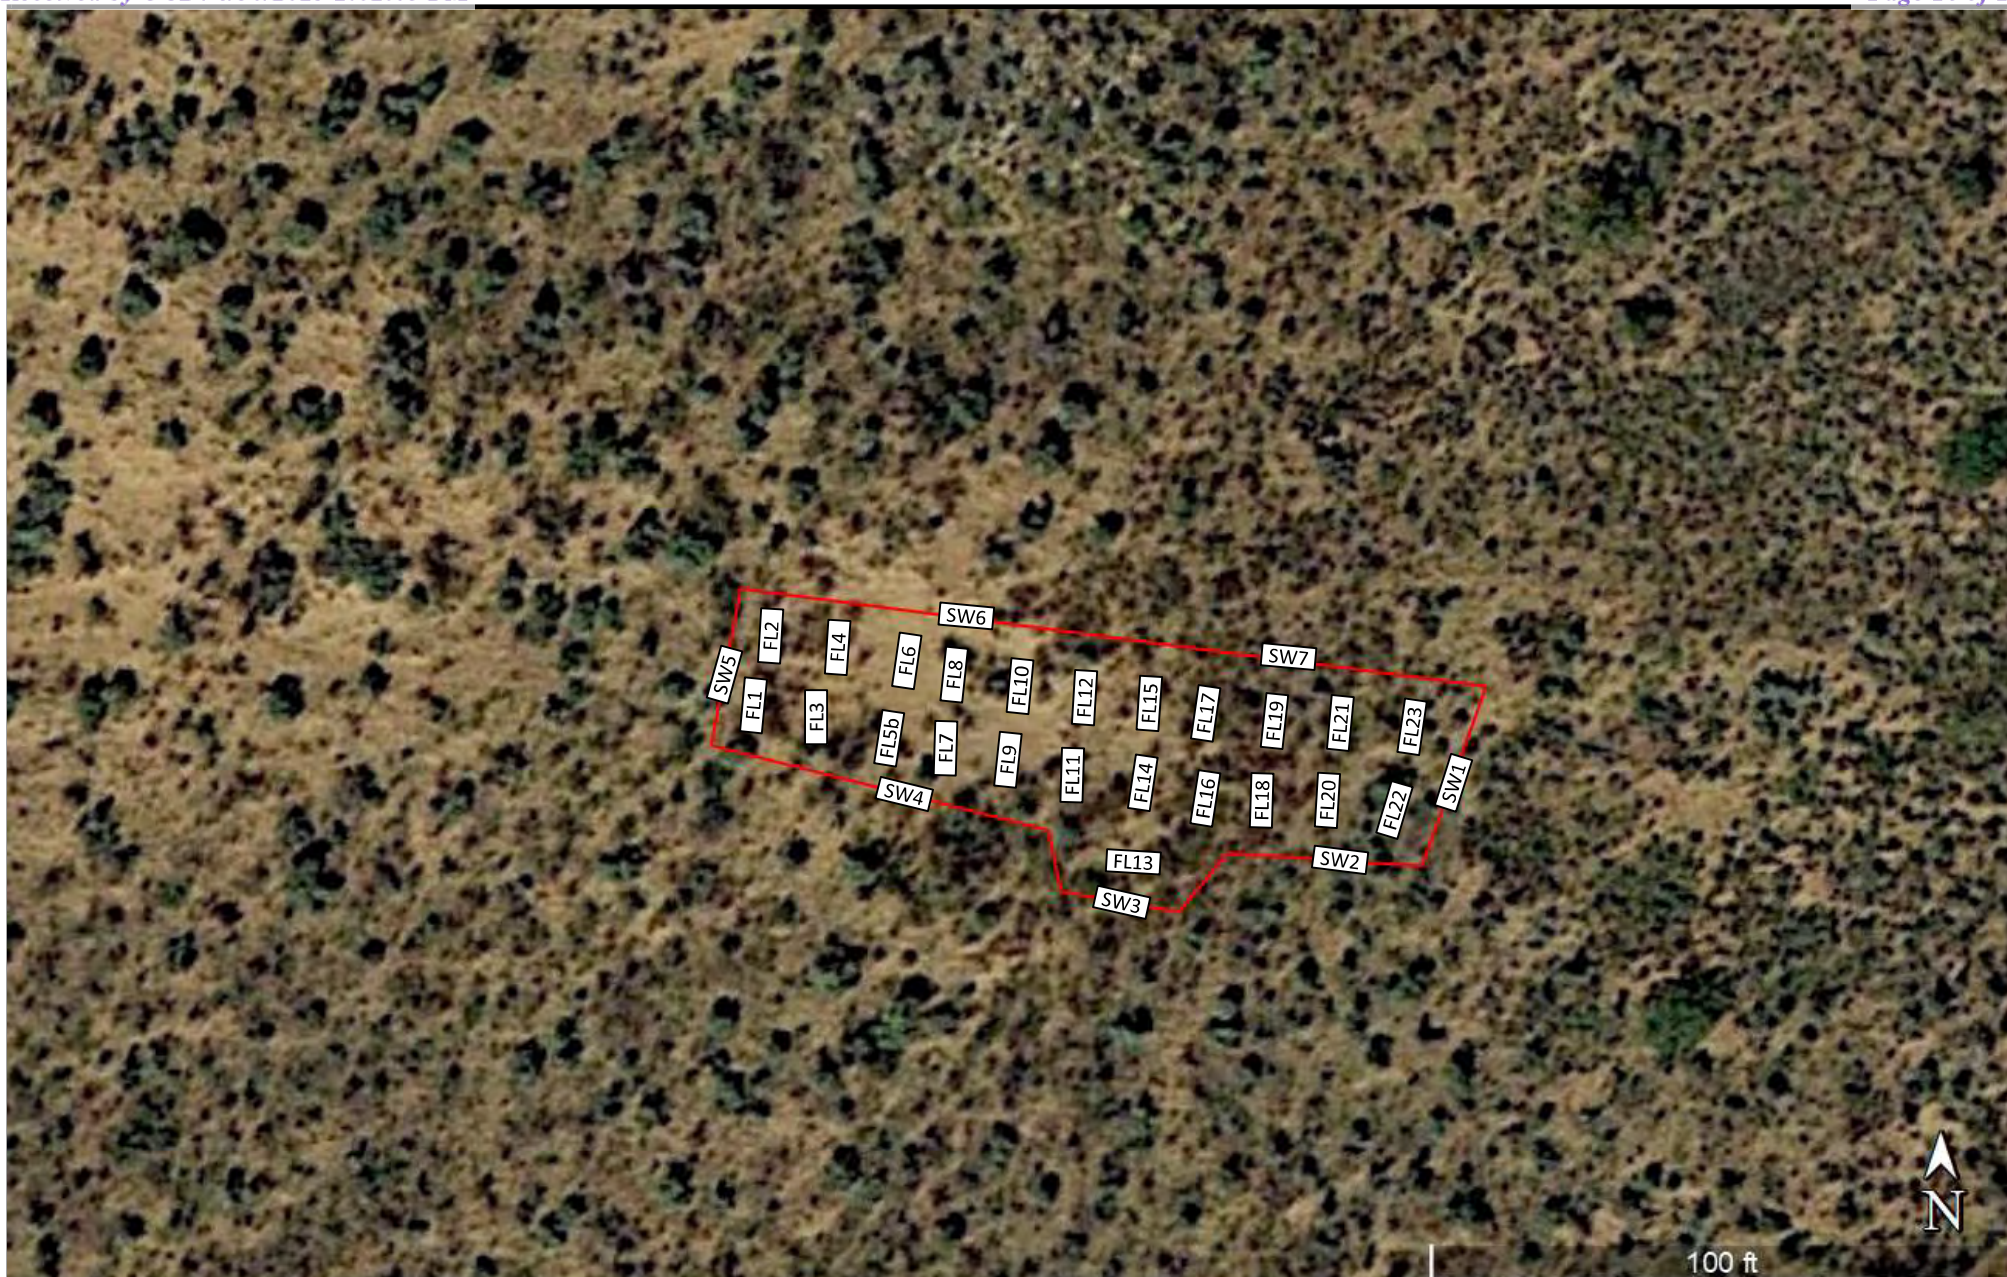
**Figure 5**

Excavation Sample Map
 Frontier Field Services, LLC
 Cedar Breaks 12"
 GPS: 32.762842, -103.897907
 Eddy County

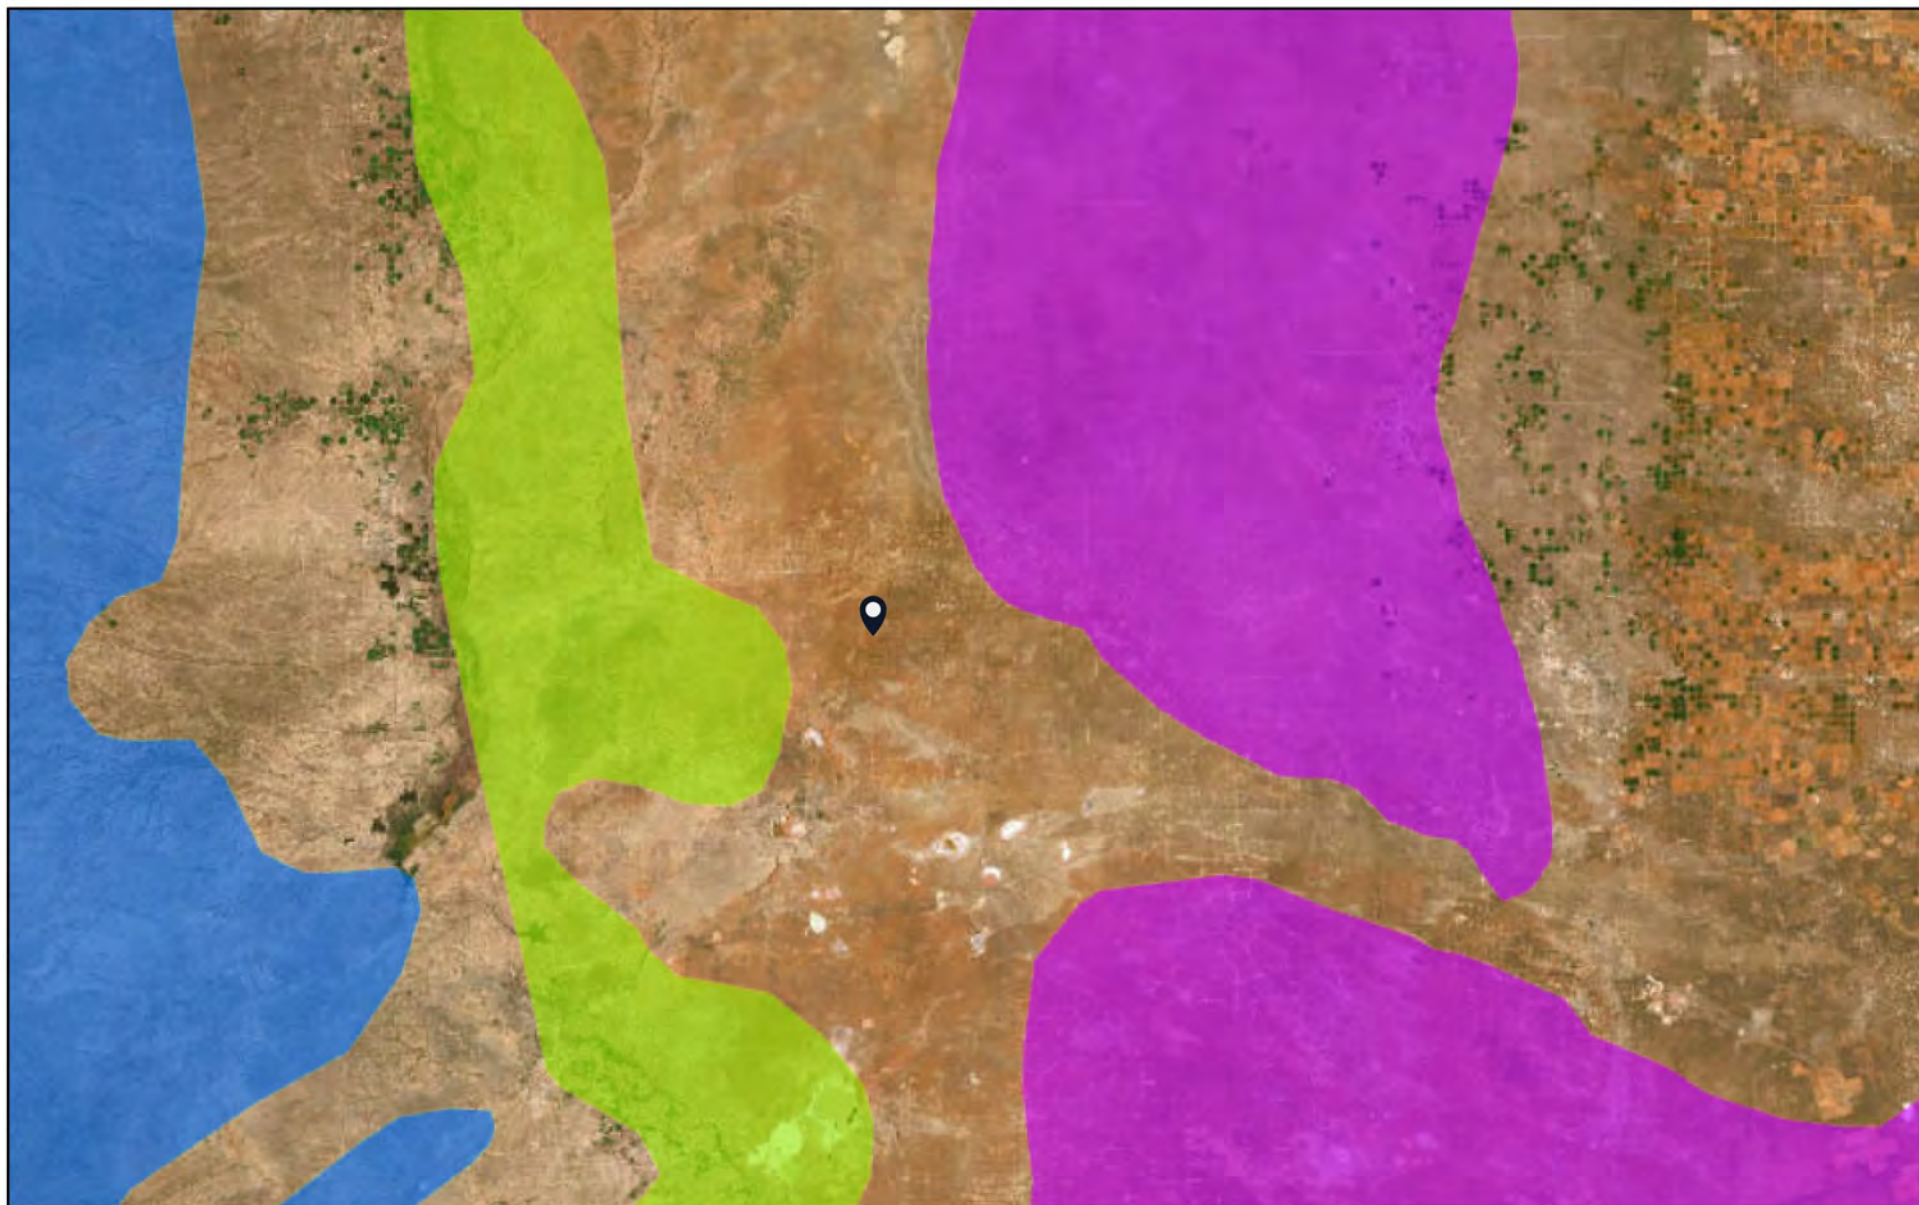
Karst and Wetland Maps

Karst Type

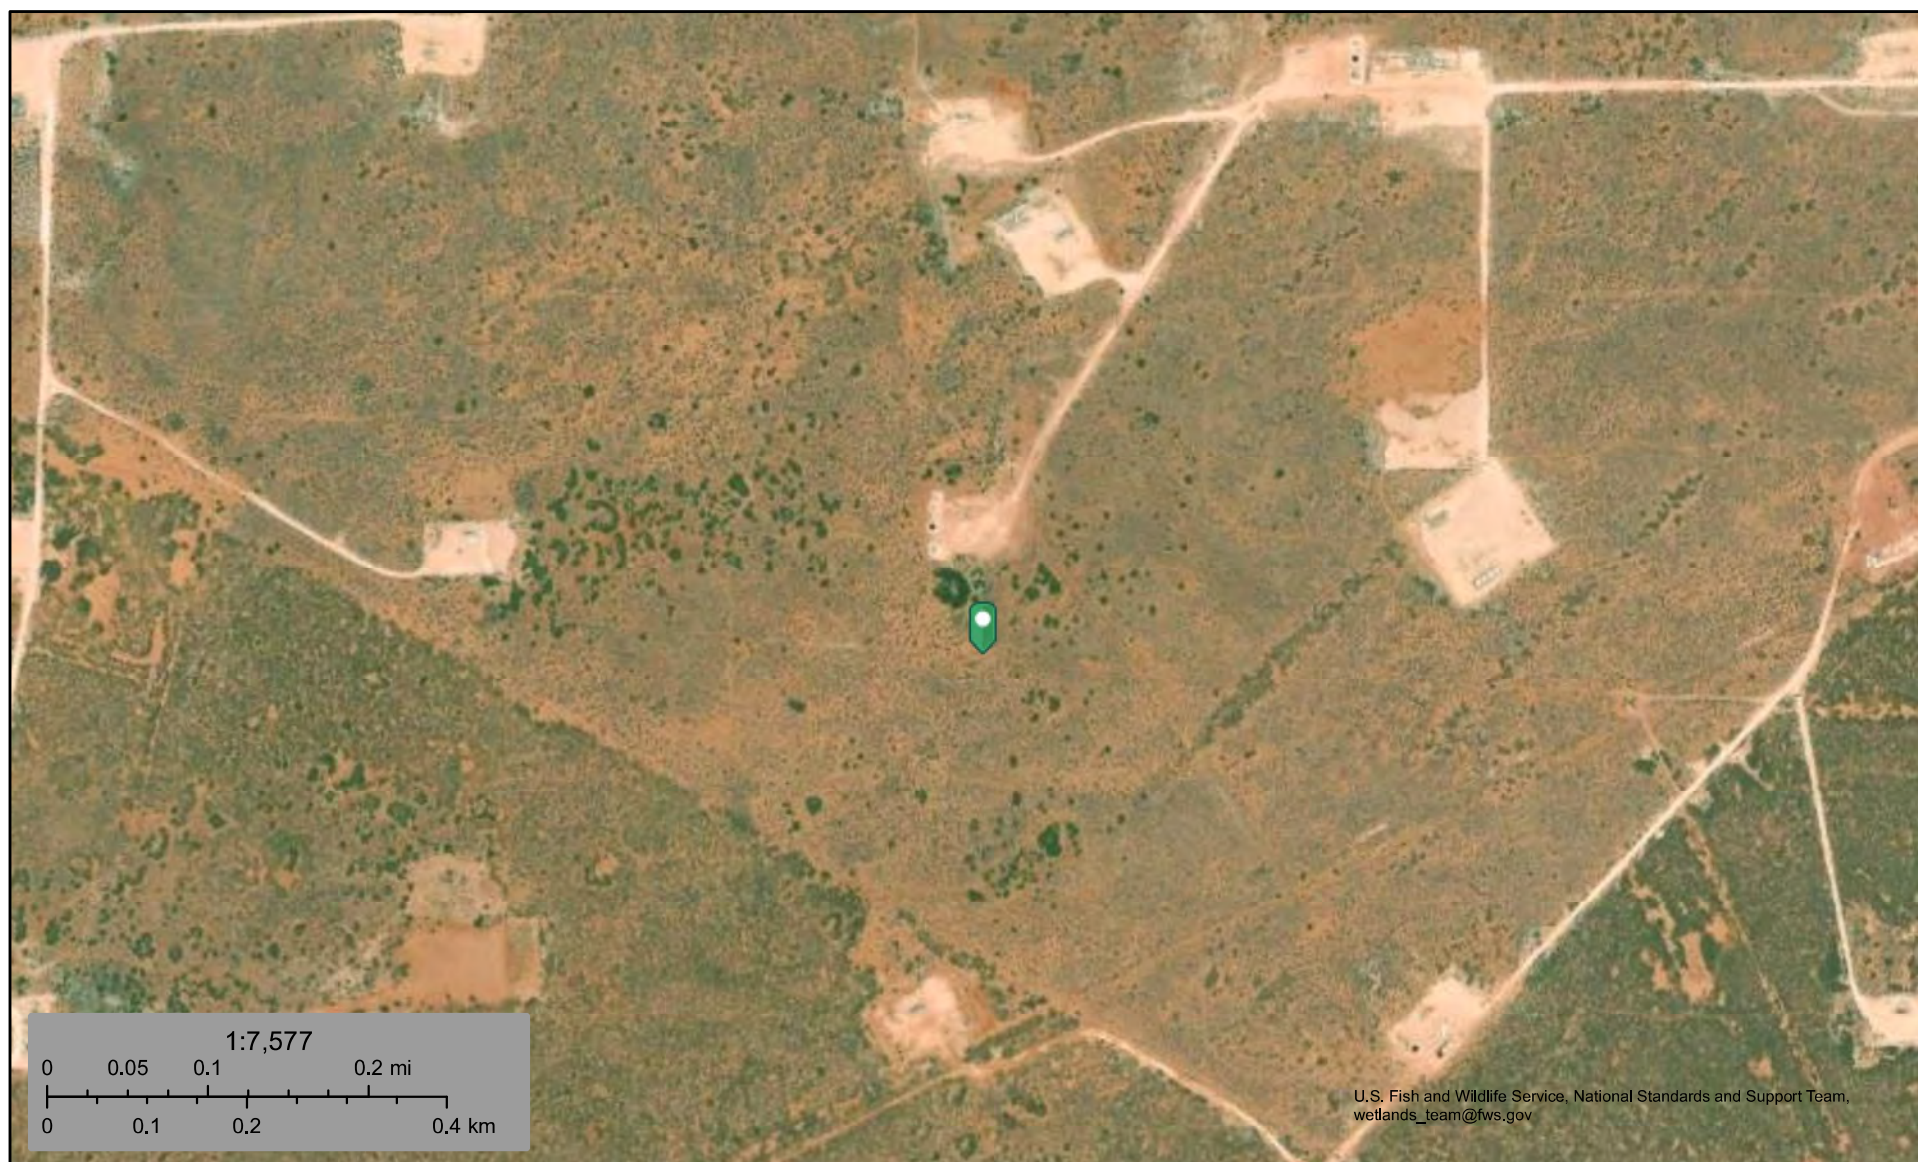
Wetlands_Alaska

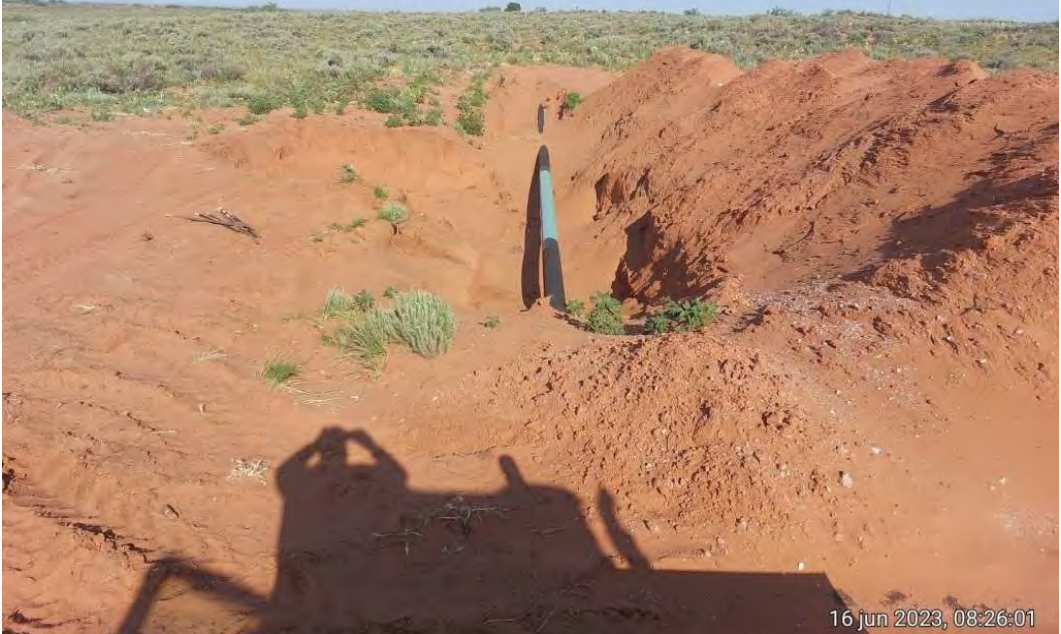
Photo:	5	Description: Excavation
--------	---	-------------------------

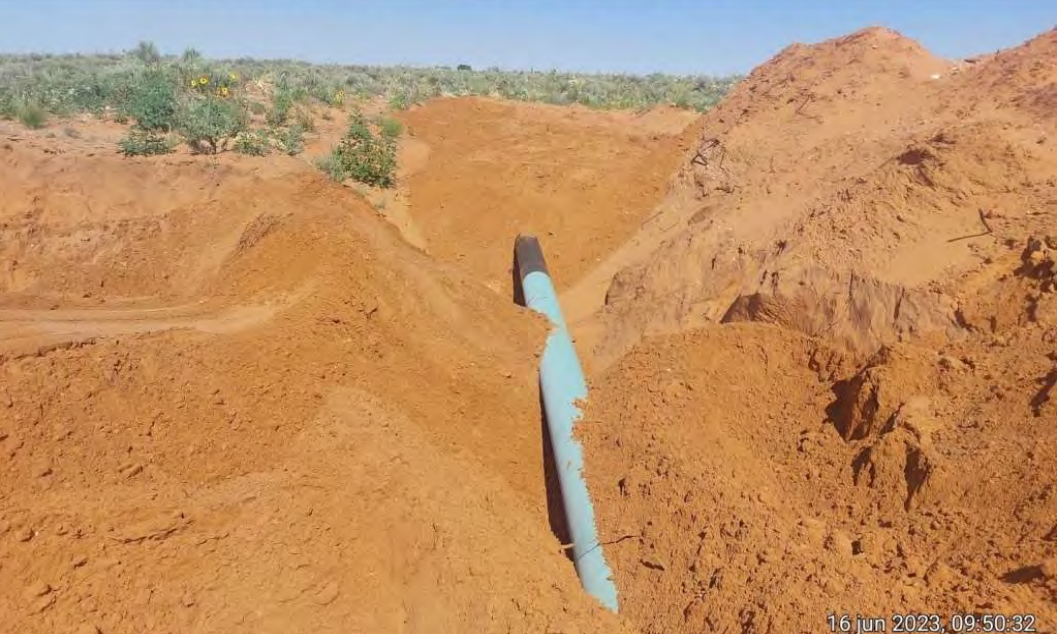
Photo:	6	Description: Backfilling
--------	---	--------------------------
