RE: Release Investigation, and Closure Report  
Cedar Breaks Walters Lake St. 1 6" Steel Line  
Unit M, Section 2, Township 18 South, Range 30 East  
32.772122°, -103.948648°  
Eddy County, New Mexico  
Terracon Project No. KH237027

Cedar Breaks Walters Lake St. 1 6" Steel Line

NMOCD Reference # nAPP2303731028

Terracon Project # KH237027

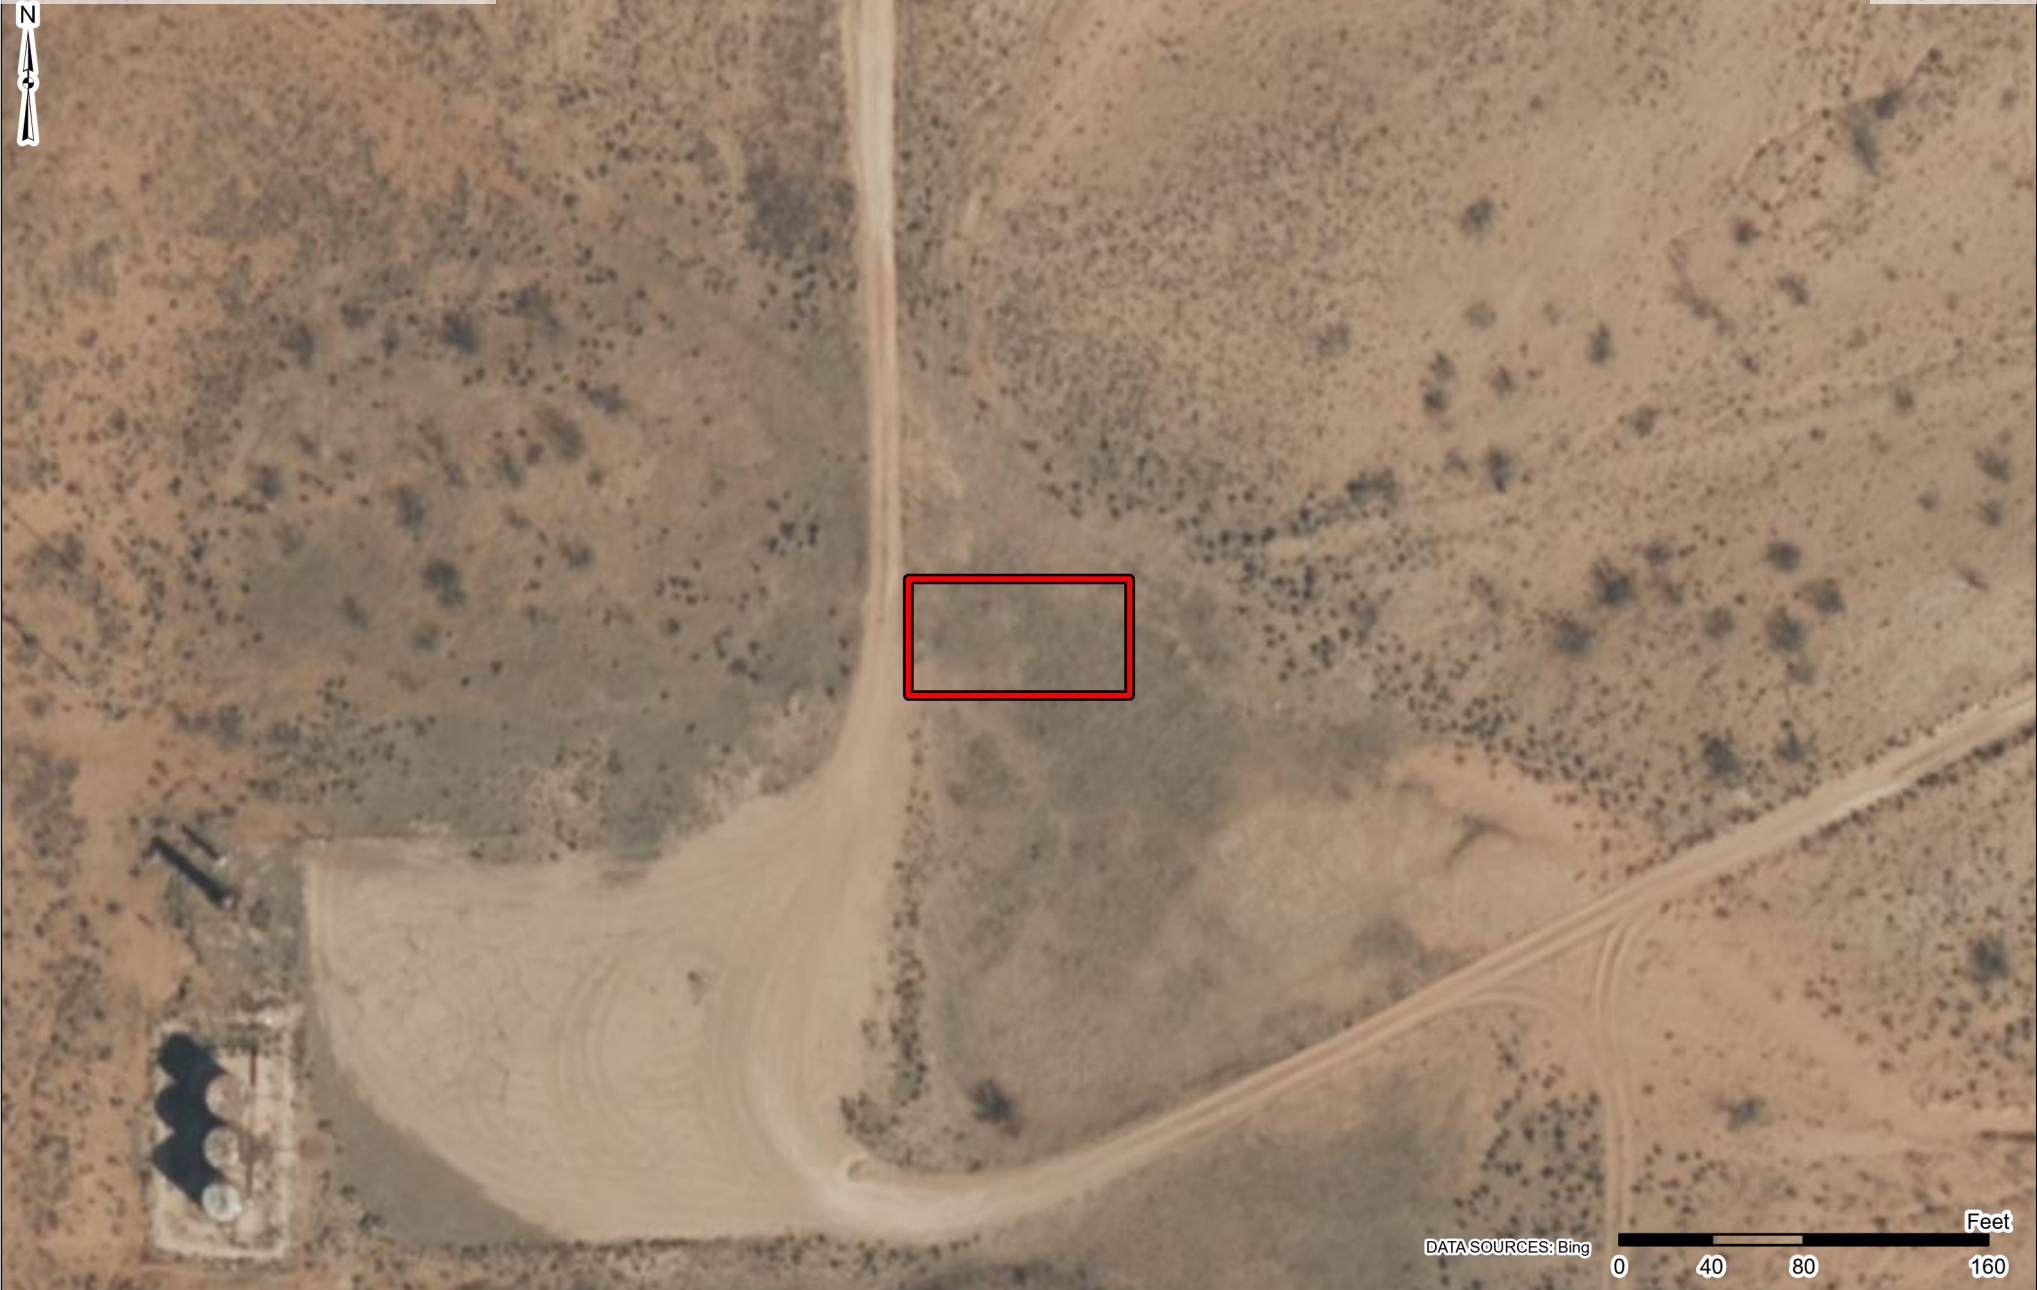
Exhibit
2

On March 28, 2023, Terracon mobilized to the site to meet Remediation Construction Services (RCS) personnel, who were to perform soil remediation activities. Areas exhibiting visual impact were excavated to a depth of approximately 4 to 8 feet bgs.

Excavation Boundary

Site Location Map
Cedar Breaks Walter Lake St. 1 6" Steel Line Durango 32.772122°, -103.948648°

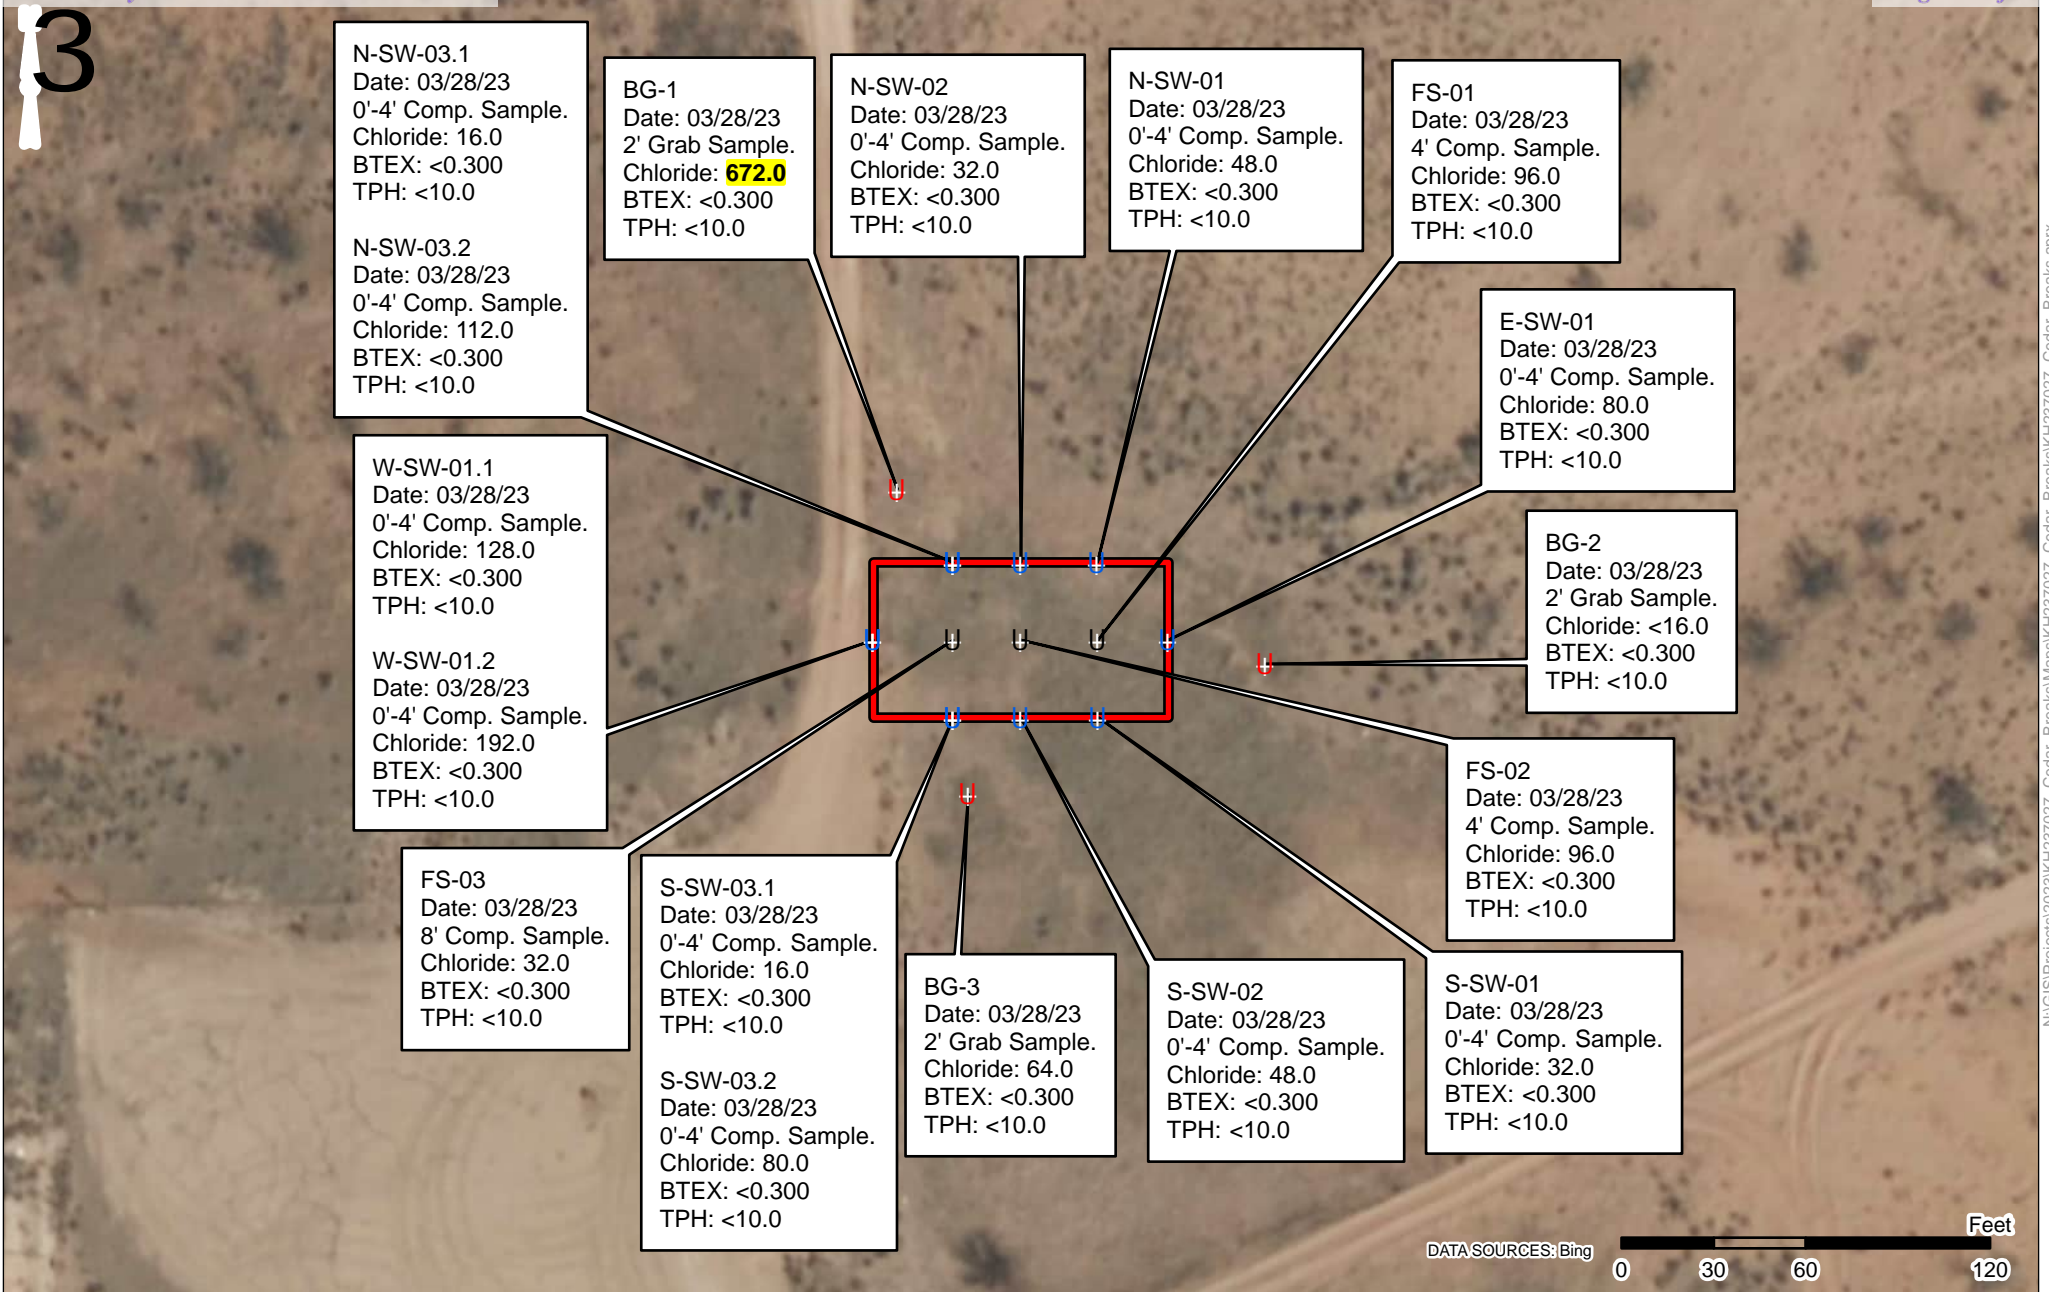
3

A total of 14 composite soil samples (N-SW-01 through 03.2, S-SW-01 through 03.2, E-SW-01, W-SW-01-1.2, and FS-01 through 03) were collected from the excavation, placed in laboratory-provided sample containers, preserved with ice, and transported under a chain of custody to Cardinal Laboratories in Hobbs, New Mexico for analysis of BTEX, TPH, and chlorides.

Excavation Boundary

Sample Locations

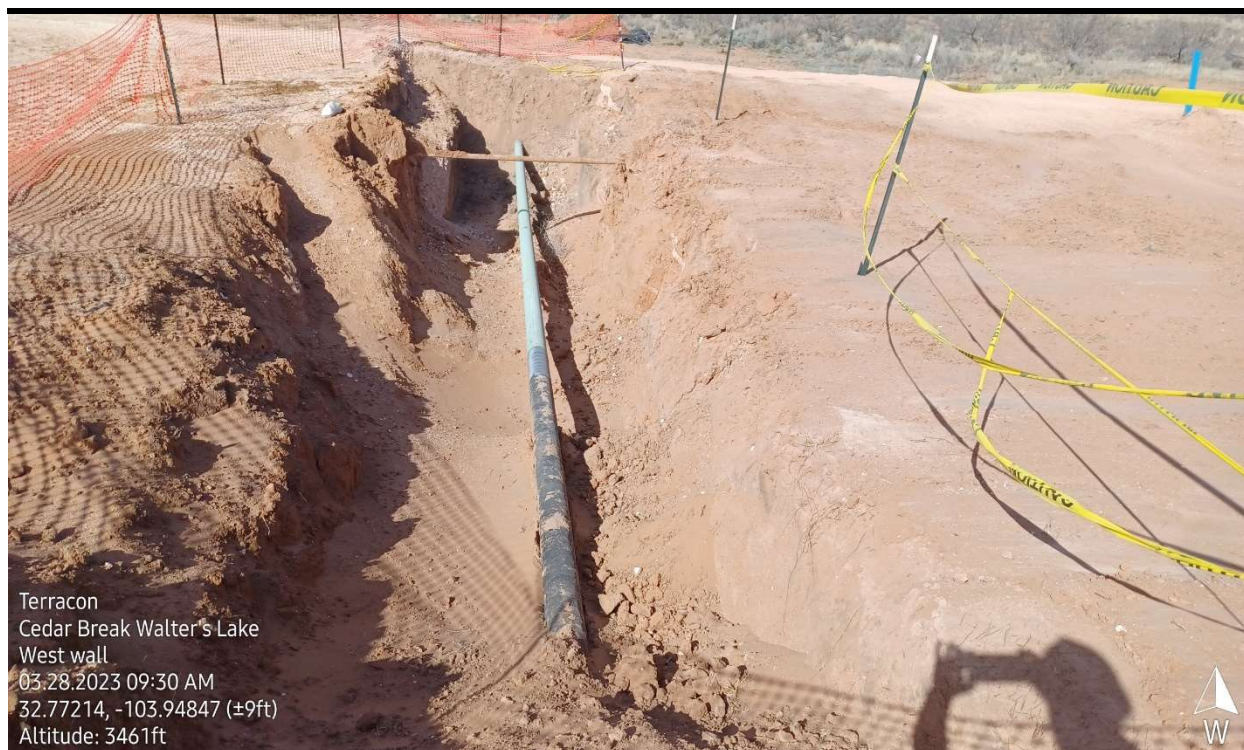
Terracon  
Cedar Break Walter's Lake  
West wall  
03/28/2023 09:30 AM  
32.77214, -103.94847 (±9ft)  
Altitude: 3461ft

**PHOTO 1:** View of area before excavation

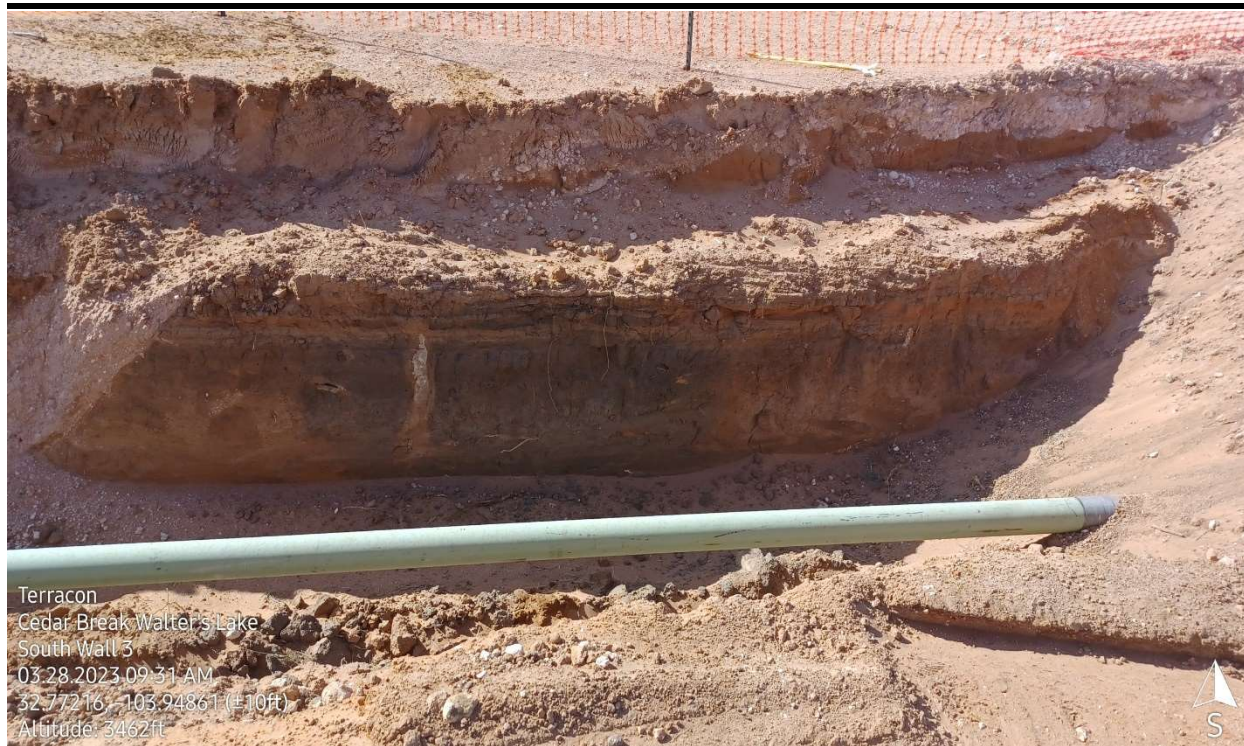
Terracon  
Cedar Break Walter's Lake  
South Wall 3  
03/28/2023 09:31 AM  
32.77216, -103.94861 (±10ft)  
Altitude: 3462ft

**PHOTO 2:** View of South Wall before excavation

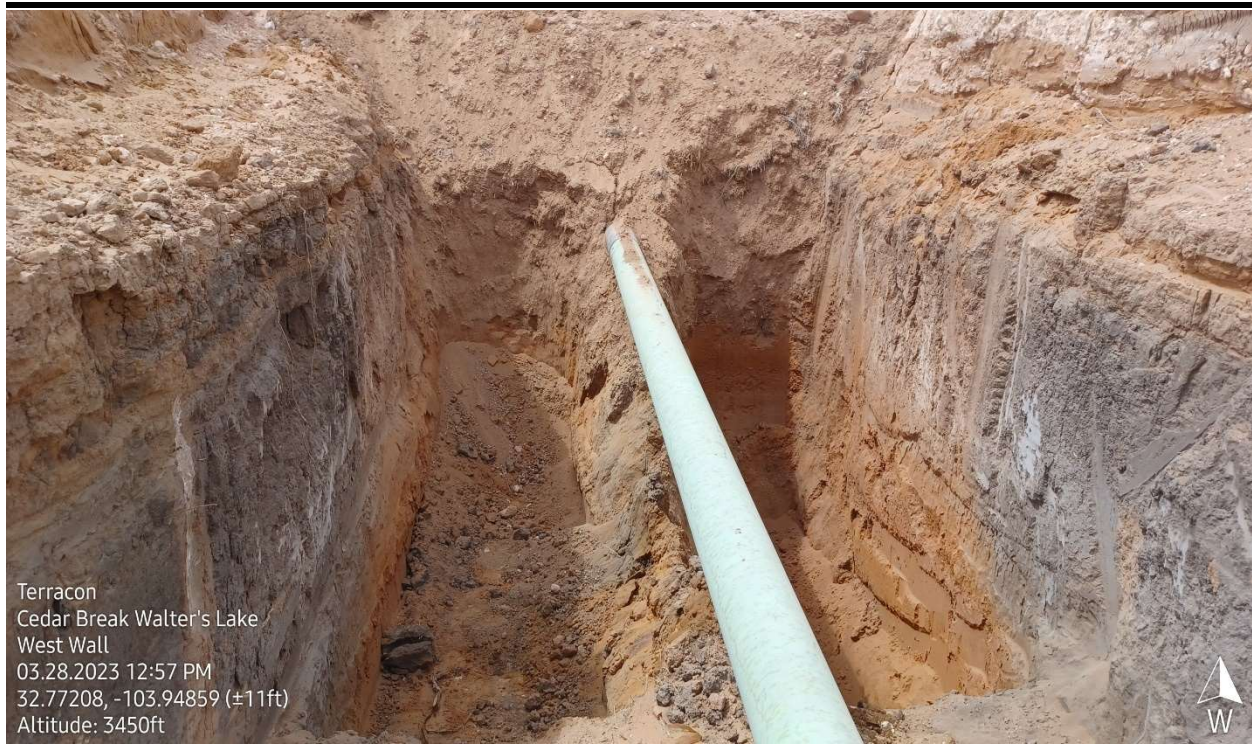
Terracon  
Cedar Break Walter's Lake  
West Wall  
03.28.2023 12:57 PM  
32.77208, -103.94859 (±11ft)  
Altitude: 3450ft

**PHOTO 3:** View of West Wall after excavation

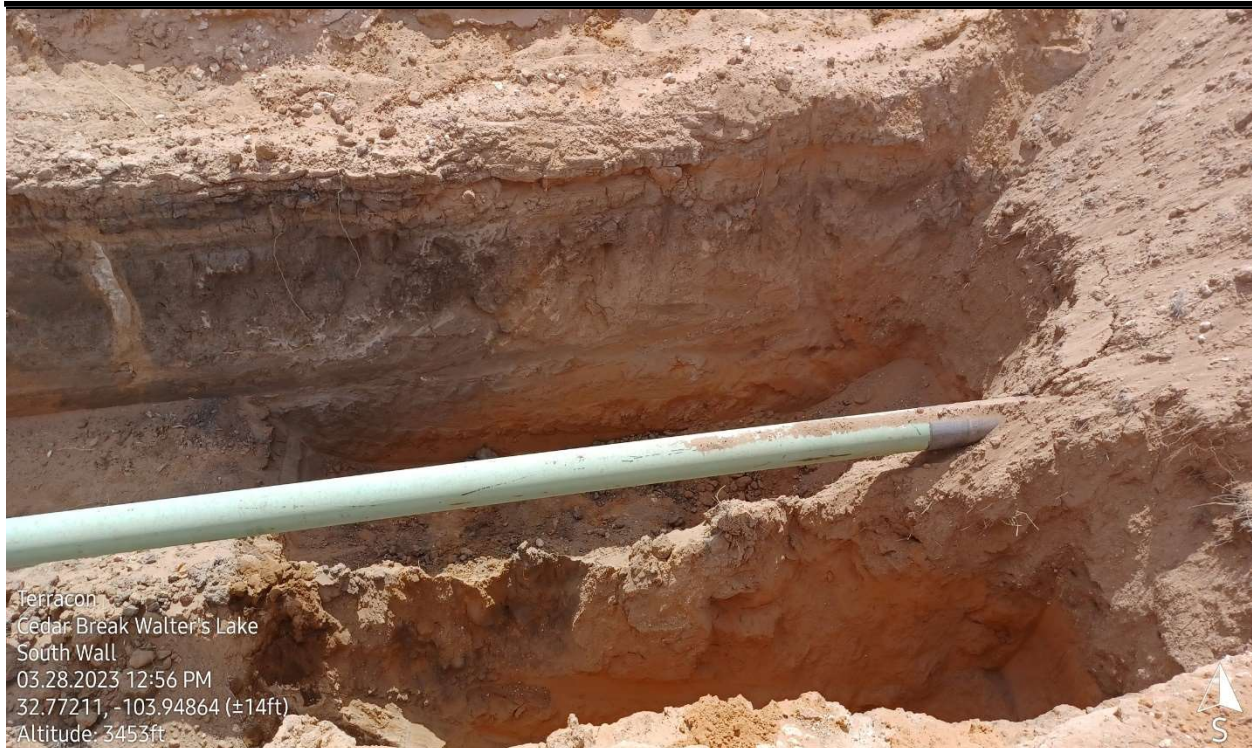
Terracon  
Cedar Break Walter's Lake  
South Wall  
03.28.2023 12:56 PM  
32.77211, -103.94864 (±14ft)  
Altitude: 3453ft

**PHOTO 4:** View of South Wall after excavation
