**Re: REVISED Release Characterization and Remediation Work Plan  
ConocoPhillips (Heritage COG Operating LLC)  
GJ West Coop Unit South Tank Battery Release  
Unit Letter B, Section 28, Township 17 South, Range 29 East  
Eddy County, New Mexico  
2RP-4923  
Incident ID nMAP1822950996**

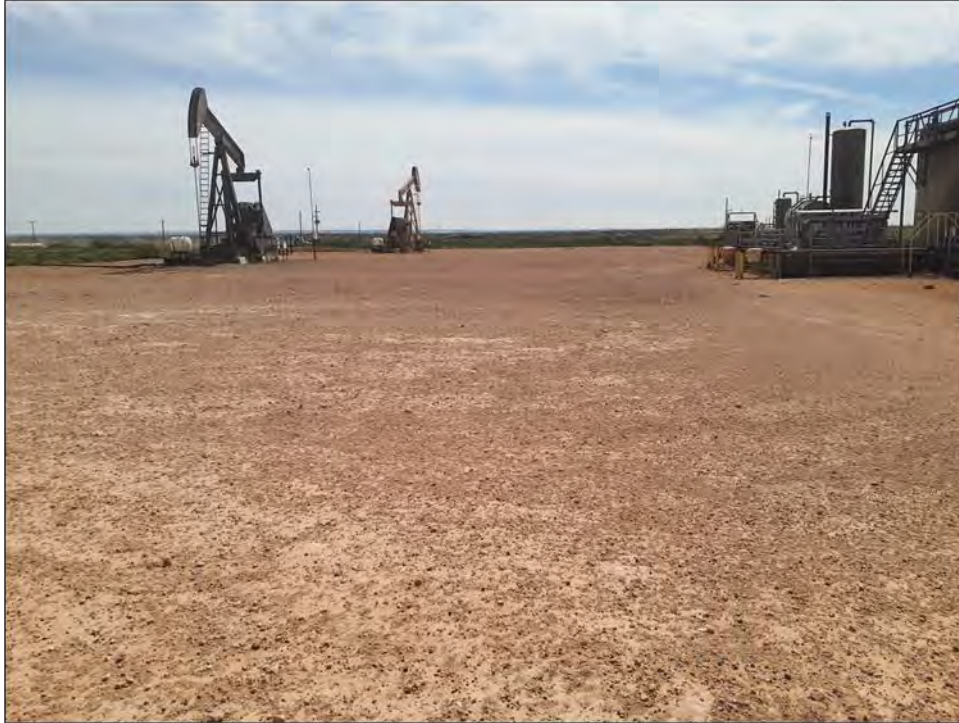
**Figure 4. Project area overview from northwest survey area, facing east (Frame T18-9287).**

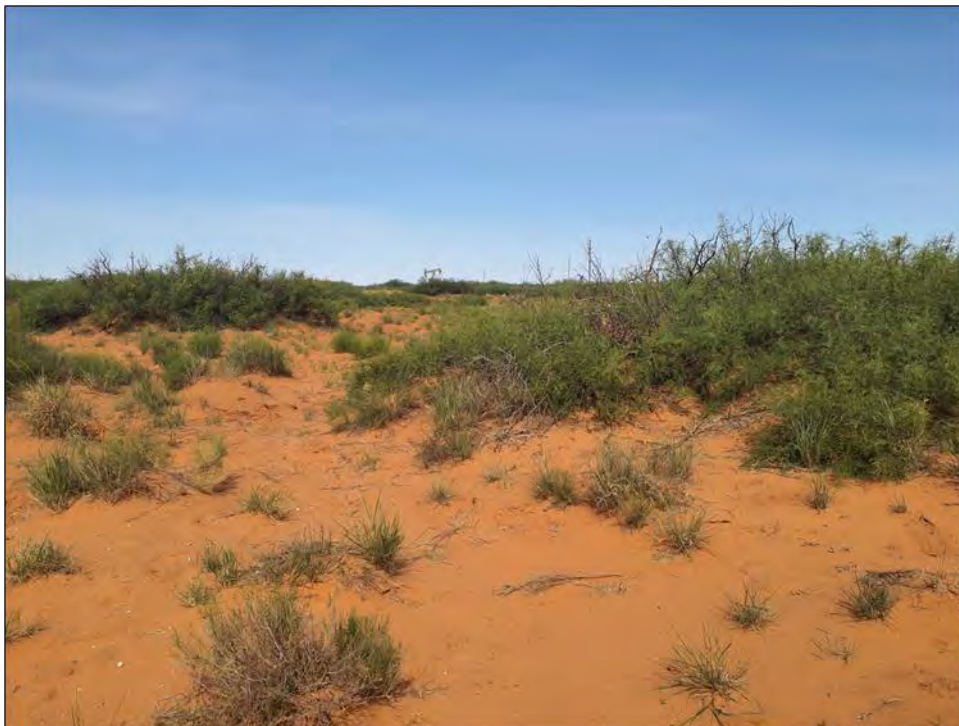
**Figure 5. Project area overview from southeast survey area, facing west (Frame T18-8450).**

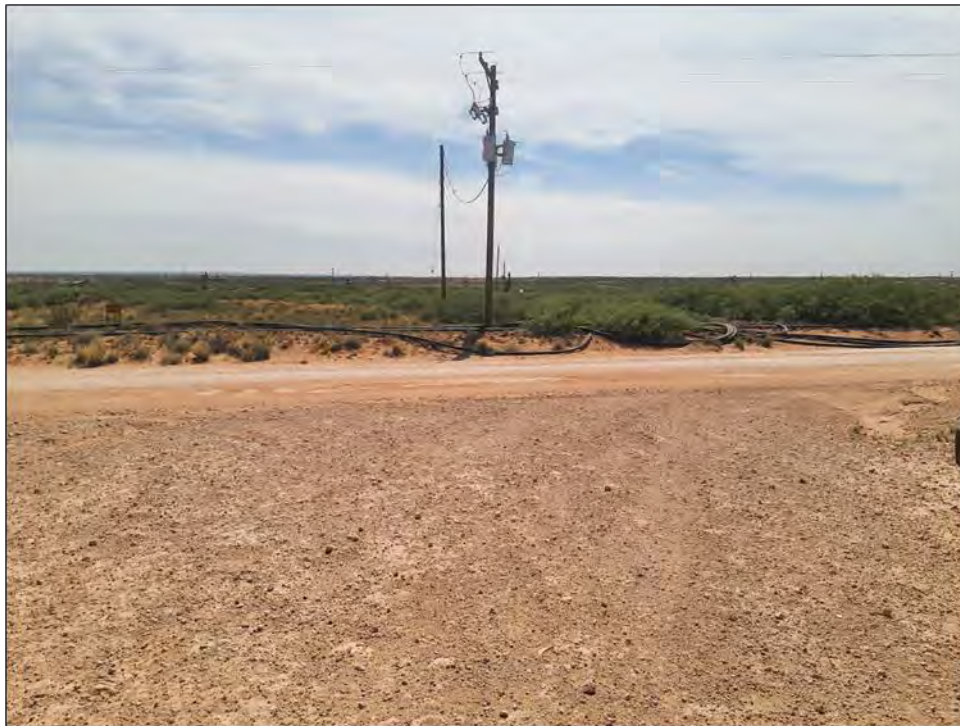
**Figure 6. Overview of location where spill crosses road, facing east (Frame T18-8387).**

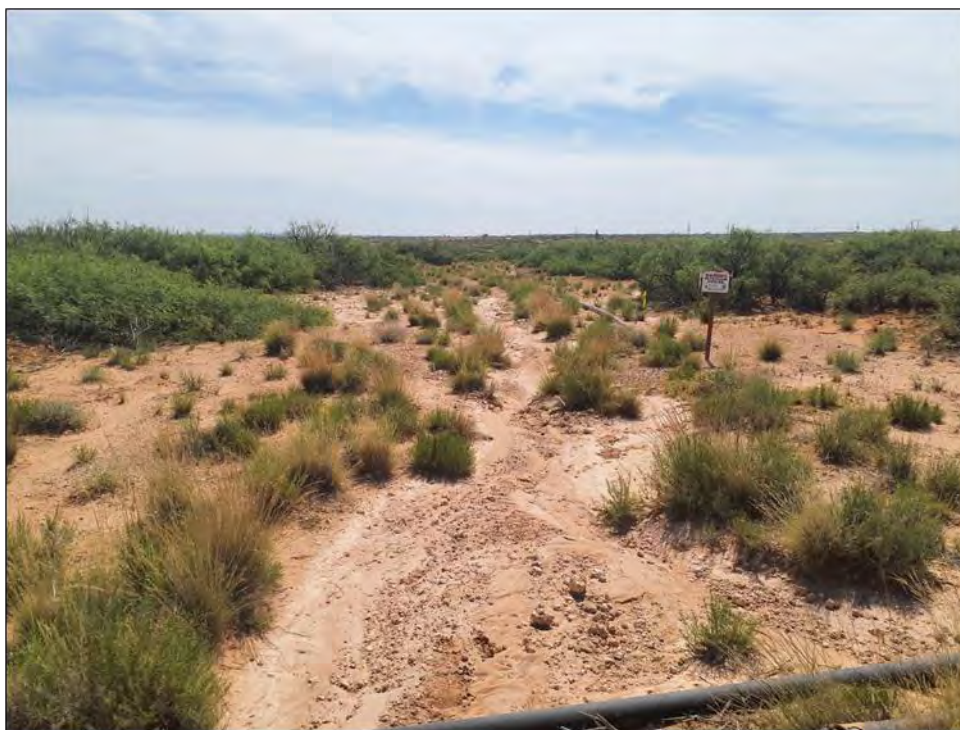
**Figure 7. Overview of spill area, facing east (Frame T18-6362).**

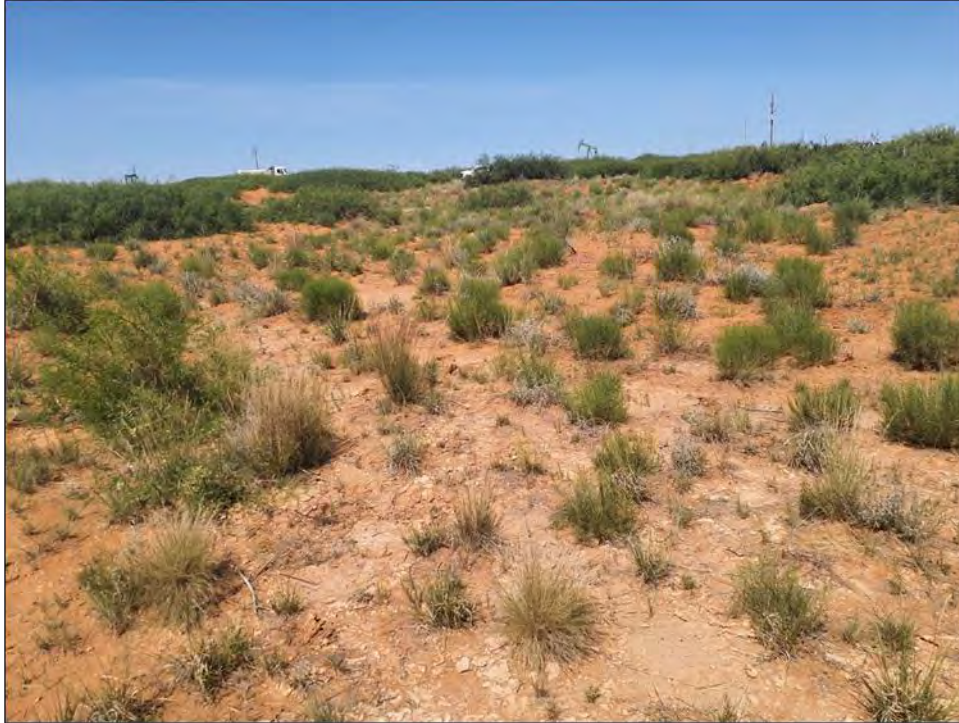
**Figure 8. Project area overview of spill area from southeast end, facing west (Frame T18-5304).**

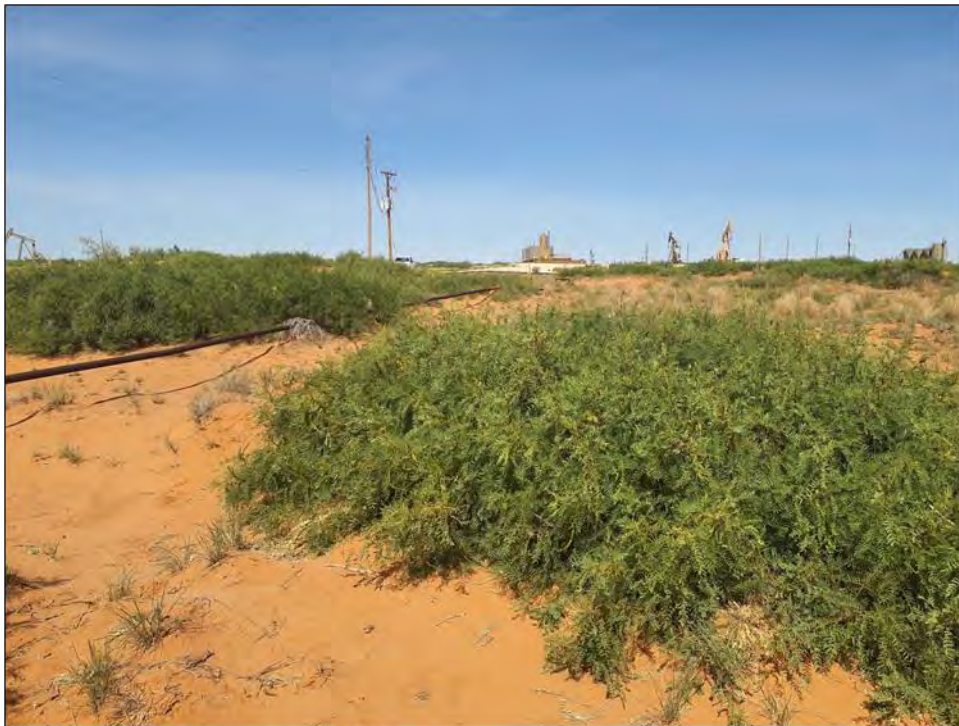
**Figure 9. Project area overview from northeast survey area, facing west (Frame T18-4401).**

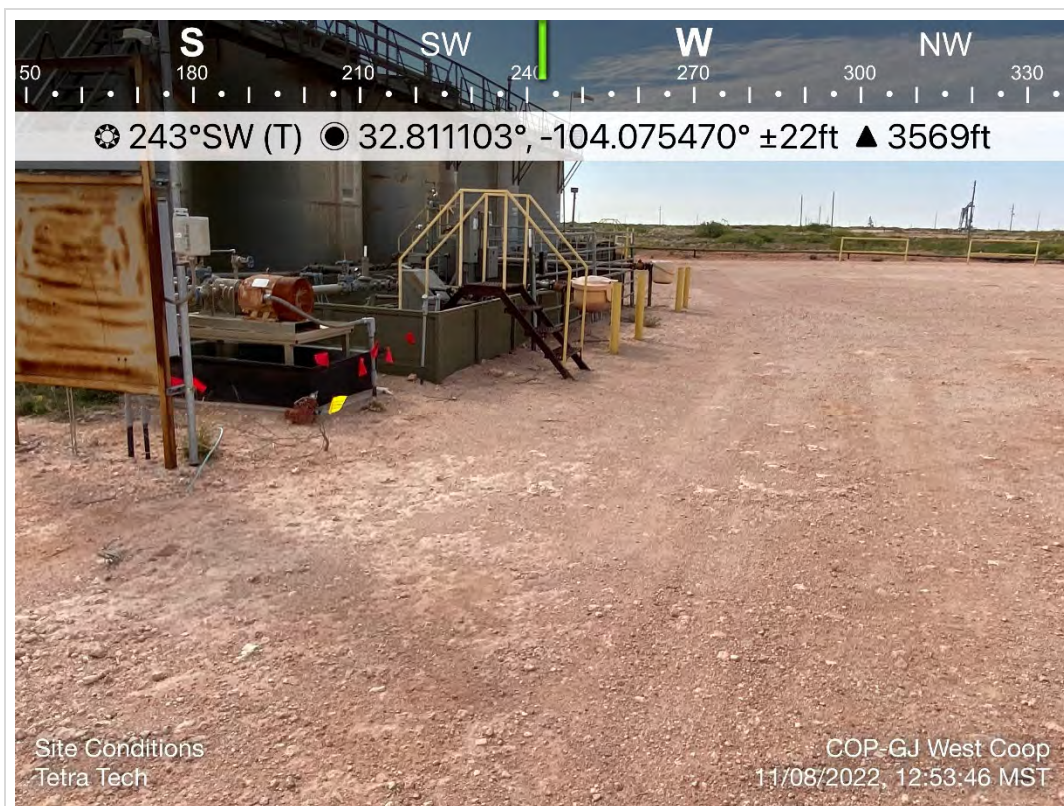
TETRA TECH, INC. PROJECT NO. 212C-MD-02848	DESCRIPTION	View southwest of lease pad, towards tank battery & approximate release point.	3
	SITE NAME	ConocoPhillips GJ West Coop South TB Release	11/08/2022

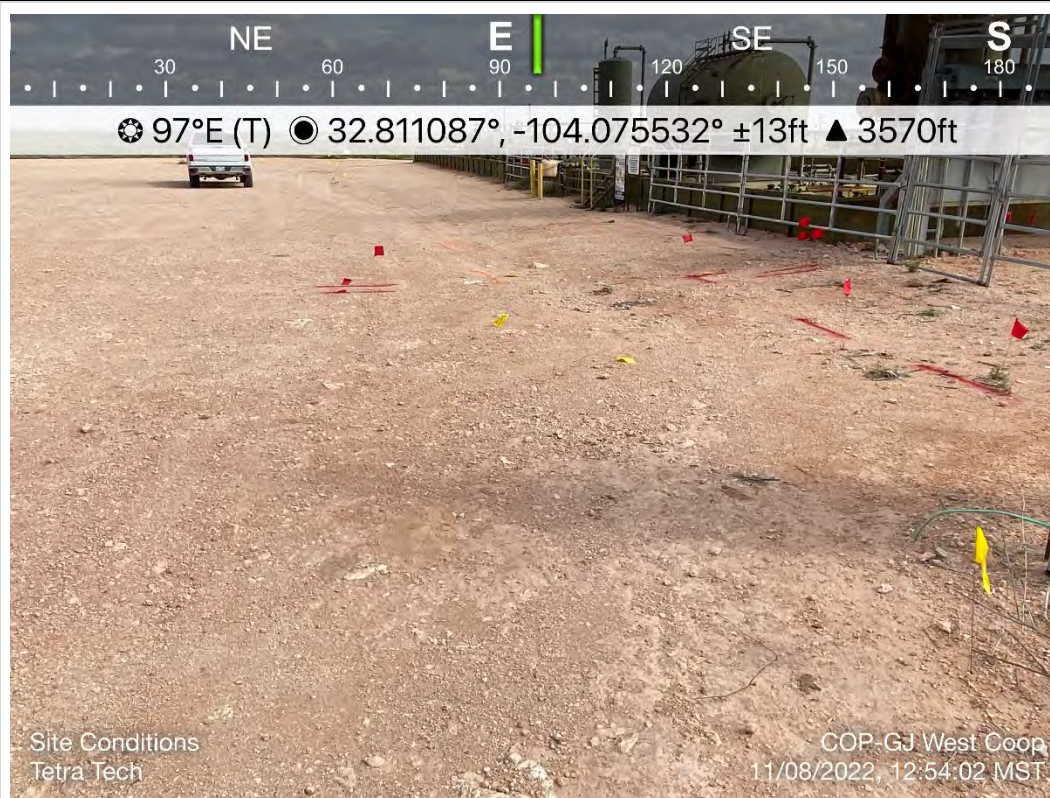
TETRA TECH, INC. PROJECT NO. 212C-MD-02848	DESCRIPTION	View east of the release area & lease pad. Various subsurface utilities present.	4
	SITE NAME	ConocoPhillips GJ West Coop South TB Release	11/08/2022

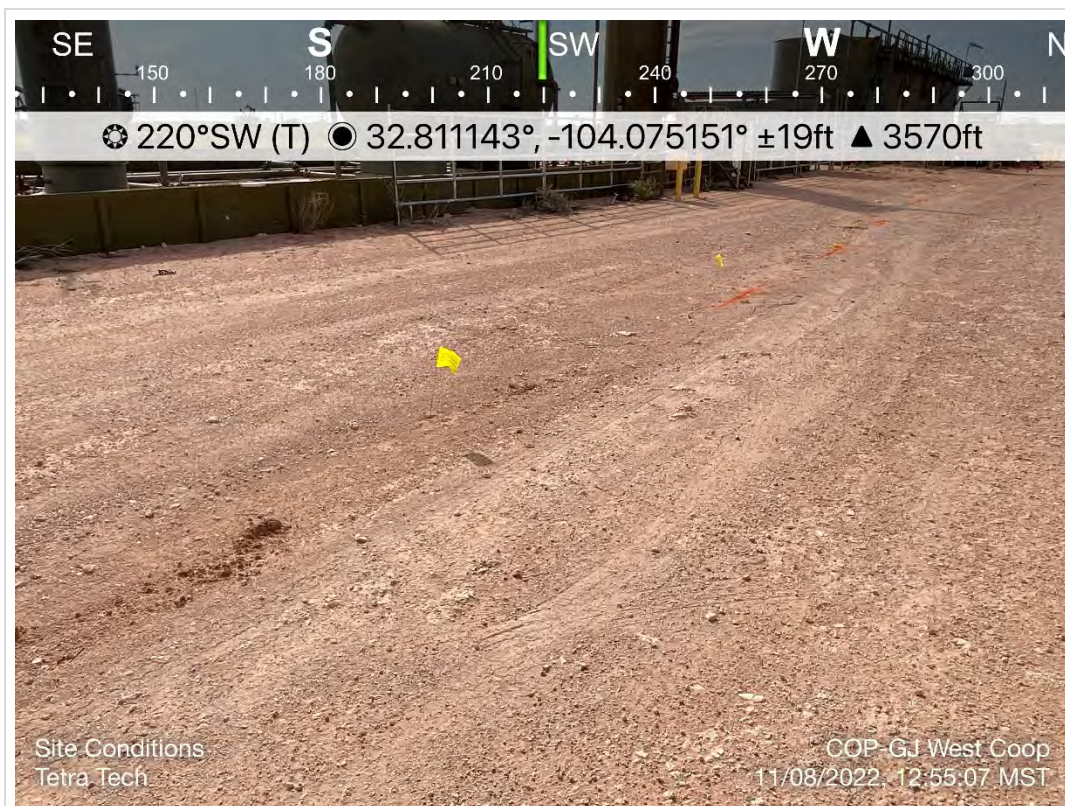
TETRA TECH, INC. PROJECT NO. 212C-MD-02848	DESCRIPTION	View southwest of the release area and lease pad. Subsurface Line present.	5
	SITE NAME	ConocoPhillips GJ West Coop South TB Release	11/08/2022

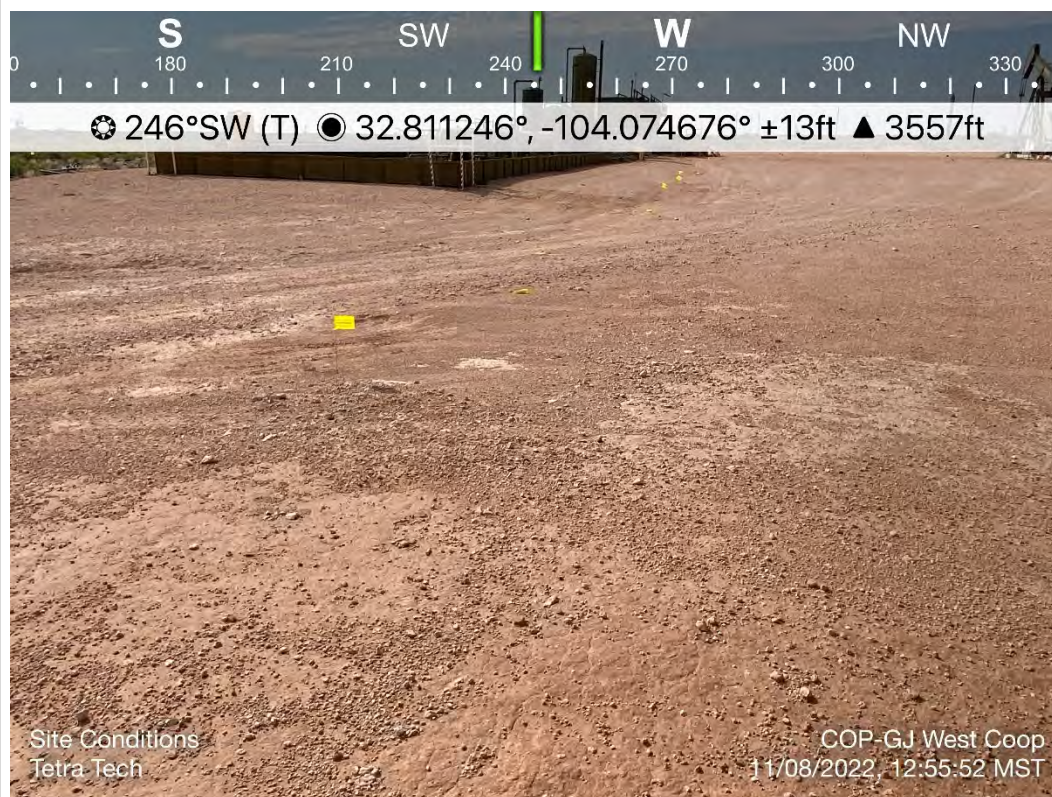
TETRA TECH, INC. PROJECT NO. 212C-MD-02848	DESCRIPTION	View west of the release area and lease pad. Subsurface line present.	6
	SITE NAME	ConocoPhillips GJ West Coop South TB Release	11/08/2022

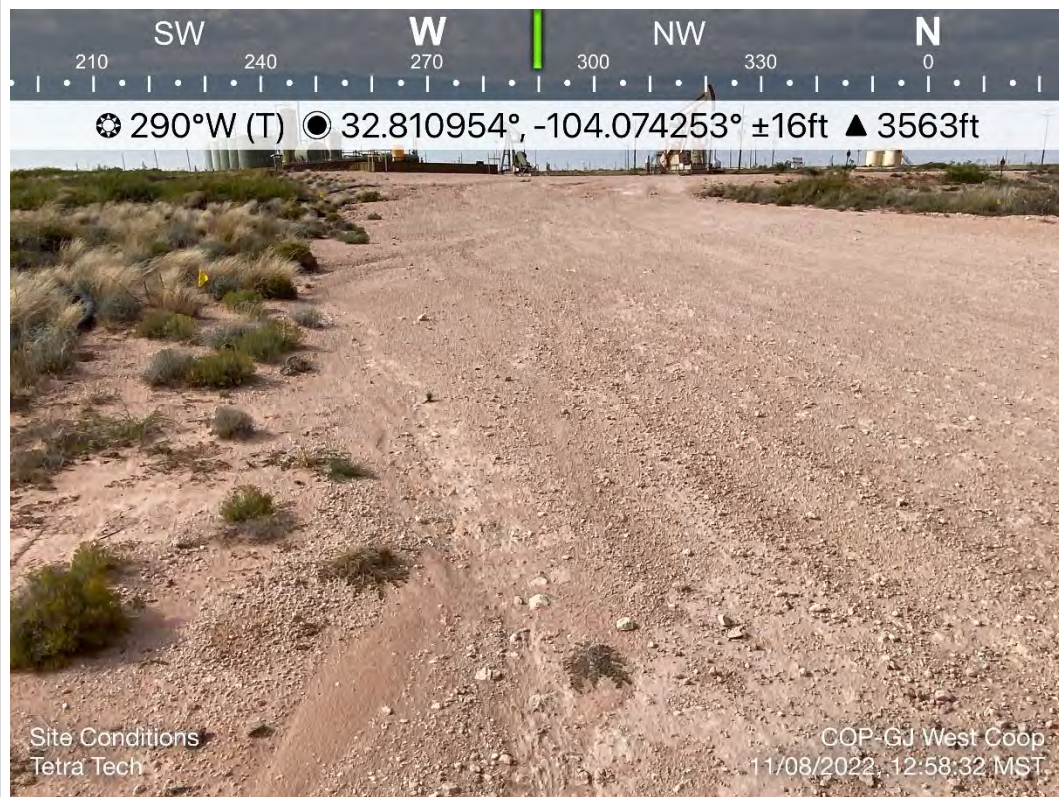
TETRA TECH, INC. PROJECT NO. 212C-MD-02848	DESCRIPTION	View west of release area, lease road/site entrance.	8
	SITE NAME	ConocoPhillips GJ West Coop South TB Release	11/08/2022

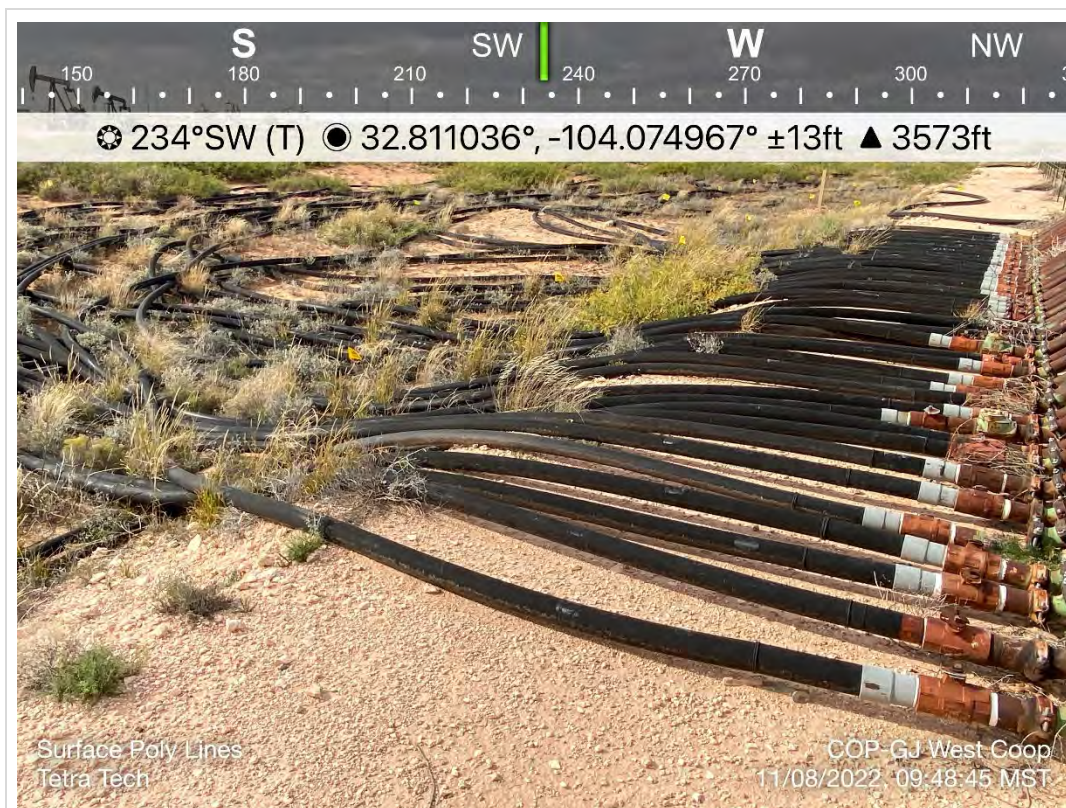
TETRA TECH, INC. PROJECT NO. 212C-MD-02848	DESCRIPTION	View southwest from the corner of the lease pad. Poly lines from southern pasture into on-site header.	9
	SITE NAME	ConocoPhillips GJ West Coop South TB Release	11/08/2022

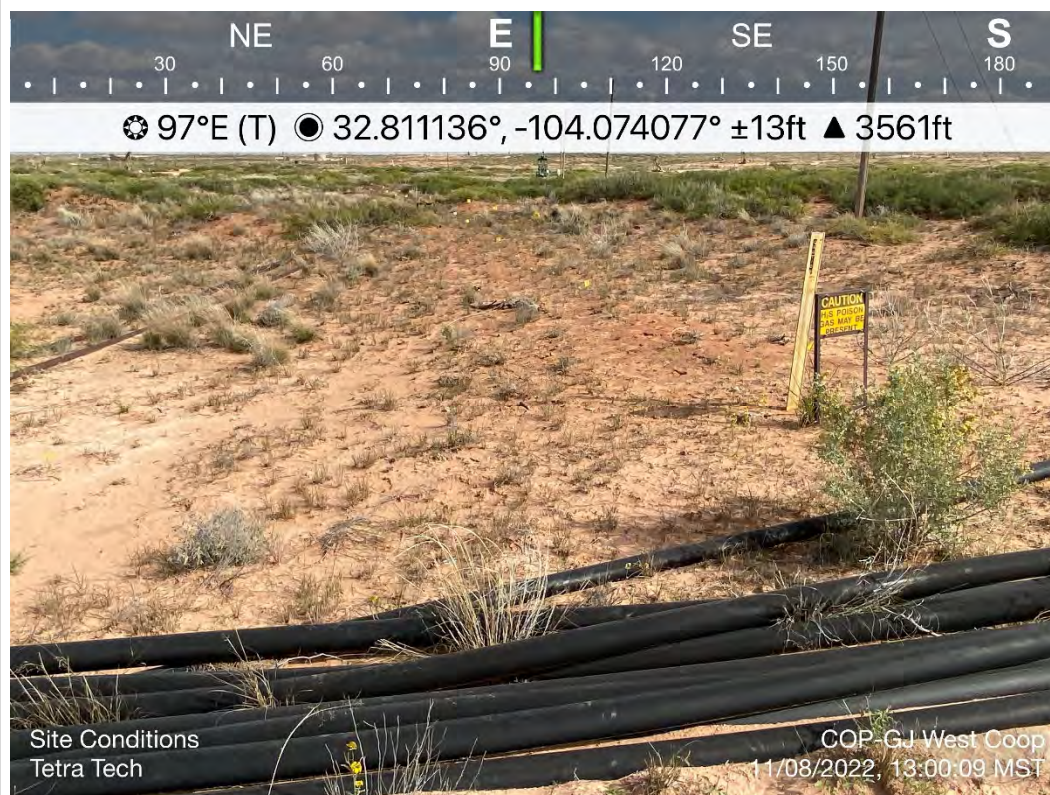
TETRA TECH, INC. PROJECT NO. 212C-MD-02848	DESCRIPTION	View east of release area across lease road. Surface lines and subsurface line with vegetation present	10
	SITE NAME	ConocoPhillips GJ West Coop South TB Release	11/08/2022

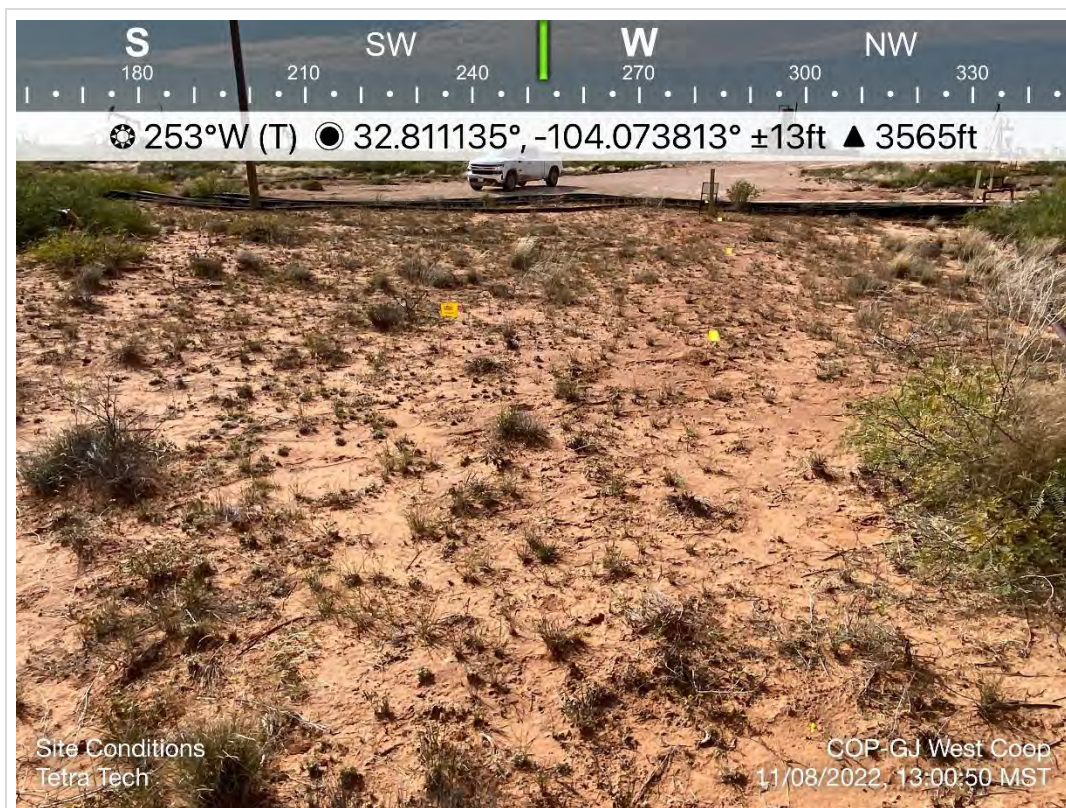
TETRA TECH, INC. PROJECT NO. 212C-MD-02848	DESCRIPTION	View west of the release area in eastern pasture, across lease road. Subsurface lines & vegetation present.	11
	SITE NAME	ConocoPhillips GJ West Coop South TB Release	11/08/2022

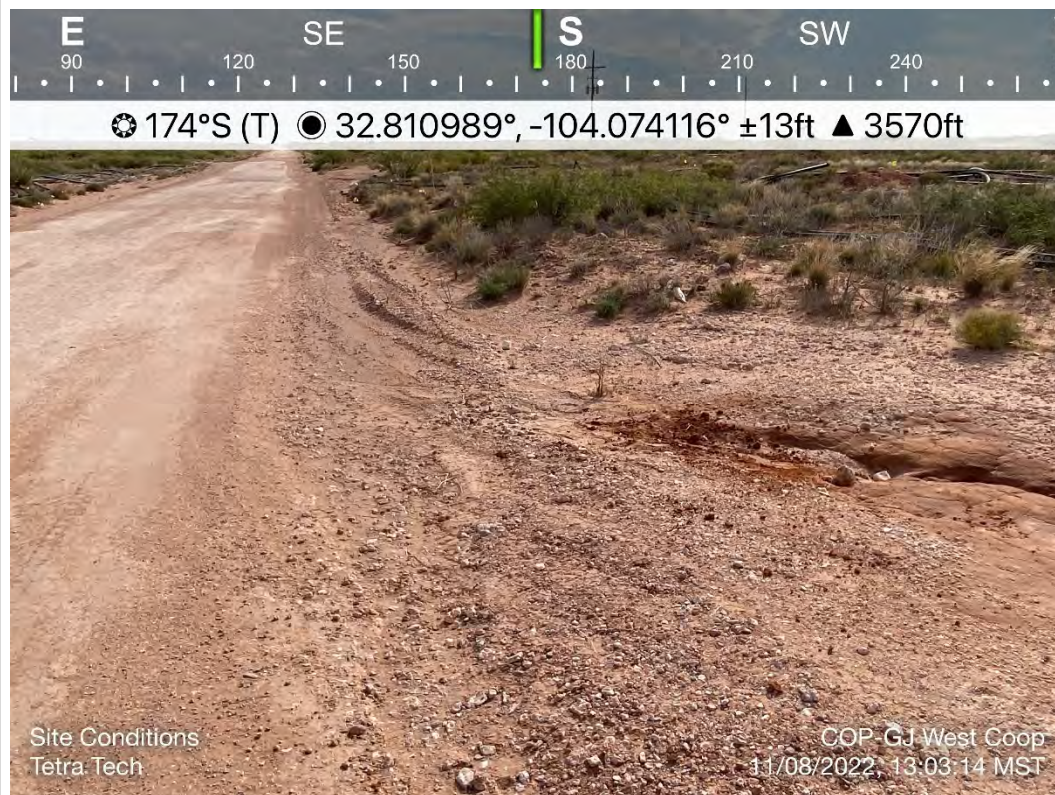
TETRA TECH, INC. PROJECT NO. 212C-MD-02848	DESCRIPTION	View south of the release area, along lease road. Vegetation present.	12
	SITE NAME	ConocoPhillips GJ West Coop South TB Release	11/08/2022

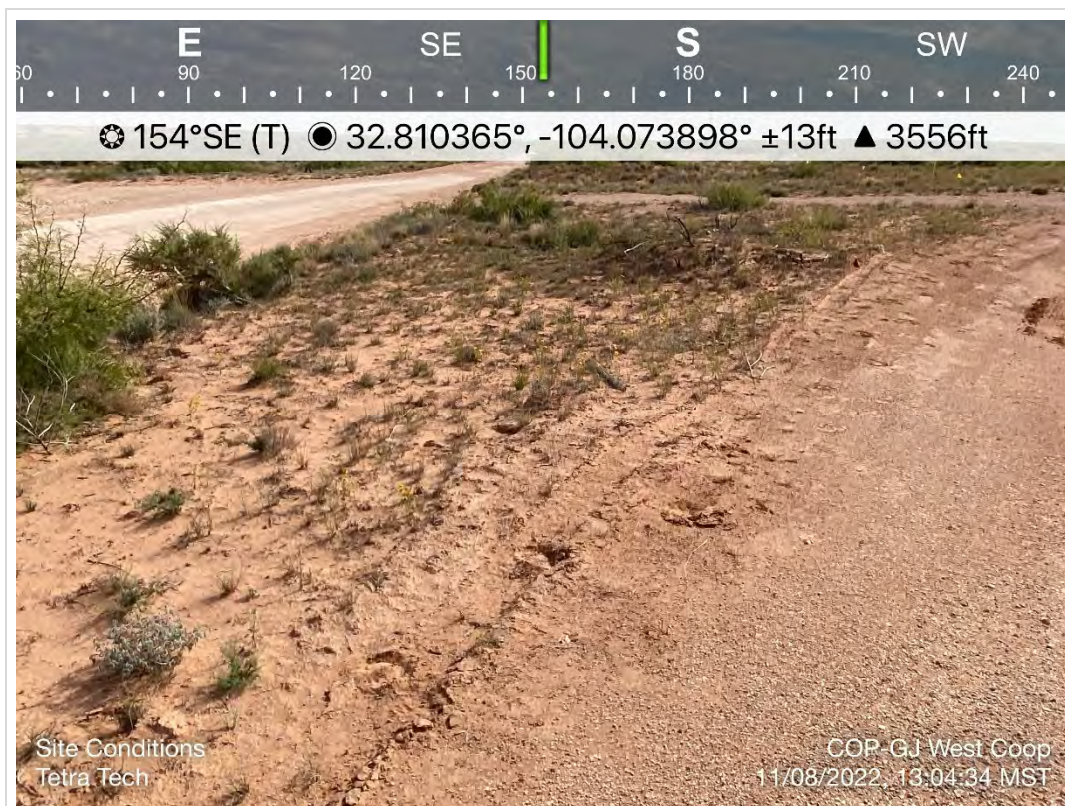
TETRA TECH, INC. PROJECT NO. 212C-MD-02848	DESCRIPTION	View southeast of the release area, along lease road. Vegetation present.	13
	SITE NAME	ConocoPhillips GJ West Coop South TB Release	11/08/2022

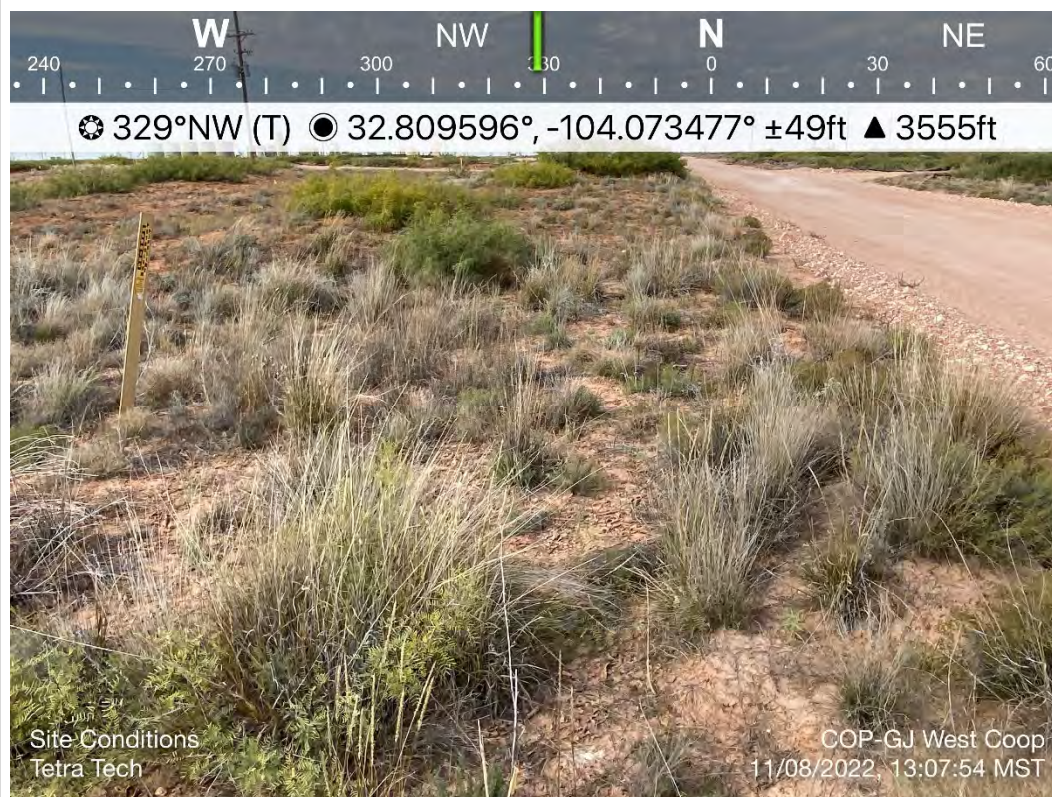
TETRA TECH, INC. PROJECT NO. 212C-MD-02848	DESCRIPTION	View northwest of the release area, along lease road. Vegetation present.	14
	SITE NAME	ConocoPhillips GJ West Coop South TB Release	11/08/2022

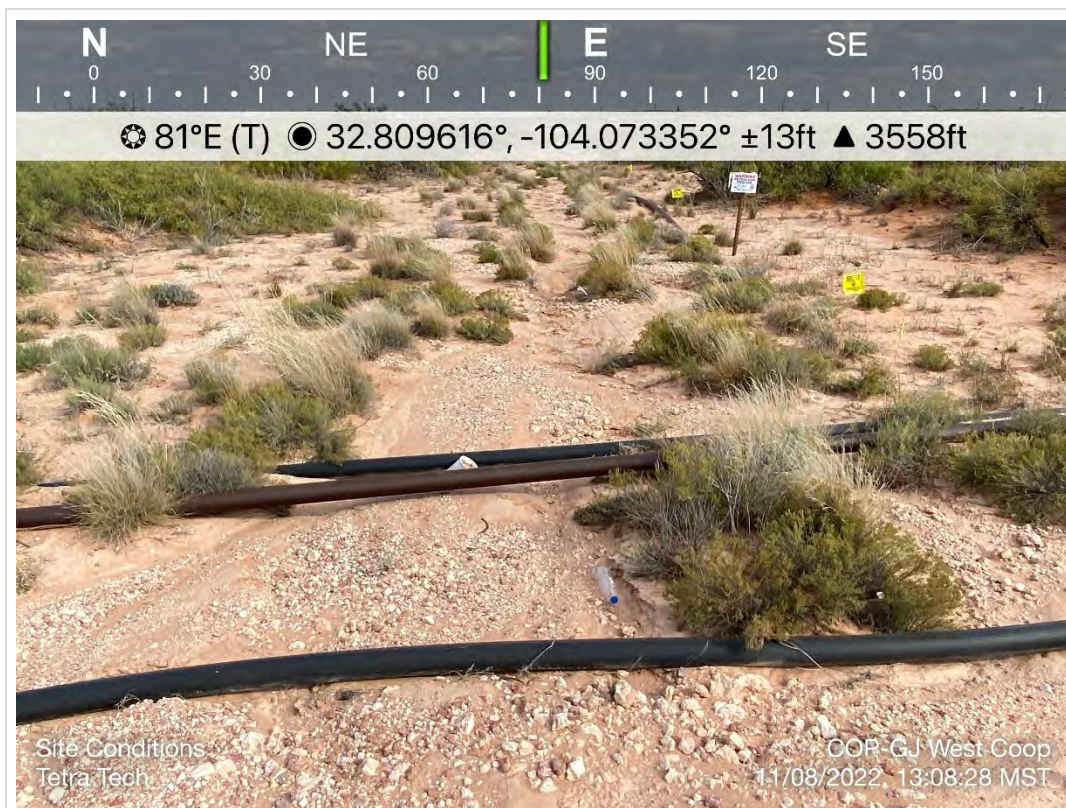
TETRA TECH, INC. PROJECT NO. 212C-MD-02848	DESCRIPTION	View east of the southeastern portion of the release area. Surface & subsurface lines present. Sparse vegetation.	15
	SITE NAME	ConocoPhillips GJ West Coop South TB Release	11/08/2022

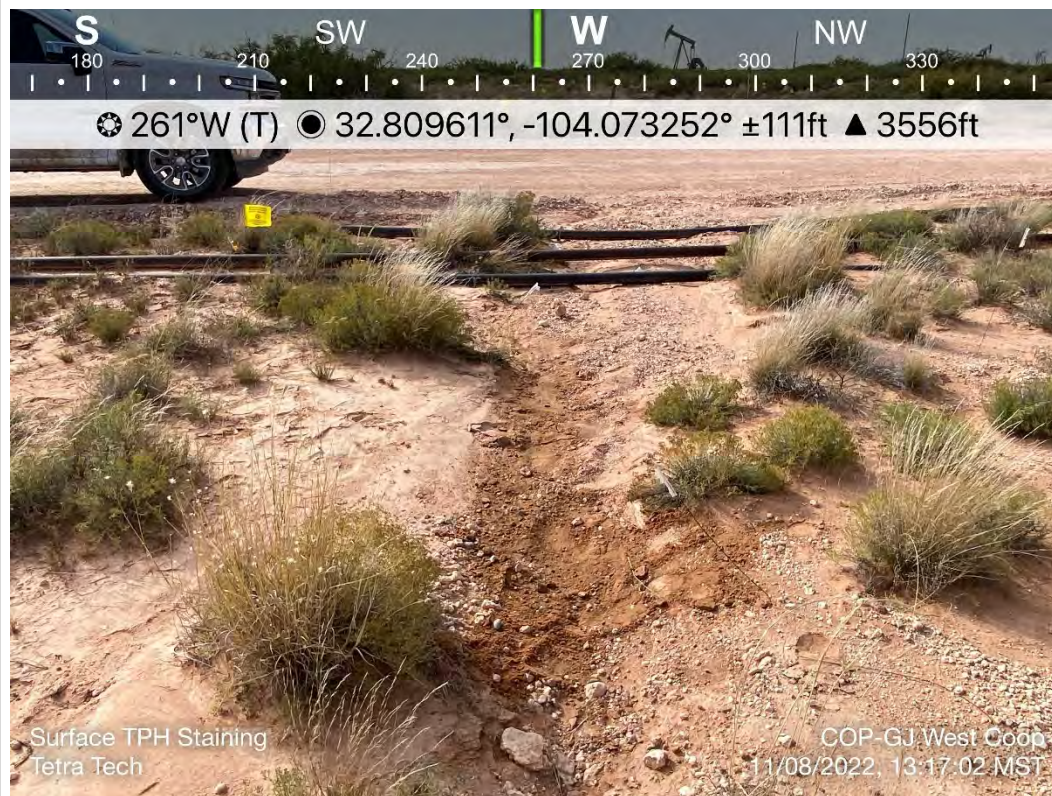
TETRA TECH, INC. PROJECT NO. 212C-MD-02848	DESCRIPTION	View west. Southeastern area of the release extent. Surface TPH staining & sparse vegetation present.	16
	SITE NAME	ConocoPhillips GJ West Coop South TB Release	11/08/2022

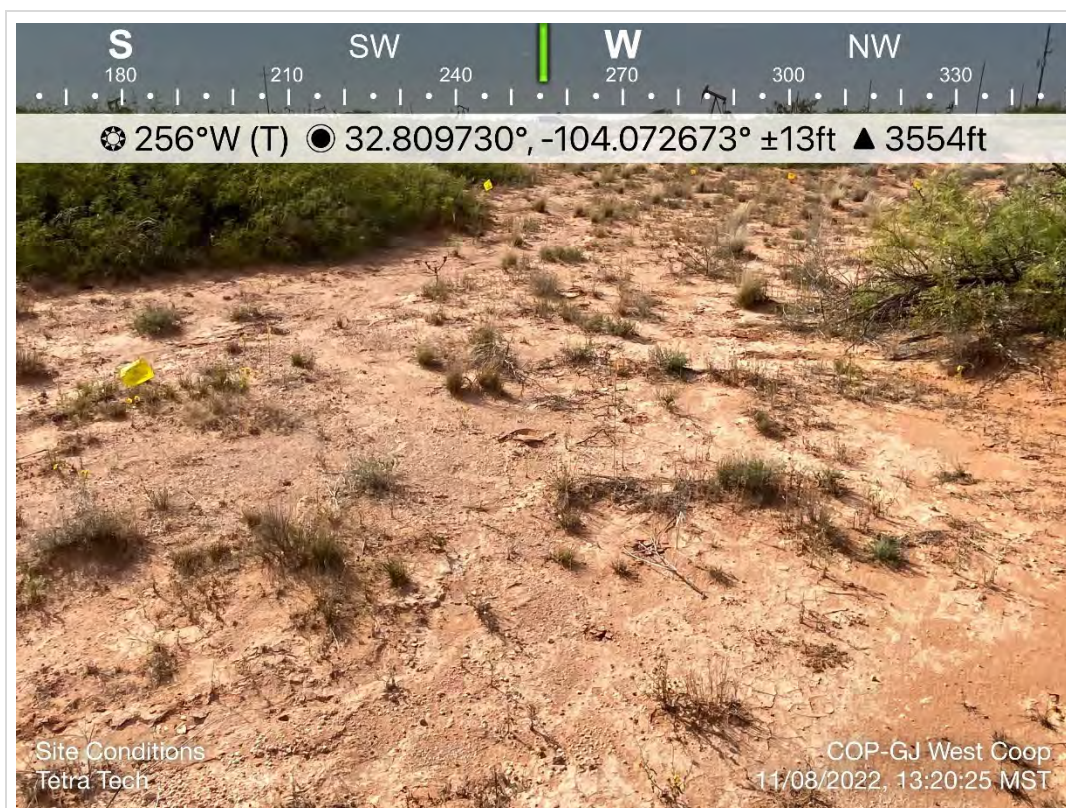
TETRA TECH, INC. PROJECT NO. 212C-MD-02848	DESCRIPTION	View west of the southeastern portion of the release area. Sparse vegetation present.	17
	SITE NAME	ConocoPhillips GJ West Coop South TB Release	11/08/2022

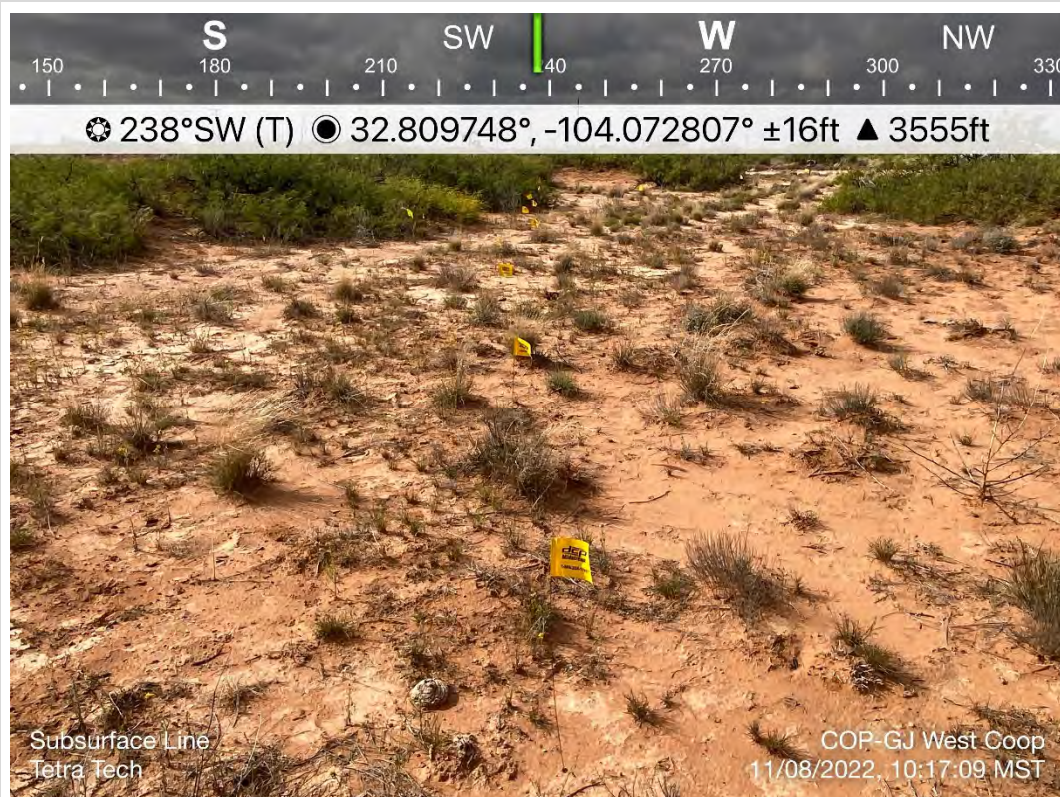
TETRA TECH, INC. PROJECT NO. 212C-MD-02848	DESCRIPTION	View southwest. Southern area of the release extent; Subsurface Plains Pipeline, vegetated.	18
	SITE NAME	ConocoPhillips GJ West Coop South TB Release	11/08/2022
