**Re: Closure Request
Rojo 20 21 Tank Battery
Incident Number nAPP2123554329
Lea County, New Mexico**

Ensolum, LLC (Ensolum), on behalf of BTA Oil Producers, LLC (BTA), has prepared this *Closure Request* to document assessment, excavation, and soil sampling activities performed at Rojo 20 21 Tank Battery (Site). The purpose of the excavation and soil sampling activities was to address impacts to soil resulting from the release of crude oil and produced water at the Site. Based on the excavation activities and laboratory analytical results from soil sampling events, BTA is submitting this *Closure Request*, describing remediation that has occurred and requesting closure for Incident Number nAPP2123554329.

BTA Oil Producers, LLC
Closure Request
Rojo 20 21 Tank Battery

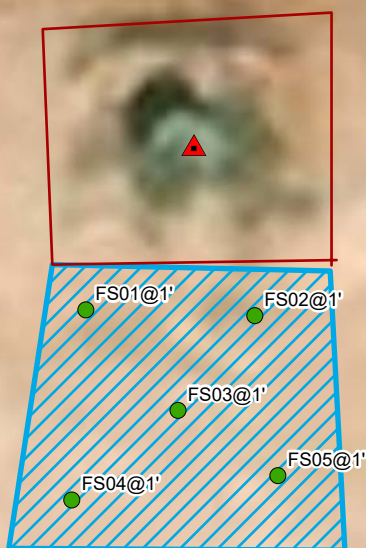
Notes:
Sample ID @ Depth Below Ground Surface.

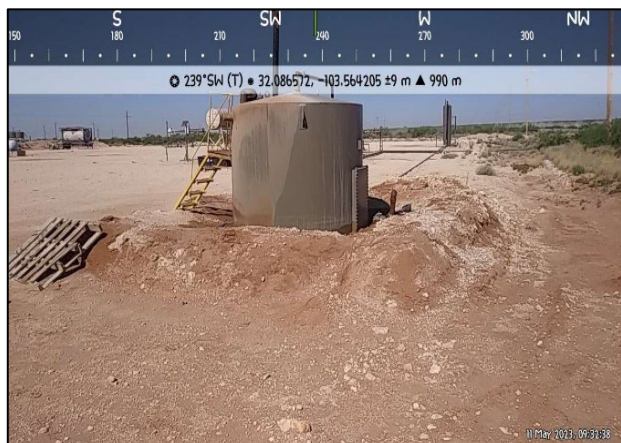
Photograph: 1 Date: 5/11/2023
Description: Initial assessment activities
View: Southwest

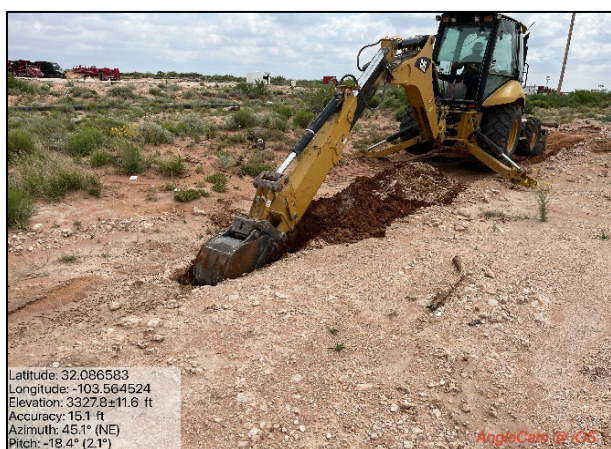
Photograph: 3 Date: 5/26/2023
Description: Delineation activities
View: Northeast

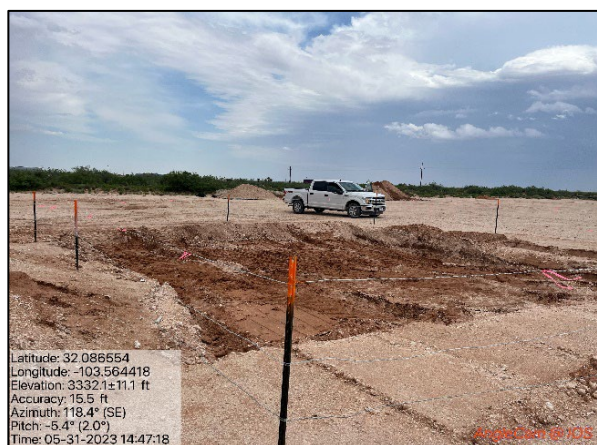
Photograph: 4 Date: 5/31/2023
Description: Excavation activities
View: Southeast
