Closure Report

Verna Rae Tank Battery
Lea County, New Mexico
API ID # 30-025-26547
Incident # NAPP2313060635

Subject: **Closure Report**
Verna Rae Tank Battery
Lea County, New Mexico
Facility ID # fAPP2203274819
Incident # NAPP2313060635

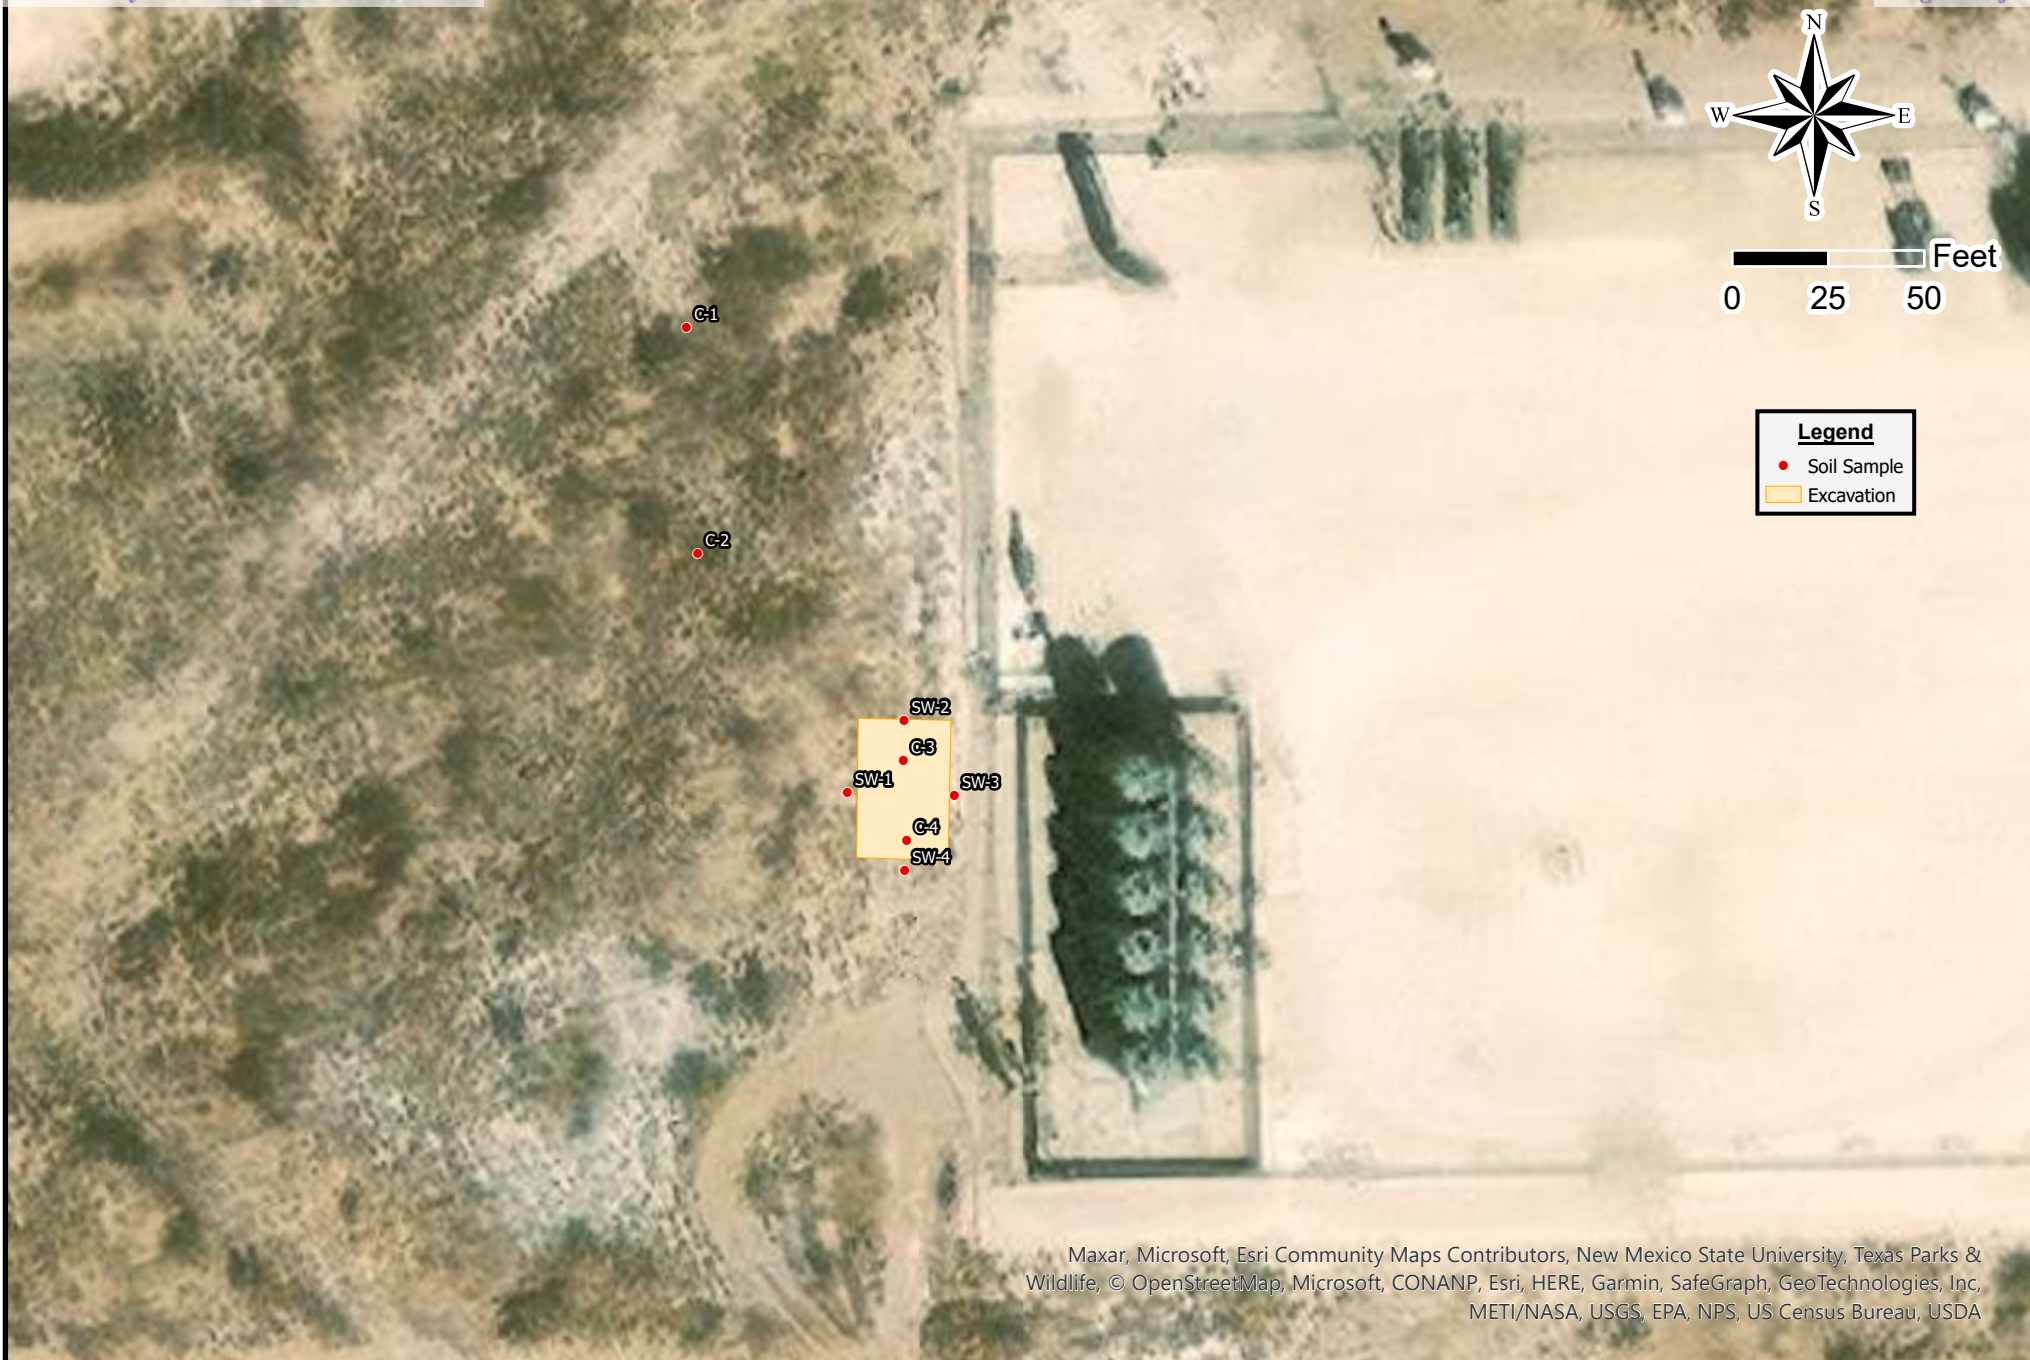
Figure 2

Matador Production Co.
Verna Rae CTB
Lea County, NM
Excavation Map

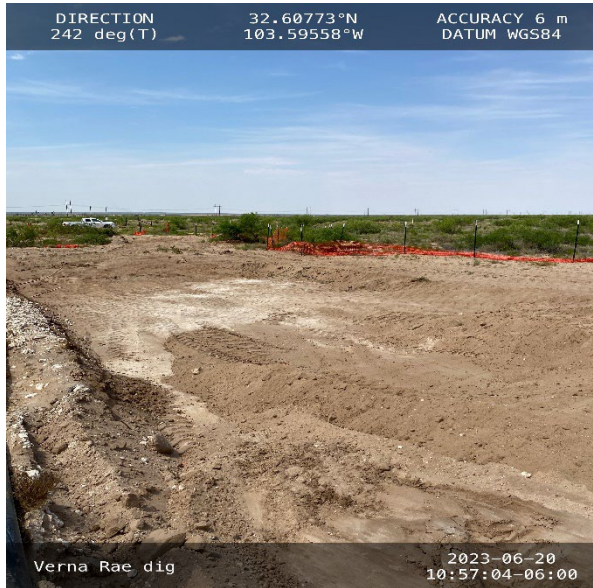
Photograph No.1 Description:

Excavation

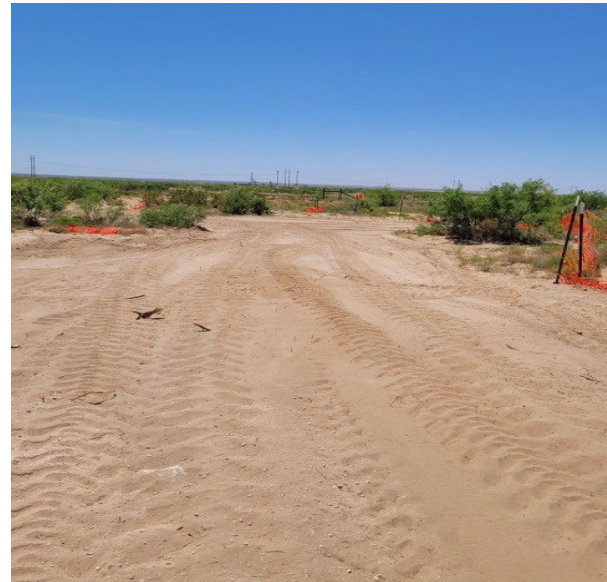
Photograph No.2 Description:

Backfill of excavation.

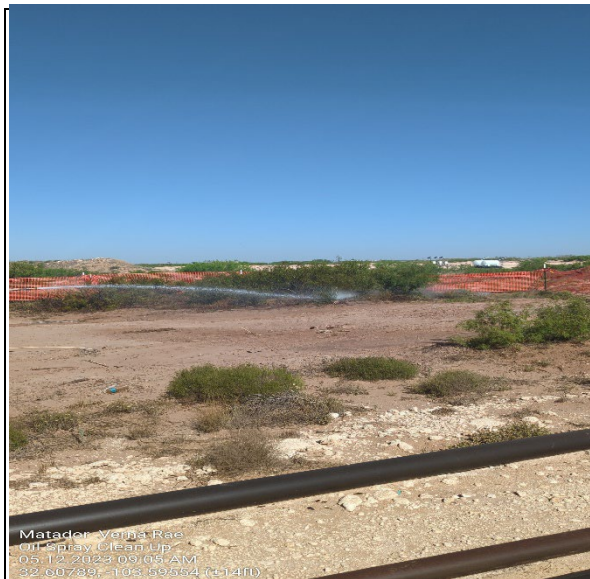
Photograph No.3 Description:

Micro-Blaze overspray

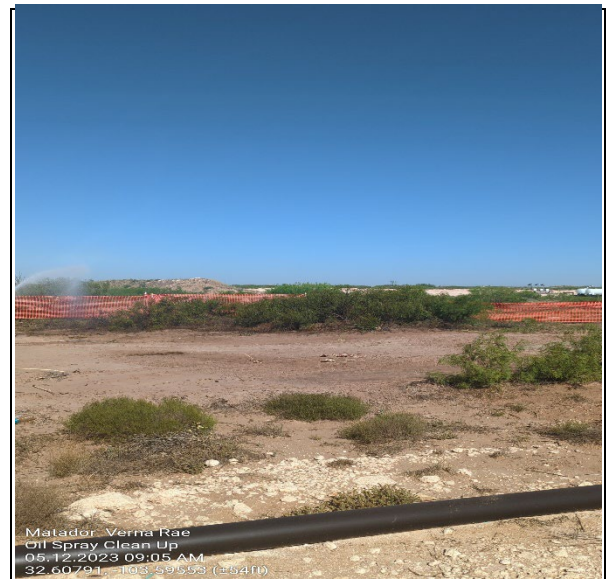
Photograph No.4 Description:

Micro-Blaze overspray
