# **Remediation Summary and Closure Request**

BTA Oil Producers, LLC
North Ridge East Tank Battery
Lea County, New Mexico
Unit Letter "A", Section 35, Township 22 South, Range 34 East
Latitude 32.352560 North, Longitude 103.436070 West
NMOCD Incident # nAPP2203851688

Hungry Horse, LLC 4024 Plains Hwy Lovington, NM 88260 Office: (575) 393-3386

August 2023

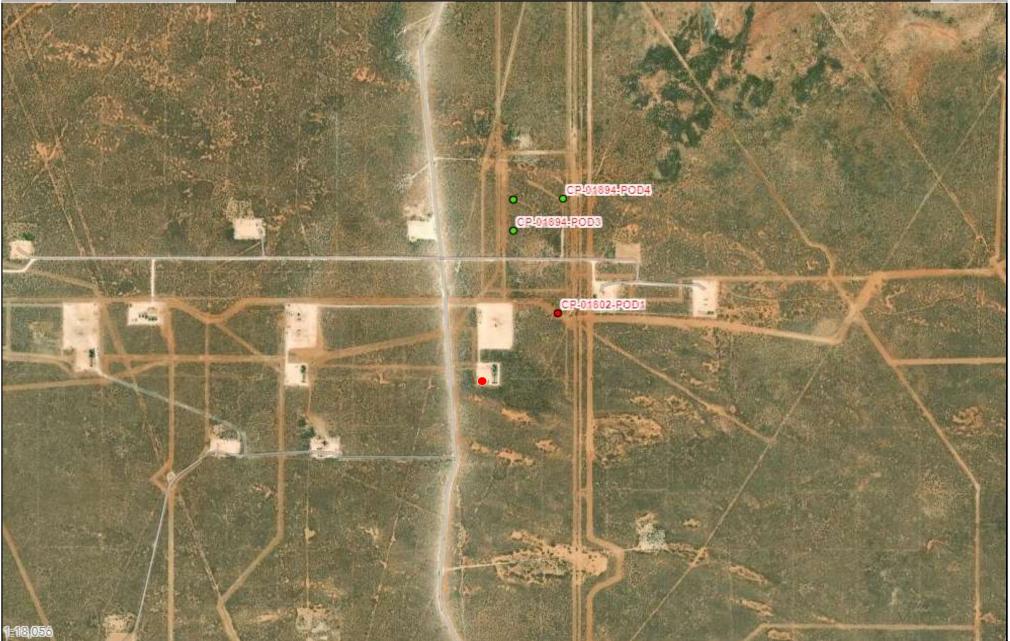
## Figure 2

**OSE POD Locations Map** BTA Oil Producers, LLC North Ridge East Tank Battery GPS: 32.35256, -103.43607 Lea County

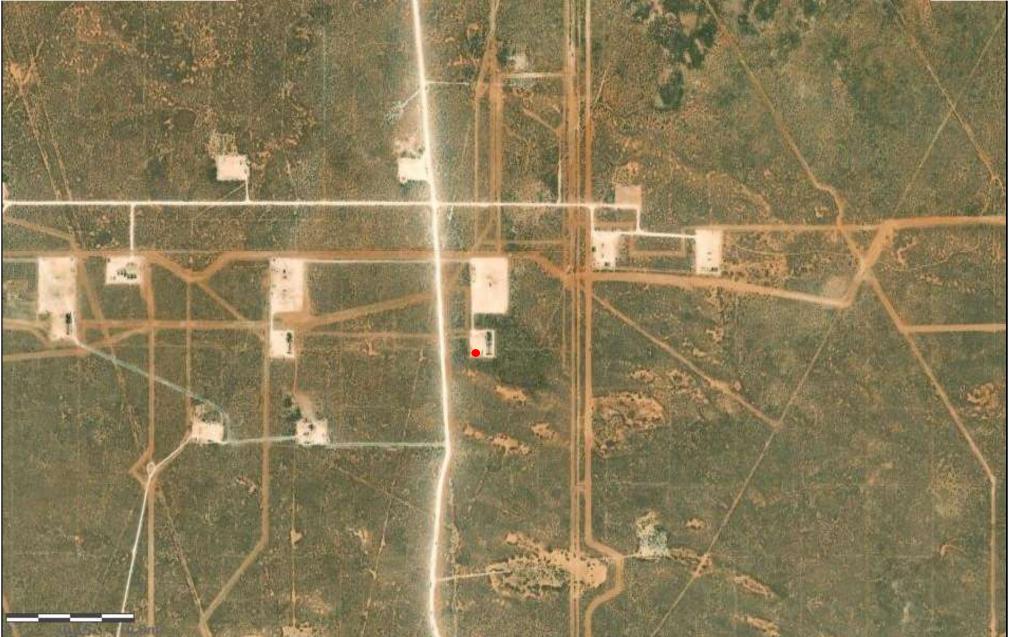
Figure 3

USGS Well Locations Map BTA Oil Producers, LLC North Ridge East Tank Battery GPS: 32.35256, -103.43607 Lea County Legend:

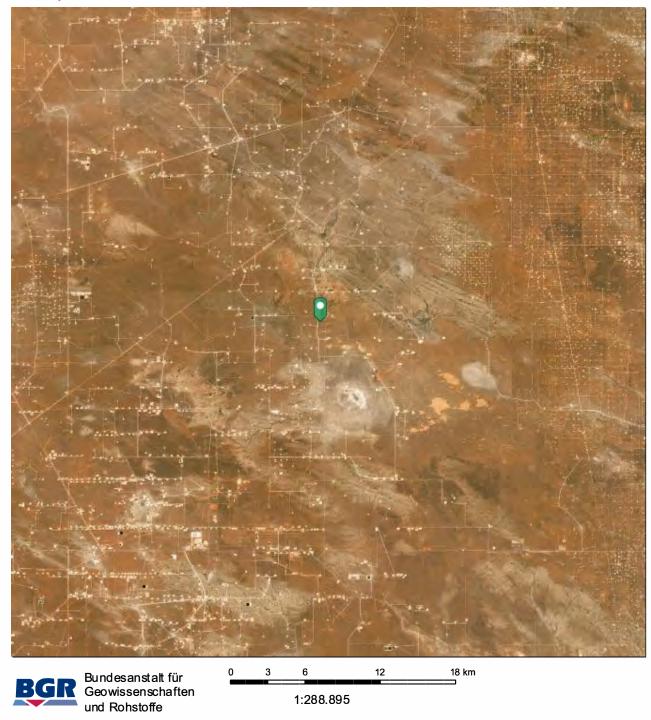
## **North Ridge East Tank Battery**

### **Karst springs**

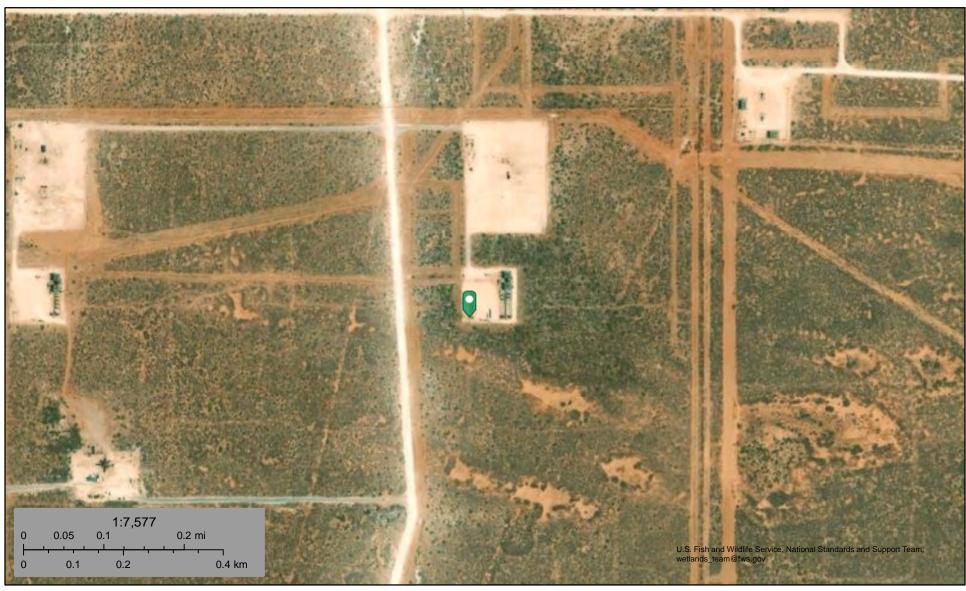
# North Ridge East Tank Battery

#### Wetlands
