Re: Site Assessment, Remediation, and Closure Report
Flagler 8 Fed 8H
API No. 30-025-44989
GPS: Latitude 32.1383485 Longitude -103.5914681
UL - O, 8, T23S, R34E
Lea County, NM
NMOCD Ref. No. NAPP2235028505

Pima Environmental Services, LLC. (Pima) has been contracted by Devon Energy Production Company, LP (Devon) to perform a spill assessment, remediation activities, and submit this closure report for a Crude oil and Produced water release that occurred at the Flagler 8 Fed 8H (Flagler). The initial C-141 was submitted on January 4, 2022 (Appendix C). This incident was assigned Incident ID NAPP2235028505 by the New Mexico Oil Conservation Division (NMOCD).

Flagler 8 Fed 8H|Devon Energy

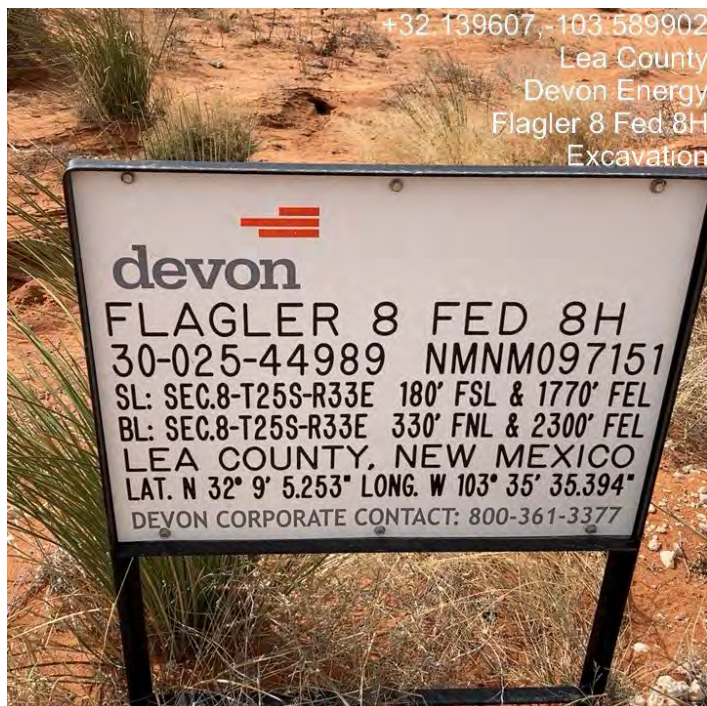
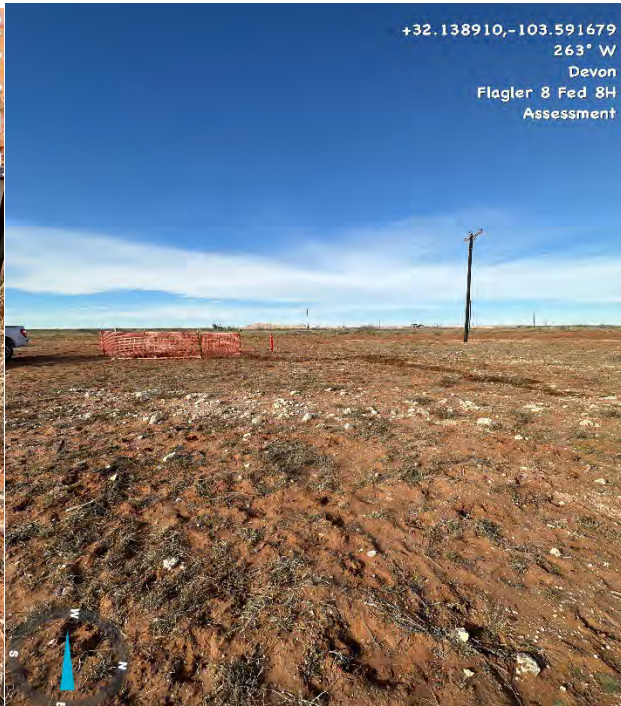
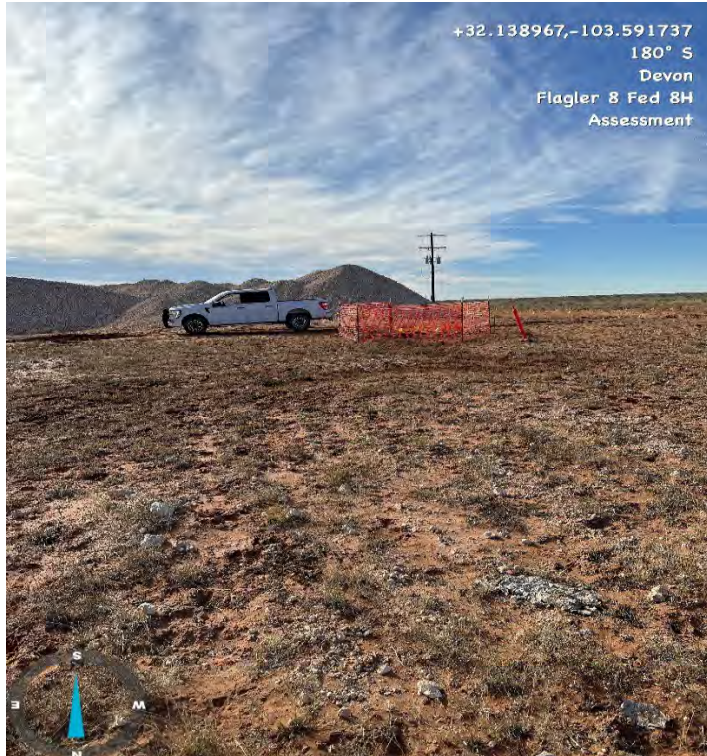
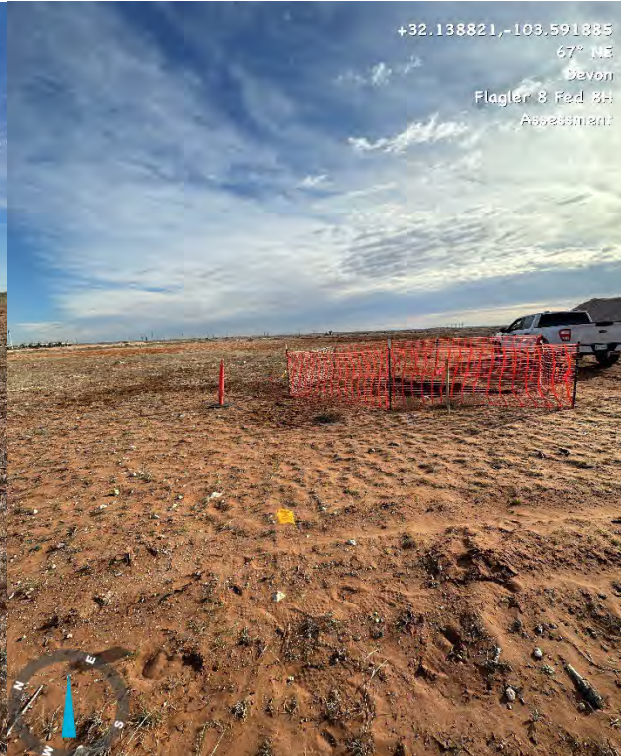
Site Assessment

NAPP2235028505: On December 15, 2022, A flowline caused fluid released on to pasture. The released fluids were calculated to be approximately 1.5 barrels (bbls) of crude oil and 13.4 bbls of produced water. No fluid was able to be recovered.

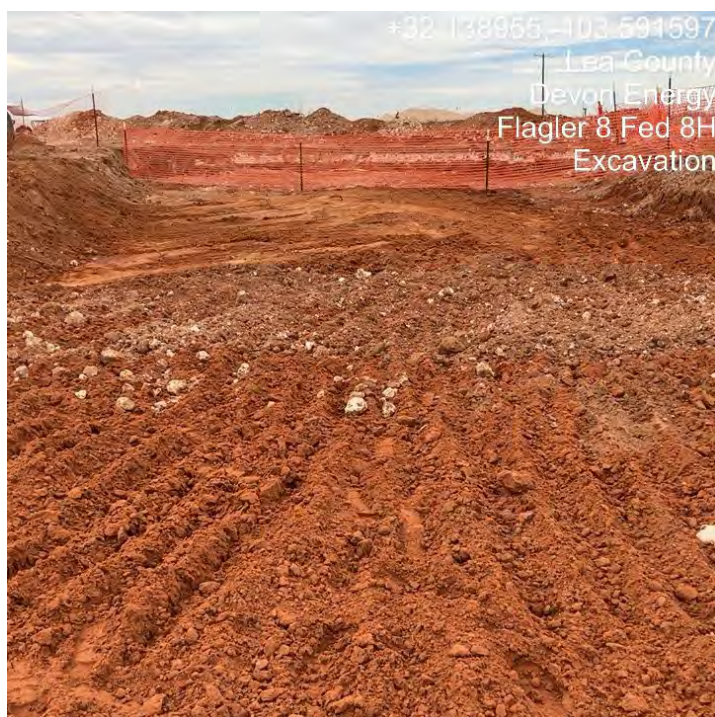
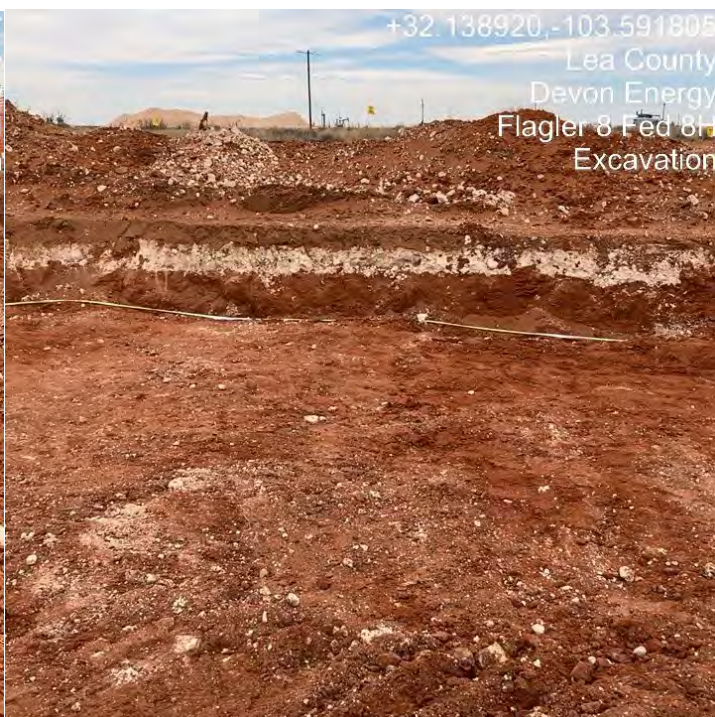
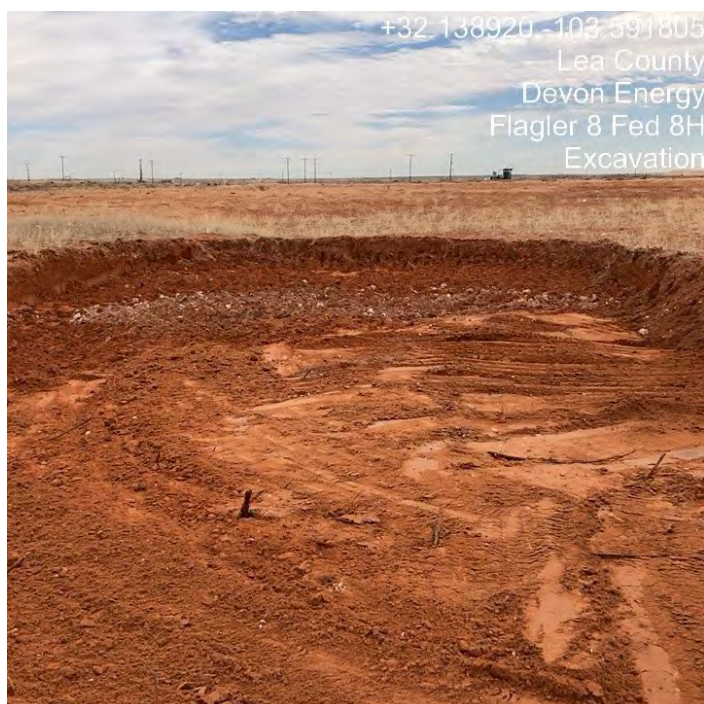
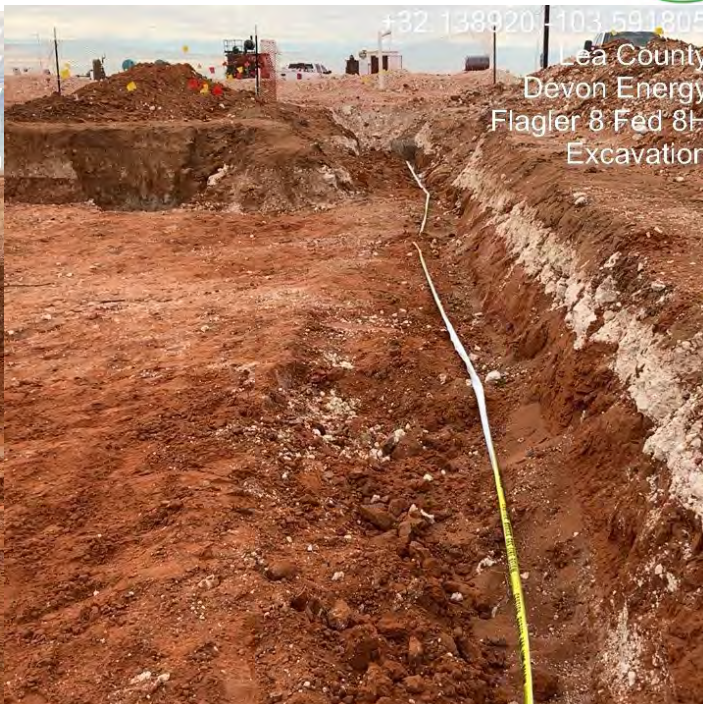
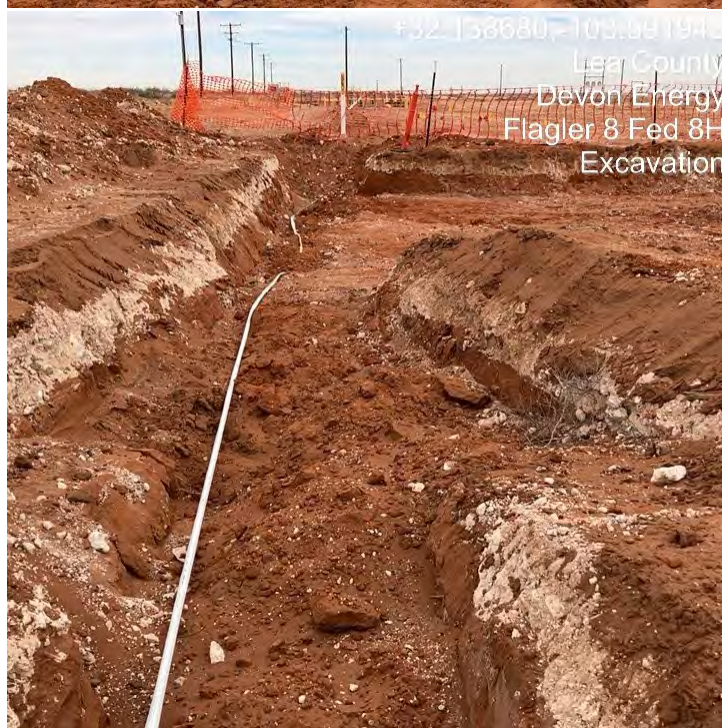
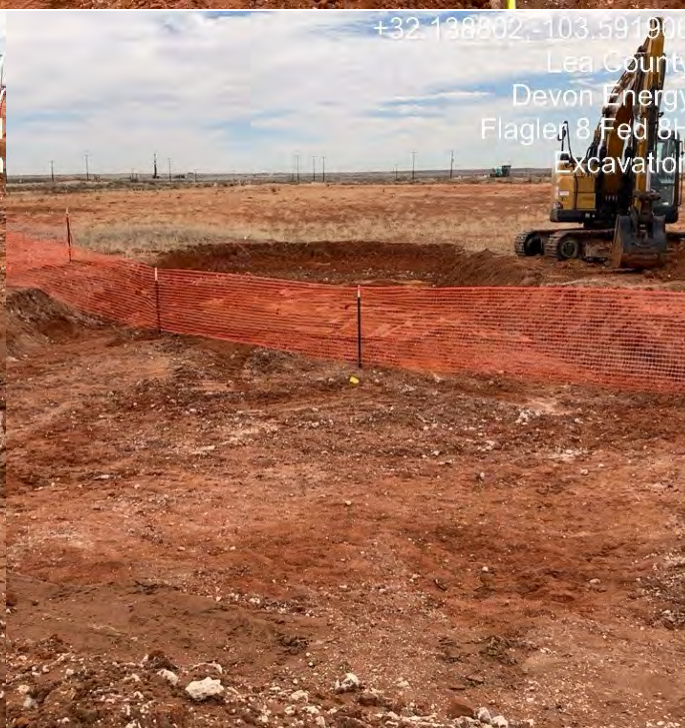
Excavation

On February 16, 2023, the Devon Construction Department mobilized personnel and equipment to begin immediate remediation activities. They began excavating the area to a depth of 3' - 5' BGS. The contaminated soil was hauled to an approved, lined disposal facility and clean backfill material was brought in.

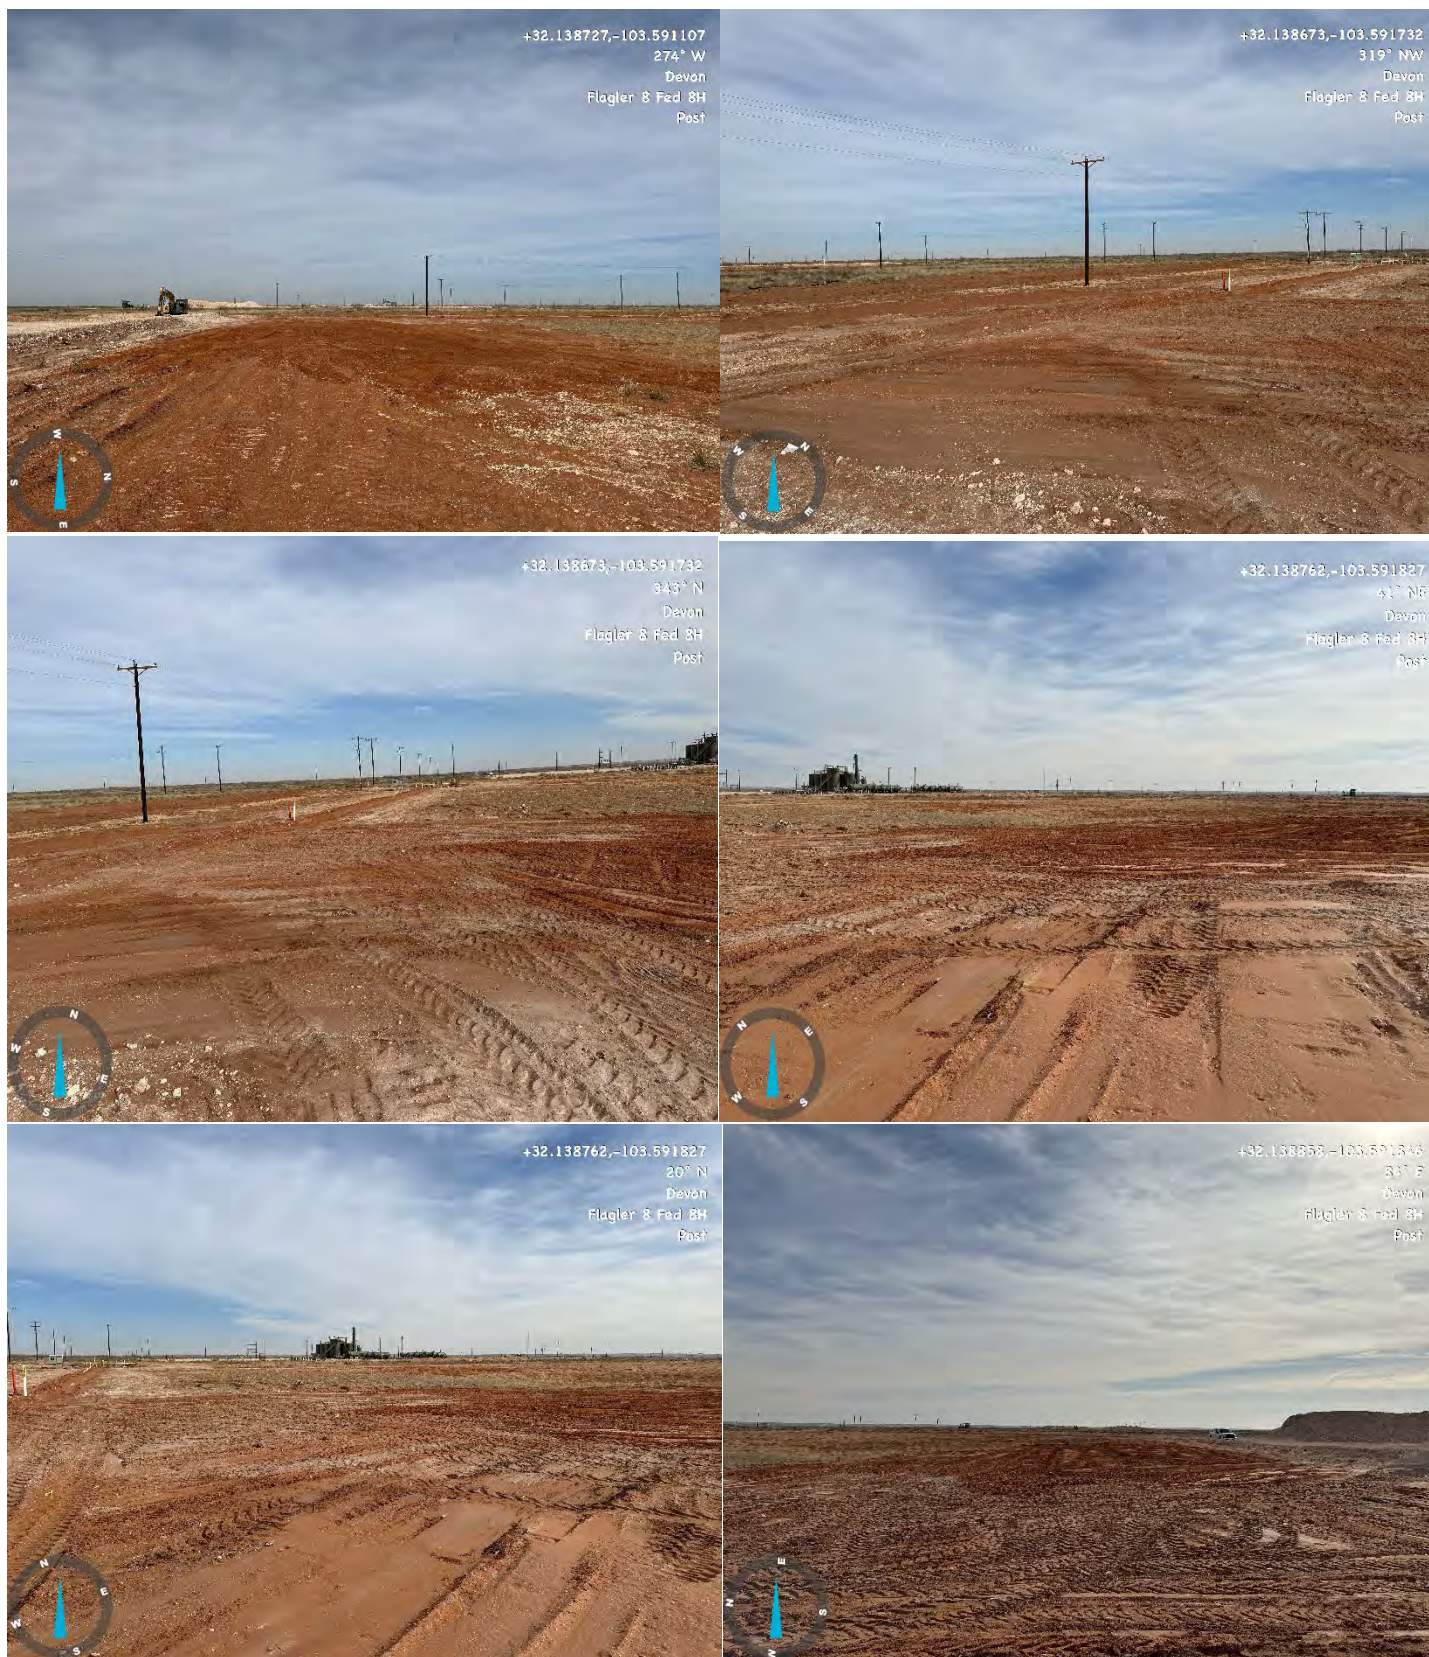
Post Excavation

Based on the sample results, the bottoms and sidewalls were below NMOCD Closure Criteria 19.15.29 NMAC. The contaminated material was sufficiently removed then transported to an NMOCD approved disposal site. The excavation was then backfilled with clean like material, machine compacted and returned to its previous state. See Appendix D for Photographic Documentation.
