**Re: Closure Request
Mesa #16H Flowline Break
Incident Number nAPP2123156473
Lea County, New Mexico**

Ensolum, LLC (Ensolum), on behalf of BTA Oil Producers, LLC (BTA), has prepared this *Closure Request* to document assessment, excavation, and soil sampling activities performed at the Mesa #16H Flowline Break (Site). The purpose of the Site assessment, excavation, and soil sampling activities was to assess for the presence or absence of impacts to soil resulting from a produced water release at the Site. Based on field observations, field screening activities, excavation activities and soil sample laboratory analytical results, BTA is submitting this *Closure Request*, describing Site assessment and excavation activities that have occurred and requesting closure for Incident Number nAPP2123156473.

BTA Oil Producers, LLC
Closure Request
Mesa #16H Flowline Break

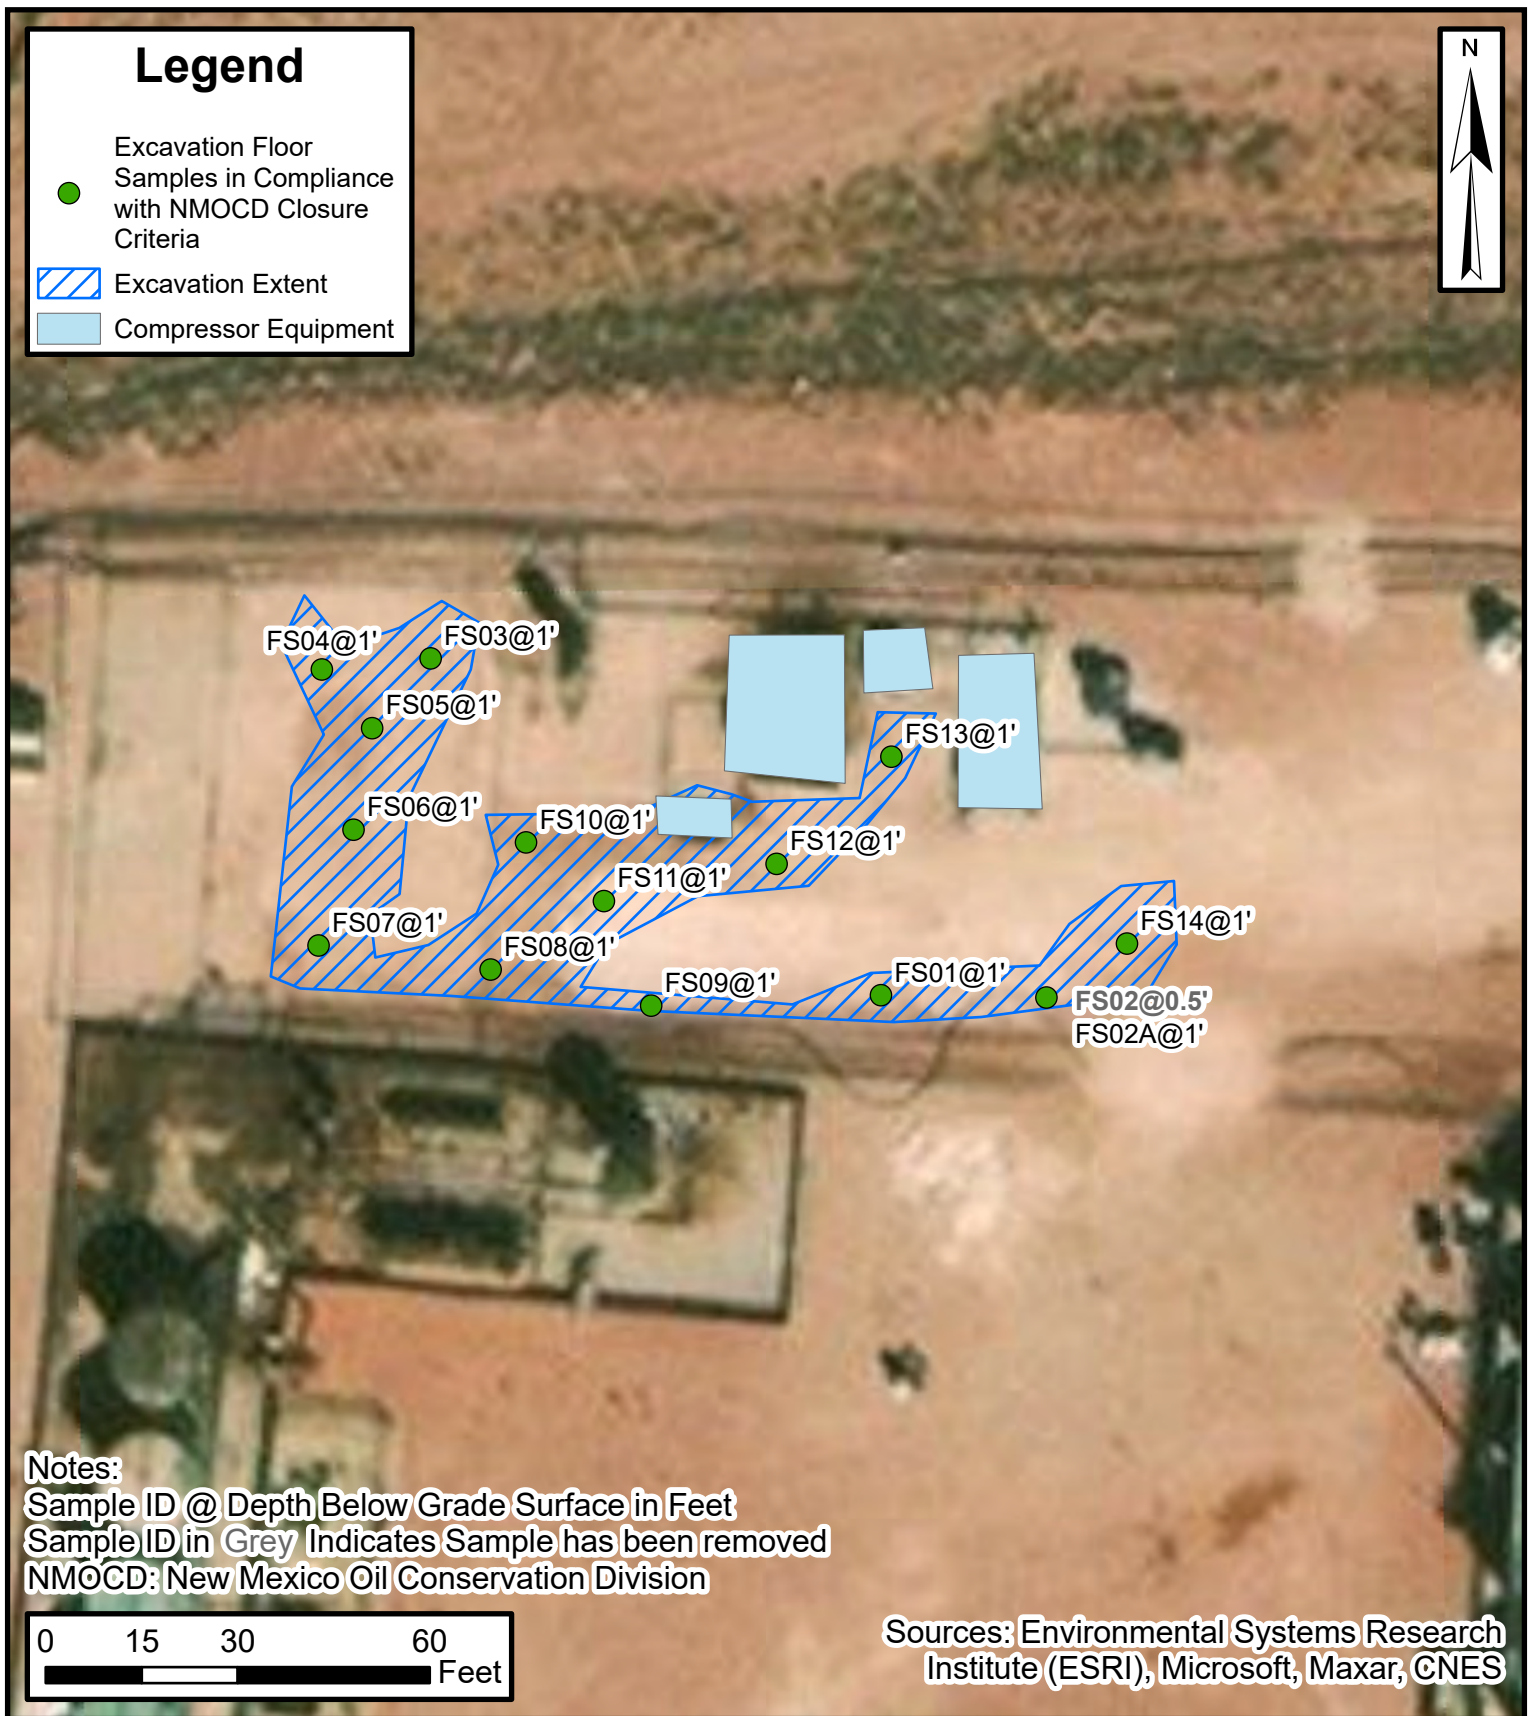
Excavation Soil Sample Locations

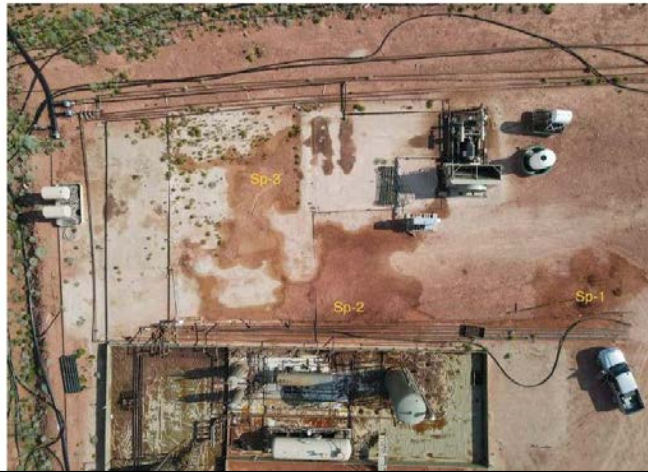
Photograph: 1
Description: Release extent
View: N/A
Date: 7/22/2021

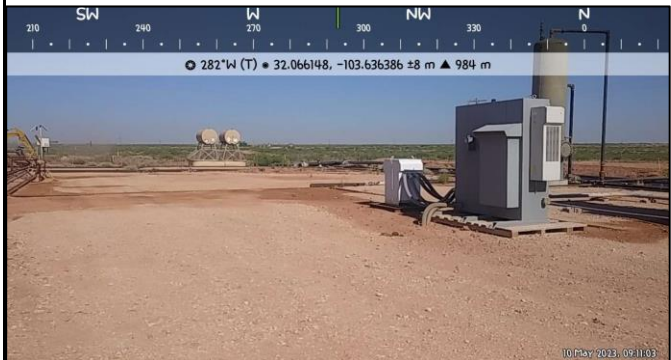
Photograph: 2
Description: Initial assessment activities
View: Northwest
Date: 5/10/2023

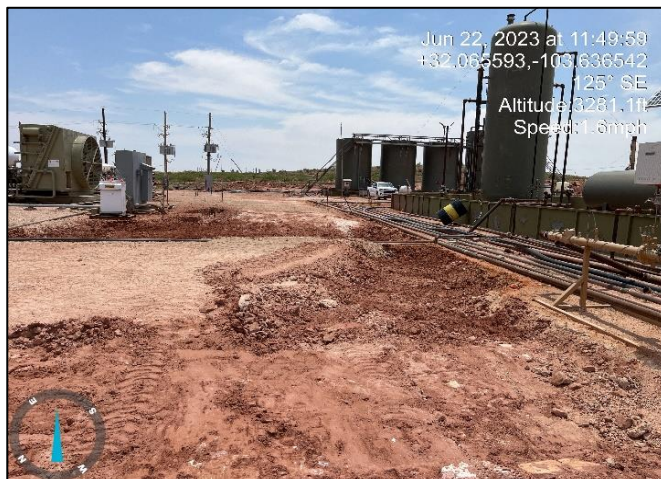
Photograph: 3
Description: Excavation activities
View: Southeast
Date: 6/22/2023

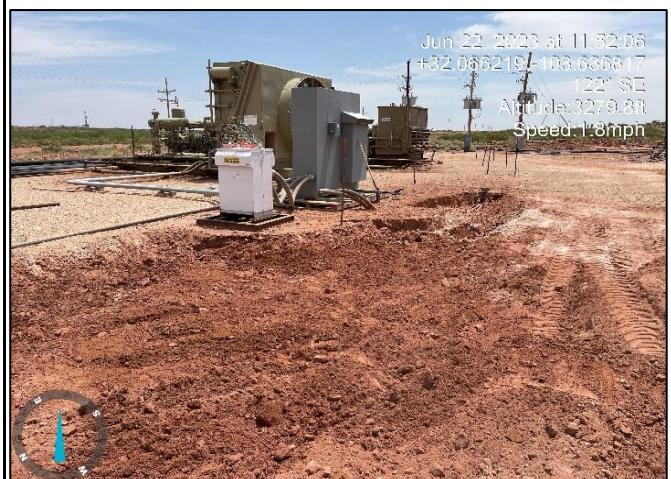
Photograph: 4
Description: Excavation activities
View: Southeast
Date: 6/22/2023
