## Site Assessment and Closure Report

Mescalero Ridge 21 Federal #001H  
Incident# nAPP2305851873  
Lea County, New Mexico

Subject: **Site Assessment and Closure Report**  
Mescalero Ridge 21 Federal #001H  
Lea County, NM

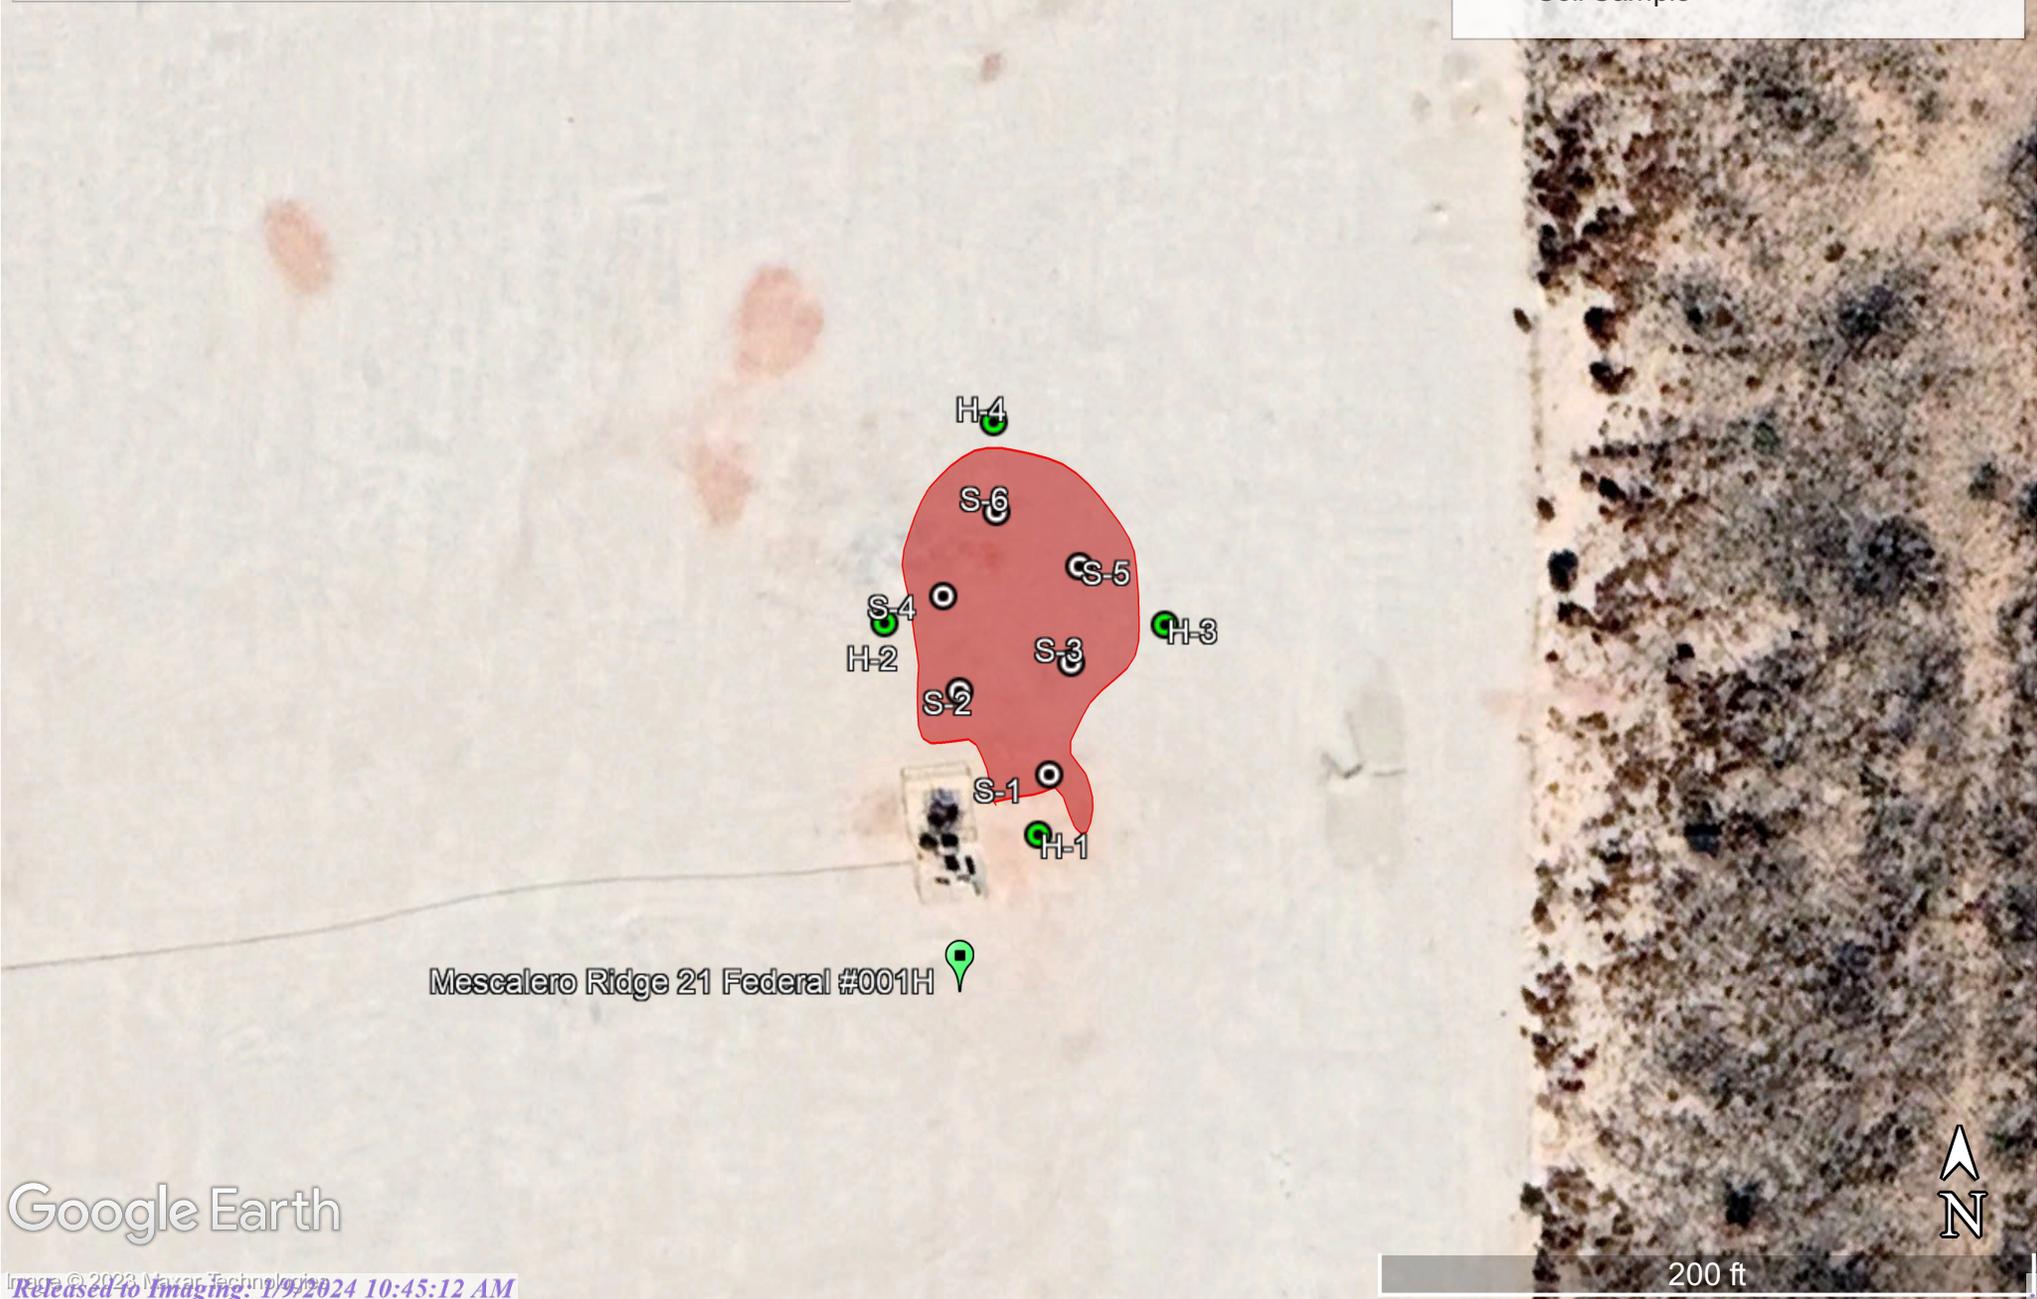
H&R mobilized personnel to begin site assessment, and sampling activities of the location. Grab samples were obtained by way of hand auger to a depth of 4-feet. Initial site assessment sampling locations are illustrated on Site Assessment Map, [Appendix I](#). Samples collected were transported to Cardinal Laboratory for analysis. Results of that analysis are shown in Table 1 below. Photographs of the location are attached in [Appendix IV](#). Complete laboratory reports can be found in [Appendix V](#).

Soil Sample

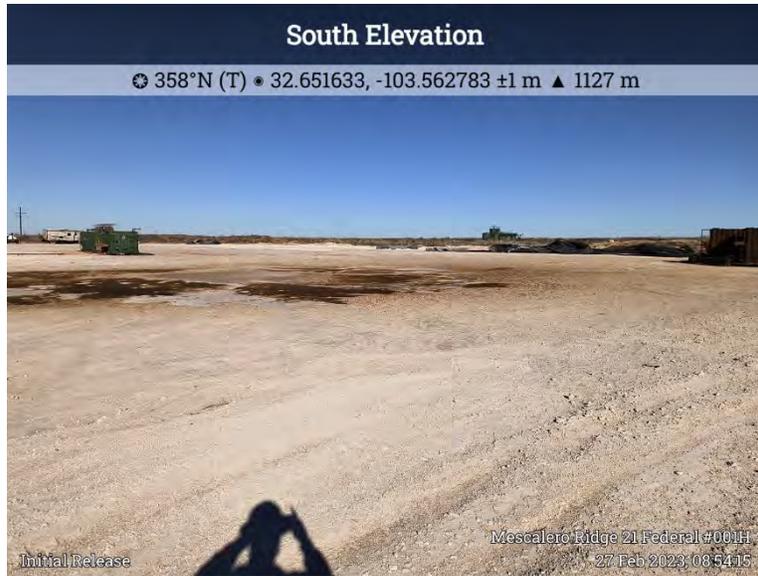
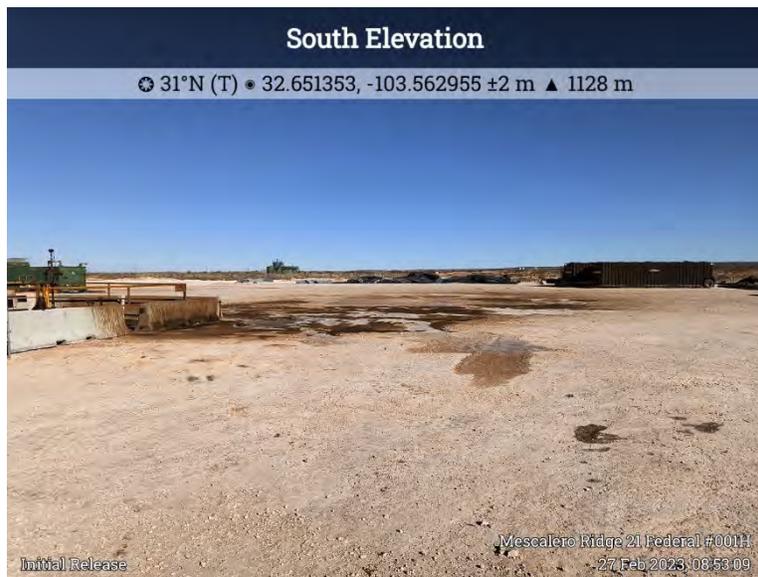
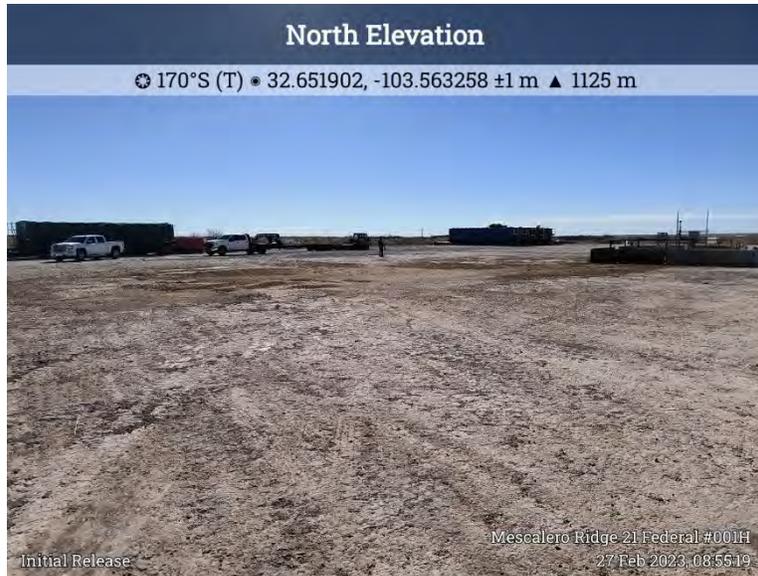
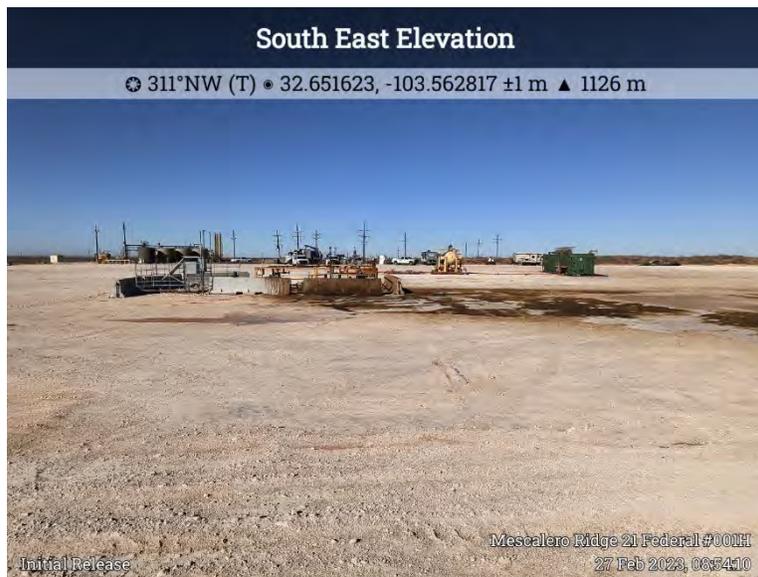
**INITIAL PHOTOGRAPHS**

On February 26, 2023, the Baird back pressure valve had been cut out by frac sand, releasing 6 barrels (bbls) of crude oil and 16 bbls of produced water onto the well pad. A total of 22 bbls of fluid were released with 0 bbls being recovered. A surface scrape was performed to take away the stain left behind.

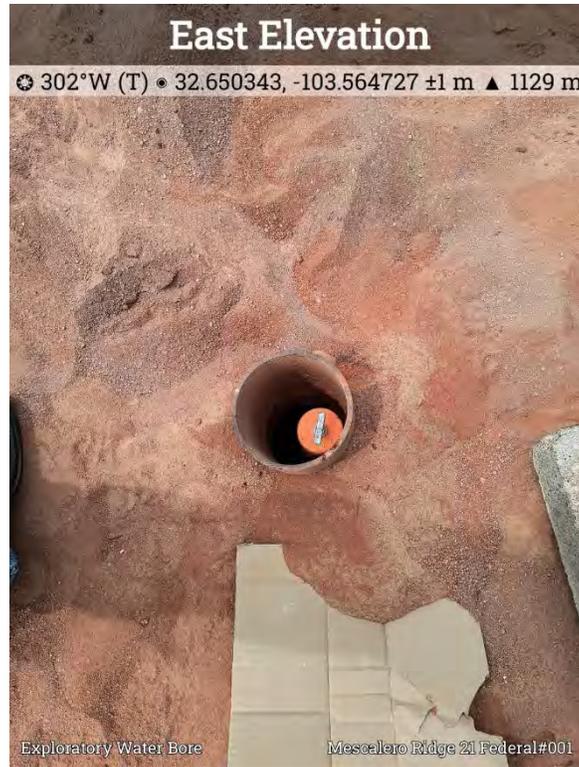
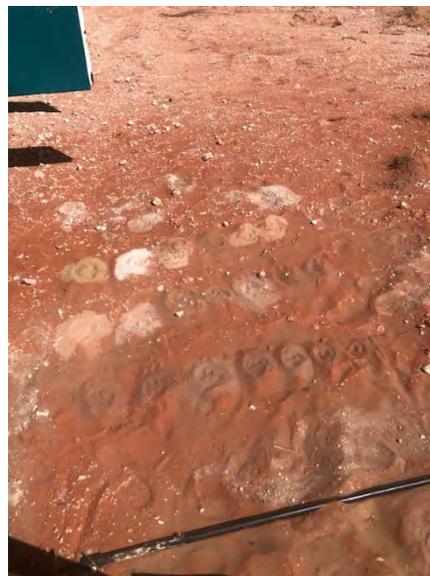
**EXPLORATORY WATER BORE PHOTOGRAPHS**

Due to groundwater data not being within 25-years or less, as well as outside the recommended 0.5-mile range, an exploratory water bore was drilled 0.13-miles away on the Mescalero Ridge 21 tank battery location to a depth of 105-feet BGS. See Exploratory Water Bore Map in [Appendix I](#). No groundwater was encountered the day of drilling nor 72-hours later when secondary gauging was performed. As this was an assessment being in an area with a depth to groundwater of more than 100-feet BGS, the closure criteria for this site are as follows:
