Closure Report
James 29 Federal Com SWD
Incident ID: nAPP2321320663
Lea County, New Mexico
Unit C Sec 29 T23S R32E
32.280523°, -103.698194°

Point of Release:
Gash to a poly flowline in the ROW
Release Date: 07.31.2023
Volume Released: 9 Barrels of Produced Water
Volume Recovered: 0 Barrels of Produced Water

Re: Closure Report
James 29 Federal Com SWD
Incident ID: nAPP2321320663
Cimarex Energy Co.
Site Location: Unit C, S29, T23S, R32E
(Lat 32.280523°, Long -103.698194°)
Lea County, New Mexico

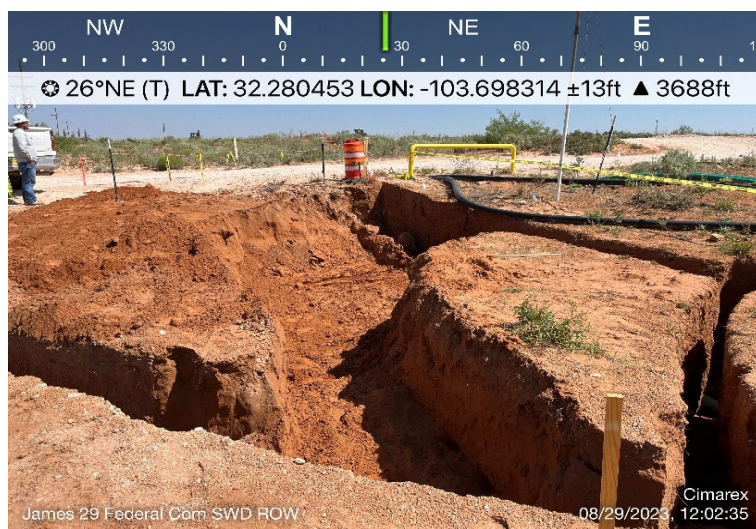
PHOTOGRAPHIC LOG**Cimarex Energy Co.****Photograph No. 1****Facility:** James 29 Federal Com SWD**County:** Lea County, New Mexico**Description:**

View North, area of CS-1 through CS-5.

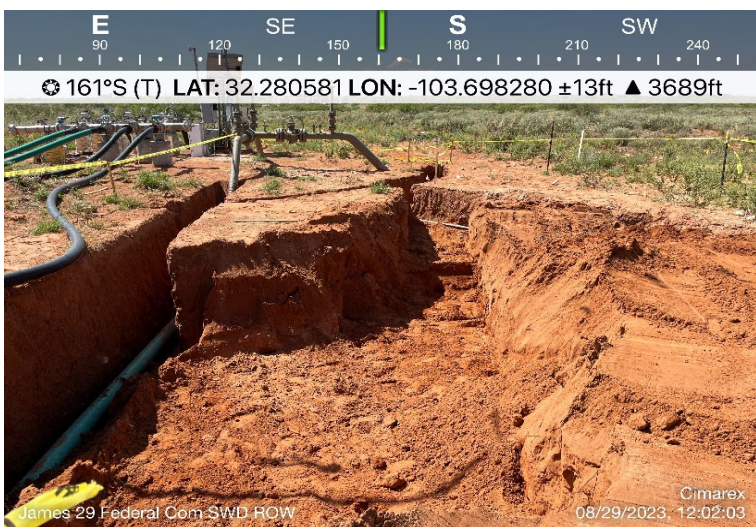
**Photograph No. 3****Facility:** James 29 Federal Com SWD**County:** Lea County, New Mexico**Description:**

View South, area of CS-1 through CS-5.
