Release Assessment and Closure

Pecos Irrigation 1-10 Tank Battery

BTA Oil Producers LLC
Pecos Irrigation 1-10 Tank Battery

Release Assessment and Closure
July 2023

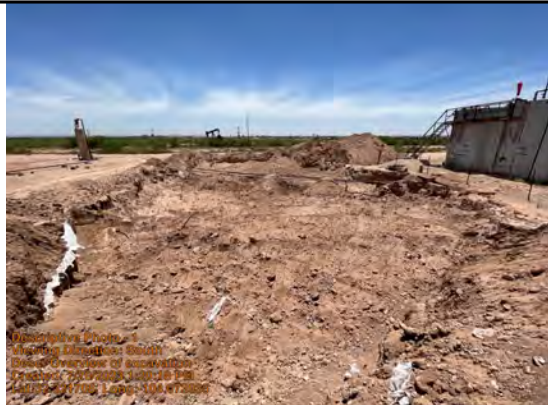
Viewing Direction: South

Overview of excavation

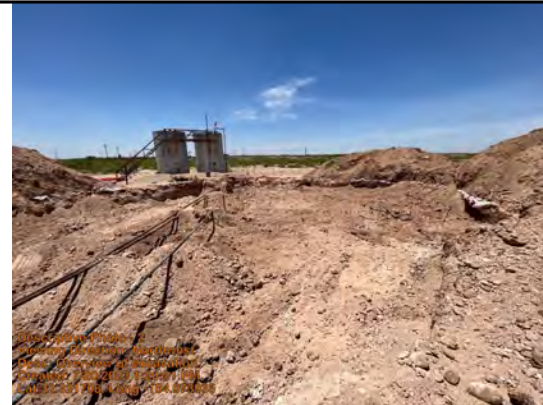
Viewing Direction: Northwest

Overview of excavation

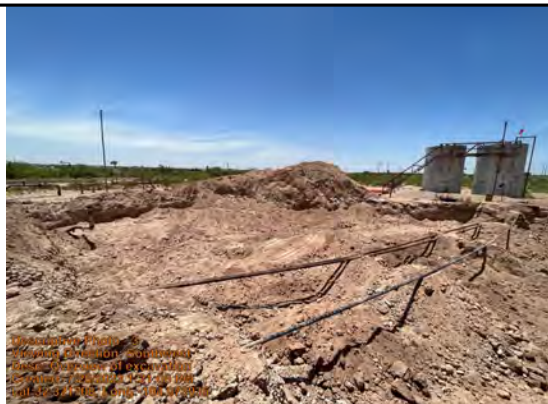
Viewing Direction: Southwest

Overview of excavation

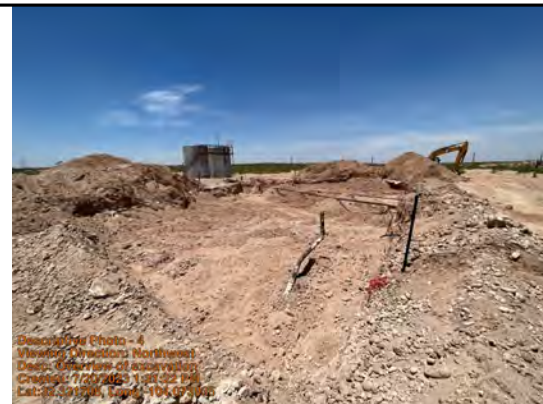
Viewing Direction: Northwest

Overview of excavation

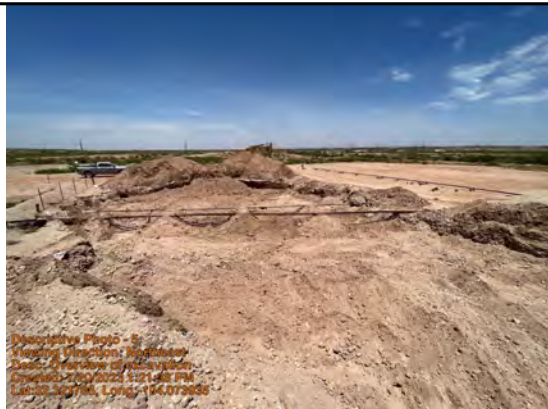
Viewing Direction: Northeast

Overview of excavation

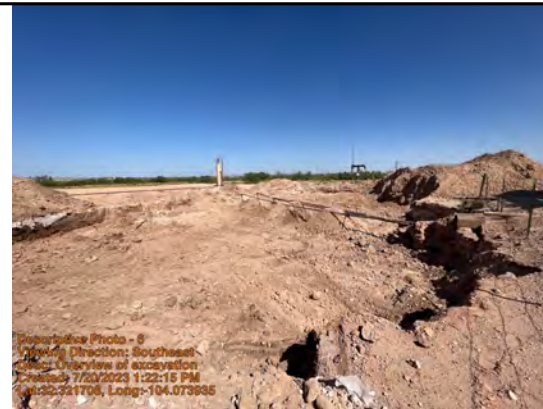
Viewing Direction: Southeast

Overview of excavation

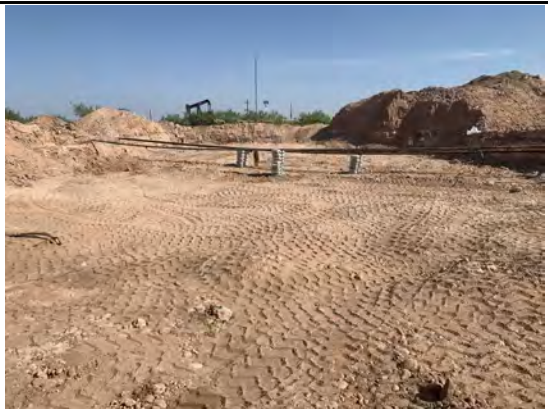
Viewing Direction: Southeast

Overview of excavation

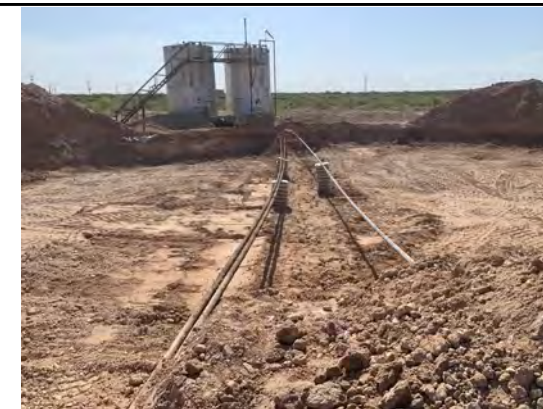
Viewing Direction: West

Overview of excavation
