**Re: Site Assessment, Remediation, and Closure Report**  
**Cotton Draw Unit 167 CTB**  
**API No. N/A**  
**GPS: Latitude 32.167493 Longitude -103.732874**  
**UL - N, Sect 36, T24S, R31E**  
**Eddy County, NM**  
**NMOCD Ref. No. NAPP2103458288**

**NAPP2103458288:** On January 21, 2021, a line to the heater treater developed a leak causing a fluid to be released on the pad. The released fluids were calculated to be approximately 11.9 barrels (bbls) of produced water. A vacuum truck was able to recover approximately 10 bbls of standing fluid.

# Cotton Draw Unit 167 CTB

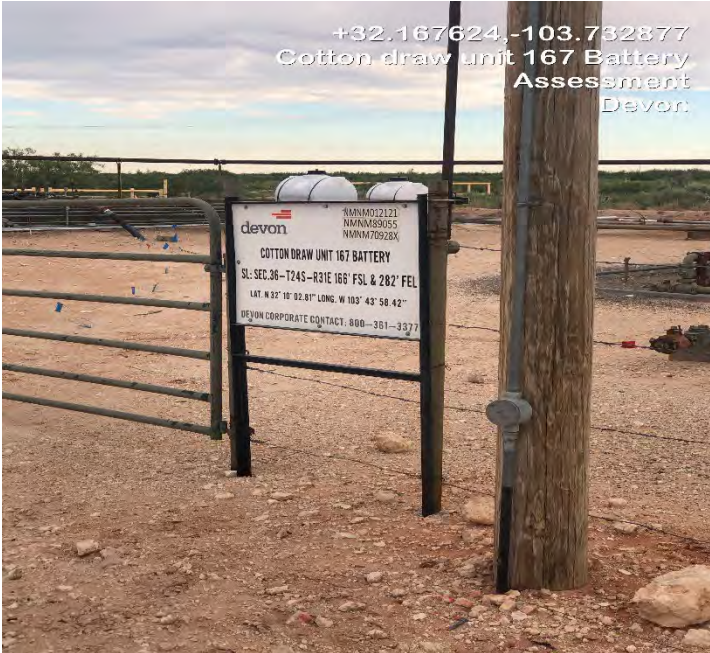
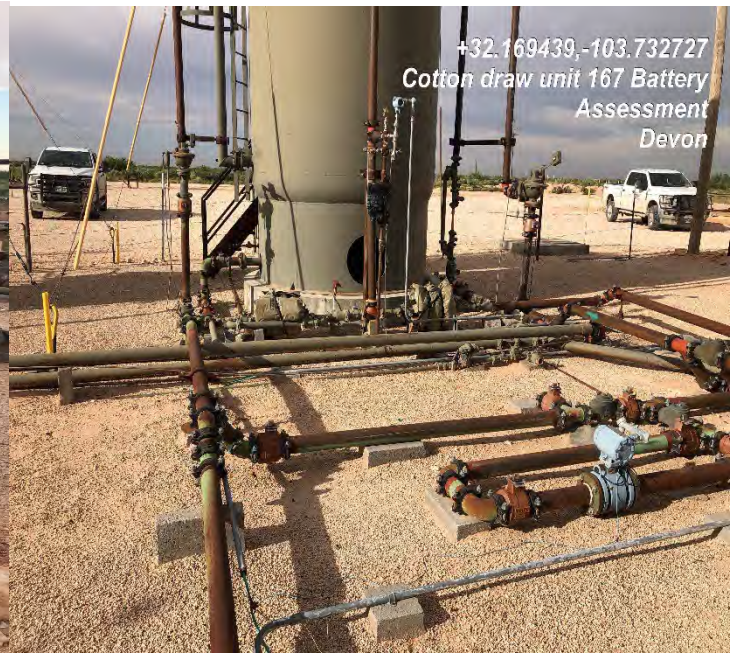
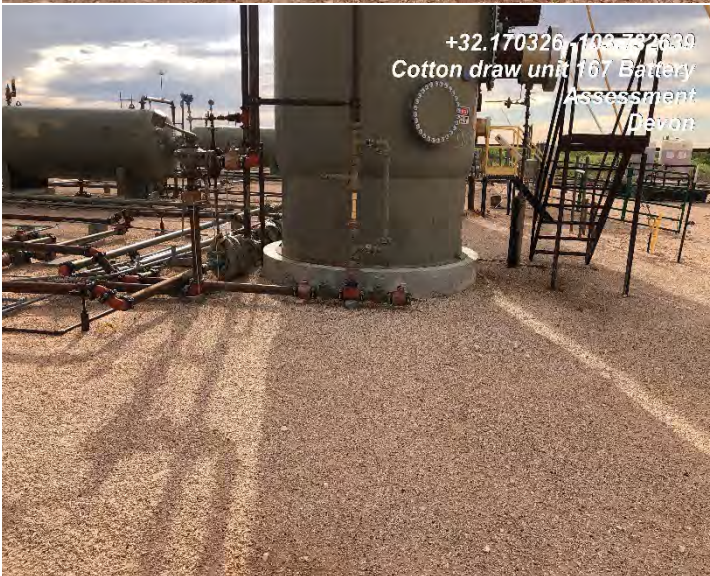
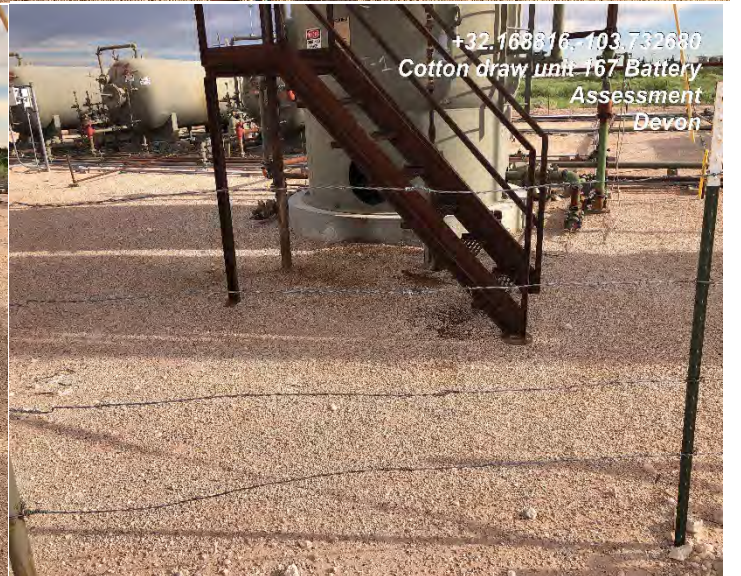
Site Assessment

+32.167624,-103.732877  
Cotton draw unit 167 Battery  
Assessment  
Devon

+32.169439,-103.732727  
Cotton draw unit 167 Battery  
Assessment  
Devon

+32.170326,-103.732689  
Cotton draw unit 167 Battery  
Assessment  
Devon

+32.168816,-103.732680  
Cotton draw unit 167 Battery  
Assessment  
Devon

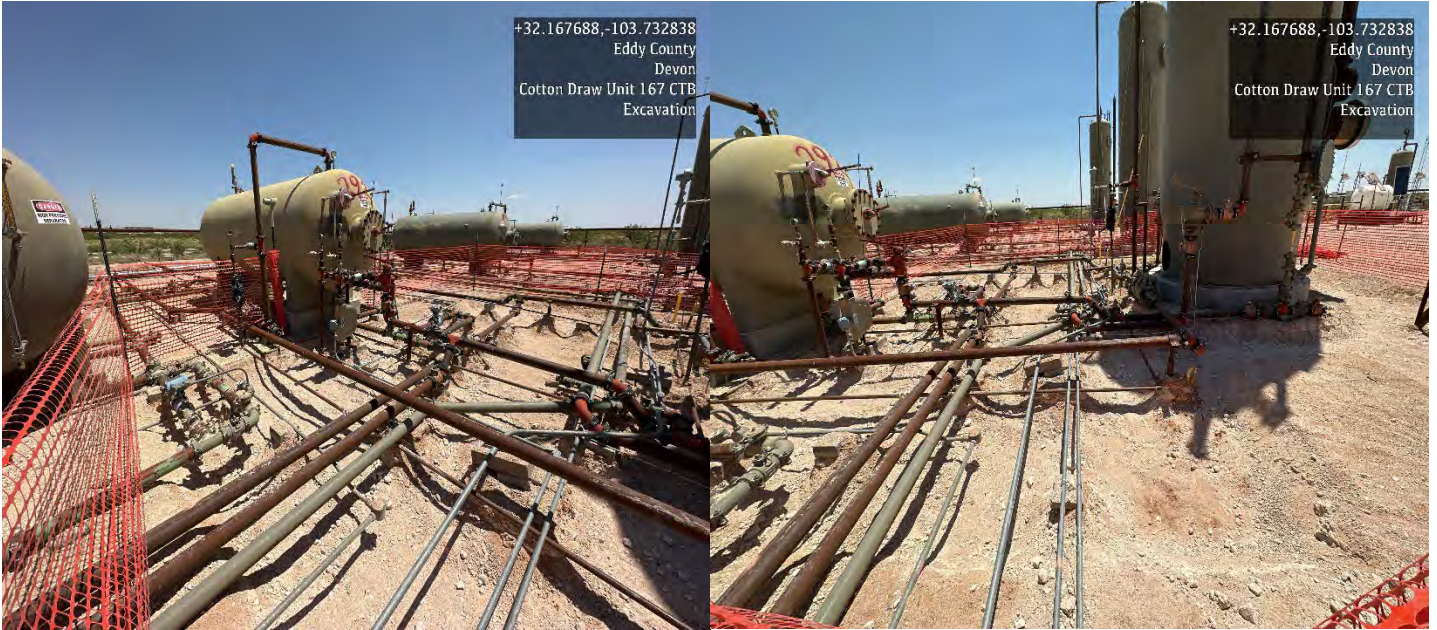
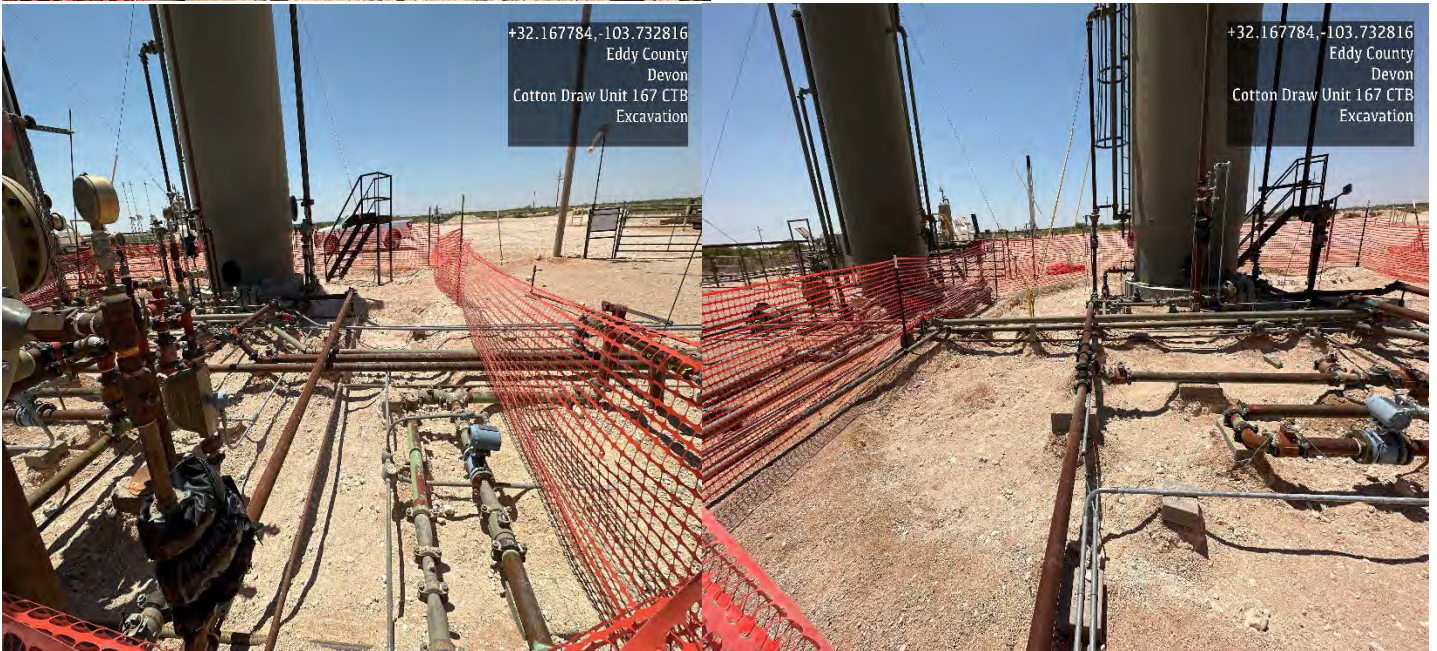
+32.167688,-103.732838  
Eddy County  
Devon  
Cotton Draw Unit 167 CTB  
Excavation

+32.167784,-103.732816  
Eddy County  
Devon  
Cotton Draw Unit 167 CTB  
Excavation

On July 19, 2023, the Devon Construction Department mobilized personnel and equipment to begin immediate remediation activities. They began excavating the area to a depth of 2' BGS. The contaminated soil 28 cubic yards was hauled to an approved, lined disposal facility and clean backfill material was brought in.
