Release Notification

Site Name: HOLLY A FEDERAL #006	Site Type: Oil Production Facility
Date Release Discovered: June 13 th , 2021	API# (if applicable) 30-015-25331

On June 13, 2021, corrosion on the bottom of a production storage tank caused approximately 1 barrel (bbls) of crude oil and 29 bbls of produced water to be released within the secondary containment earthen berm. A vacuum truck was dispatched to the Site and recovered approximately 20 bbls of produced water. WPX reported the release to the New Mexico Oil Conservation Division (NMOCD) on a Form C-141 on June 22, 2021, and was subsequently assigned Incident Number nAPP2116548791. **Figure 2** in **Appendix A** depicts the observed release footprint, hereafter referred to as the Area of Concern (AOC).

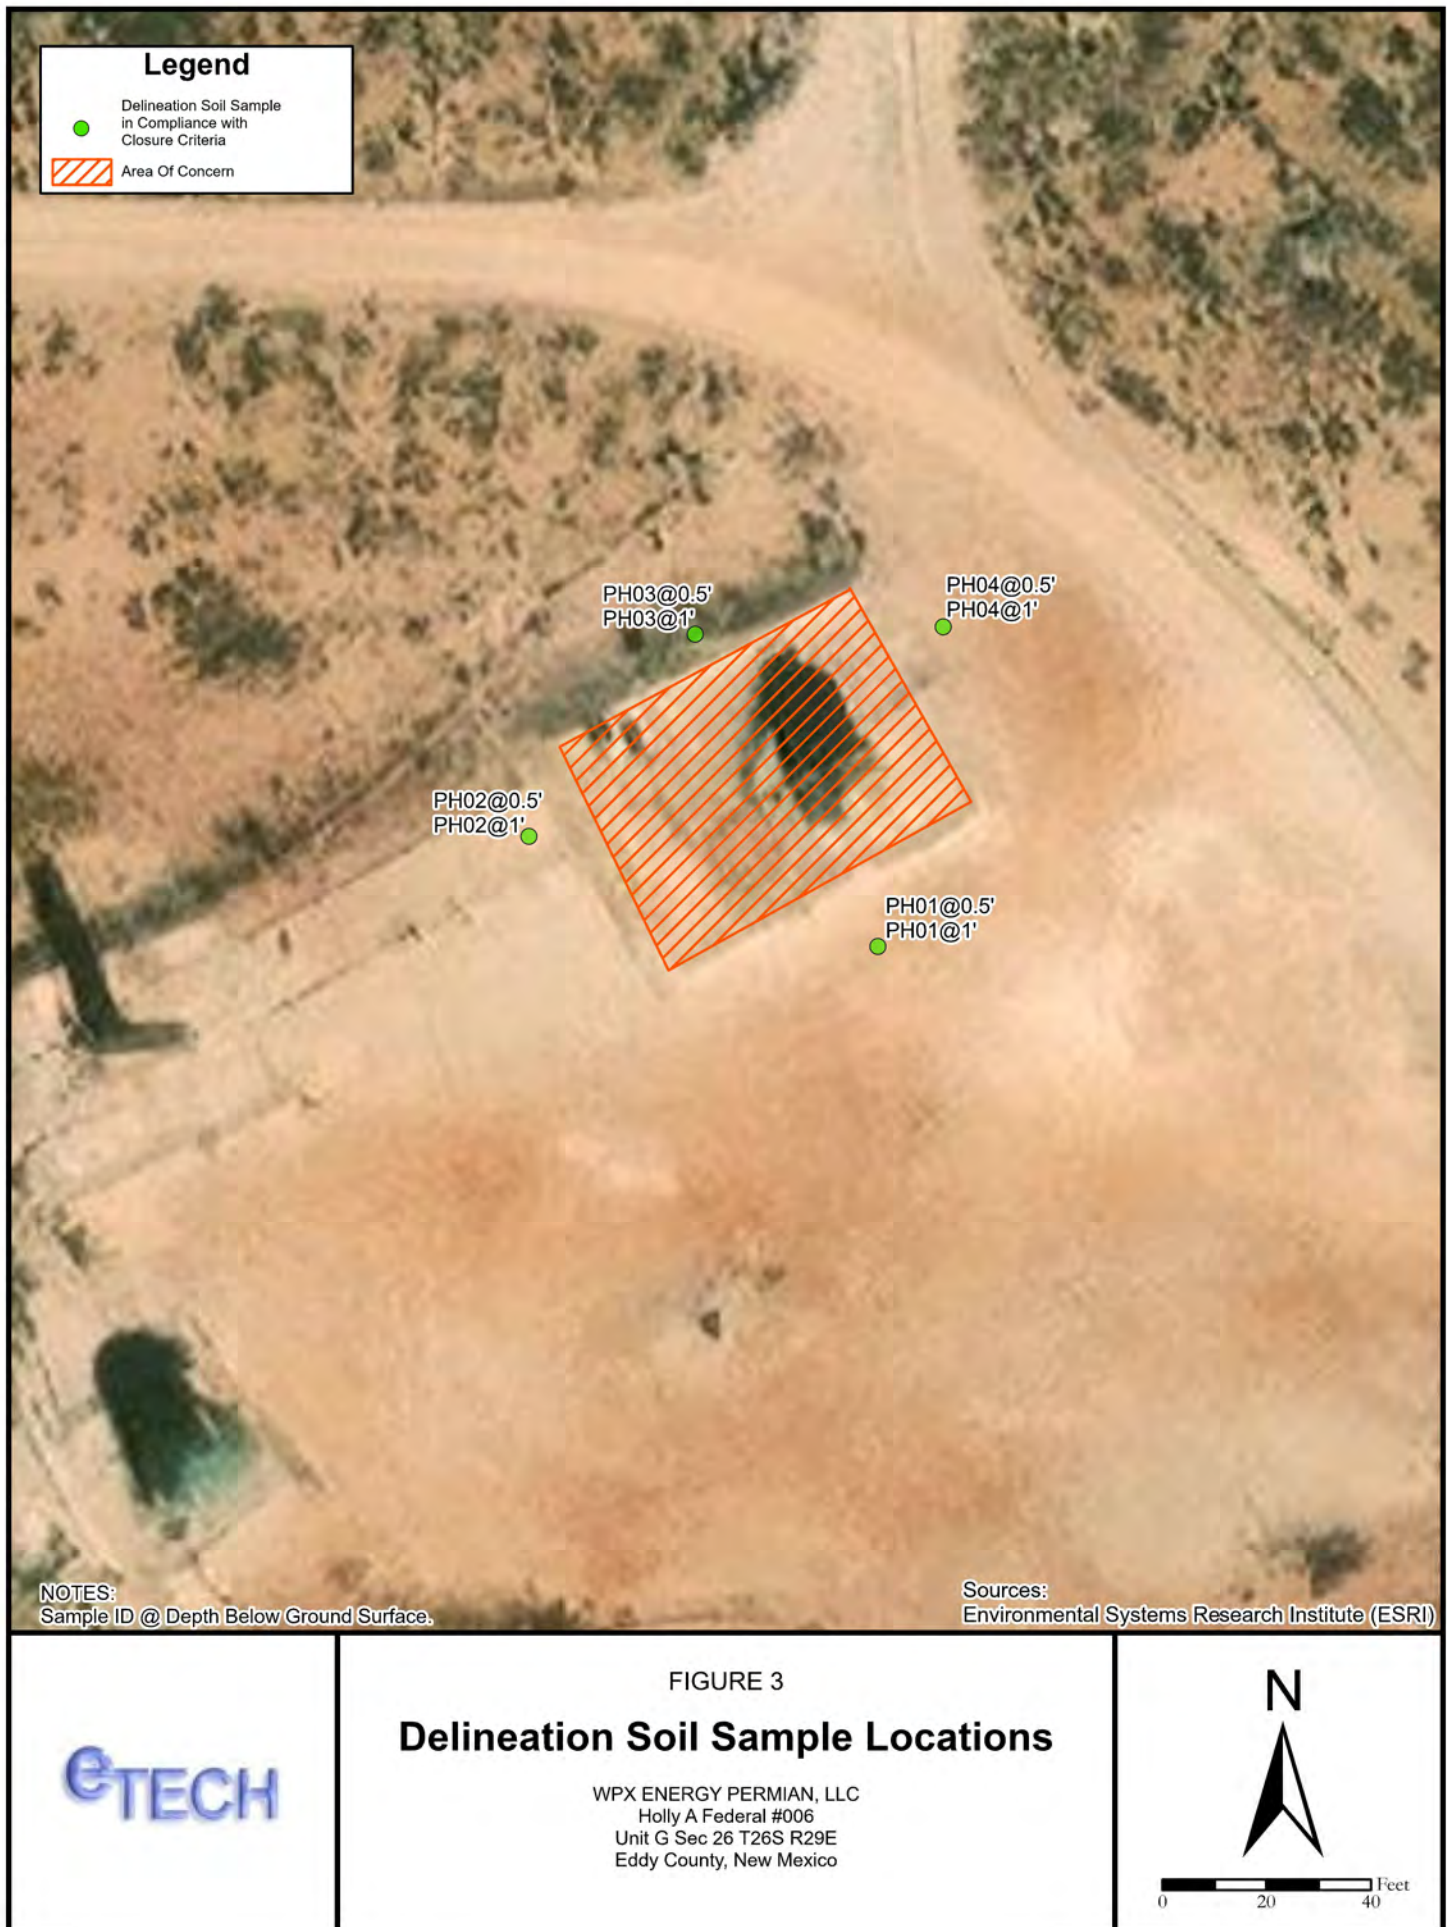
delineation soil sample location, representing the highest observed field screening concentrations and the greatest depth. The soil samples were handled, collected, and analyzed as previously described. Field screening results and soil descriptions are included on soil sampling logs shown in **Appendix C**. The location of the delineation soil samples is shown in **Figure 3** in **Appendix A**.

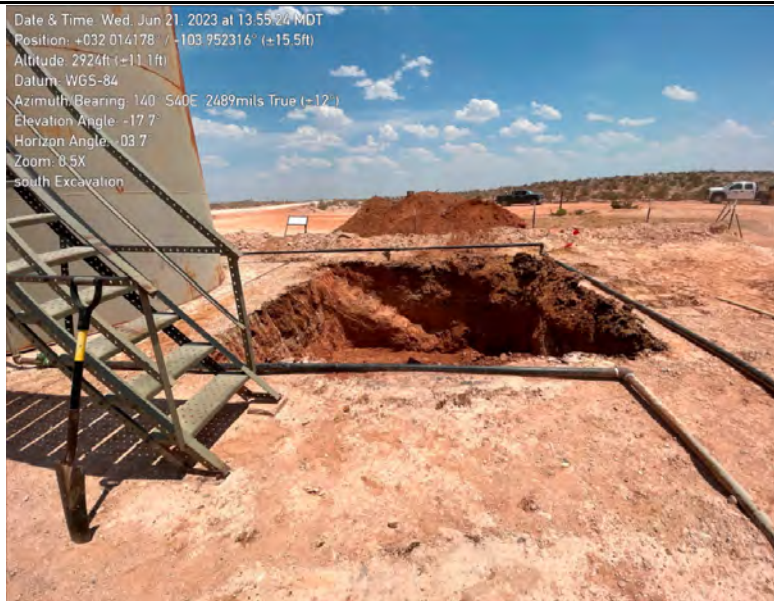
**Photograph 1****Date: 06/21/2023**

Description: View of southern excavation activities

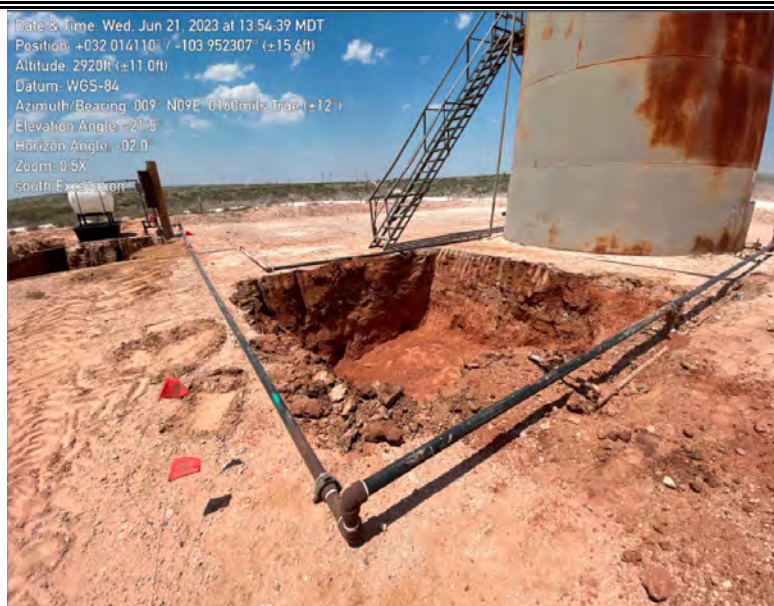
**Photograph 2****Date: 06/21/2023**

Description: Northern view of final excavation extents.

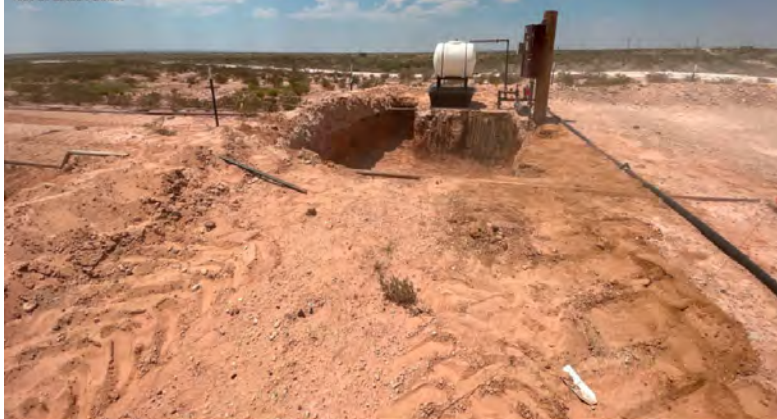
**Photograph 3****Date: 06/21/2023**

Description: View of northern excavation extent.

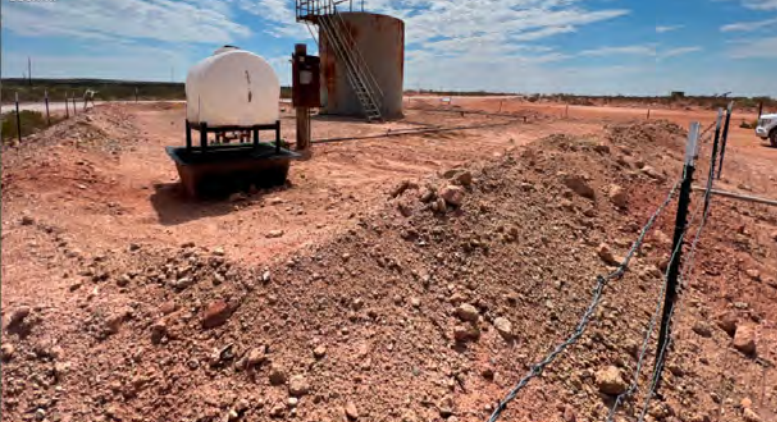
**Photograph 4****Date: 07/11/2023**

Description: Eastern view of backfilled excavations.

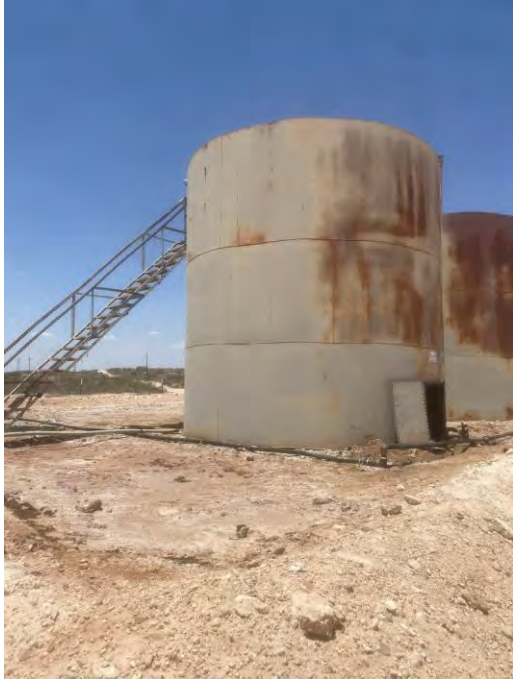
Photo No.	Date	
1	June 15, 2021	
Southeast view of the Site during the assessment.

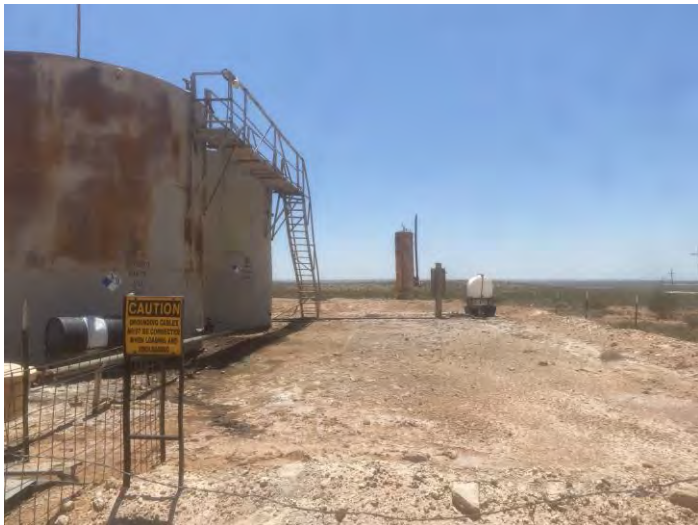
Photo No.	Date	
2	June 15, 2021	
West view of the Site during the assessment.

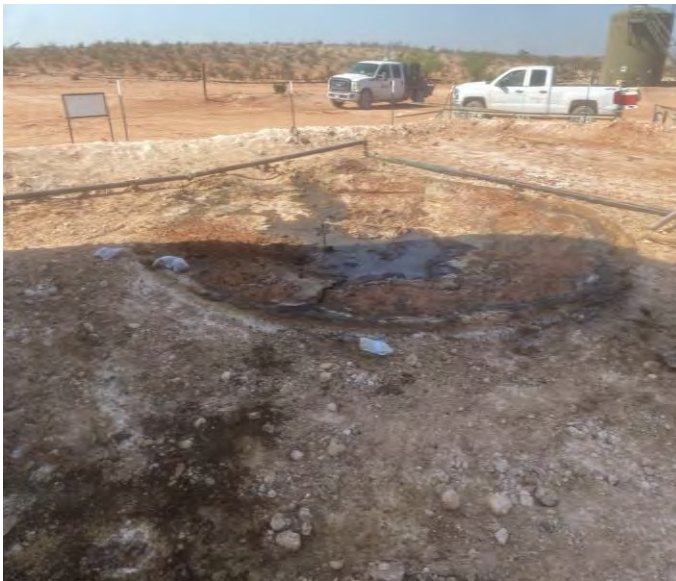
Photo No.	Date	
3	June 18, 2021	
View of the release area following removal of decommissioned tank.

A photograph showing a large, dark, irregularly shaped area of contamination on the ground. The area is surrounded by dry, brown earth. In the background, there are two white pickup trucks parked on a dirt road, and a green storage tank is visible on the right side.

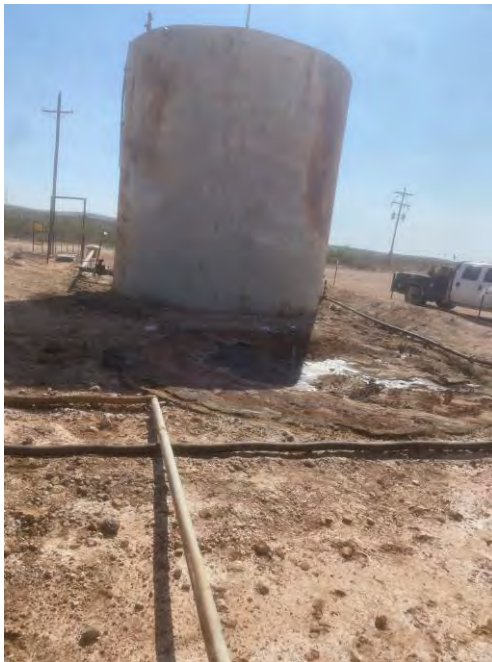
Photo No.	Date	
4	June 18, 2021	
View of the release area following removal of decommissioned tank.

A photograph showing a large, cylindrical, rusted metal tank standing upright on a dirt surface. The tank is surrounded by dry, brown earth. In the background, there are utility poles and a white pickup truck parked on a dirt road.
