## Closure Report

Spurck F State #5  
Eddy County, New Mexico  
API # 30-015-21598  
**Incident #nAPP2224139385**

**Subject:** Closure Report  
Spurck F State #5  
Eddy County, New Mexico  
API # 30-015-21598  
Incident #nAPP2224139385

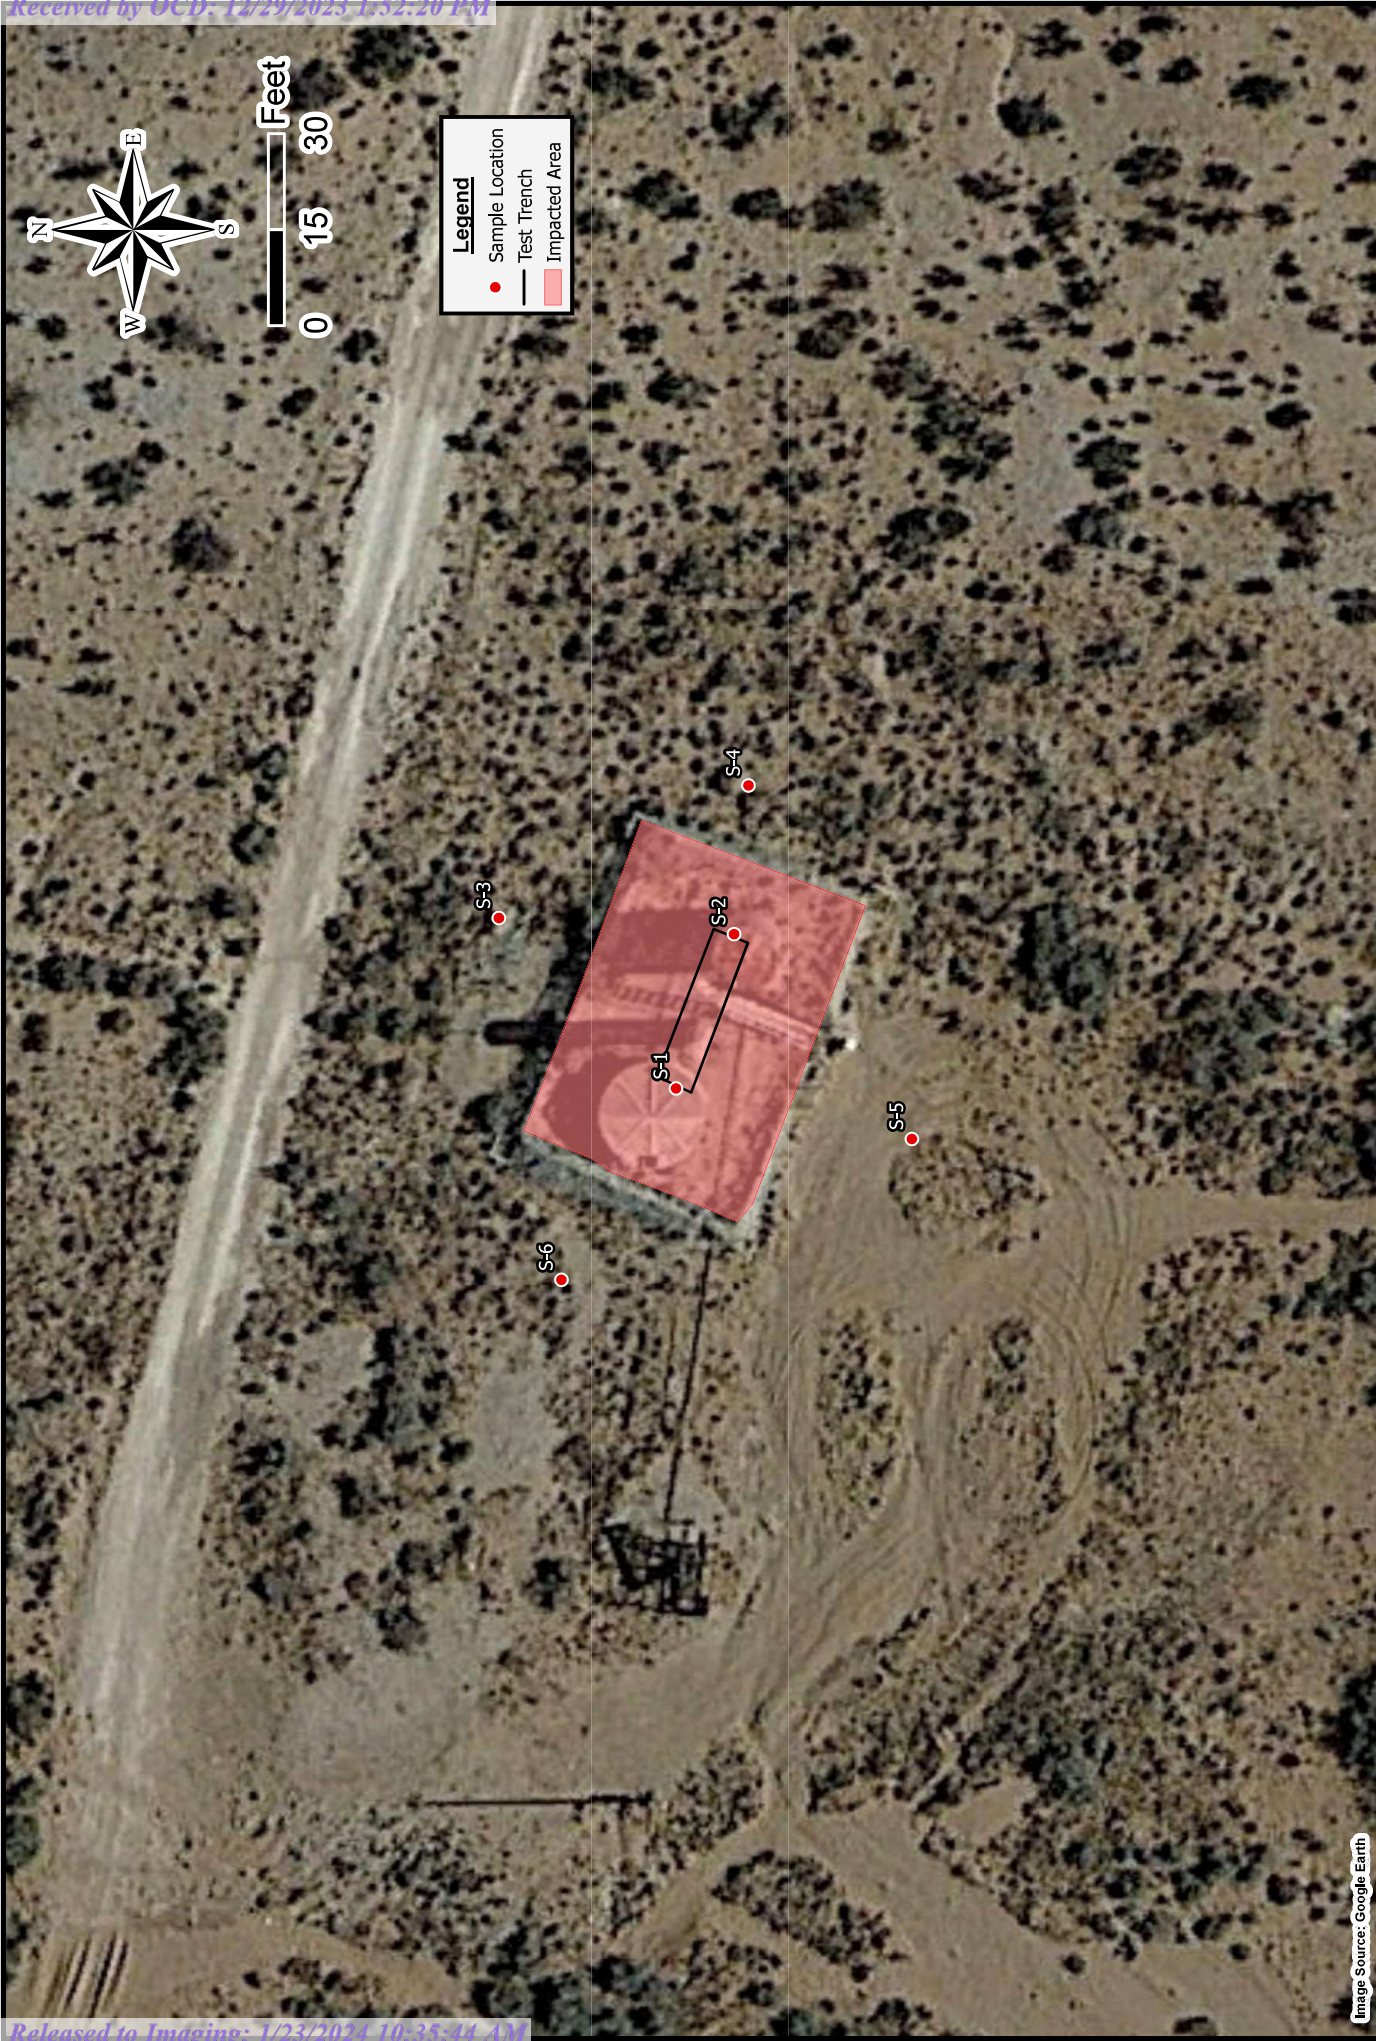
EOG Resources  
Spurck F State #005  
Eddy County, New Mexico  
Figure 1 - Site Assessment Map

On August 09, 2022, Talon mobilized personnel to the site to conduct an initial site assessment. The impacted area was mapped utilizing a Trimble GEO XH 6000, photographed, and sampled utilizing a hand auger. Due to the soil characterization for the area, auger refusal was encountered at sample positions S-1 and S-2.

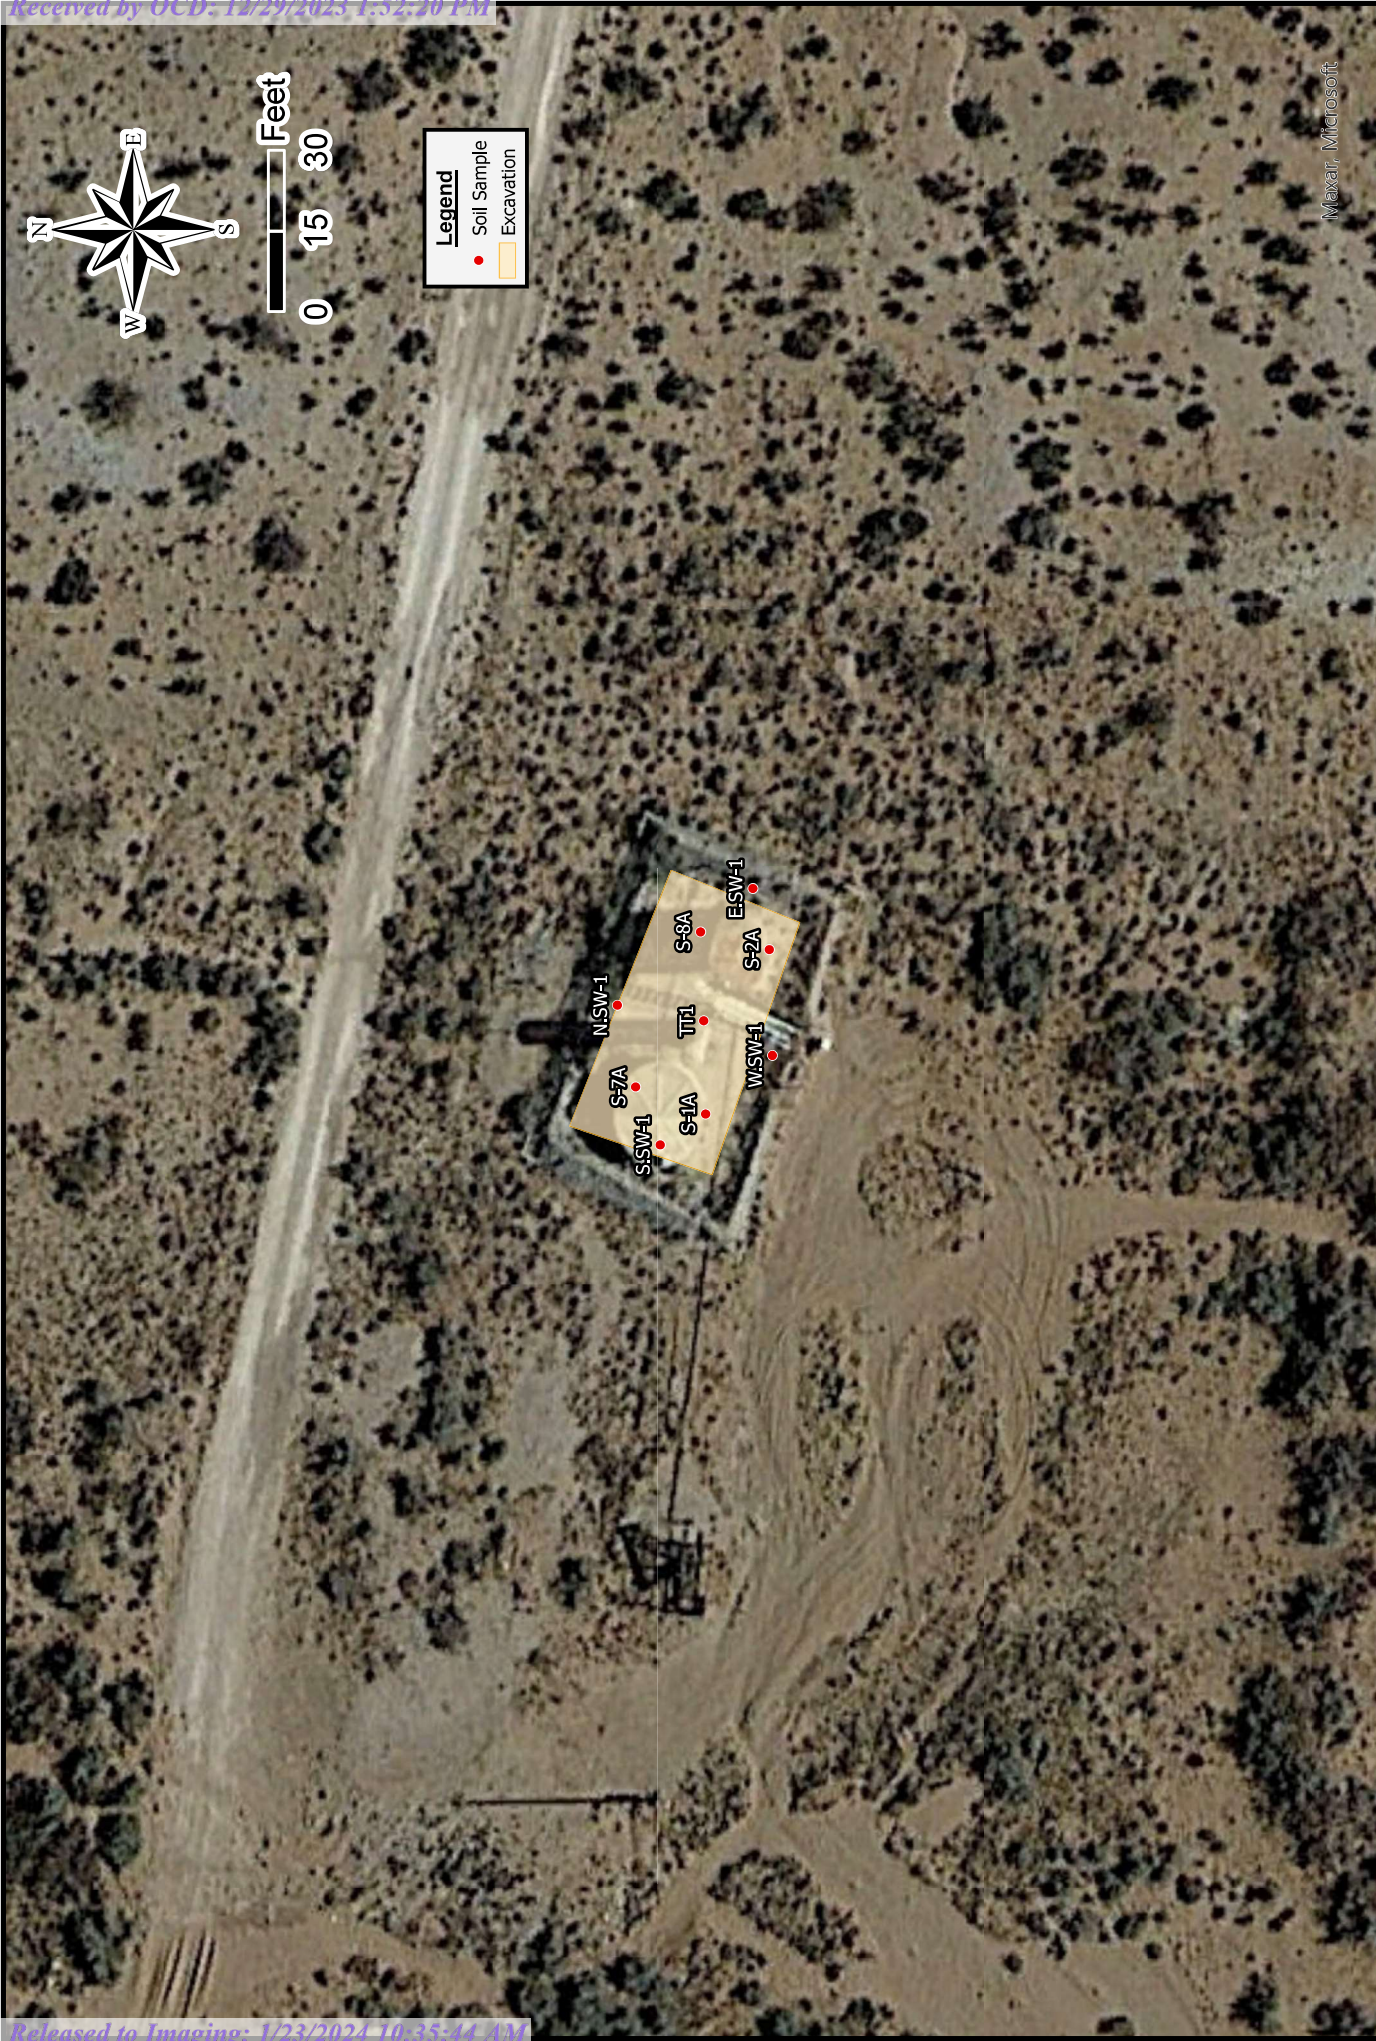
EOG Resources  
Spurck F State #005  
Eddy County, New Mexico  
Figure 2 - Confirmation Sample Map

On September 09, 2022, Talon personnel completed excavation of the impacted area to a depth of four and half (4.5) feet bgs. Five-point composite confirmation samples were collected on a 200 square foot basis. All soil samples were properly collected and preserved for transport to Cardinal Laboratories for analysis. The confirmation sampling results are tabulated below in Table III. Sample locations are illustrated on Figure 3 ([Appendix I](#)).

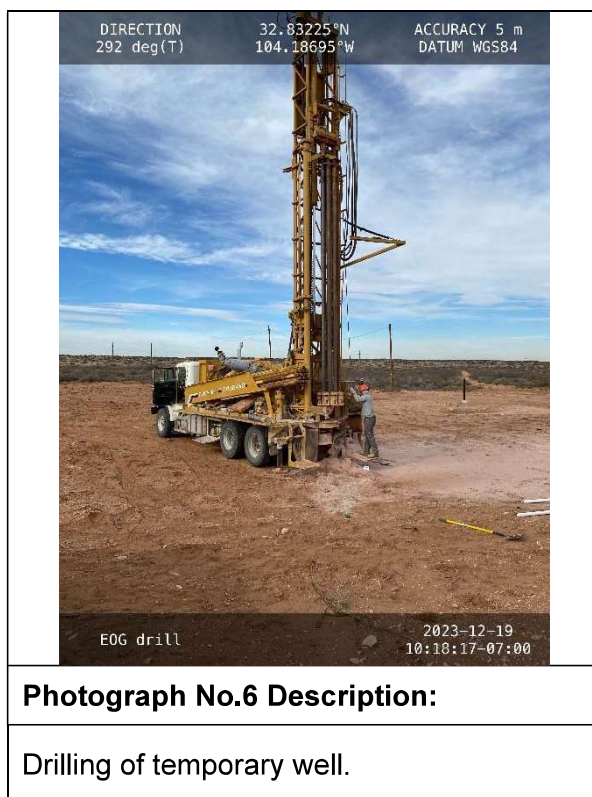
**Photograph No.6 Description:**

Drilling of temporary well.

On December 19, 2023, Talon LPE mobilized a reichdrill air rotary with a six (6) inch PDC bit to install a temporary well bore for DTW determination on location.

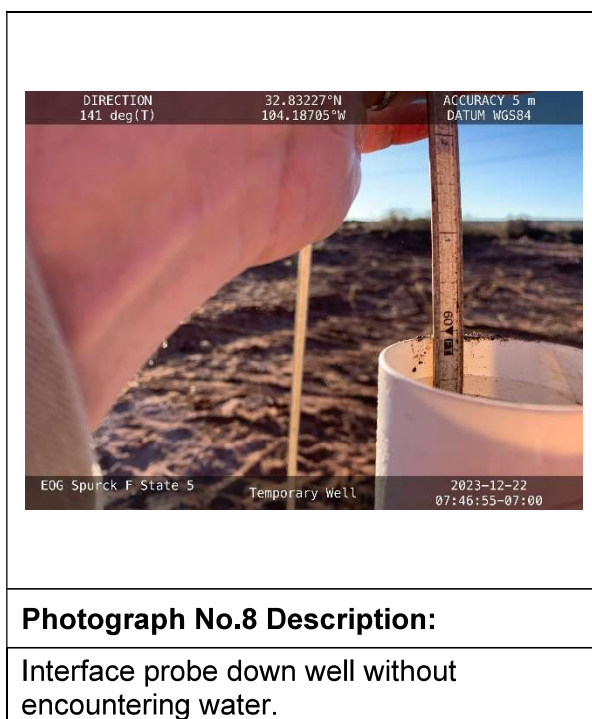
**Photograph No.8 Description:**

Interface probe down well without encountering water.
