October 11, 2023

**Re: Release Characterization and Remediation Work Plan
ConocoPhillips
Wilder CTB Vessel Release
Unit Letter A, Section 29, Township 26 South, and Range 32 East
Lea County, New Mexico
Incident ID NAPP2317132356**

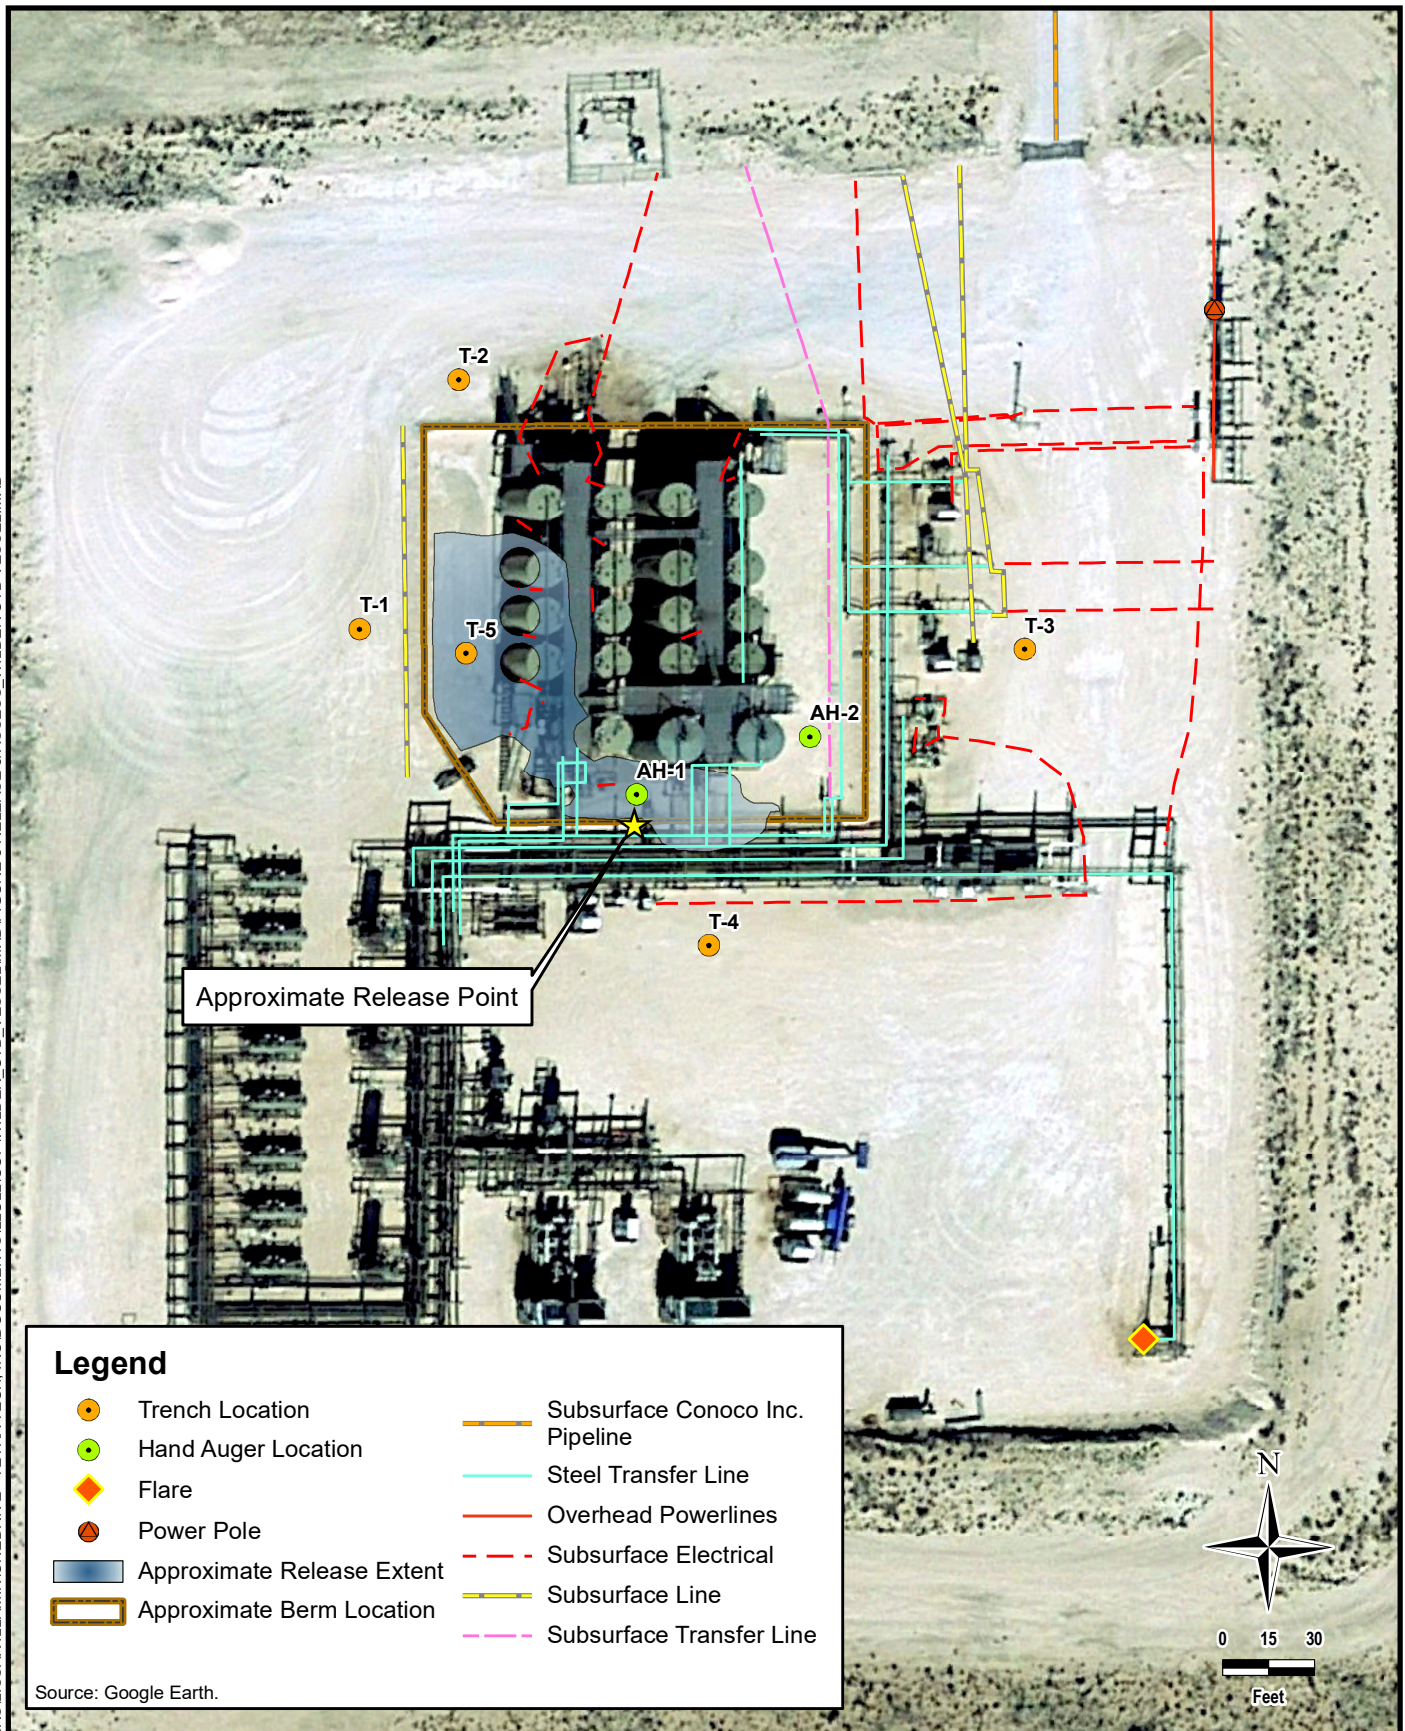
3

Tetra Tech personnel were onsite to delineate and sample the release area and the surrounding vicinity in September 2023. Soil samples were collected from seven (7) locations within and around the release to evaluate the vertical and horizontal extent of the release. AH-1 and AH-2 were installed via hand auger to depths of 4 feet bgs and 2 feet bgs, respectively. Trenches T-1 through T-4 were installed around the perimeter of the release footprint to depths of 2 feet bgs. Trench T-5 was installed within the release footprint to a depth of 11 feet bgs. The boring locations and trench locations are shown on Figure 3.

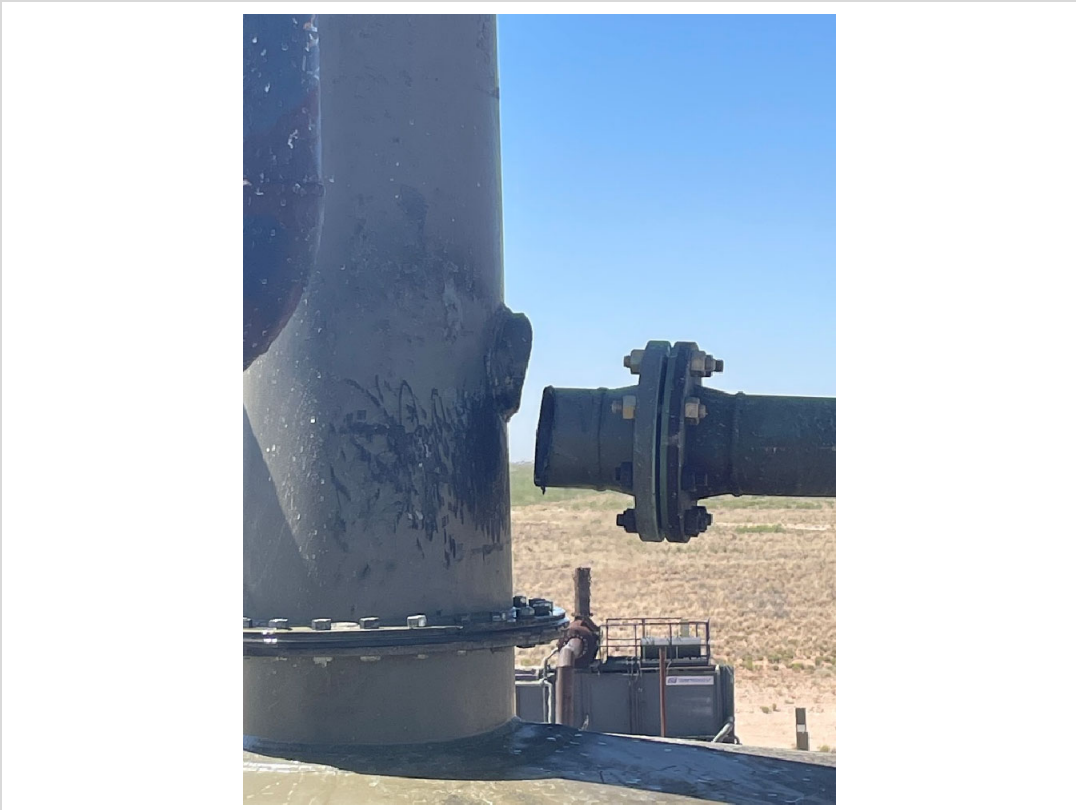
TETRA TECH, INC. PROJECT NO. 212C-MD-03183	DESCRIPTION	View unknown. Failed weld at release location.	1
	SITE NAME	WILDER CTB Vessel Release	6/2023

The release was caused by a weld failure on the gas buster due to equipment failure.
This release was within an unlined berm on the pad.
Evaluation will be made of the site to determine if we may commence remediation immediately or delineate any possible impact from the release and we will present a remediation work plan to the NMOCD for approval prior to any significant remediation activities.

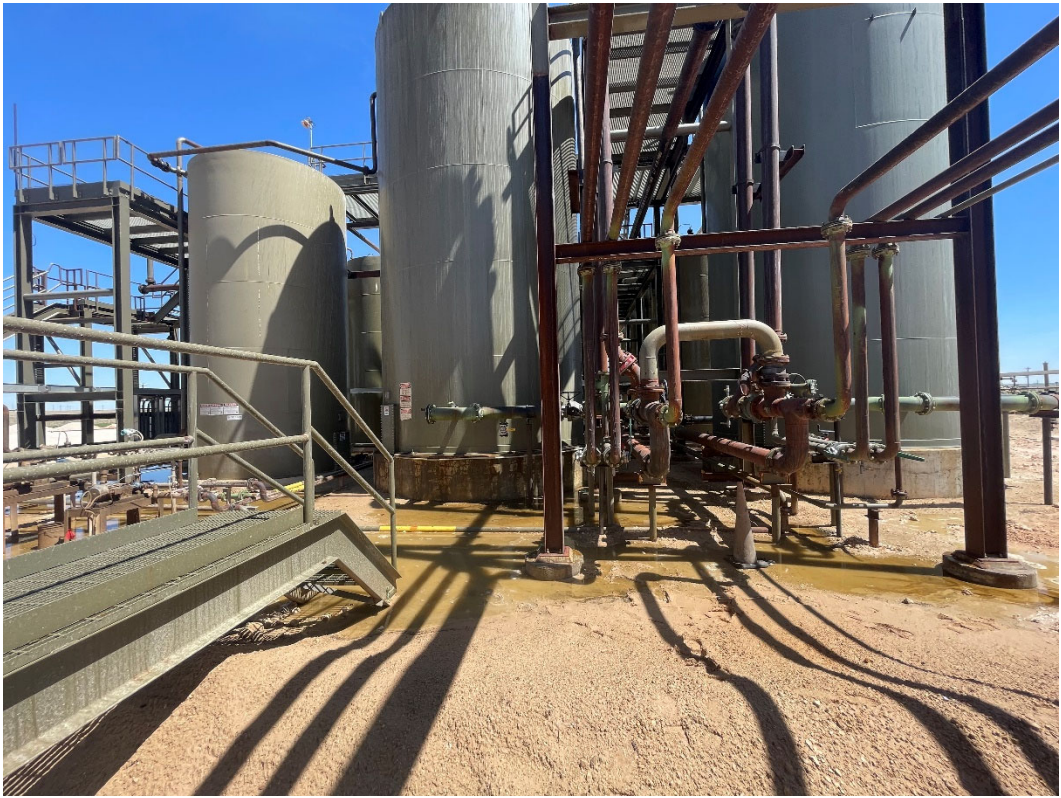
TETRA TECH, INC. PROJECT NO. 212C-MD-03183	DESCRIPTION	View north. Southeastern portion of release footprint.	2
	SITE NAME	WILDER CTB Vessel Release	6/2023

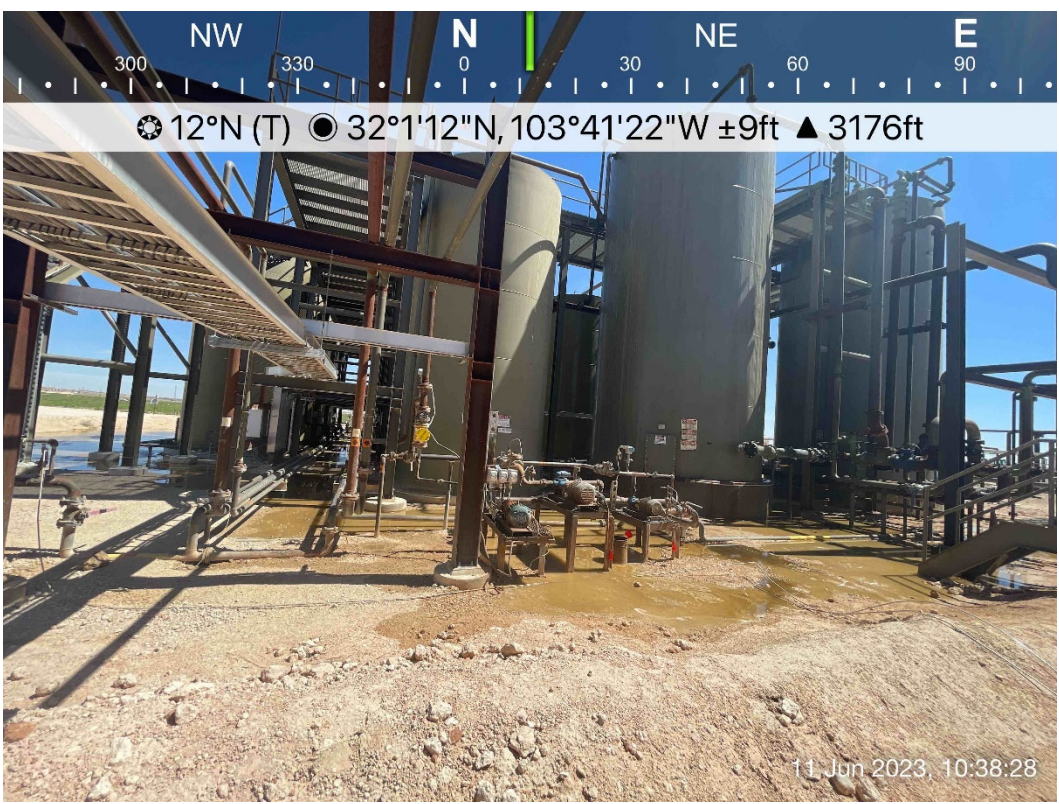
TETRA TECH, INC. PROJECT NO. 212C-MD-03183	DESCRIPTION	View north. Southern portion of release footprint.	3
	SITE NAME	WILDER CTB Vessel Release	6/2023

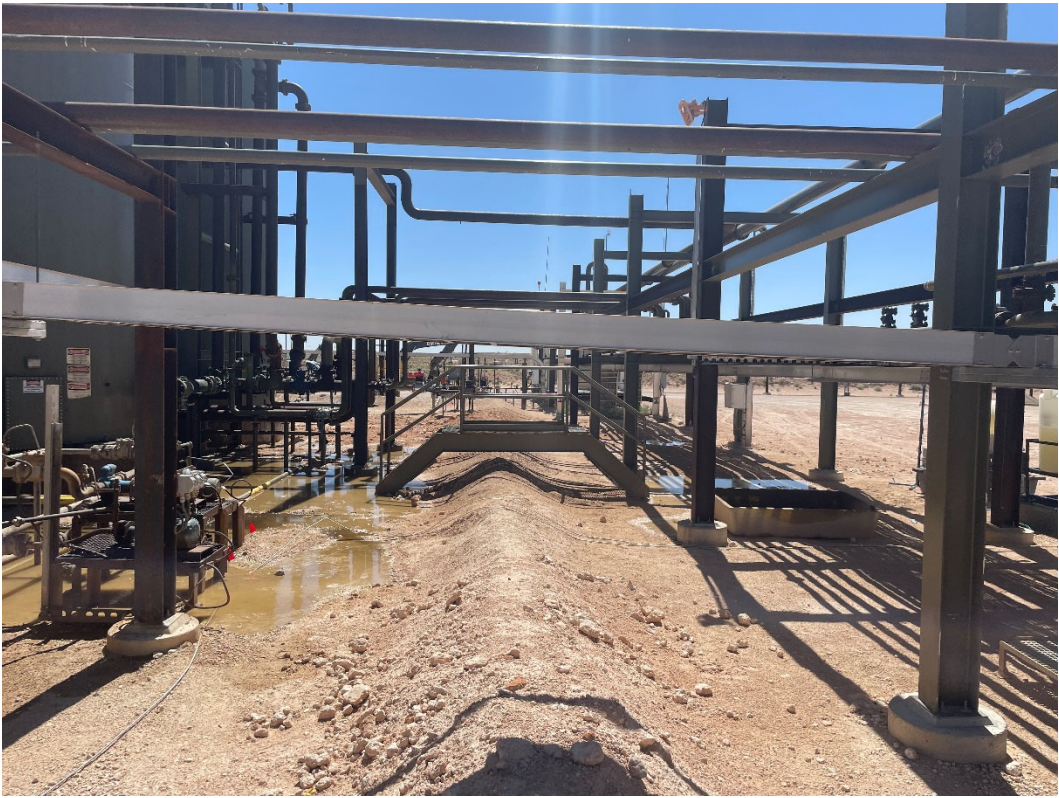
TETRA TECH, INC. PROJECT NO. 212C-MD-03183	DESCRIPTION	View east. Southern portion of release footprint. Fluid visible south of berm.	4
	SITE NAME	WILDER CTB Vessel Release	6/2023

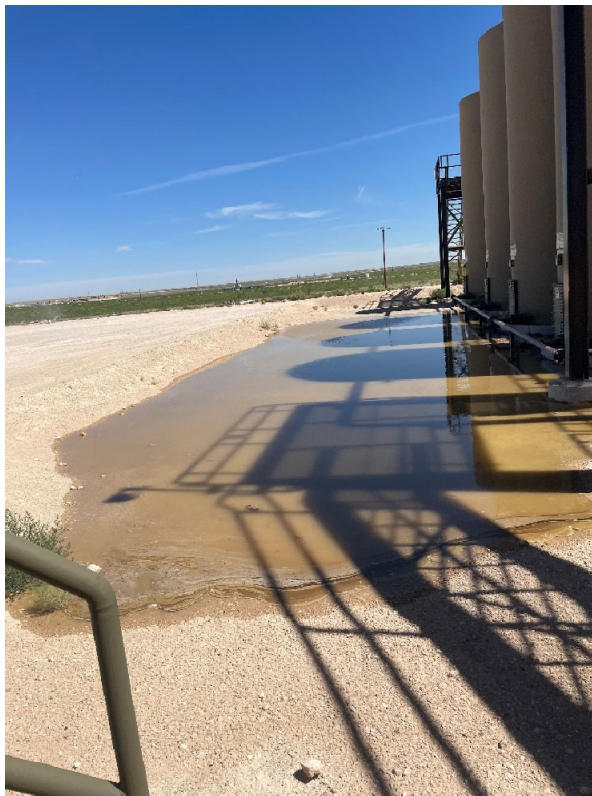
TETRA TECH, INC. PROJECT NO. 212C-MD-03183	DESCRIPTION	View north. Western portion of release footprint.	5
	SITE NAME	WILDER CTB Vessel Release	6/2023

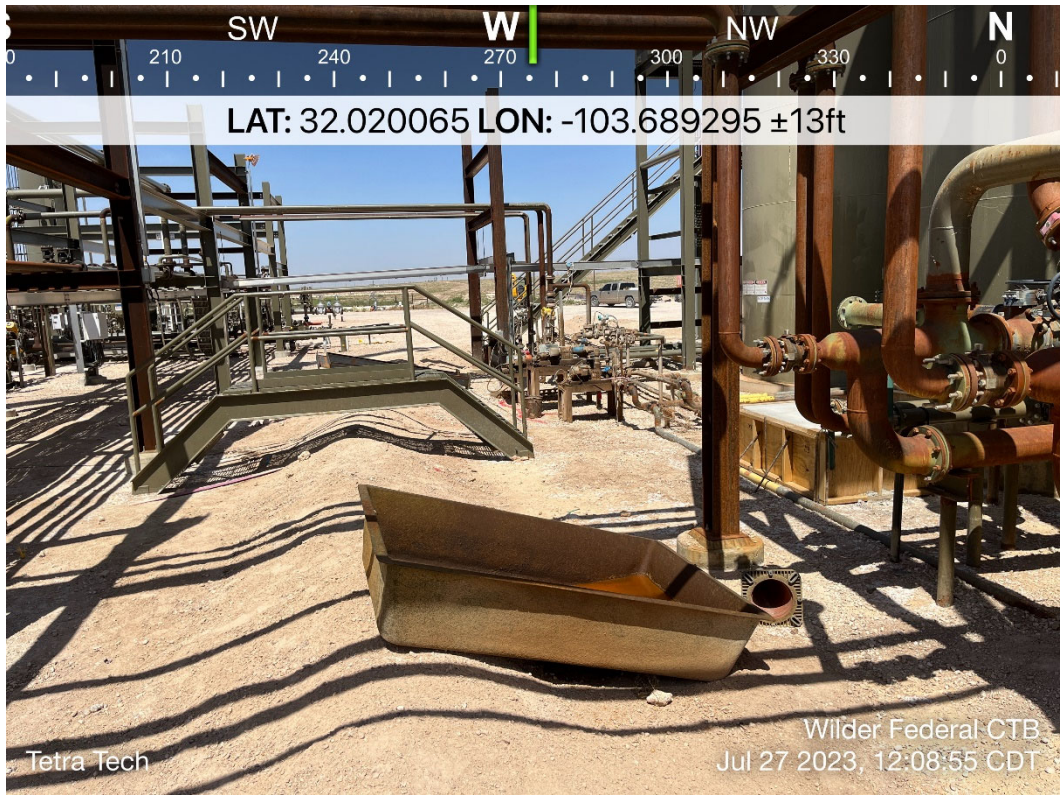
TETRA TECH, INC. PROJECT NO. 212C-MD-03183	DESCRIPTION	View west. Southern portion of release footprint.	6
	SITE NAME	WILDER CTB Vessel Release	7/27/2023

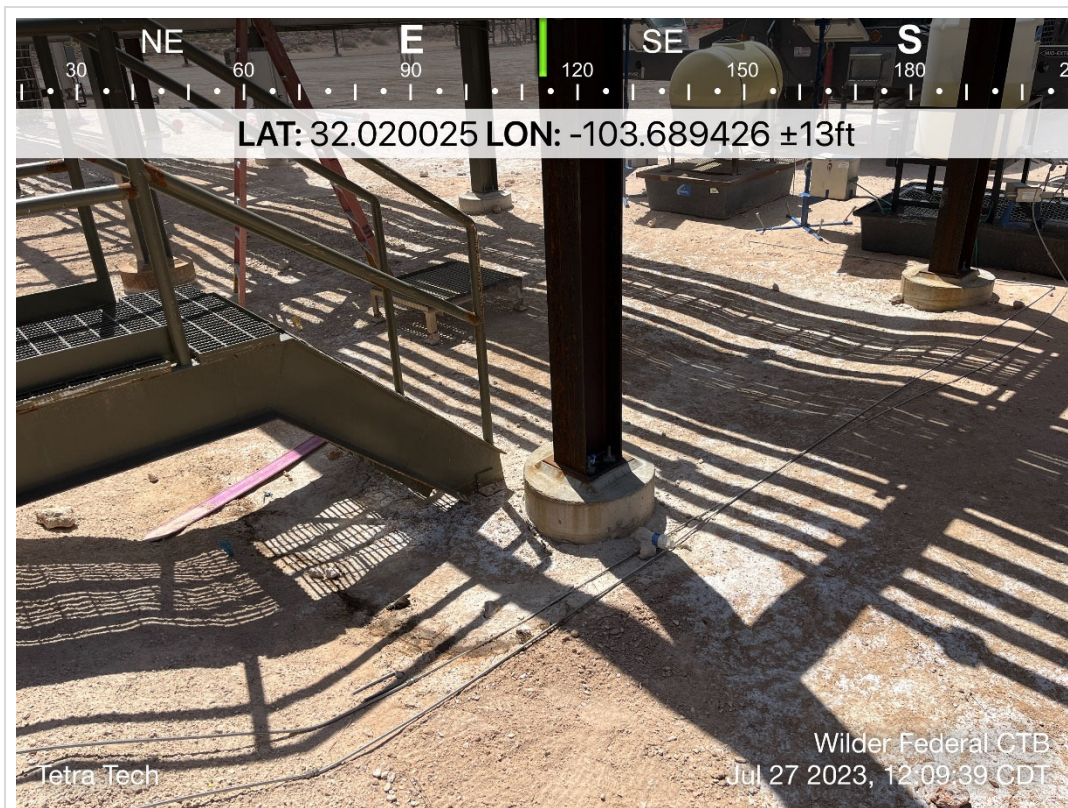
TETRA TECH, INC. PROJECT NO. 212C-MD-03183	DESCRIPTION	View east-southeast. Visible discoloration south of southern berm.	7
	SITE NAME	WILDER CTB Vessel Release	7/27/2023

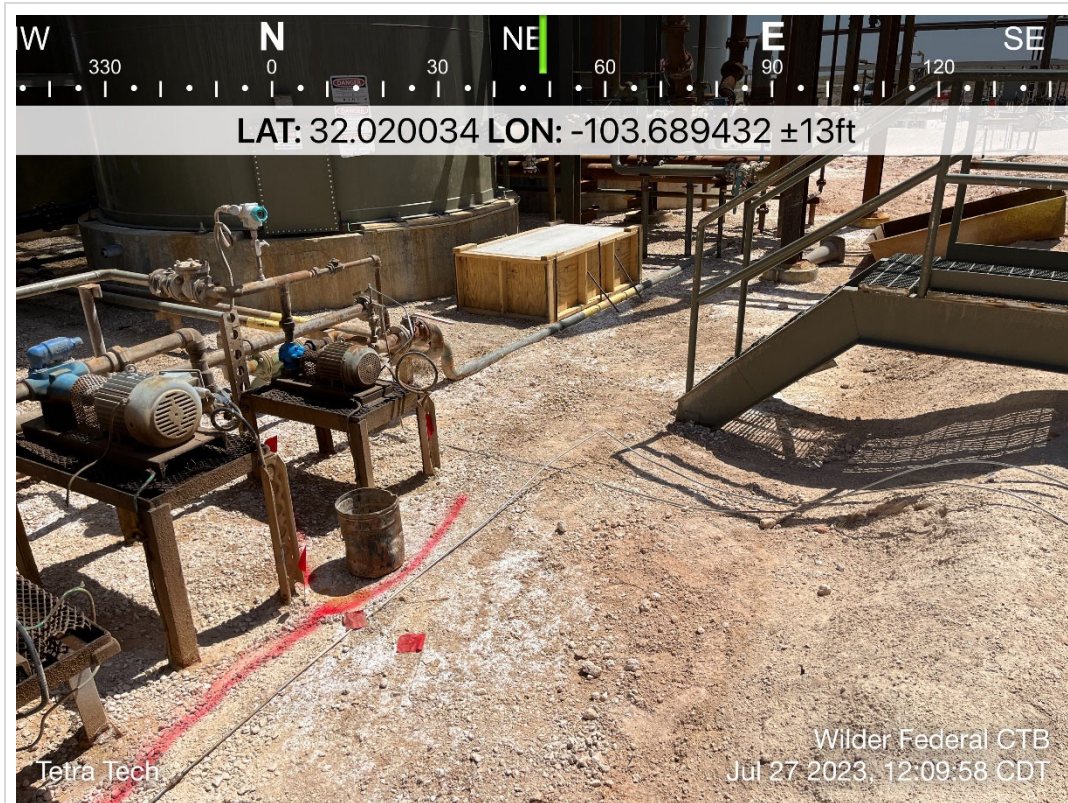
TETRA TECH, INC. PROJECT NO. 212C-MD-03183	DESCRIPTION	View northeast. Subsurface electrical line markings within southern portion of release area.	8
	SITE NAME	WILDER CTB Vessel Release	7/27/2023

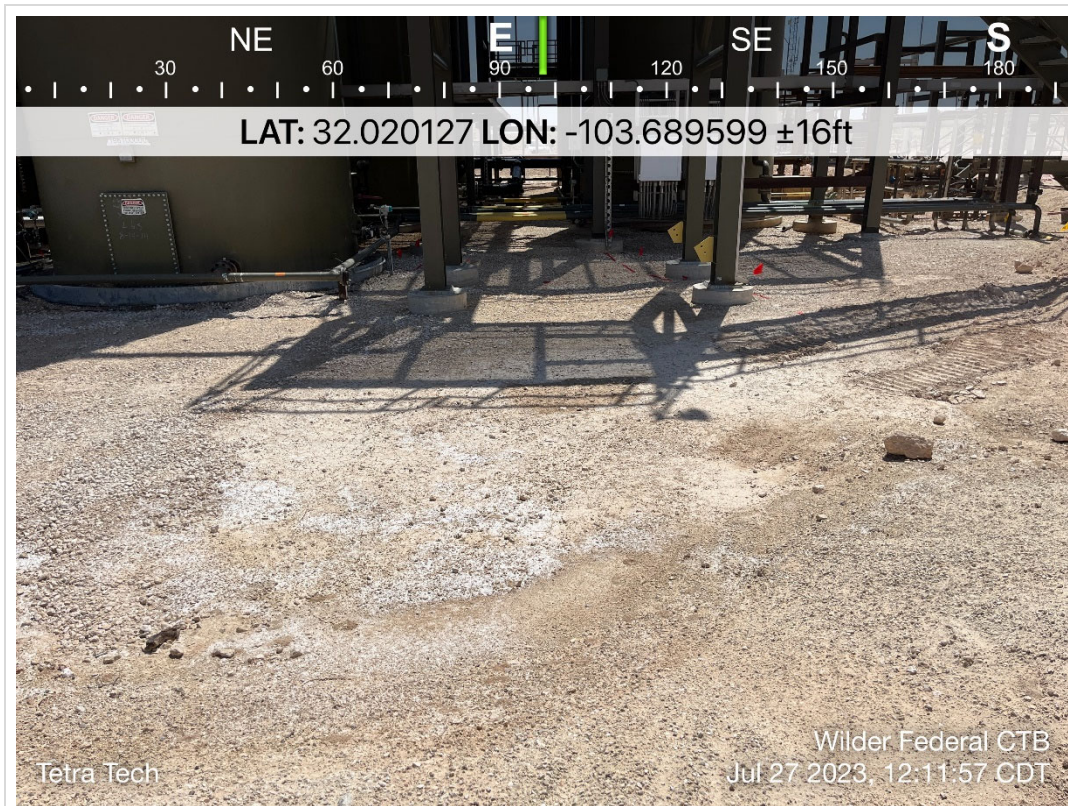
TETRA TECH, INC. PROJECT NO. 212C-MD-03183	DESCRIPTION	View east. Visible discoloration and subsurface electrical line markings within the southwestern portion of release area.	9
	SITE NAME	WILDER CTB Vessel Release	7/27/2023

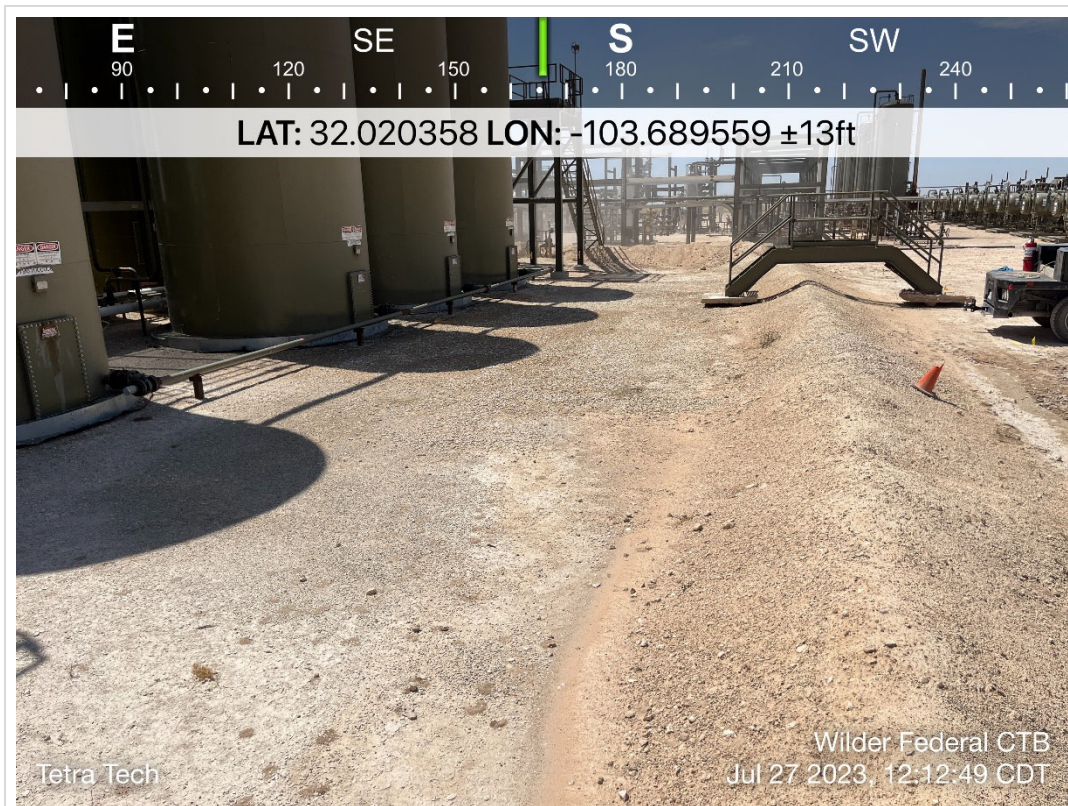
TETRA TECH, INC. PROJECT NO. 212C-MD-03183	DESCRIPTION	View south, berm along right side of photo, visible discoloration on pad surface inside berm.	10
	SITE NAME	WILDER CTB Vessel Release	7/27/2023

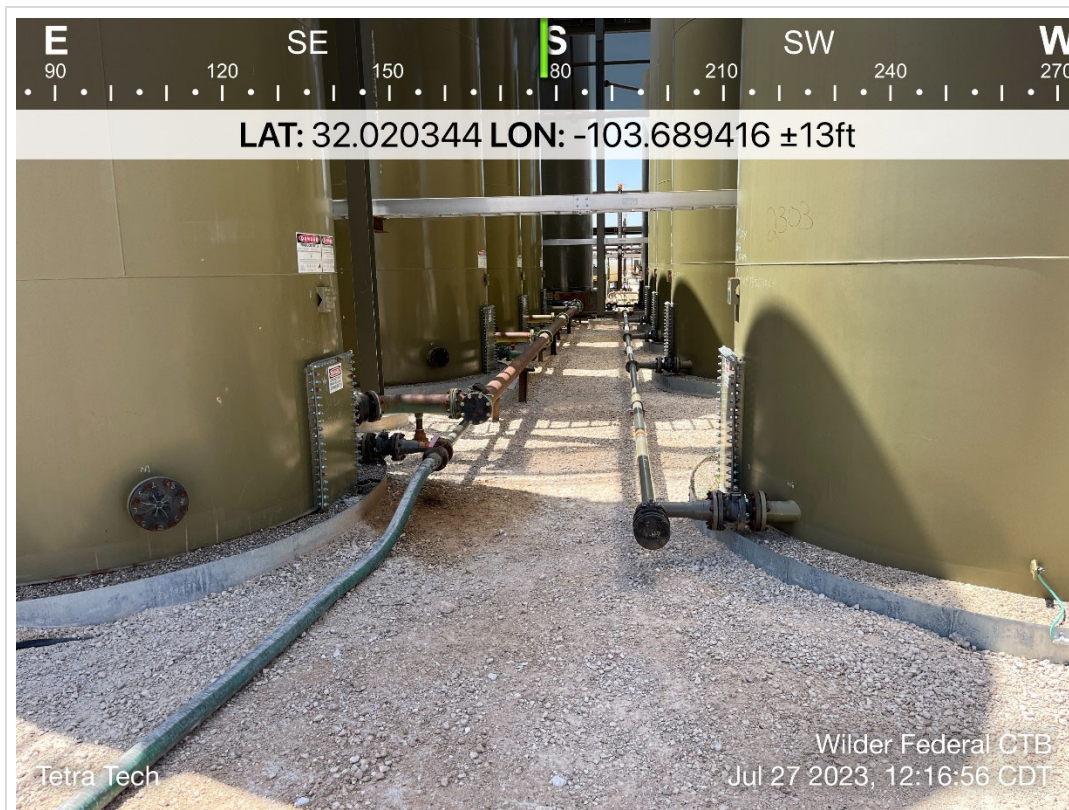
TETRA TECH, INC. PROJECT NO. 212C-MD-03183	DESCRIPTION	View south. Area east of western-most tanks. Unrelated soil staining in the foreground. Visible discoloration of pad materials from release in background.	11
	SITE NAME	WILDER CTB Vessel Release	7/27/2023

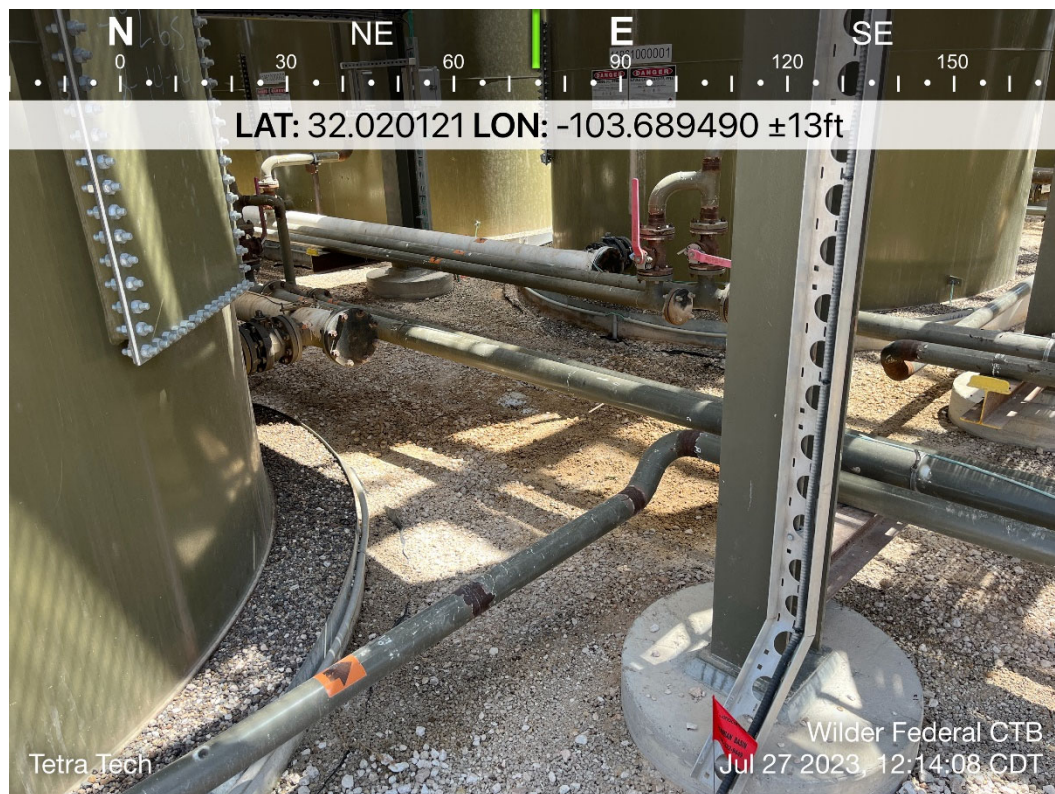
TETRA TECH, INC. PROJECT NO. 212C-MD-03183	DESCRIPTION	View southeast. Visible staining below electrical and facility lines within the tank battery.	12
	SITE NAME	WILDER CTB Vessel Release	7/27/2023

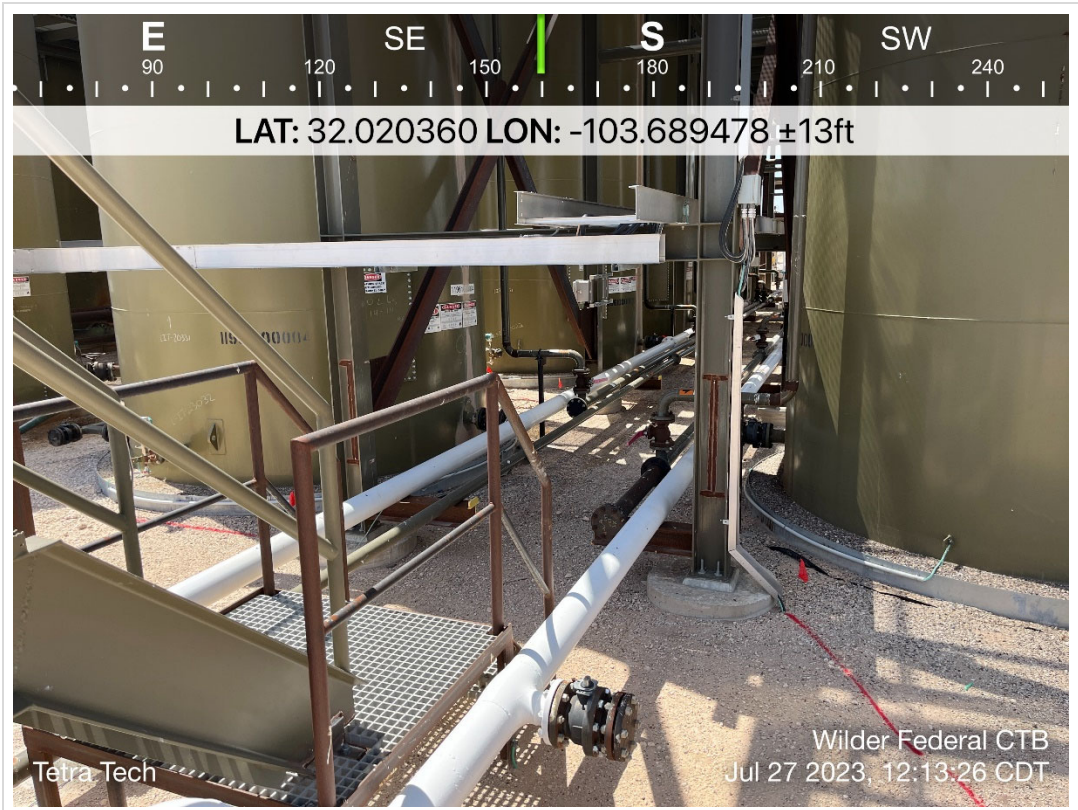
TETRA TECH, INC. PROJECT NO. 212C-MD-03183	DESCRIPTION	View south-southeast. Facility lines and subsurface electrical line markings in northwestern portion of the tank battery.	13
	SITE NAME	WILDER CTB Vessel Release	7/27/2023
