Remediation Summary & Soil Closure Request

Mewbourne Oil Company Pronghorn 15 B3DB Fed Com #1H Battery

Lea County, New Mexico
Unit Letter "D", Section 15, Township 23 South, Range 34 East
Latitude 32.3117380° North, Longitude 103.46513° West
NMOCD Reference No. nAPP2324032362

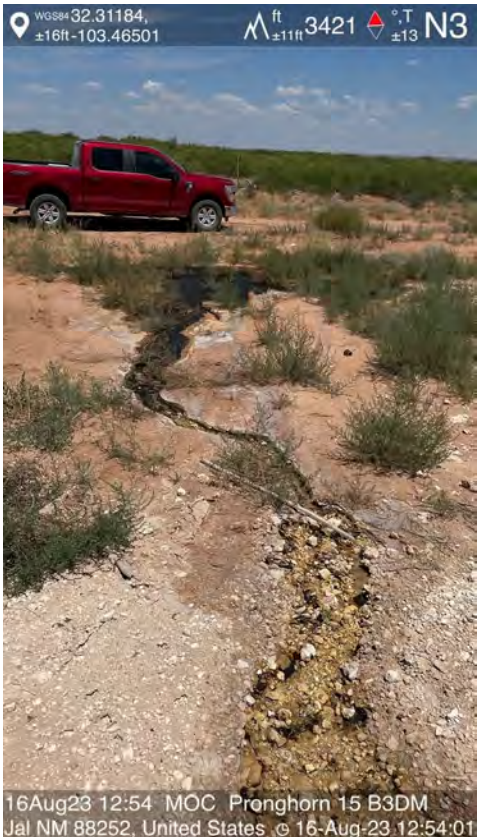
Photo Number: 3

Photo Direction: North	
Photo Description: View of the affected area.

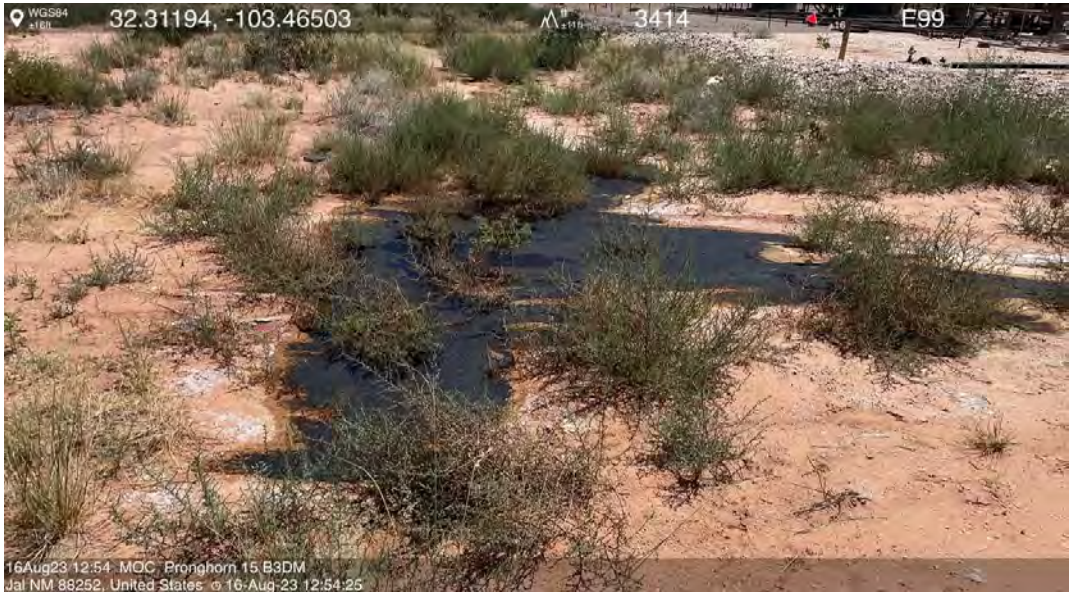
Photo Number: 4

Photo Direction: East	
Photo Description: View of the affected area.

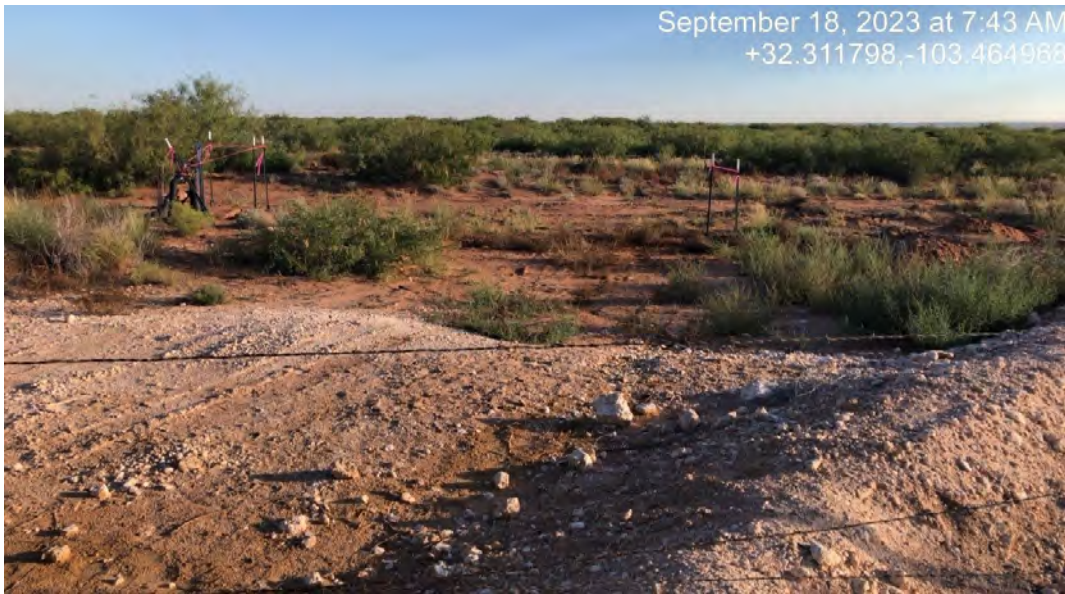
Photo Number: 7

Photo Direction: North	
Photo Description: View of the excavated area.

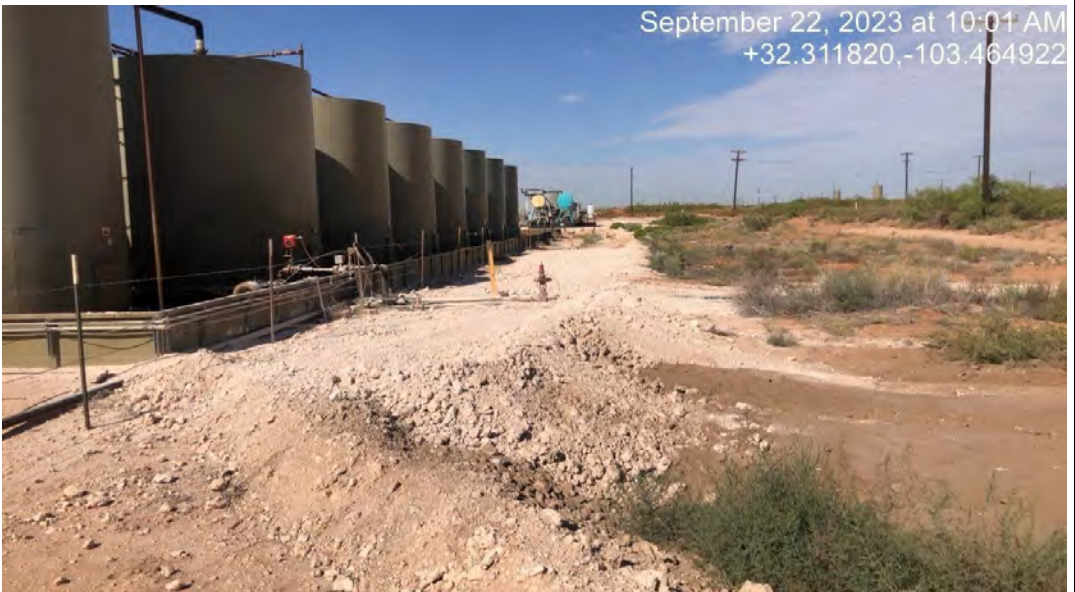
Photo Number: 10

<p>September 22, 2023 at 10:01 AM +32.311820,-103.464922</p>
Photo Direction: West-Southwest	
Photo Description: View of the remediated area after backfill and regrading.
