# **Remediation and Closure Report**

Marquardt 1 Federal #013 & #014 CTB Incident# nAPP2328269861 Eddy County, New Mexico

Cimarex Energy Co. of Colorado 6001 Deauville Blvd. Suite 300N Midland, TX 79706

H&R Enterprises, LLC 5120 W. Kansas St. Hobbs, New Mexico 88242

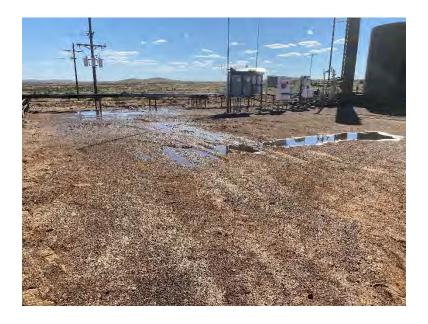
# **INITIAL PHOTOGRAPH**

On October 8, 2023, it was discovered that a gasket on the heater treater failed and released 12 barrels (bbls) of fluid inside the lined containment and 4 bbls of fluid onto the well pad. A total of 5 bbls of crude oil and 11 bbls of produced water were released with a total of 13 bbls of fluid recovered.

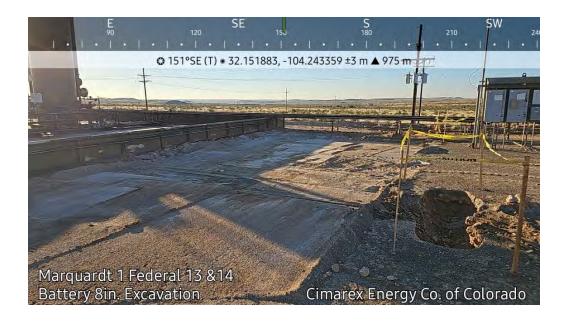
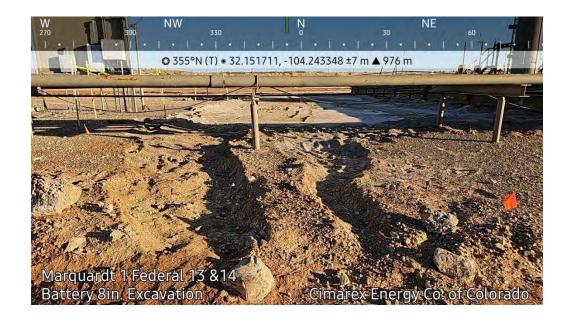
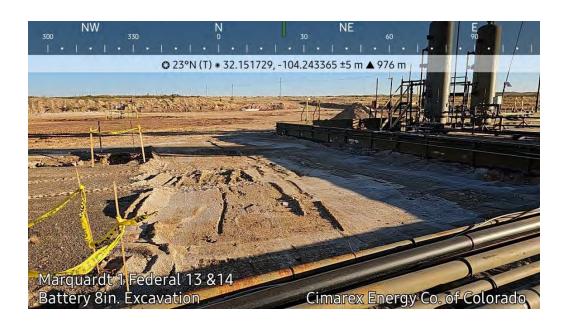
# **EXCAVATION PHOTOGRAPHS**

- The impacted areas in the vicinity of sample points S-1 through S-4 were excavated to a total depth of 0.5-feet BGS.
- Composite confirmation samples were obtained from the bottom and sidewalls of the excavated areas to verify that all contaminants above closure criteria had been removed.
- All the excavated material (12yds) was hauled to Lea Land, a NMOCD approved solid waste disposal facility.
- The excavated area on the well pad were backfilled with new caliche at depth and brought to grade, machine compacted and contoured to match the surrounding location.
- The Final C-141 formally documenting the remedial actions is attached in Appendix III.

H&R mobilized personnel to begin remediation and confirmation sampling activities of the release area. Composite confirmation samples were obtained from the bottom and sidewalls of the excavation and transported to Cardinal Laboratory for analysis. The results of that analysis are presented in the following data table. Confirmation sampling locations and excavation dimensions are illustrated on Confirmation Sample Map, Appendix I. Before, during, and after photographs of the location are attached in Appendix IV. Complete laboratory reports can be found in Appendix V.
