**Re: Closure Request  
Harroun East Tank Battery  
Incident Number nAPP2204151142  
Eddy County, New Mexico**

BTA Oil Producers, LLC  
Closure Request  
Harroun East Tank Battery

BTA Oil Producers, LLC  
Harroun East Tank Battery  
Incident Number: nAPP2204151142  
Unit O, Sec 34, T23S R29E  
Eddy County, New Mexico

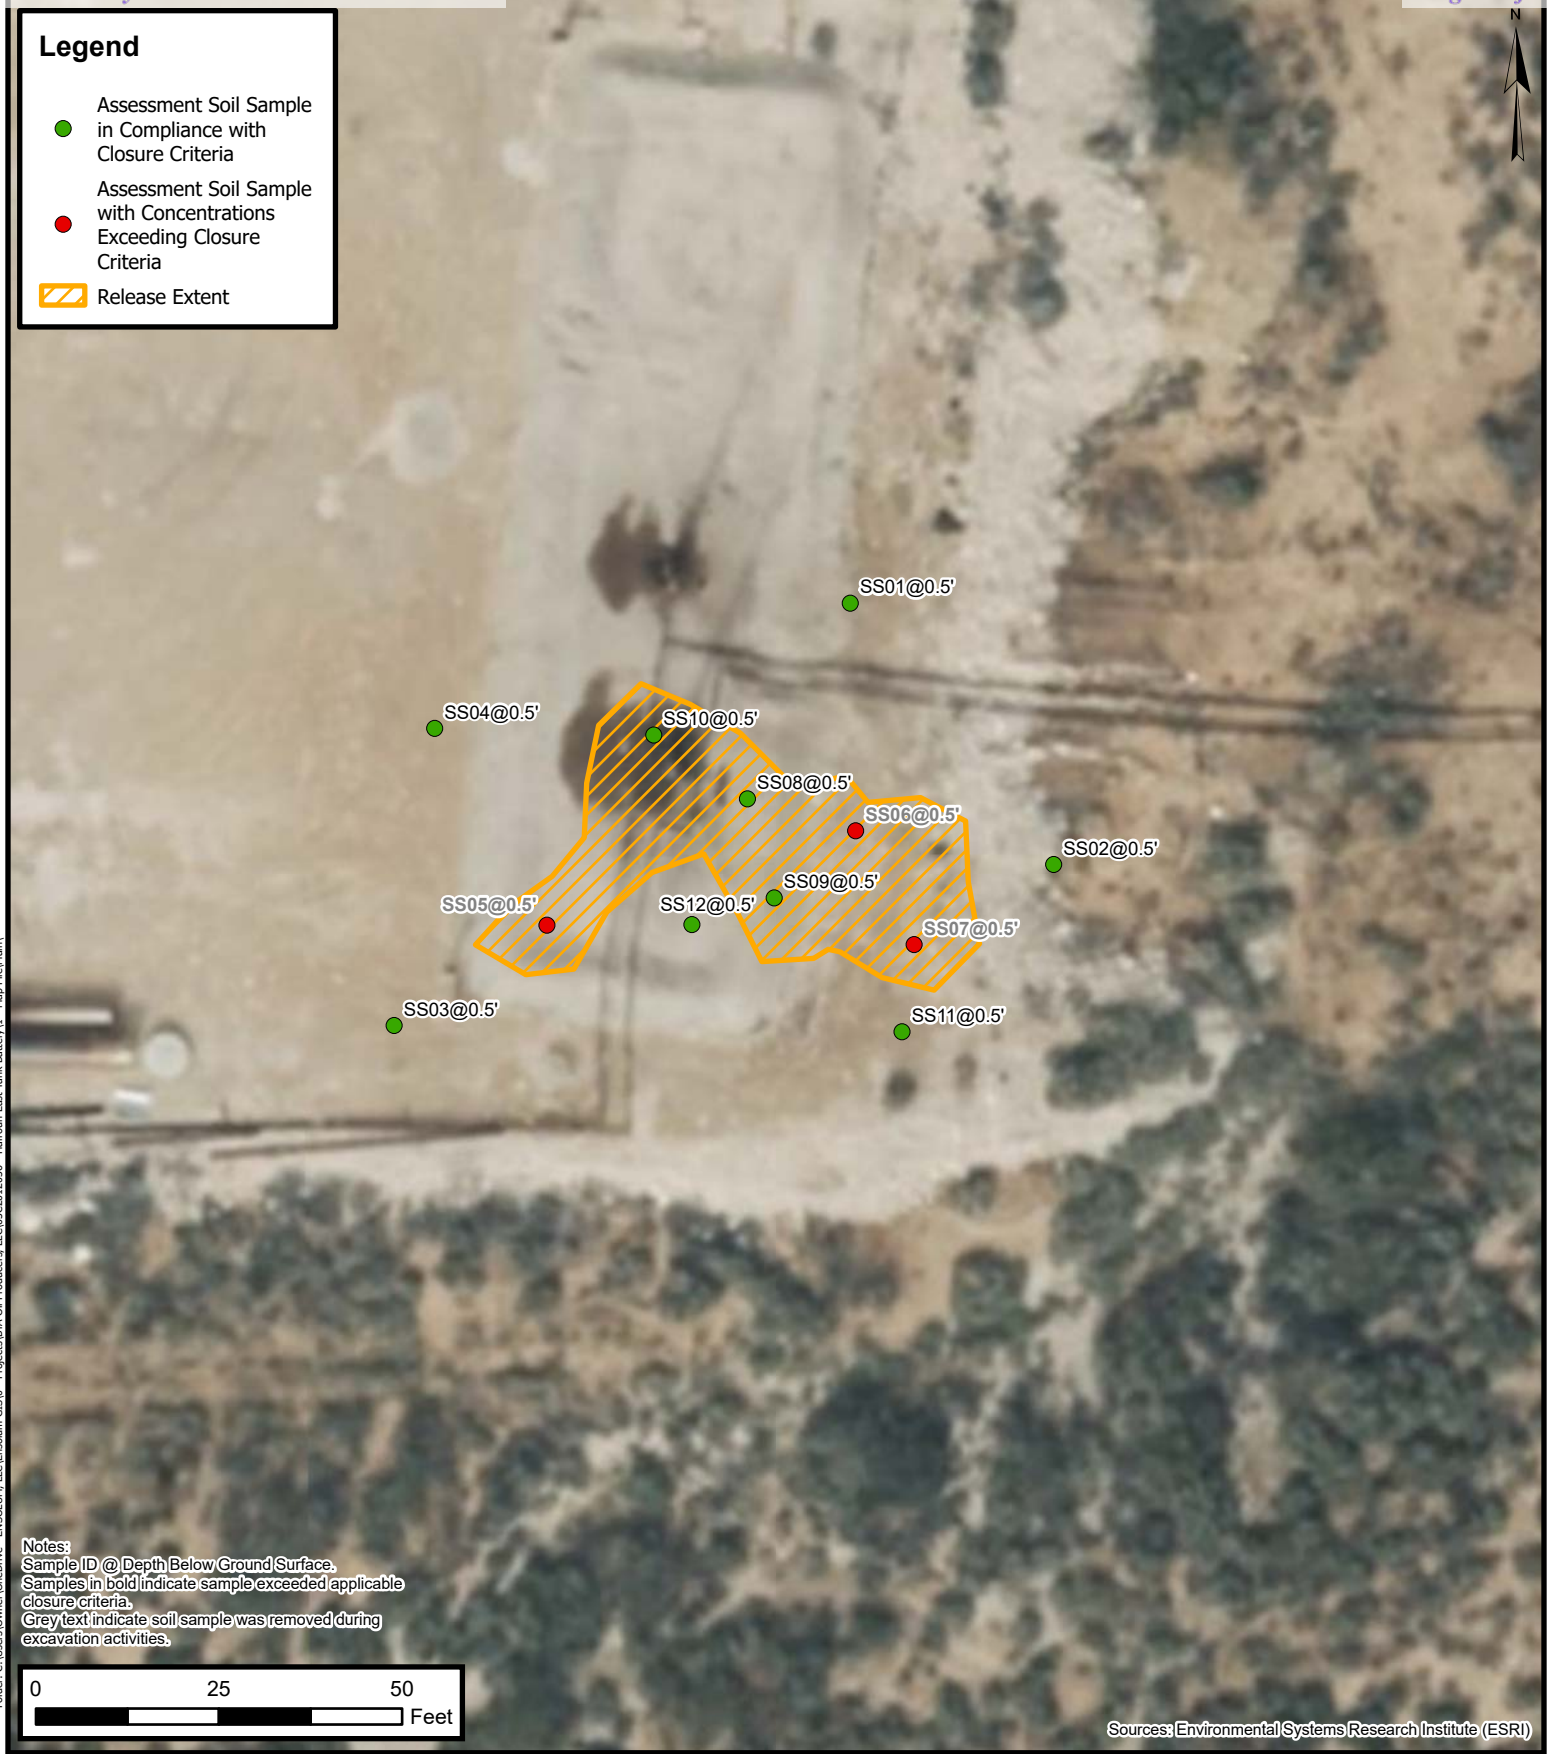
## Assessment Soil Sample Locations

Laboratory analytical results for assessment samples SS01 through SS04, SS11, and SS12, collected around the release extent, indicated all COC concentrations were compliant with the Site Closure Criteria and successfully defined the lateral extent of the release. Laboratory analytical results for assessment samples SS08 through SS10, collected within the release area, indicated all COC concentrations were compliant with the Site Closure Criteria. Laboratory analytical results for assessment samples SS05 through SS07, collected within the release area, indicated TPH and/or chloride concentrations exceeded the Site Closure Criteria. Based on laboratory analytical results for assessment samples SS05 through SS07, excavation activities were warranted.

- Assessment Soil Sample in Compliance with Closure Criteria
- Assessment Soil Sample with Concentrations Exceeding Closure Criteria
- ▨ Release Extent

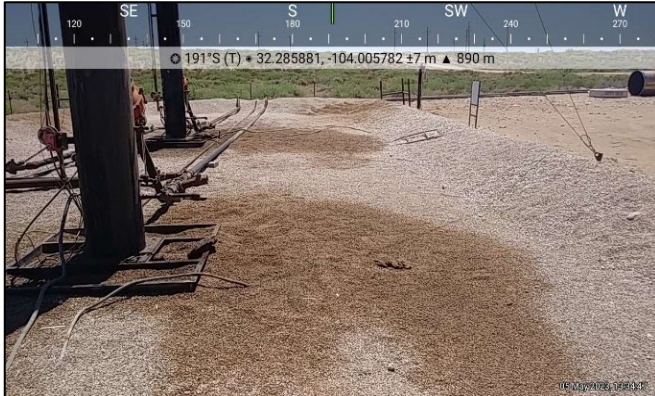
Photograph: 1                      Date: 5/5/2023  
Description: Soil staining during initial assessment  
View: South

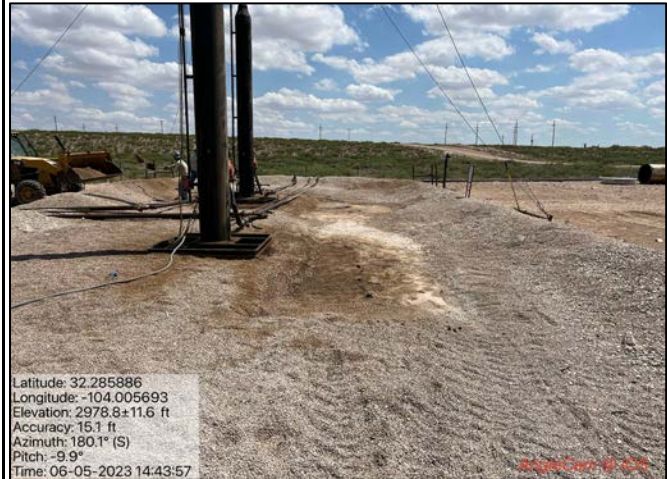
Photograph: 2                      Date: 6/5/2023  
Description: Excavation activities  
View: Southwest

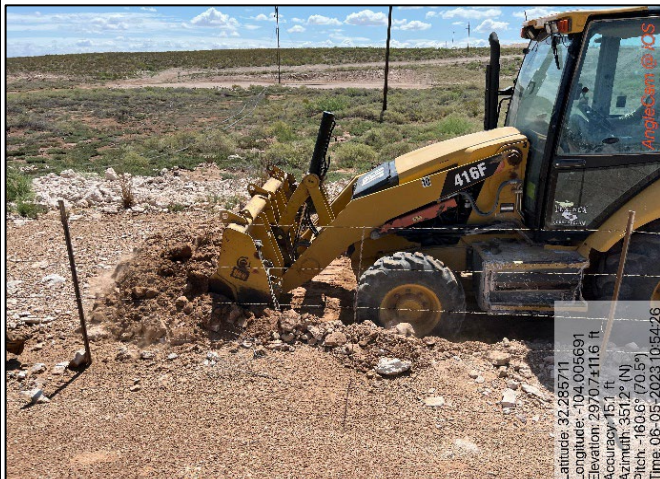
Photograph: 3                      Date: 6/5/2023  
Description: Excavation activities  
View: East

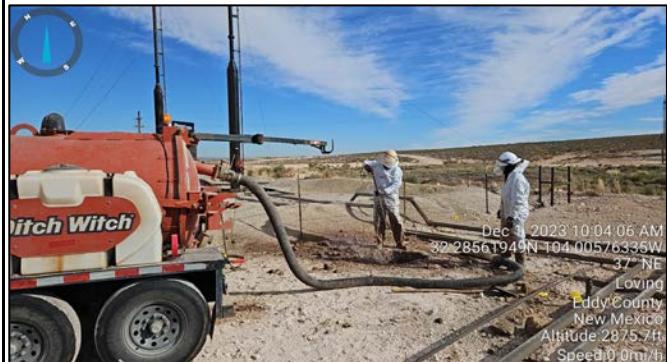
Photograph: 4                      Date: 12/1/2023  
Description: Excavation/Hydrovac activities  
View: Northeast
